SIO Shipyard Representative Bi-Weekly Progress Report		
Project: AGOR 28	Contract No.: N00014-12-C-0305	Shipyard: Dakota Creek Industries
Prepared by: Paul D. Bueren Scripps Institution of Oceanography (SIO) 297 Rosecrans St. San Diego, CA 98106	Date: 18 May 2016	Program Officer: Robert (Tim) Schnoor Office of Naval Research 875 Randolph St ONR 321 Arlington, VA 22203-1995
Distribution Statement A: Approved for public release; distribution unlimited.		Report No. A002.099

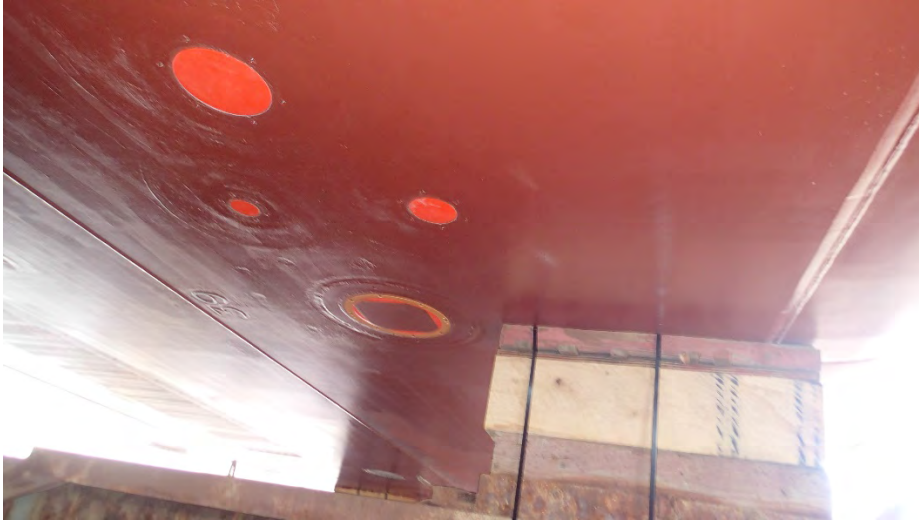
Figure 1EK80 Single Beam Transducers This is prior to the yard adding a light coat of AF.

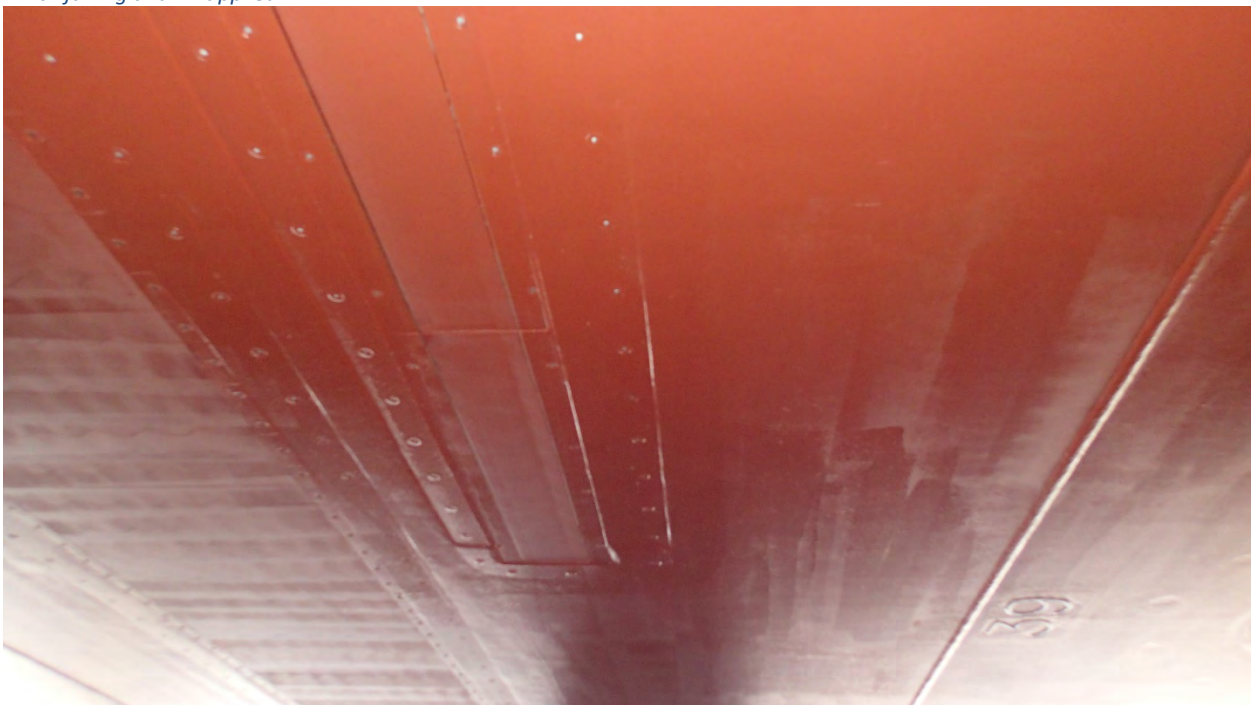
Figure 2EM712 With fairing and AF applied.

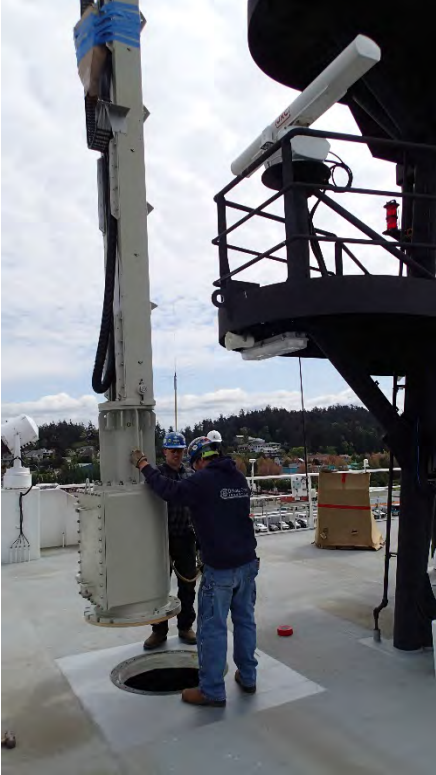
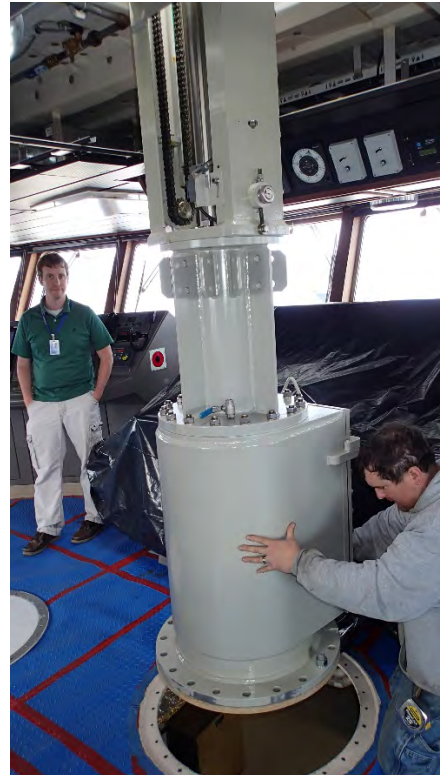
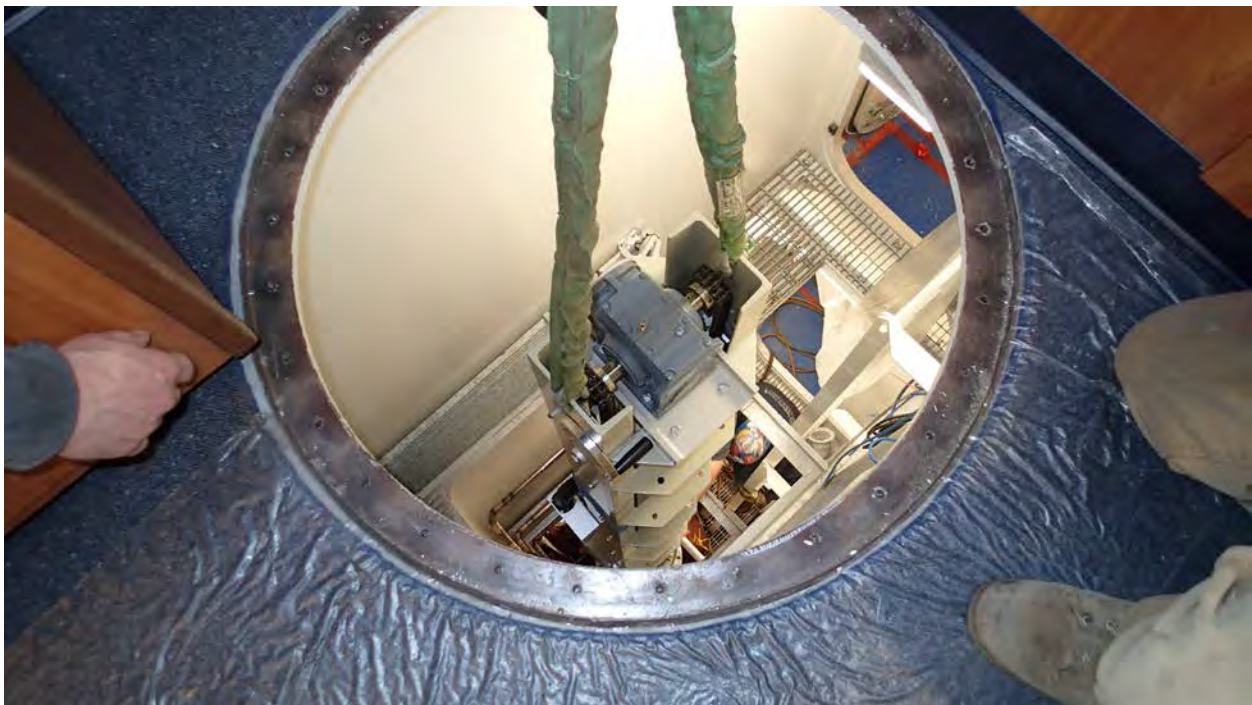
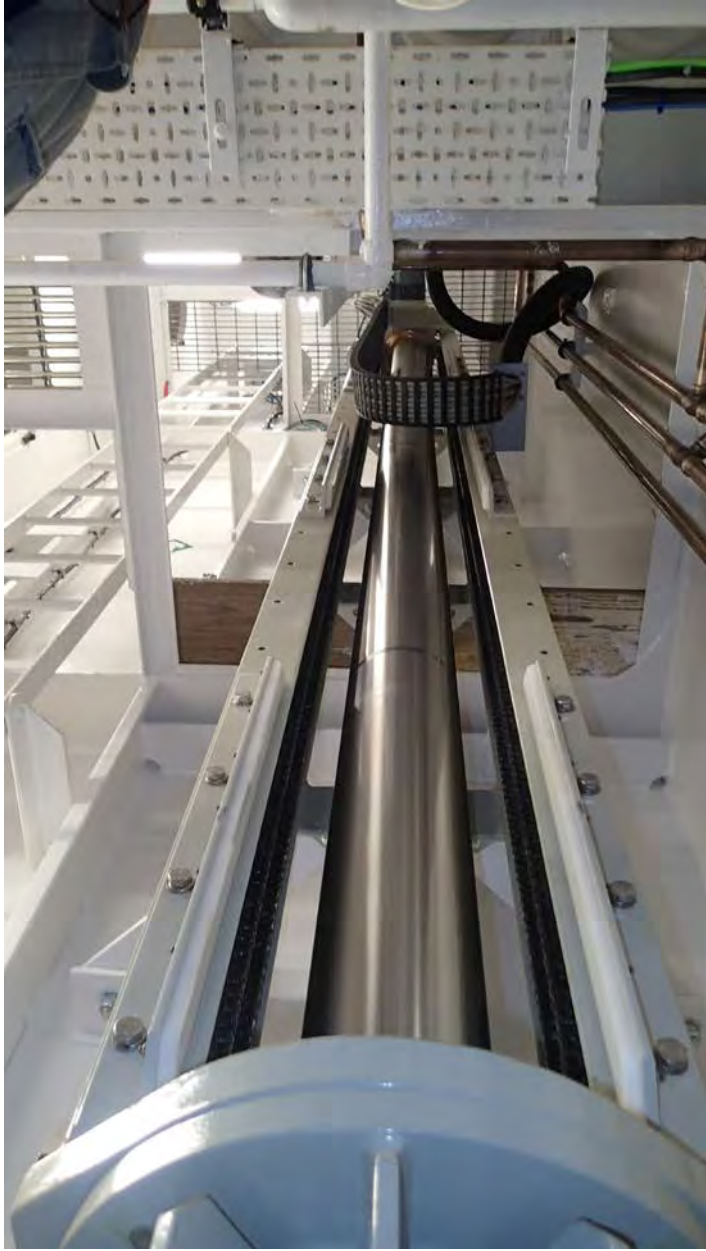
Figure 3 HiPap Install 28 April

- HiPAP Installation – The HiPAP has been installed. Yard continues to make the interconnects and is currently installing the hydraulic lines to the sea valve actuator. The actual installation went very smoothly.

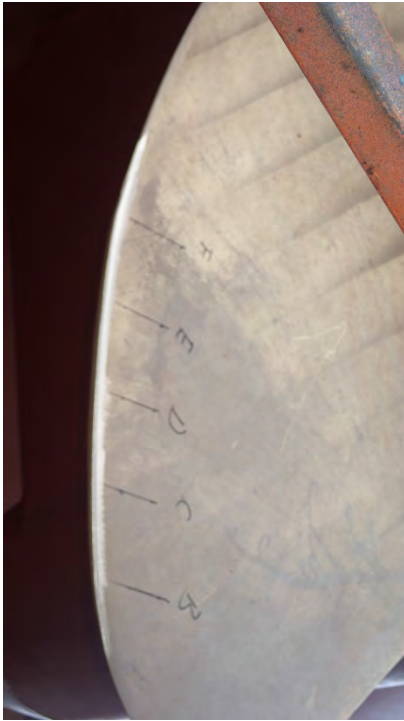
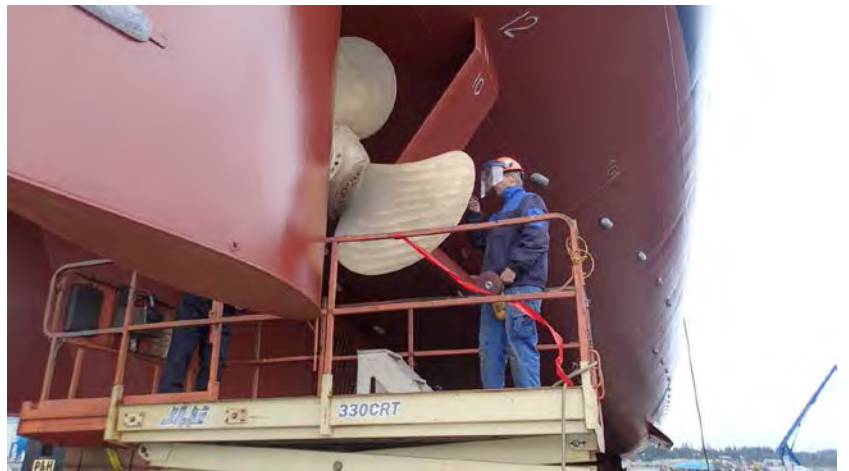
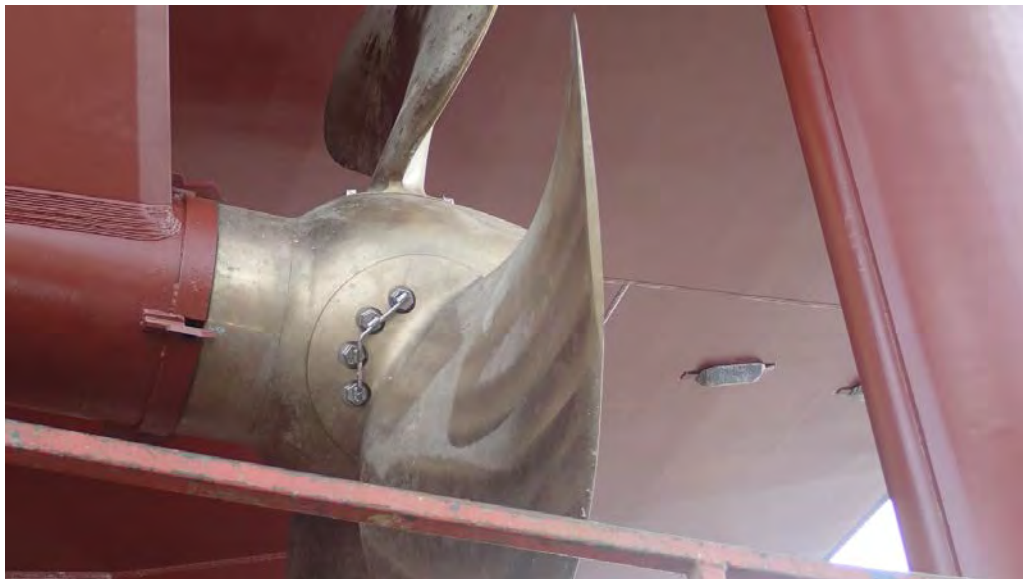
- Propeller Tips -
The local Hundested vendor and a technician from Norway were on site. They broke the edges on the blade tips on both props. The tech had half a dozen machined gauges that he used to ensure that the final profile was correct. The blade tips now have a more rounded profile compared to the original flat end with sharp 90-degree angles on the suction and trailing edges.

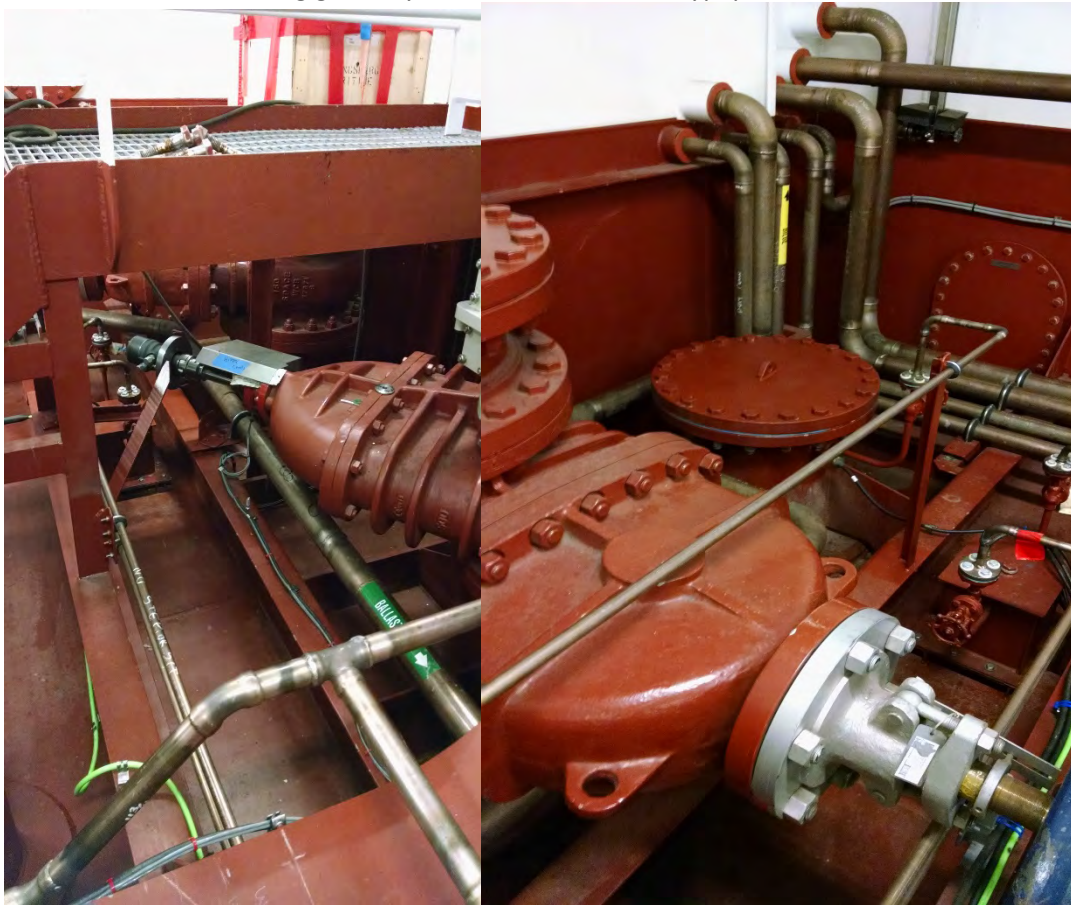
Transducer Room looking good, hydro-electric valve for Hypap .
