## **Matthew Jones House: Recommendations for Treatment**

April 2016

Final report

Prepared for Civil Engineer Division, 733d Mission Support Group  
Joint Base Langley-Eustis  
Fort Eustis, VA 23604

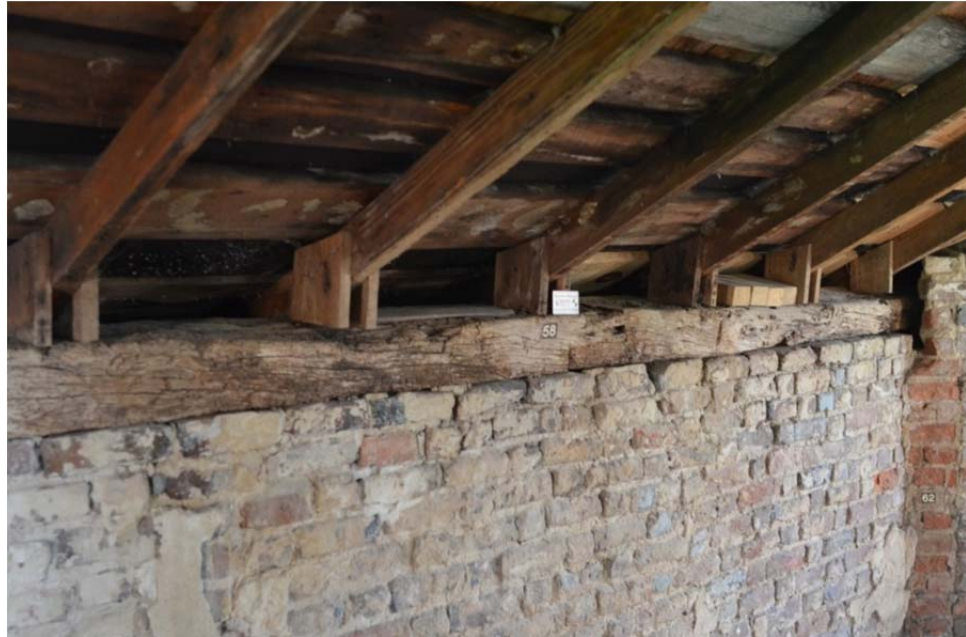
Roof sheathing was not physically inspected during the site visit, except where accessible from the ground floor in the rear chamber. Sheathing exhibits visible signs of water-related damage and should be inspected further to determine its condition and suitability for continued use (Figure 6).

**Figure 6. Exposed rafters and sheathing in rear chamber exhibiting signs of past and ongoing water damage. (NCPTT, 2015)**

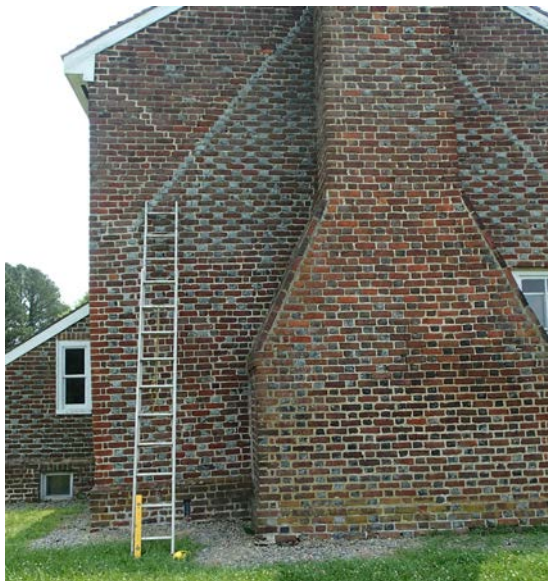
The Period II/III gable end wall is in the shape of an inverted U, and surrounds, but is not engaged with, the Period I chimney mass and fireplace opening. The Period II/III wall is weakened by the decay of the embedded Phase I timber top plate which extended from the mass of the fireplace to the corners of the building at the level of the Period I/II loft and Period III second floor. Above the line of the beam pocket, the Period II/III wall appears to be rotating inward about three axes – the two vertical axes at the exterior corners and the horizontal axis where the masonry section is weakened by the void for the no-longer extant/intact wall plate. The upper corners of the wall may also be rotating about the joint of the Phase II/III intersection. The corresponding exterior and interior crack patterns in the wall are more pronounced at the north end than the west end, possibly because the pocket for the wall plate on the west end was supplemented with steel reinforcement whereas the north end was not.

Matthew Jones House crack at Northwest  
Photo credit: Michael C. Henry

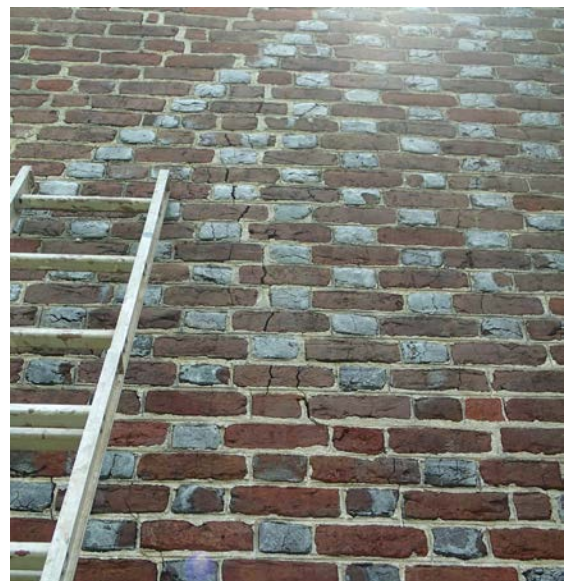
Matthew Jones House Crack Detail  
Photo credit: Michael C. Henry
