Evaluation of the Structural Performance of CTS Rapid Set Concrete Mix®

Lucy P. Priddy, Haley P. Bell, Lulu Edwards,
William D. Carruth, and James F. Rowland

August 2016

Final report

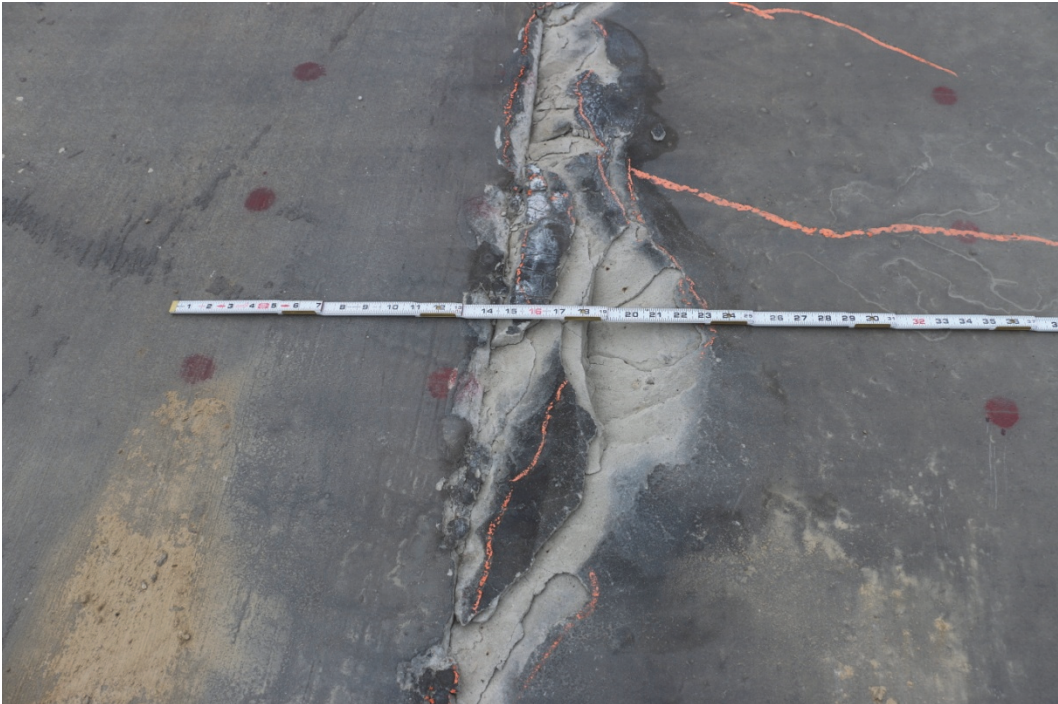
Figure 7. Joint spall presenting high FOD (swept) and tire damage potential.

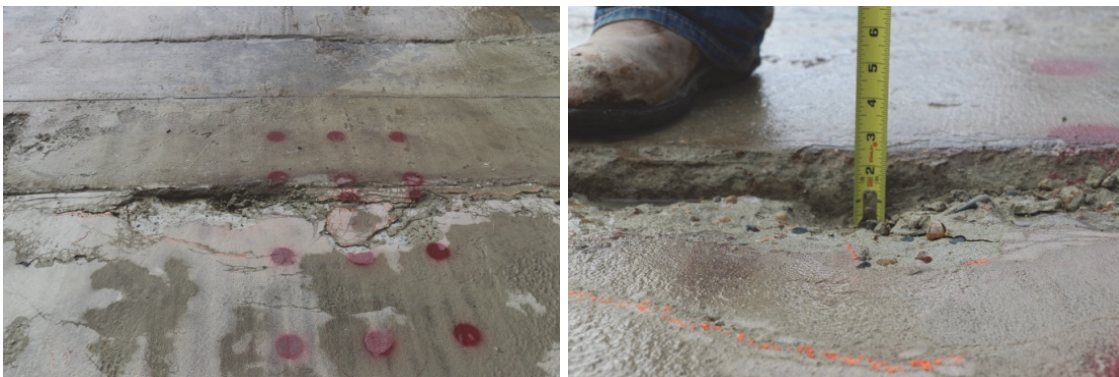
Figure 20. Series 1, Repair 1 - west edge at failure (560 passes).

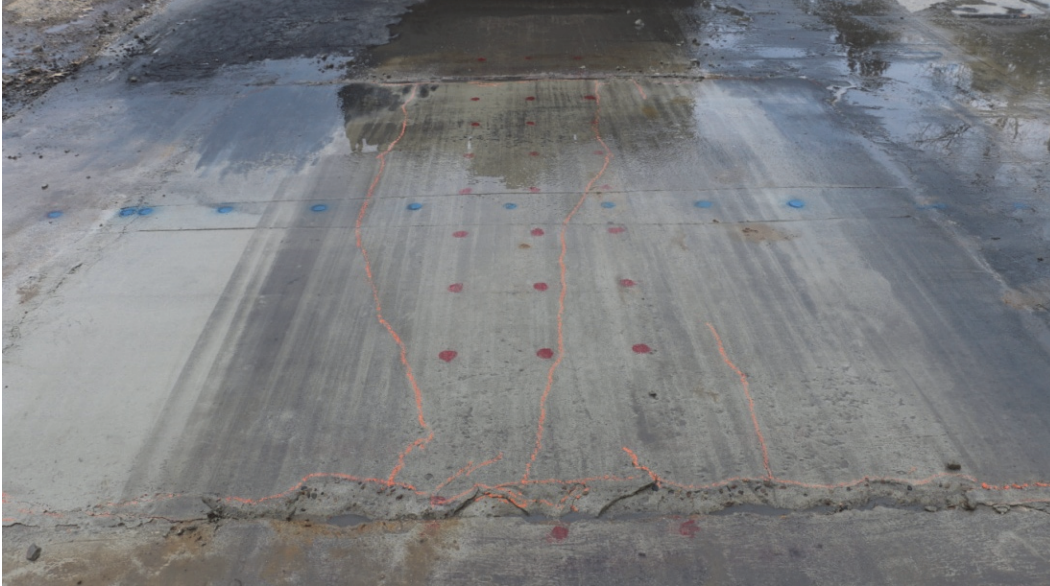
Figure 21. Series 1, Repair 2 - overall at failure (1,750 passes).

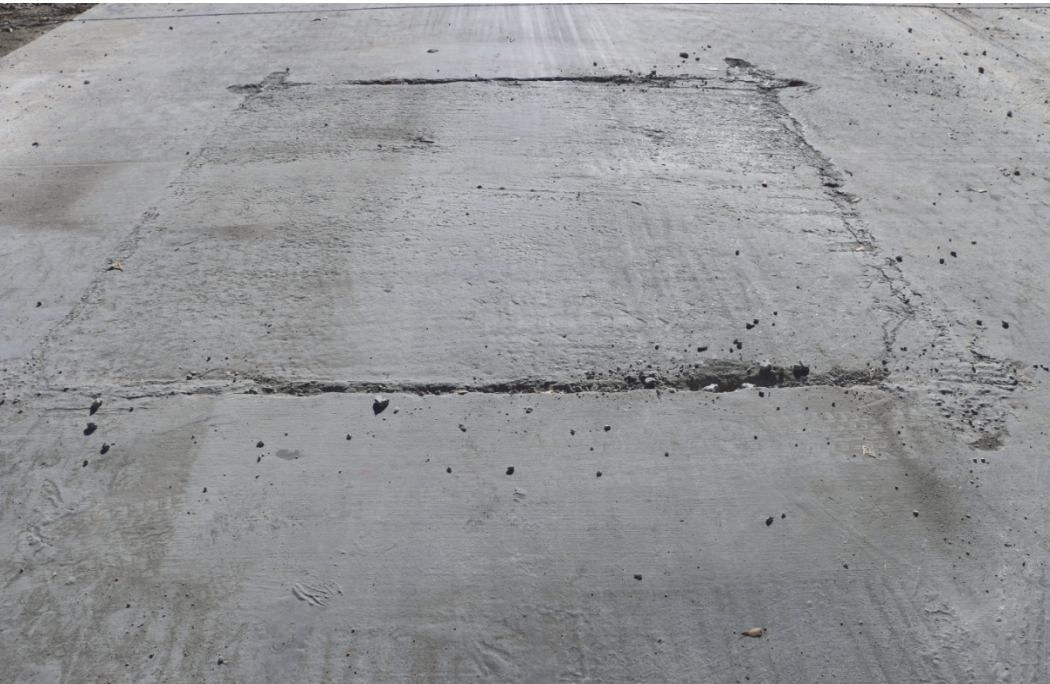
Figure 22. Series 1, Repair 3 - overall at failure (3,000 passes).

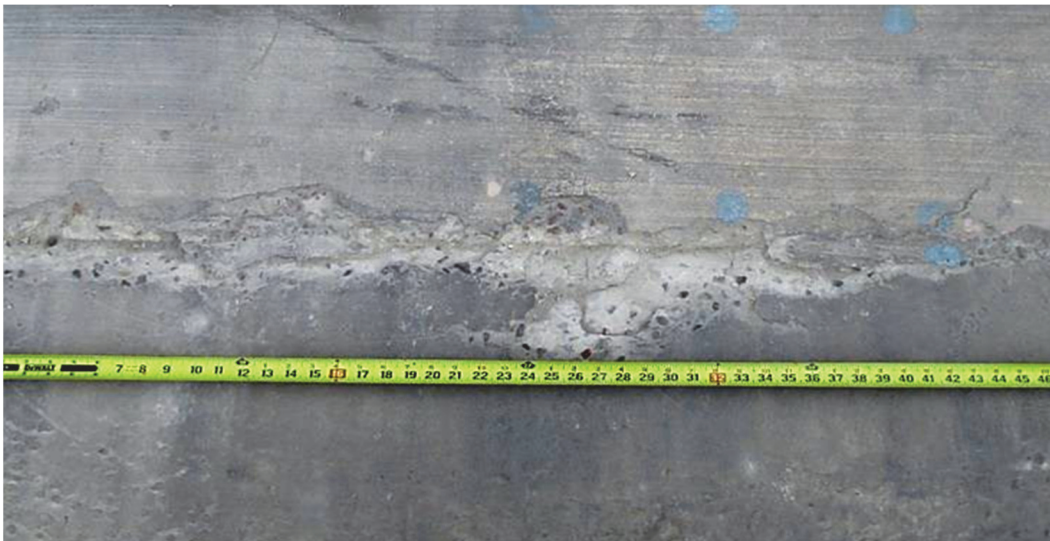
Figure 23. Series 2, Repair 6 - east edge at failure (1,300 passes).

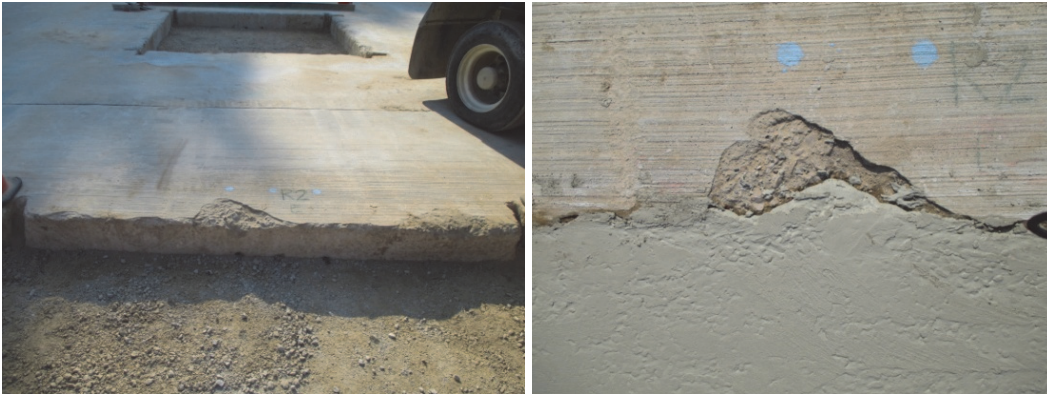
The main mode of failure for Repairs 7-1 and 7-2 was spalling along the transverse joints (joints perpendicular to the direction of travel). Repair 7-1 likely failed prematurely after 2,500 passes due to the condition of the adjacent parent PCC along the east edge of the repair. The parent PCC was severely damaged during the repair process, with spalled areas approximately 6 in. by 6 in. and 0.125 in. deep prior to traffic. During the capping of this repair, rapid-setting concrete was used to partially patch these areas; however, the material quickly deteriorated during the first 500 passes and was not repaired during trafficking. Figure 24 shows the damaged area prior to capping and prior to trafficking. Failure occurred at 2,500 passes (Figure 25).

Figure 24. Spalled parent PCC for Series 2, Repair 7-1 - spalled areas on east edge (left) and partially filled spall prior to traffic (right).

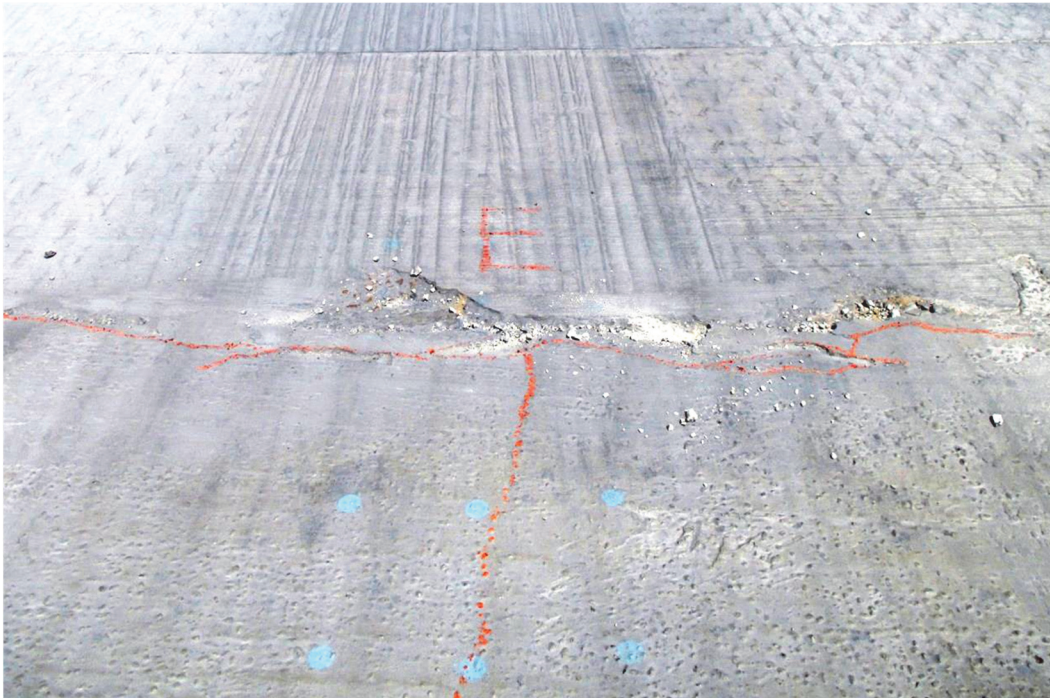
Figure 25. Series 2, Repair 7-1 - overall at failure (2,500 passes).

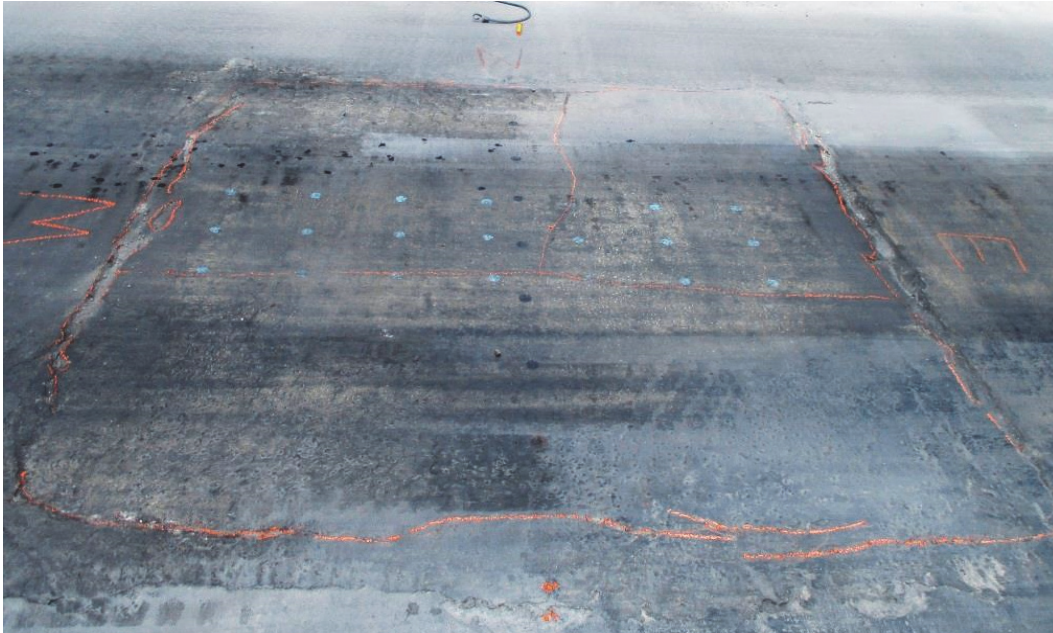
Trafficking of Repair 8 was discontinued following 10,000 passes; however, the repair was close to failure with a maximum spall size of 93 in.

Figure 26. Series 2, Repair 8 - overall at 10,000 passes.

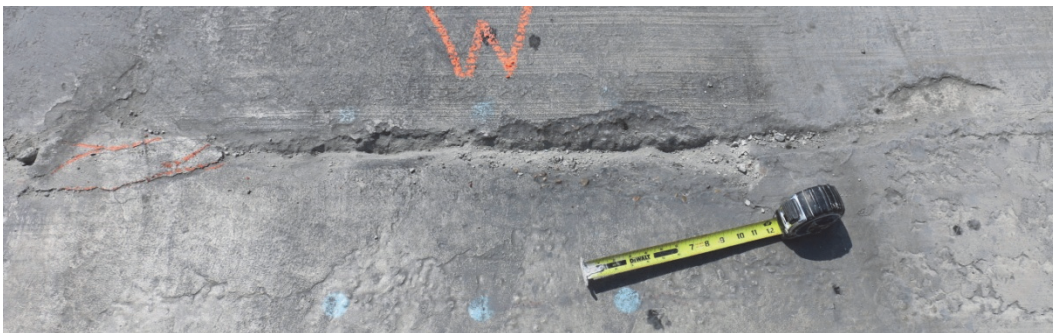
Figure 27. Series 3, Repair 9 - west edge at failure (3,500 passes).

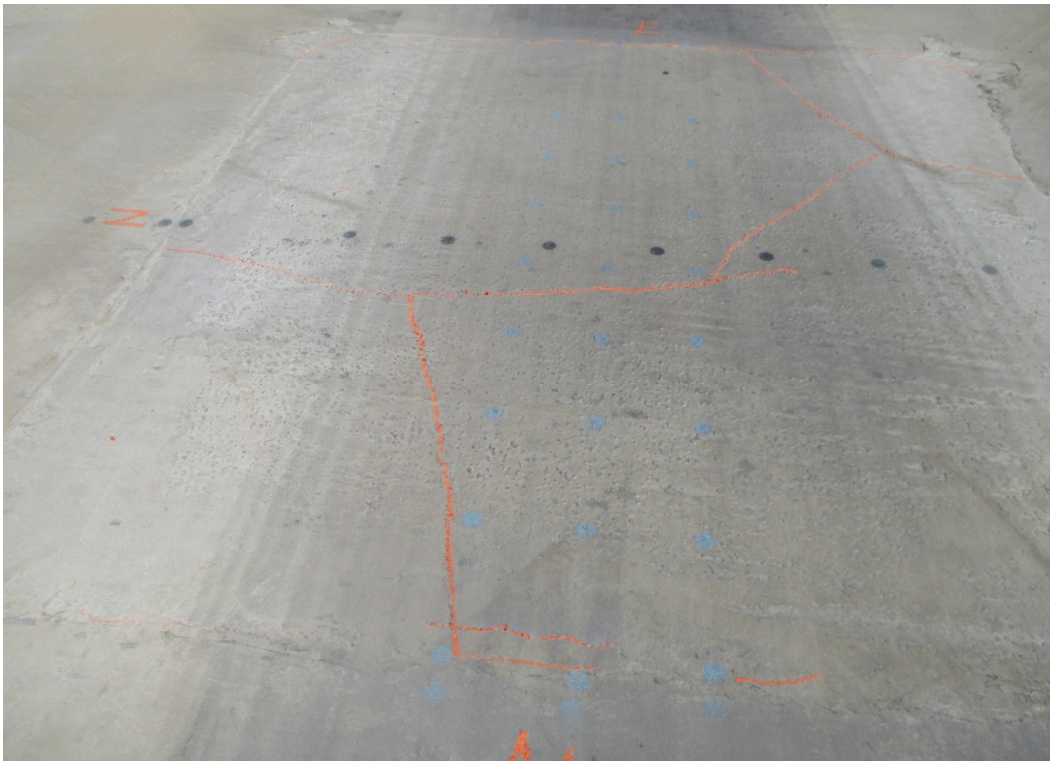
A low-severity shattered slab was noted at 560 passes on Repair 10-1. This did not occur during the Series 2 testing for the same cap thickness over a weaker base material. The shattered slab, however, did not progress in severity and did not result in the repair's failure. Because of the early instance of a shattered repair cap, Repair 10-1 was repeated as Repair 10-2. Repair 10-2 had shrinkage cracks, the longest of which was 46 in., over the repair before trafficking began. Repairs 10-1 and 10-2 were not failed following the application of 10,000 passes. Both repairs had minor spalling along the edges at 10,000 passes. Figure 28 shows the low-severity shattered slab of Repair 10-1 at 560 passes, and Figure 29 shows the Repair 10-1 at 10,000 passes.

Figure 28. Series 3, Repair 10-1 - low-severity shattered slab at 560 passes.

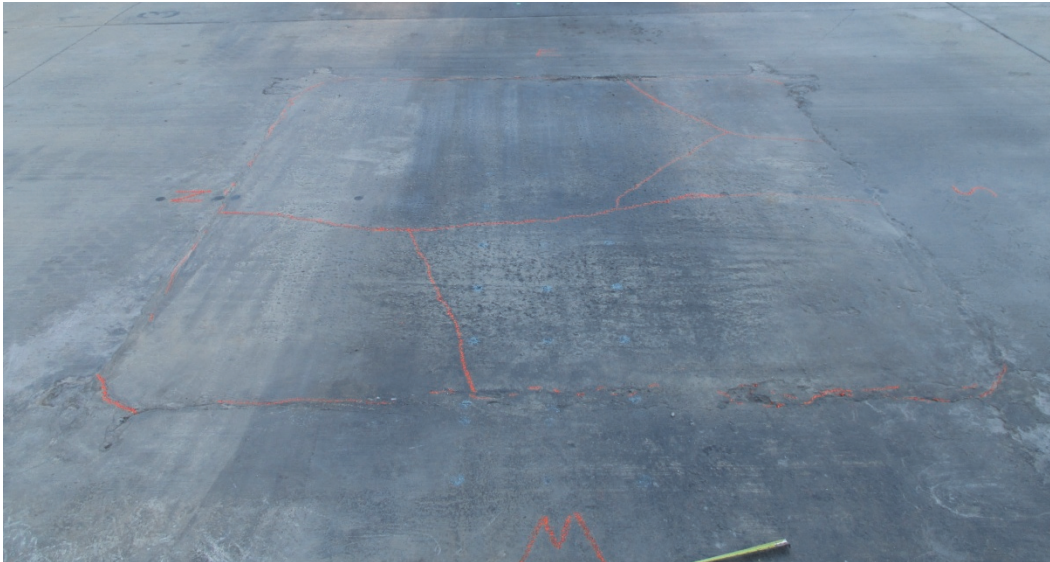
Figure 29. Series 3, Repair 10-1 - not failed at 10,000 passes.

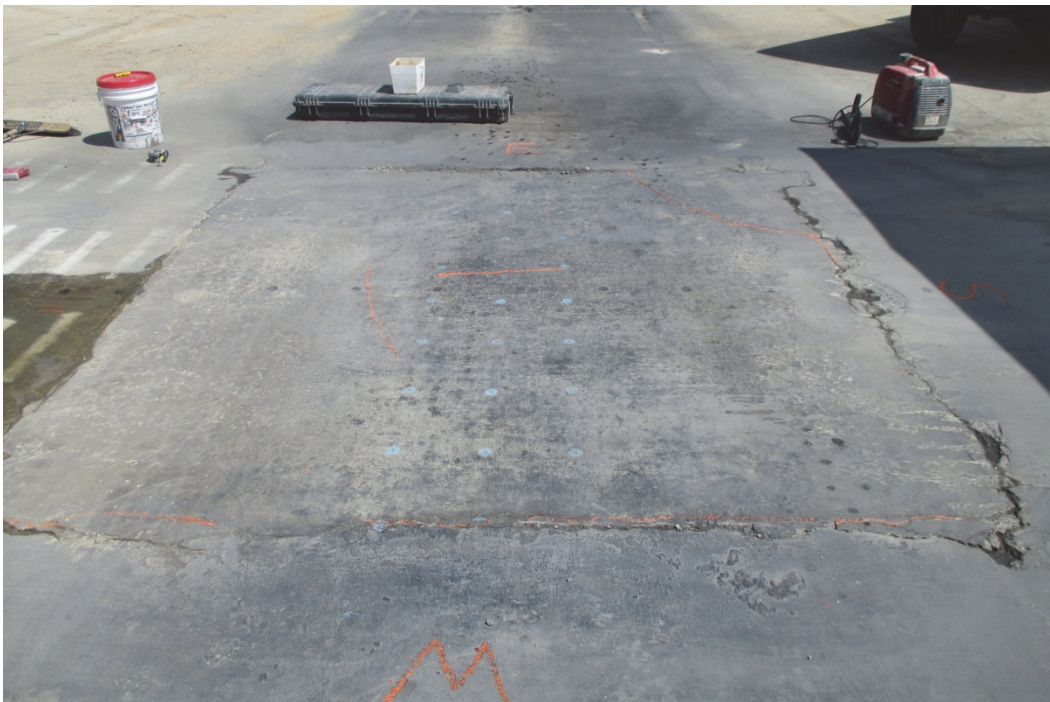
Repair 11 was constructed the same day as Repair 10-1; however, Repair 11 did not have any surface distresses prior to trafficking. A low-severity corner break occurred after the application of 560 passes, and low-severity joint spalling began to develop along the trafficking edges around 4,000 passes. After the application of 10,000 passes, the east edge had a low-severity spall 63 in. long, 2 in. wide, and 0.5 in. deep. Figure 30 shows Repair 11 at 10,000 passes.

Figure 30. Series 3, Repair 11 - not failed at 10,000 passes.

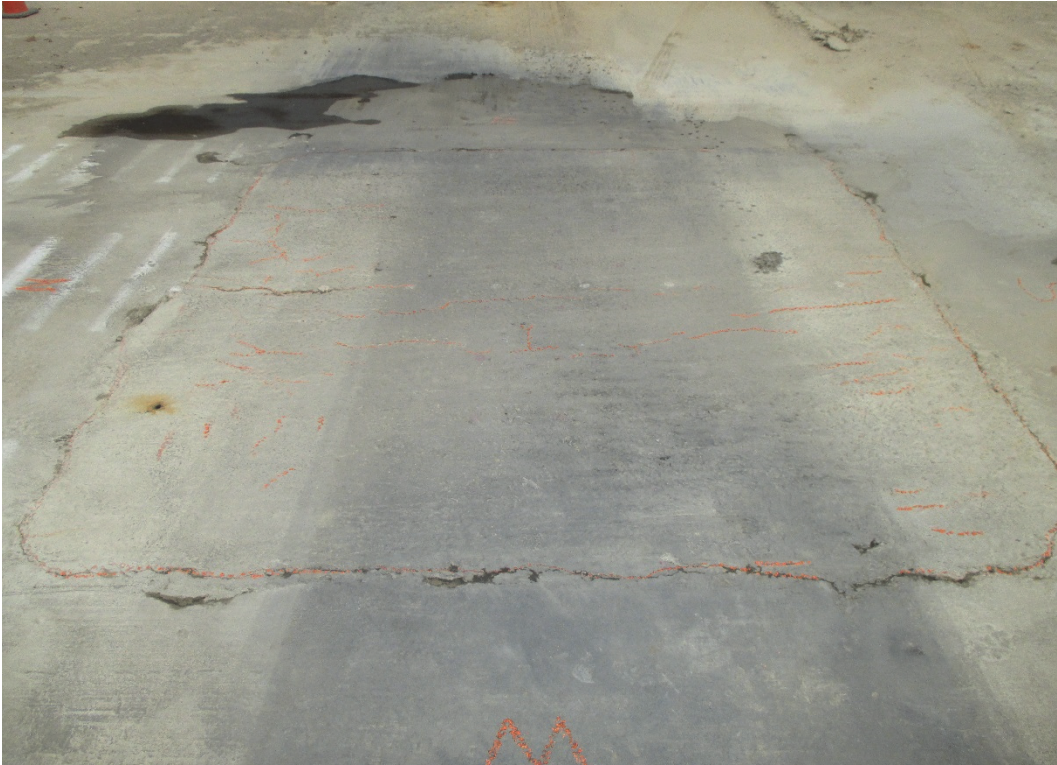
Figure 31. Series 4, Repair 14 - after 10,000 passes.

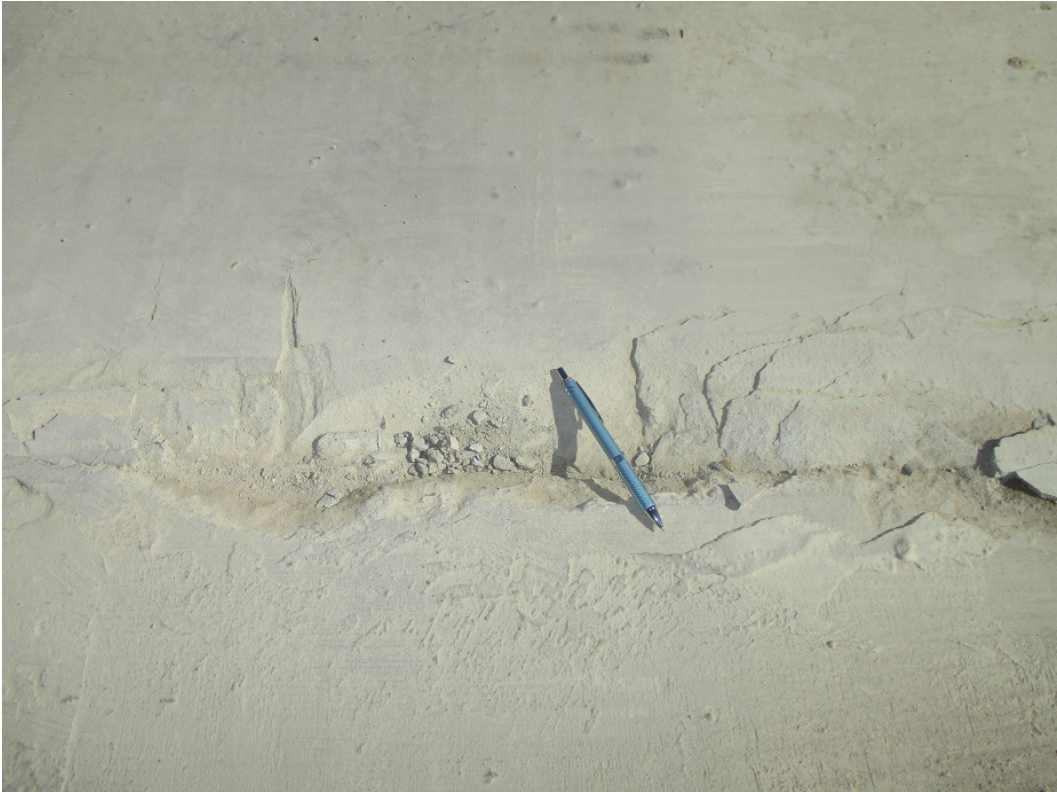
Figure 32. Repair 15 spalling at 800 passes (after being swept).

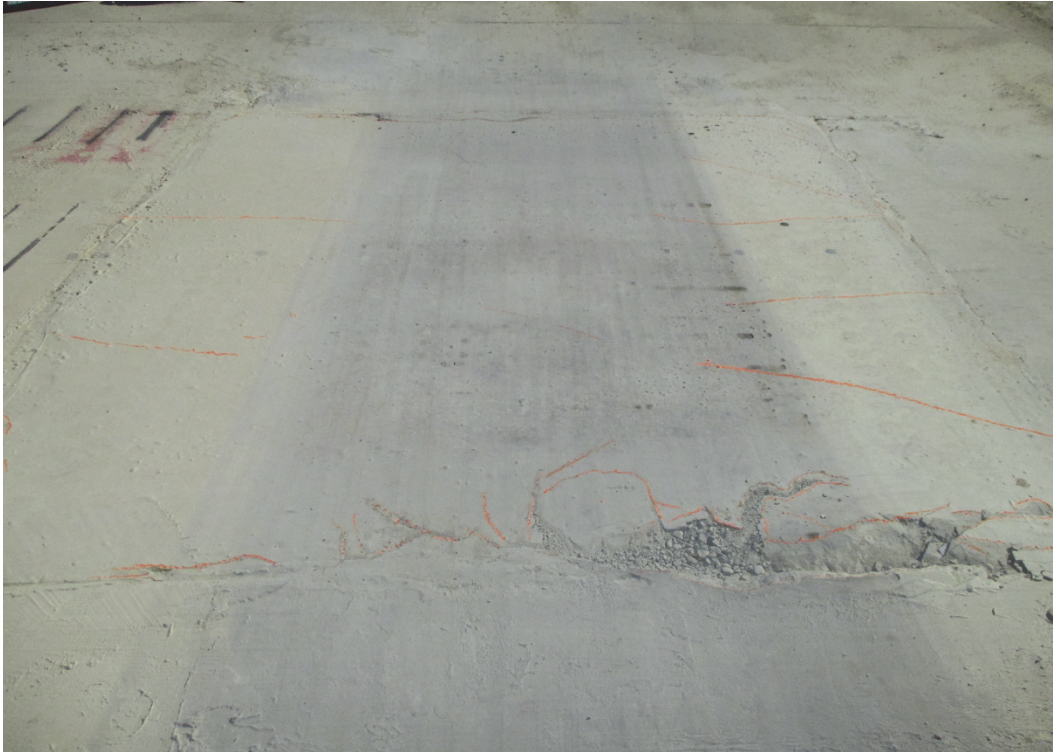
Figure 33. Repair 15 at failure of 1,508 passes.

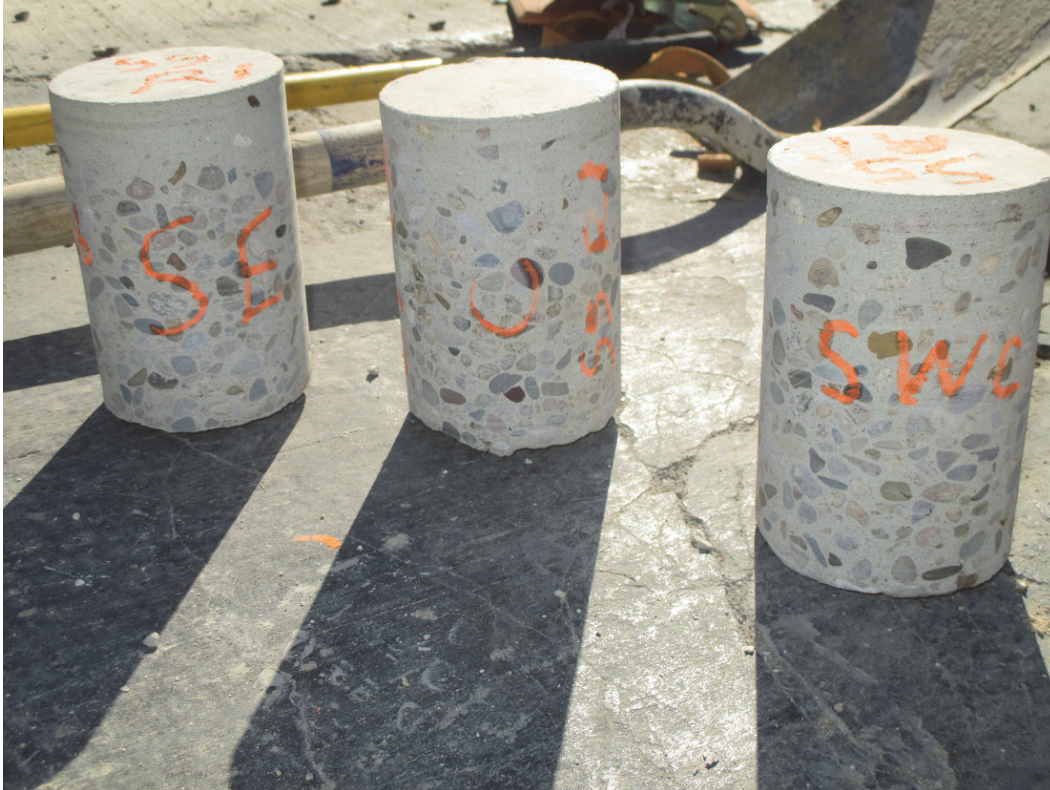
Figure 36. Repair 15 – aggregate segregation of the Rapid Set Concrete Mix® cap.
