## Multi-Site Fatigue Testing and Characterization of Fuselage Panels from Aging Aircraft Structure

Sandeep R. Shah<sup>1</sup>, Todd B. St John<sup>1</sup>, Ian L. Pryce, Jr.<sup>1</sup>,  
Gregory A. Shoales<sup>2</sup> and James M. Greer, Jr.<sup>2</sup>

**Abstract:** Multi-site fatigue damage is a common problem in the riveted lap joint structure of aging aircraft. Modeling and characterization of such damage is an especially daunting task. In this effort we present the results from fatigue tests which were performed on fuselage lap joints extracted from various retired USAF military aircraft. The test specimens were extracted from a variety of fuselage locations of these aircraft and subjected to spectrum loading simulating fuselage pressurization cycles. The test panels varied in width from 15 to 22 inches and typically had three (3) rows of fasteners in the lap joint. Some spot welded lap joint panels were also tested during the larger program; however, only the results from mechanically fastened joints are presented here. The results from approximately 25 panels from two different aircraft are presented here. Also presented is the process used to prepare the panel test sp

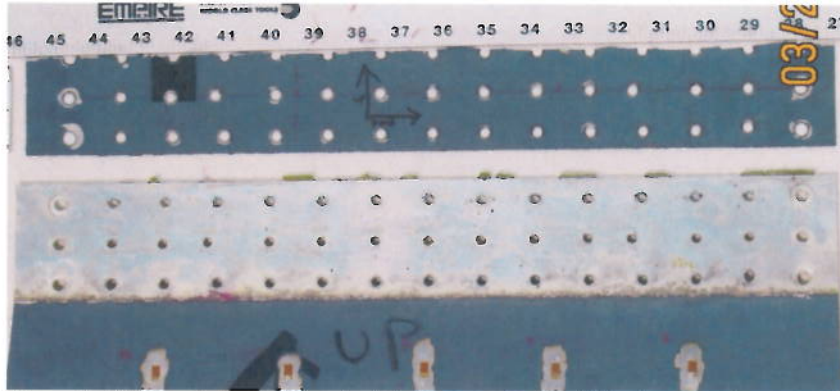
The panels were carefully investigated after failure to identify the locations of fatigue damage and to determine where panels failed under overload due to accumulated damage leading to fast fracture. It was easy to identify these features optically, as the fatigue regions showed planar fracture surfaces oriented predominantly perpendicular to the loading axis, while the fast fracture region was characterized by dominant shear lips. Figure 6 shows a panel immediately after failure. It can be seen that the top panel of the lap joint has failed at the topmost

row of the fasteners, while the bottom panel has remained intact. The unsymmetric lap joint creates an out-of-plane load eccentricity such that the topmost row of the fasteners experiences the maximum flexural tensile load due to tension loading. This additional load makes the topmost row of fasteners more susceptible to failure. For most panels, failure occurred at this location. Some panels, however, had spot welded doublers in the lap joint, creating dual laps in one lap joint. Such panels primarily failed by the failure of the topmost row of the spot welded doubler. Again the topmost row of the spot welds experiences higher stress due to the eccentric loading and is therefore the first to fail.

**Figure 6: Failure of the test panel at the top most row of the fasteners (nearest the scale; scale in inches). It can be seen that the bottom panel is completely intact.**

Table 1 lists the size of the cracks emanating from each fastener hole along the failed fastener row, shown in Figure 6, in which the 15 holes are numbered from left to right ("1" being the left-most hole). Cracks emanating from the left side of the hole are simply labelled with the hole number. Cracks emanating from the right side of the hole are labelled with a "b" suffix (e.g., 14b). The crack lengths are represented in  $a$  and  $c$  dimensions, where  $a$  is the length of the crack along the face of the skin and  $c$  is the length of the crack in the thickness direction of the panel. Where  $c$  is marked as  $t$ , it indicates that the crack has grown through the thickness of the panel. As seen from this table, fastener holes 1 and 15 showed no sign of fatigue cracking. They are the outermost rivets and, as mentioned earlier, these rivets were replaced with the next oversize rivet and were assembled with some interference specifically to avoid the crack initiation at these locations arising from edge effects. Video indicated the crack originated between fastener numbers 13 and 14. Analysis indicates the crack started from the left side of Hole 14. A few of the cracks from this panel with their identifying crack numbers are shown in Figure 7.

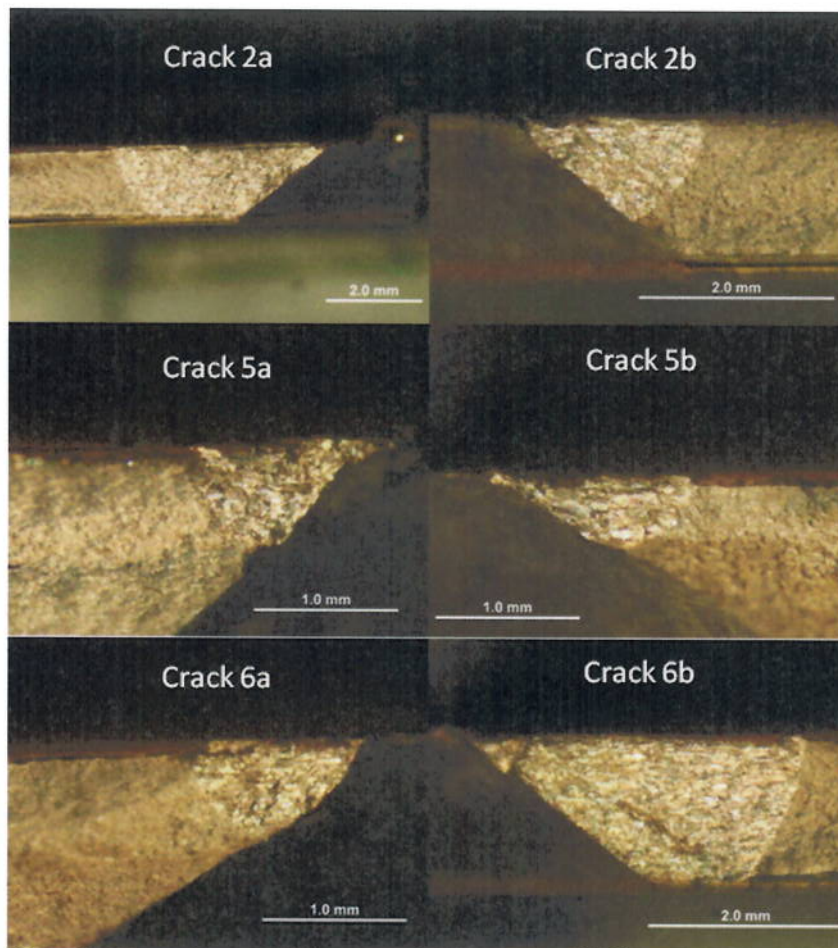
Figure 7 shows the cracks emanating from fastener holes 2, 5 and 6 of the failed panel shown in Figure 6. It can be seen that this panel had multi-site damage prior to its final failure. Close examination of Figure 7 reveals that all the cracks initiated from the knife edge of the countersink hole. This knife edge, due to its sharpness, has a higher stress intensity factor. Note also that the bottom of the countersink is in close proximity to the bottom panel of the lap joint. The actual initiation site could be due to fretting with the bottom panel, but detailed microstructural examination is beyond the scope of the present work. Data have been compiled for 14 panels in similar fashion. Furthermore, we have also created SolidWorks models for each panel showing the location and the extent of each crack. Figure 8 shows the SolidWorks model where the cracks are superimposed at the fastener hole locations.

**Figure 7: Stereomicrographs of the cracks emanating from fastener holes 2, 5 and 6. The shiny surfaces are the fatigue cracks and the dull surfaces are the fast fracture regions.**
