*Airfield Damage Repair Modernization Program*

## **AM2 Brickwork Pattern Evaluation**

December 2016

Final report

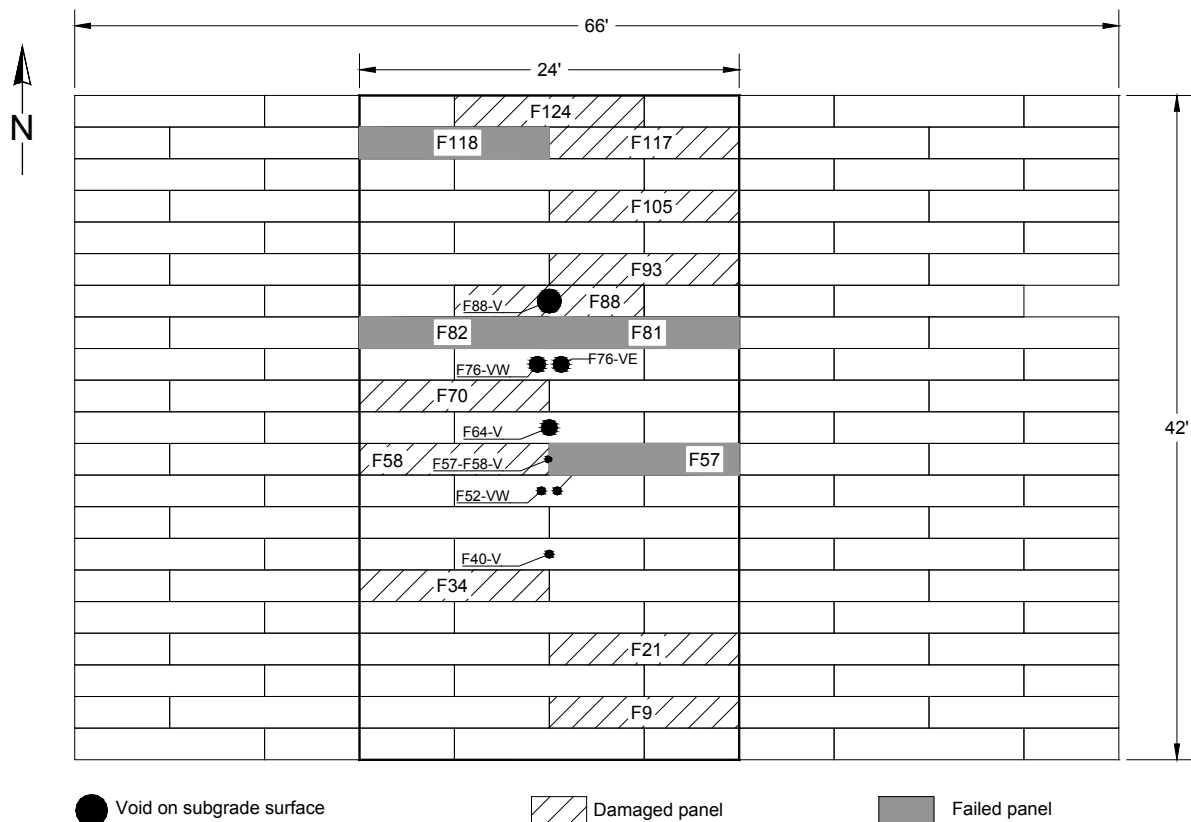
Figure 4.1. Layout of damaged and failed panels in the F-15-V item.

Figure 4.1 shows the layout of failed and damaged panels for the F-15E-V item after trafficking concluded.

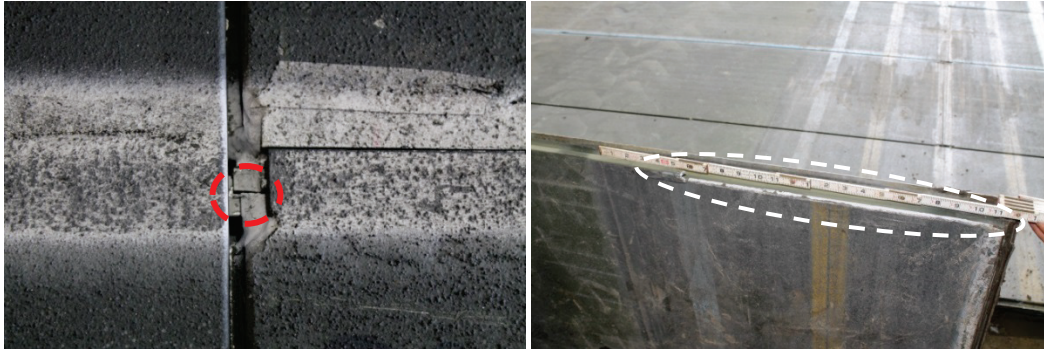
Figure 4.2. Broken upper underlap rail (left) and top skin tear (right) in F81.

located on the traffic centerline developed 1/8-in. corner curls. Panel F81 had an 11-in.-long top skin tear after pass 548. The skin tear began near the southwest corner and propagated along the top flange of the female hinge. The loose piece of skin was posing a risk to the tire and was cut for maintenance.

| Pass Number | Panel Number | Description of Damage | Cumulative Failed Panels | Cumulative Mat Breakage, % |
|---|---|---|---|---|
| 548 | F81 | Top skin tear length increased to 11 in. in southwest corner. Cut for maintenance to prevent a tire hazard | - | - |

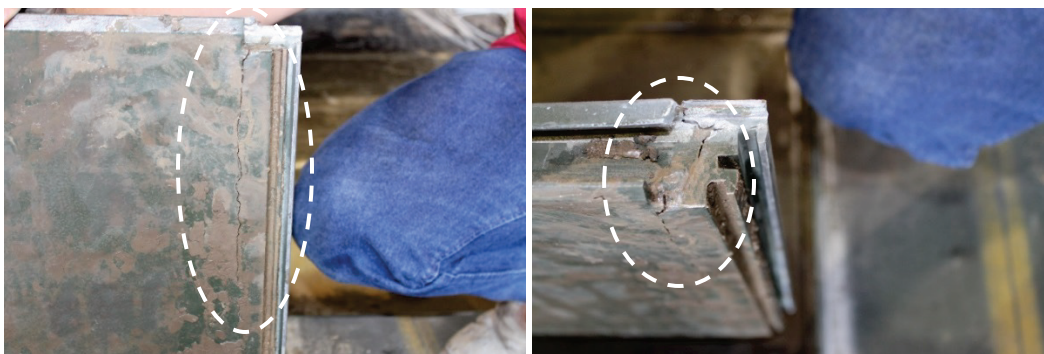
Figure 4.3. Broken end connector in F118.

After 643 passes, Panel F118 failed when a 5-in.-long crack developed along the weld of the overlap end connector, causing the end connector to separate from the panel (Figure 4.3). Panel F82 had a 7-in.-long top skin tear along the top flange of the female hinge after pass 794. The loose piece of skin was removed to prevent a tire hazard. Panel F57 failed after pass 794 when the upper underlap rail broke. A 6.5-in.-long top skin tear had also developed.

| Pass Number | Panel Number | Description of Damage | Cumulative Failed Panels | Cumulative Mat Breakage, % |
|---|---|---|---|---|
| 643 | F118 | 5-in.-long crack developed along weld of prongs down end connector. End connector separating from panel | 2 | 4.8 |
| Posttest<br>(1,008) | F118 | End connector weld cracked length of 10 in. on bottom surface, starting at female hinge connector side | - | - |

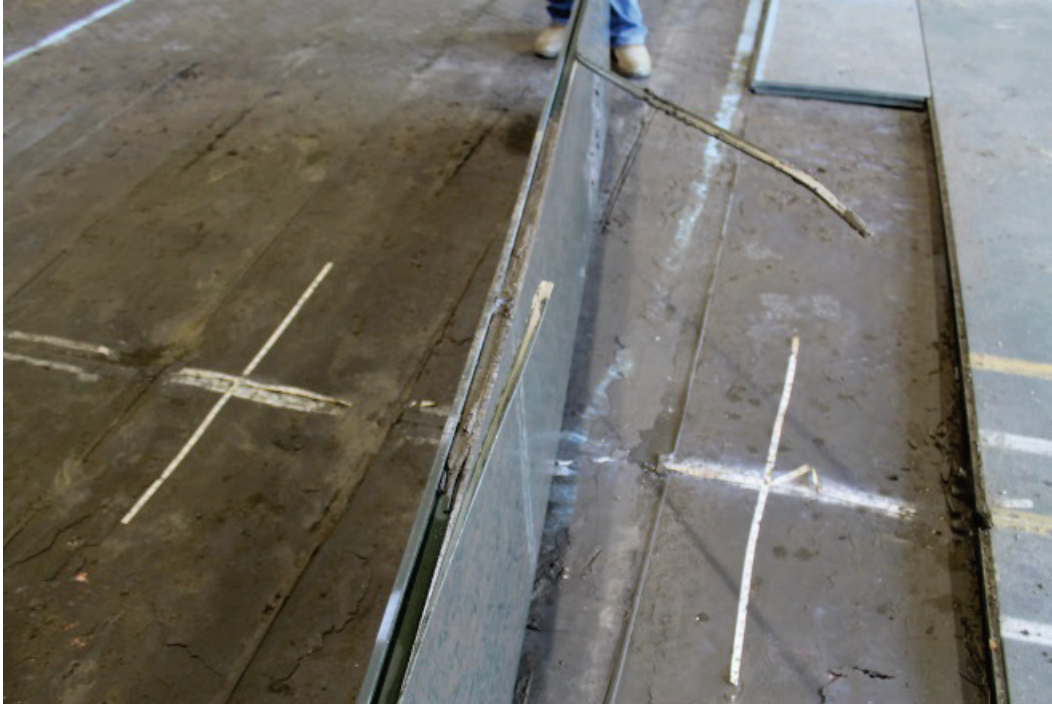
Figure 4.9. G65 after removing from test section.

When panels were removed after trafficking was completed, additional damage was noted. The upper underlap rail of G34 broke a length of 10 in., starting at the north edge. However, since the length of breakage was less than 12 in. (half the length of the end connector), the panel was not considered failed. The bottom flange of the female hinge tore a length of 60 in. along the center of G65 (Figure 4.9). Panel G107 developed cracking at the weld of the overlap end connector, from the top surface to the bottom surface (Figure 4.10). Panel G71 had minor cracking at the southeast corner below the top flange of the female hinge connector. Table 4.2

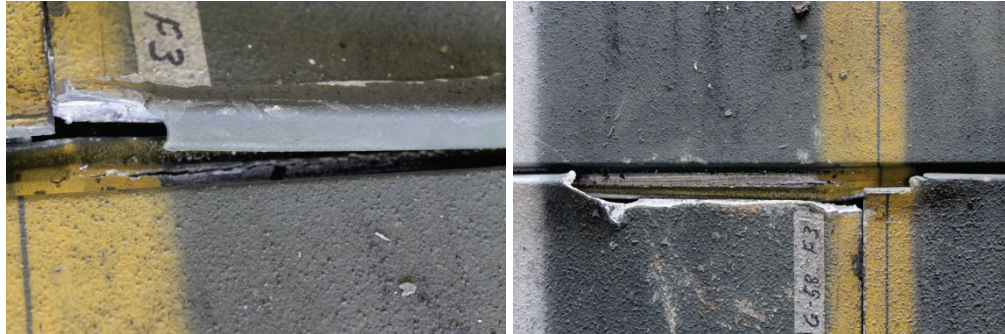
Figure 7.20. Joint of Panels G58 and G53.

| Pass Number | Panel Number | Description of Damage | Cumulative Failed Panels | Cumulative Mat Breakage, % |
|---|---|---|---|---|
| | G53 | Horizontal crack, 6 in., above male hinge connector. Crack visible due to skin removed from Panel G58. | - | - |
