## **Geologic Controls of Sand Boil Formation at Buck Chute, Mississippi**

June 2017

Final report

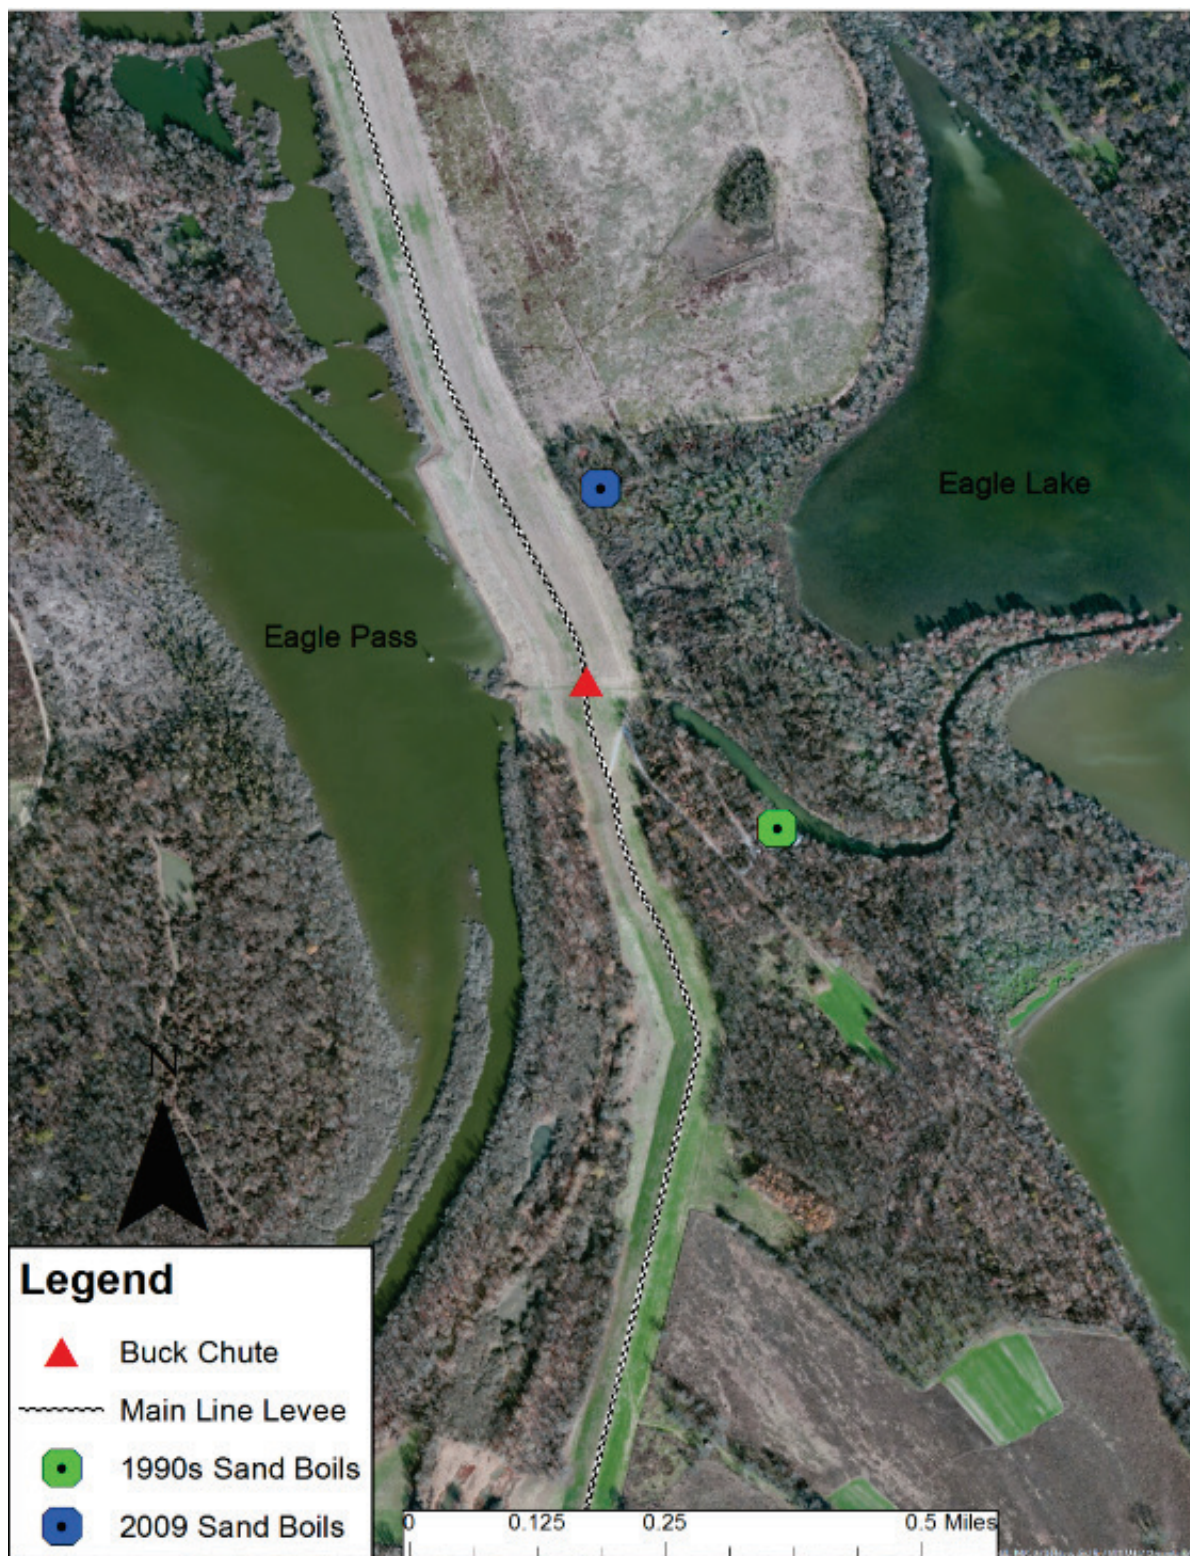
Figure 3. Aerial imagery of the immediate vicinity of the Buck Chute site with the locations of sand boils (Modified from World Imagery base map downloaded from ESRI ArcMap 10.1 library).

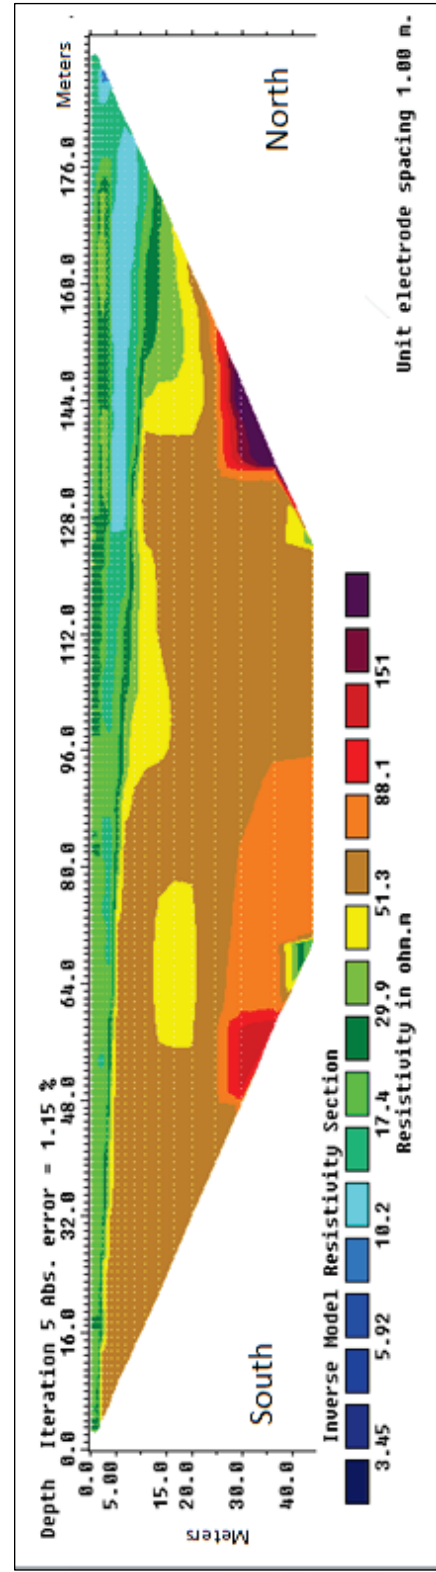
The 7 March 2014 survey was performed to identify possible seepage pathways for the 1990s sand boil occurrences; however, the survey could not be extended far enough south because surface conditions prevented emplacement of electrodes. Due to the orientation of the path through the woods in the southern portion of the study area, the survey was not able to be combined with the 15 January through 19 February surveys. The results are interpreted as a blanket, which thins rapidly from the north to the south (Figure 16).

Figure 16. ERT results near 1990s sand boils from March 2014.

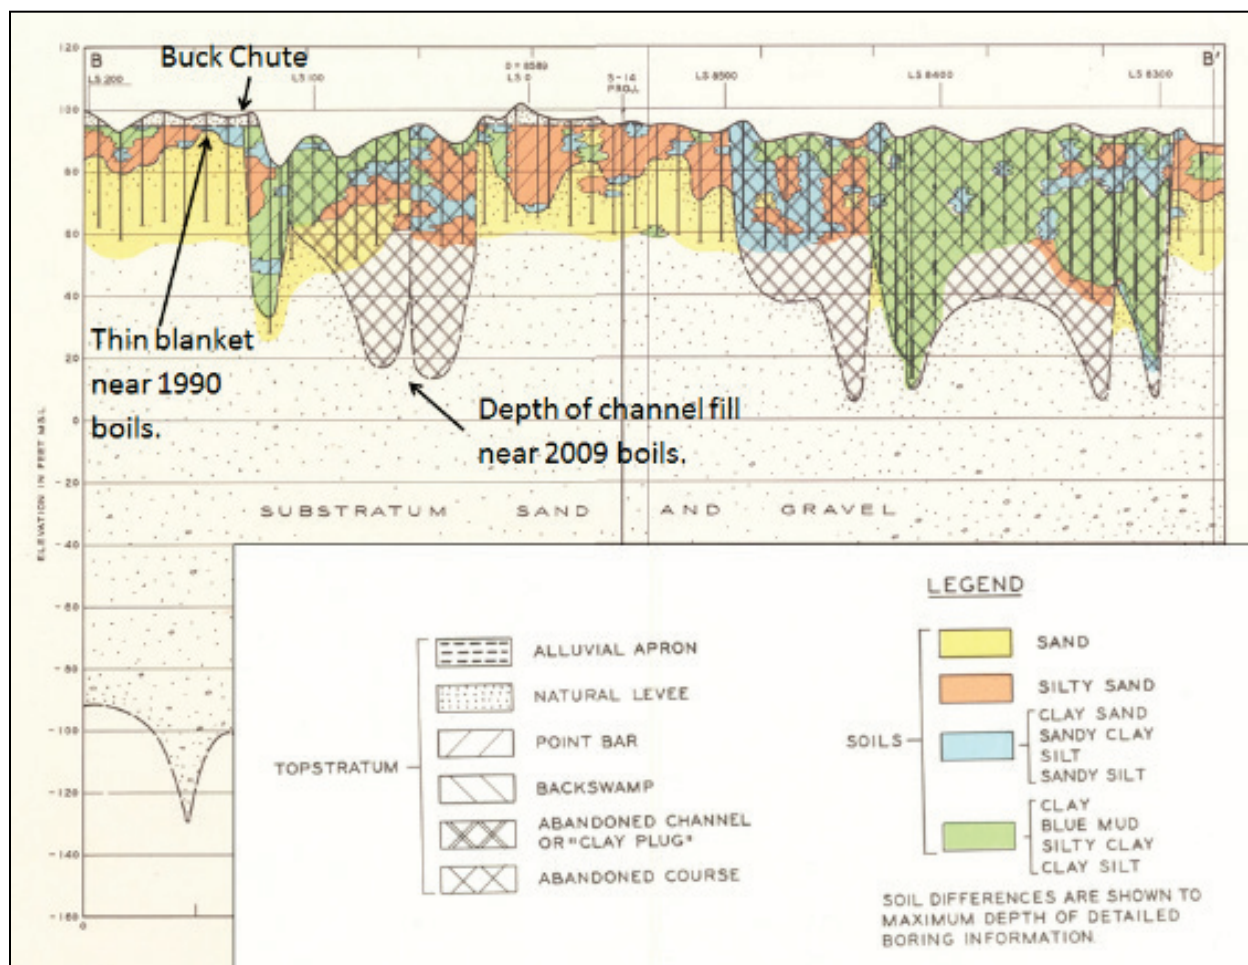
As part of the levee enlargement project that performed the borings, a cross section was produced that extends from south of the study area through the area and continues to the northeast (Figure 12). The Kolb (1968) cross section is more than 7.4 miles long and compares the stratigraphy of the alluvial deposits in the region. The borings are referenced to Levee Stationing (LS), and the study area extends from LS 100 to 160 (Figure 17). Near boring 105, there is channel fill deposit nearly 60 ft below the approximate mean land surface. This clay plug extending deep into the sands of the aquifer coincides with the area of the 2009 sand boils (Figure 18). It should also be noted that the extremely thin blanket near LS 150 is adjacent to the 1990s sand boils.

Figure 18. Boring cross section (Modified from Kolb 1968).

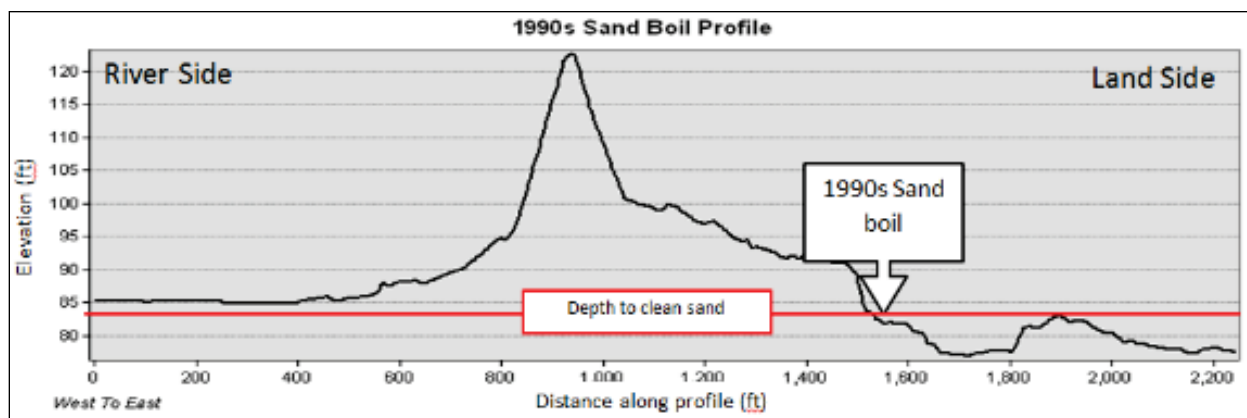
Figure 25. 1990s sand boils elevation profile.

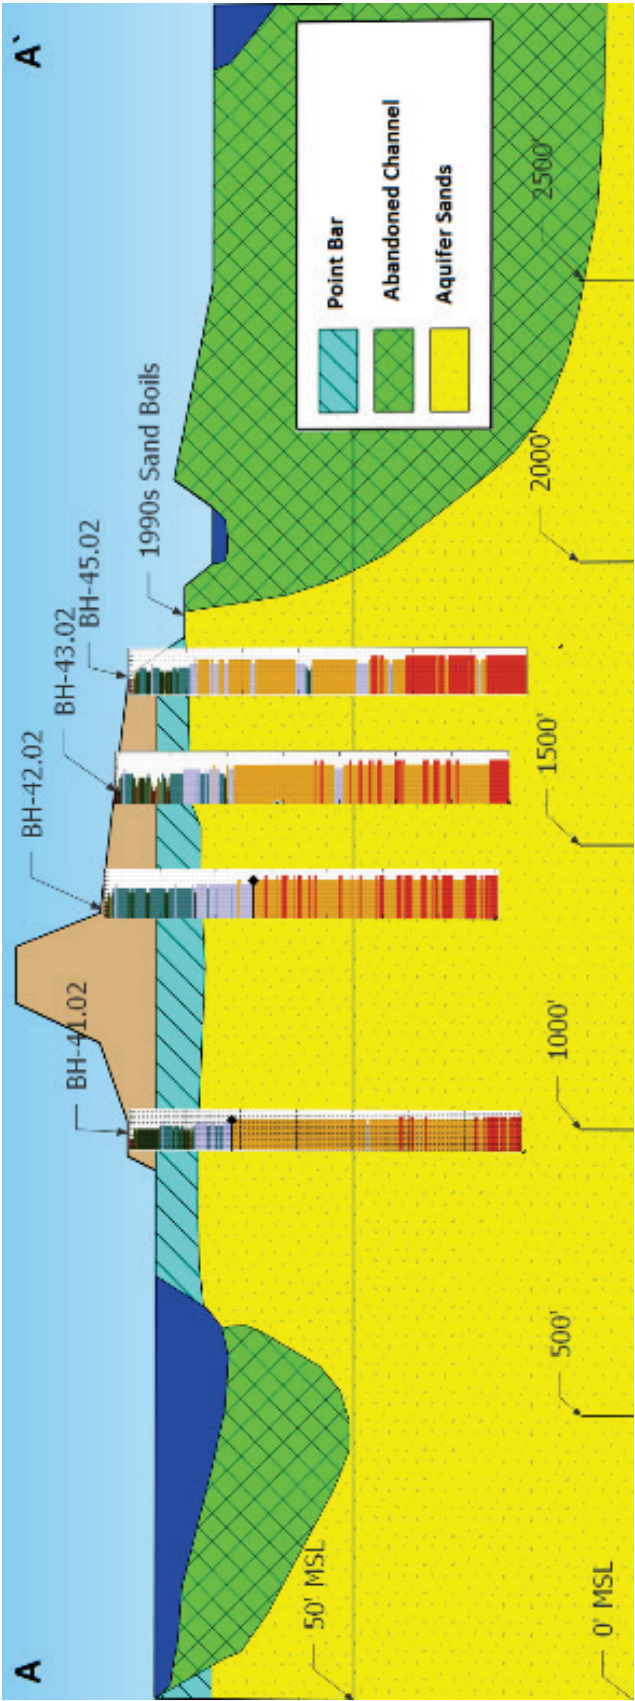
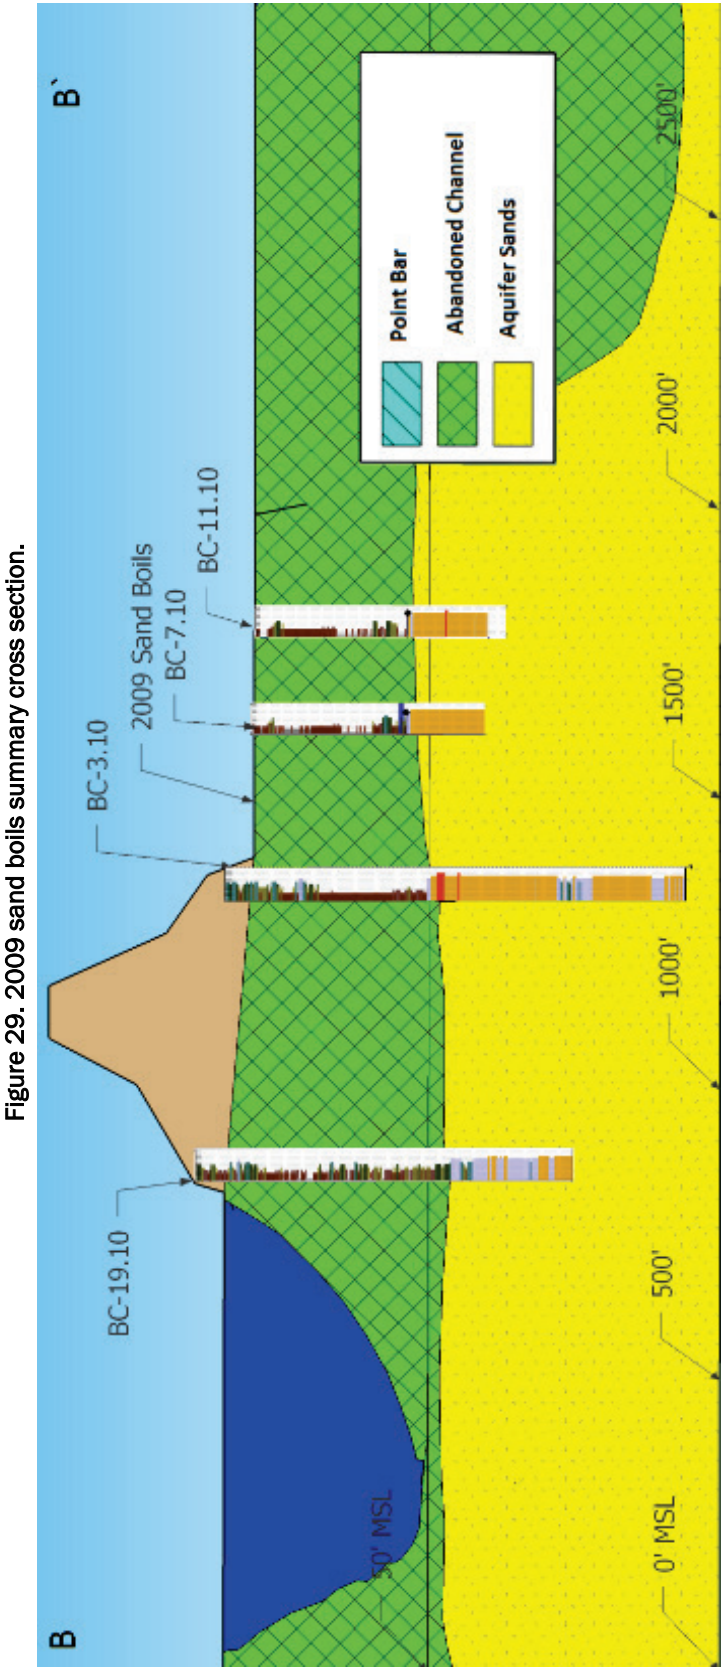
Figure 28. 1900s sand boils summary cross section.
