*Monitoring Completed Navigation Projects (MCNP) Program*

## **Use of Dolos Armor Units to Repair Hurricane Sandy-Damaged Great Lakes Harbor Breakwaters**

Michael C. Mohr, Gerlyn J. Hinds, Weston P. Cross,  
Shanon A. Chader, and Jeffrey A. Melby

June 2018

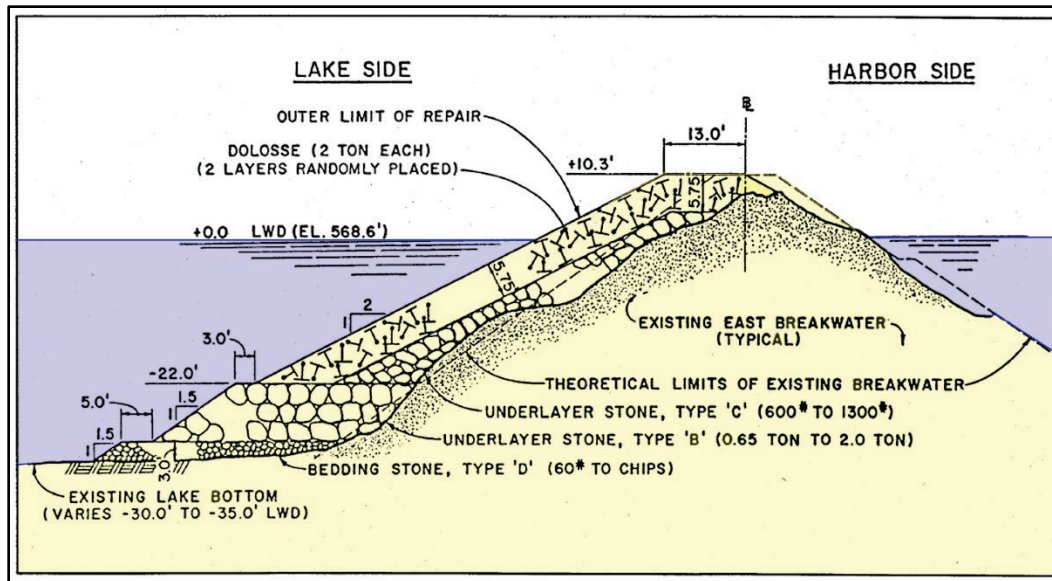
Figure 1-3. Cleveland East Breakwater section with 2-ton dolosse, 1979.

Cleveland Harbor East Breakwater on Lake Erie, and Oswego Detached Breakwater on Lake Ontario, were severely damaged on the lake sides by wave and water level effects resulting from Sandy. It was subsequently determined that the Cleveland Harbor East Breakwater would be rehabilitated by using 6.5-ton dolosse<sup>1</sup>, and the Oswego Detached Breakwater would be repaired by using 16-ton dolosse.

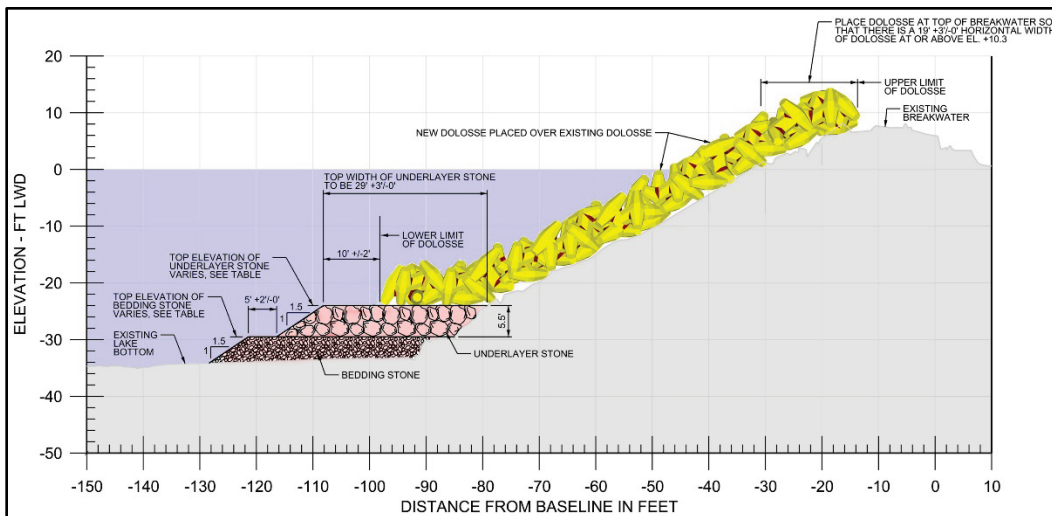
Figure 2-7. Cleveland East Breakwater typical repair section with 6.5-ton dolosse.

The typical section for the Cleveland dolos overlay was based on the previously constructed dolos overlay. The existing dolosse provided a rough slope for the random placement of the new dolos overlay. This random placement encouraged proper interlocking of the new dolosse. The typical section for the Oswego dolos overlay is an initial placement over a laid-up stone breakwater. The laid-up stone posed as a concern for slope stability. The specific placement of the toe dolosse was to ensure a stable slope, and the proper interlocking of the remaining dolosse would occur.

The typical repair sections for the dolos overlay for the Cleveland East Breakwater and the Oswego Detached Breakwater are presented in Figure 2-7 and Figure 2-8, respectively.

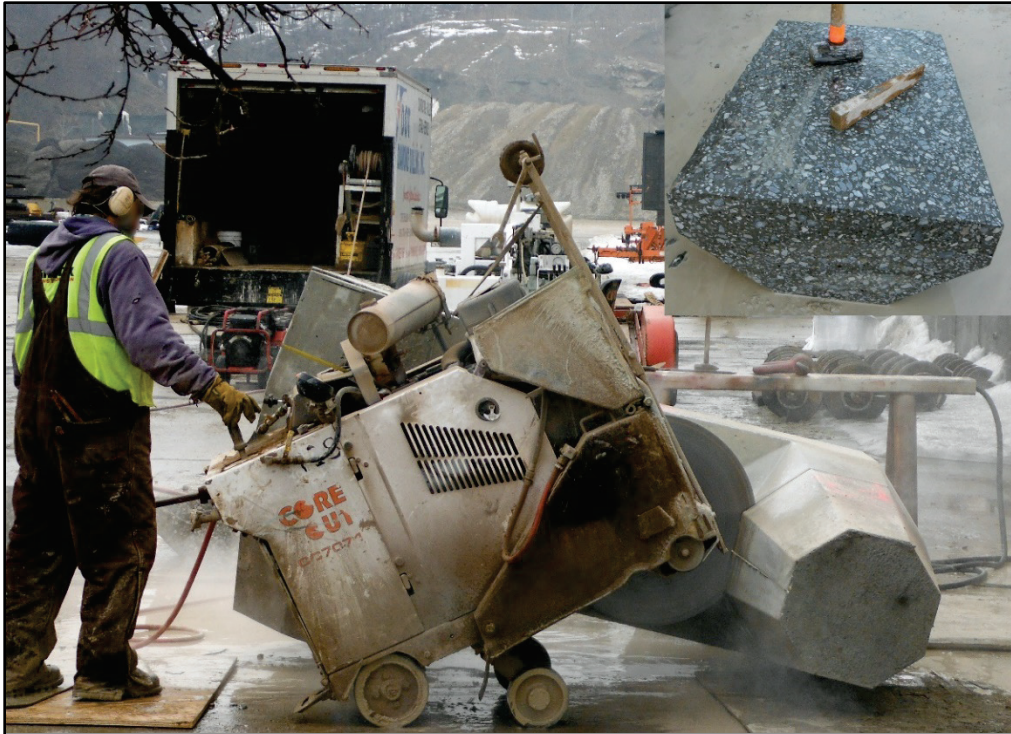
Figure 3-13. Cutting Cleveland 6.5-ton dolos and cut sample.

After having made the sample dolos, the contractor cut the dolos (in the presence of a government representative) to check for voids and other imperfections in the following manner:

- Flukes from both ends were cut from the dolos at the shank.
- One fluke from each end was cut into three equal pieces cross-sectionally.
- The remaining flukes were cut in half, longitudinally.
- The shank was cut in half, cross-sectionally.
  - One half was cut into three equal parts, cross-sectionally.
  - The other half was cut in half, longitudinally.

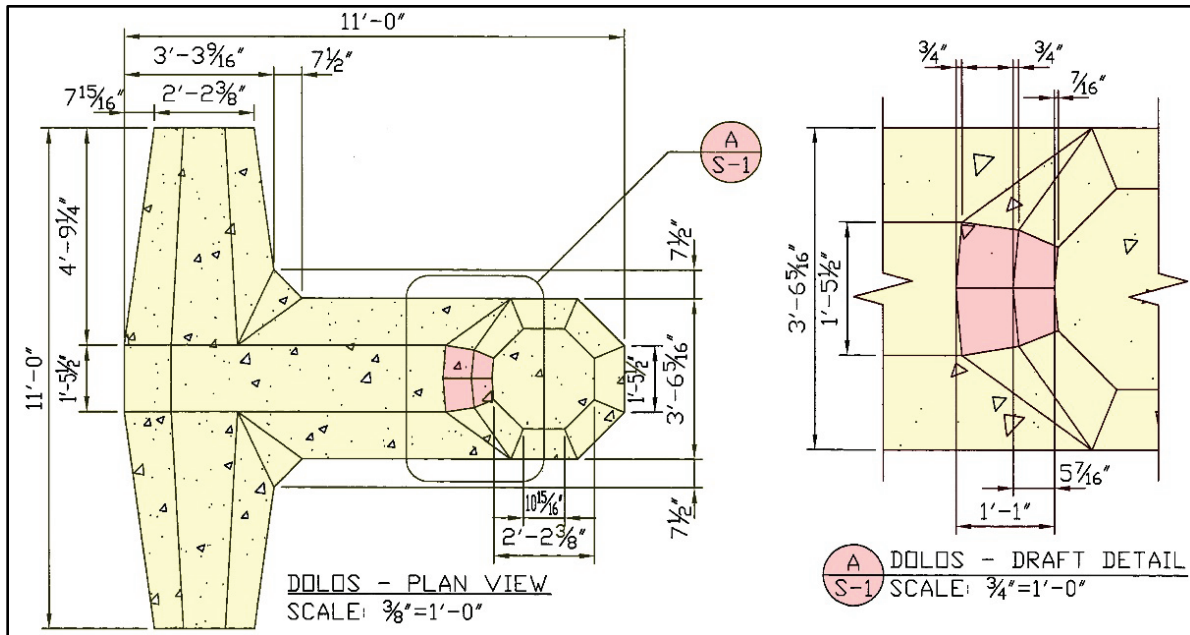
Figure 3-17. Minor modification to Oswego 16-ton dolos shape.

The Oswego Detached Breakwater required 973 16-ton dolosse. Lakelands Concrete chose to build the steel reinforcement cages and cast the dolosse inside the its plant using eight forms. The concrete mix was designed to allow the dolosse to be removed from the forms each day (24 hr), with the outside designated dolos storage area occupying approximately 2.5 acres (Figure 3-16). The contractor requested a slight change to the dolos shape by chamfering the inner facet of the vertical fluke (orientation when casting) to aid in the removal from the form, which added a slight addition of material (Figure 3-17).

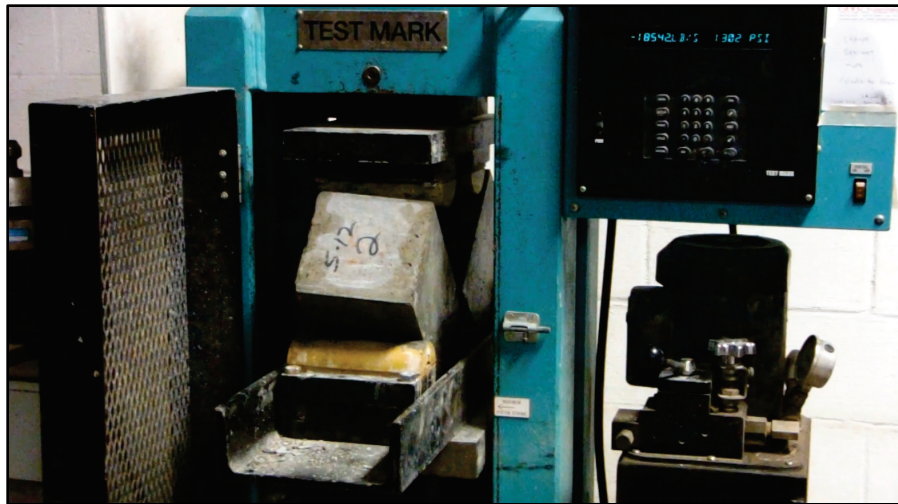
Figure 3-21. Cleveland dolos 28-day flexural strength test (sample failed at 1,302 lb/in.<sup>2</sup>).

The actual mean 28-day flexural strength of 1,192 lb/in.<sup>2</sup> was more than double the minimum required tensile strength of 500 lb/in.<sup>2</sup>. Table 3-6 presents the 28-day compressive strength descriptive statistics, and Figure 3-19 is a histogram of the flexural strength results. Figure 3-20 presents a plot of actual measured flexural versus compressive strengths with the American Concrete Institute (ACI) equation also shown. Figure 3-21 presents a photo of the testing equipment with a failed specimen at 1,302 lb/in.<sup>2</sup>.
