US Army - TARDEC

Bootloader-Application Transition Failure Investigation

GVR-BOT Technical Report

Valascho, Ty
3-27-2017

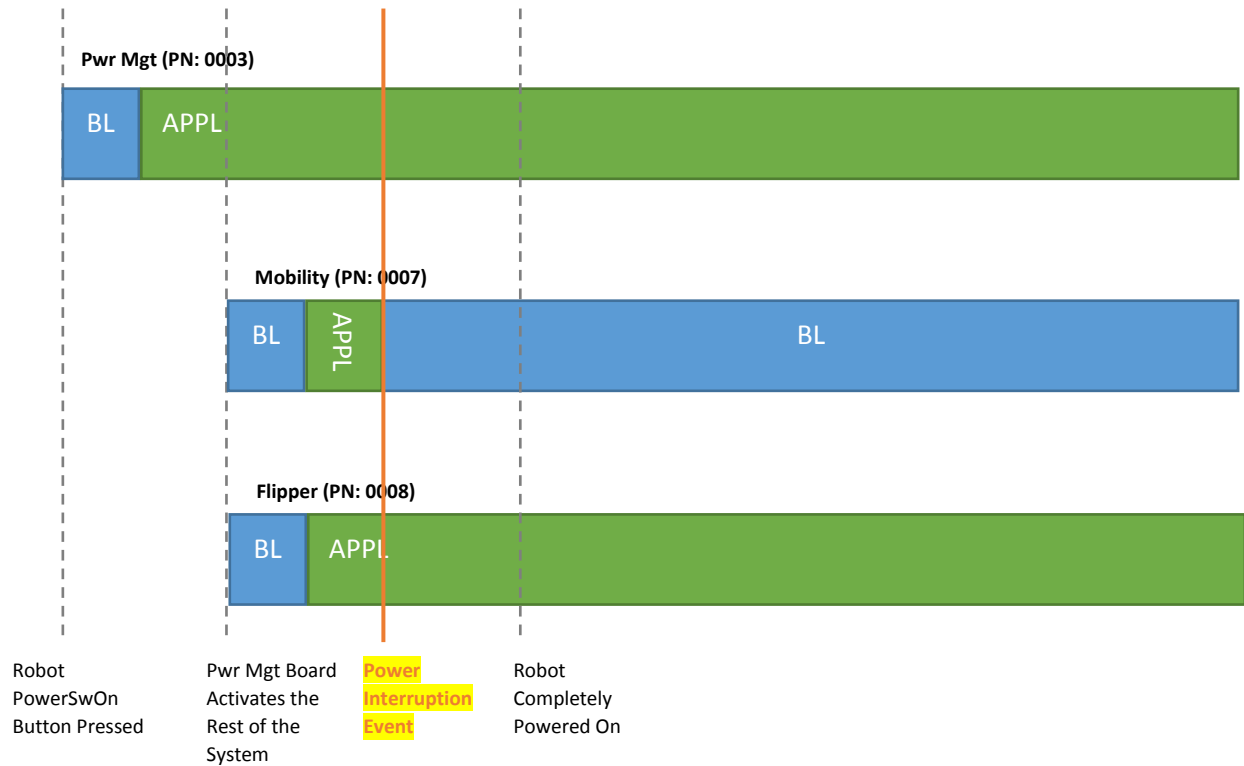
Figure 3 - Interrupted GVR-BOT Power-On Sequence Resulting in Bootloader Issue

When the inrush event happens, the system bus voltage dips from 34 VDC down to 5 VDC for 0.4 milliseconds and the power-on sequence of the Mobility board is interrupted because its main processor loses power. If this interruption happens at the wrong moment in time – between the bootloader software setting the Signature Byte to 0x00 and the application software setting it to 0x55 – the circuit board will power-on with the Signature Byte still set to 0x00 and remain in bootloader indefinitely.

A Power Interruption Event could be caused by batteries at 0% SOC or some other disturbance of the power system that causes the internal circuit boards to lose power while the robot is booting up.

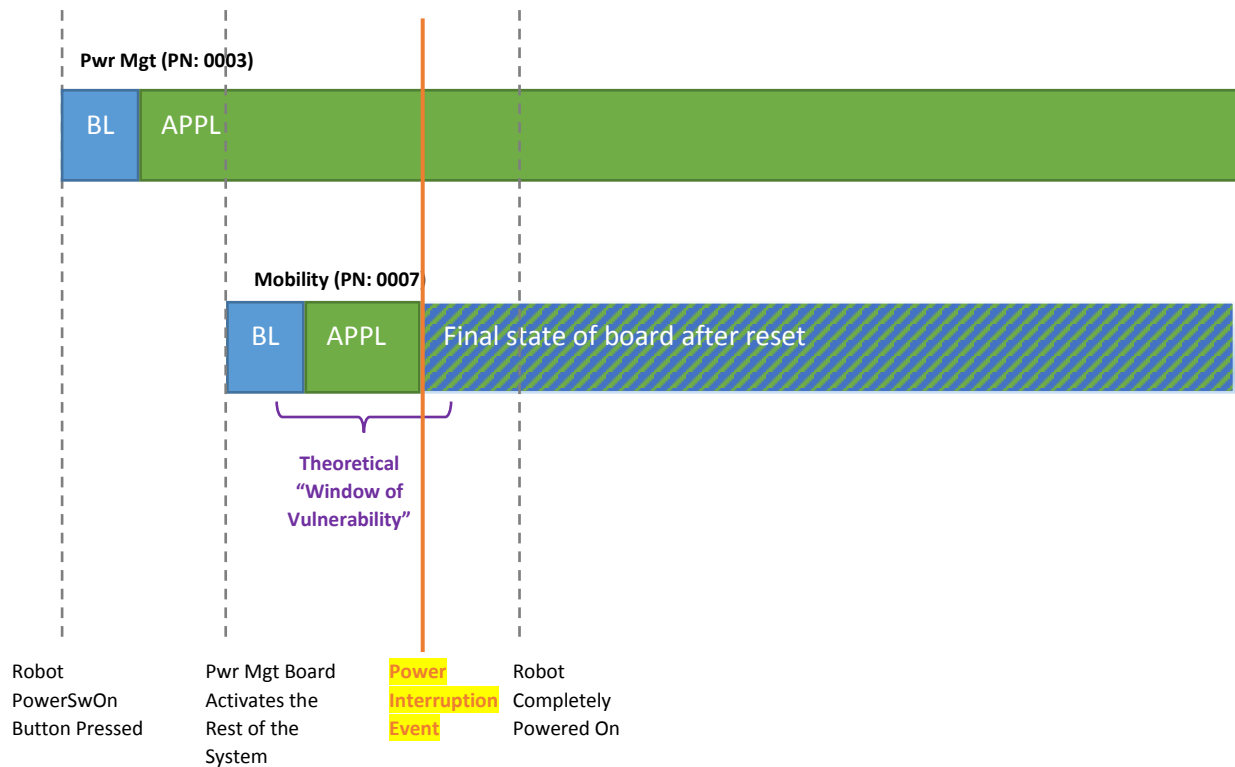
Figure 4 - Theoretical "Window of Vulnerability" During GVR-BOT Power-On Sequence

If the theory was correct, there would be a small window of time that the Mobility board was vulnerable to a power off event. Any reset before this “window of vulnerability” would not cause a change to the Signature Byte, so subsequent power-on events would be correct. Any reset that happened after the window of vulnerability would allow the application code to set the Signature Byte correctly and the system would not experience the problem.

If a Power Interruption Event occurred within the window, the failure would occur and the robot's Mobility board would get stuck in bootloader mode. If the Power Interruption Event occurred outside this window, the robot would power up normally and transition to application mode.

To reduce the likelihood of this occurring, it is recommended that the activation of the payload ports be moved until the robot's internal circuit boards have correctly transitioned from bootloader to application software.

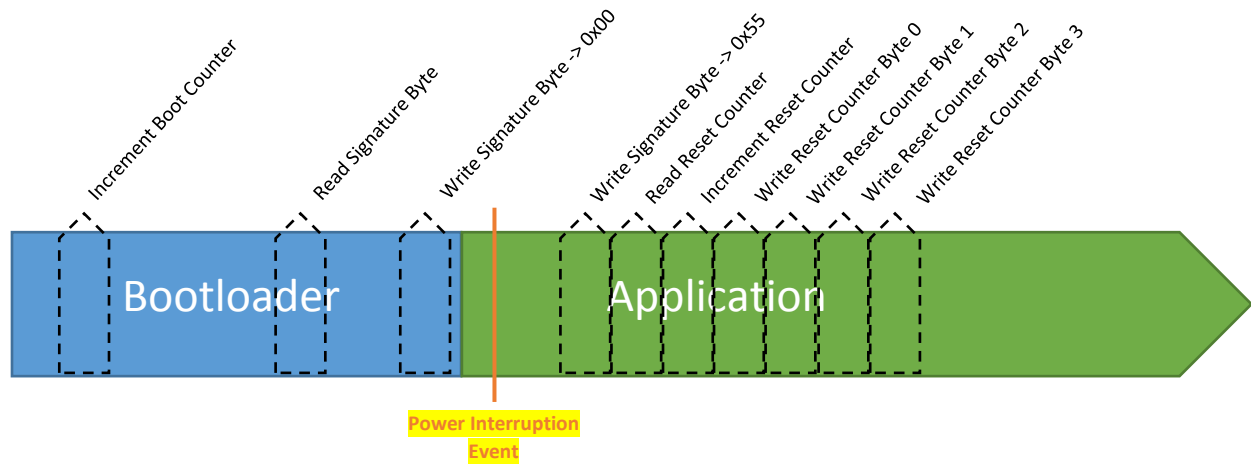
Figure 8 - Category 1 Power Interruption Event

In Category 1 results, the Mobility board enters the bootloader software and increments the Boot Counter, then sets the Signature byte to 0x00. Power is interrupted before the Reset Counter is incremented and before the Signature byte is overwritten by 0x55 by the application software. This means that when the second processor power-on happens, the Boot Counter is incremented a second time but the software is stuck in bootloader mode so it never will increment the Reset Counter. The location of the Power Interruption Event within the execution sequence is shown in Figure 8.

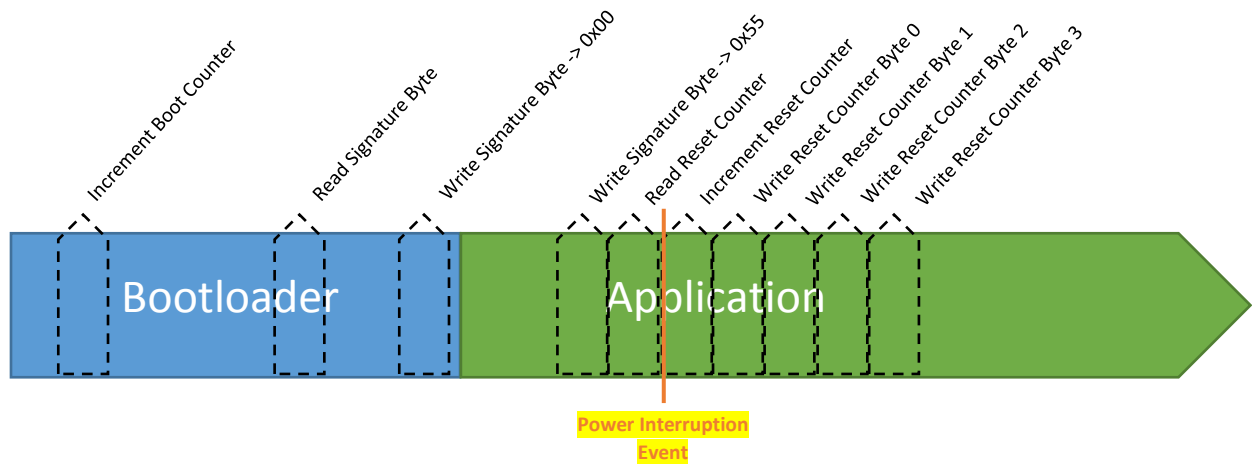
Figure 9 - Category 2 Power Interruption Event

Category 2 is not a system failure – the Mobility board powers up correctly to application mode. The Reset Counter value is inconsistent with a correct power-on. This happens because the Power Interruption Event occurs after the bootloader increments the Boot Counter and after the application software starts and gets a chance to overwrite the Signature byte with 0x55. The processor is powered down almost immediately after the 0x55 is written, because the application software never gets a chance to write the incremented Reset Counter value to EEPROM. After the processor reboots, both the Boot Counter and Reset Counter do get incremented correctly. The approximate location of the Power Interruption Event is provided in Figure 9.

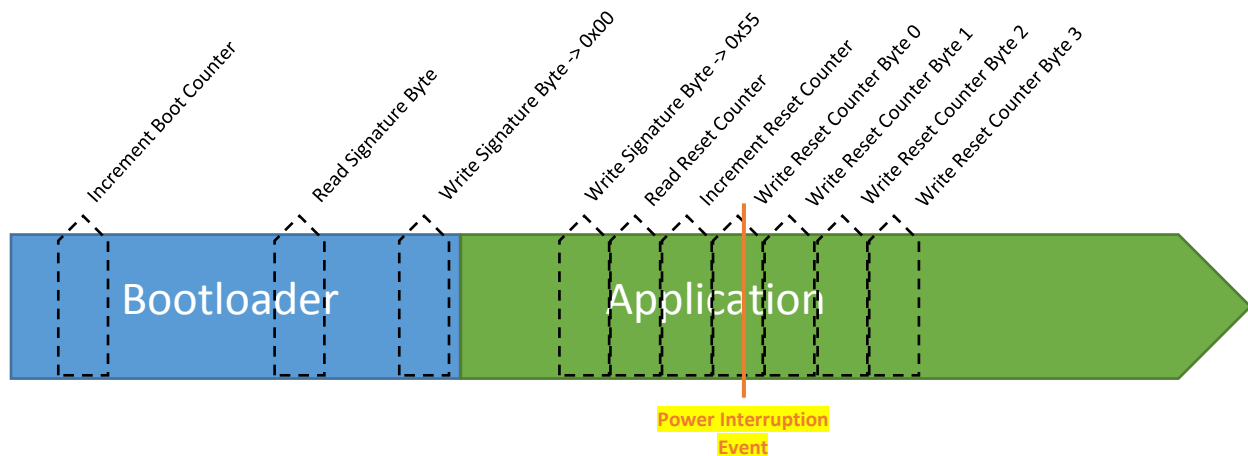
Figure 10 - Category 3 Power Interruption Event

Category 3 does not result in a system failure but does corrupt the Reset Counter. In this test result, the Power Interruption Event occurs after the bootloader increments the Boot Counter and after the application software overwrites the Signature byte with 0x55. The interruption occurs during the writing of the Reset Counter which corrupts the value. As mentioned previously, the Reset Counter is four bytes and each byte is written individually as separate instructions in the source code. Careful examination of the values of the Reset Counter reveal that the Power Interruption Event occurs during the writing of the least significant byte of the number, resulting in a 0xFF instead of the correct, incremented value. Figure 10 shows where the Power Interruption Event is happening for this category of test result.

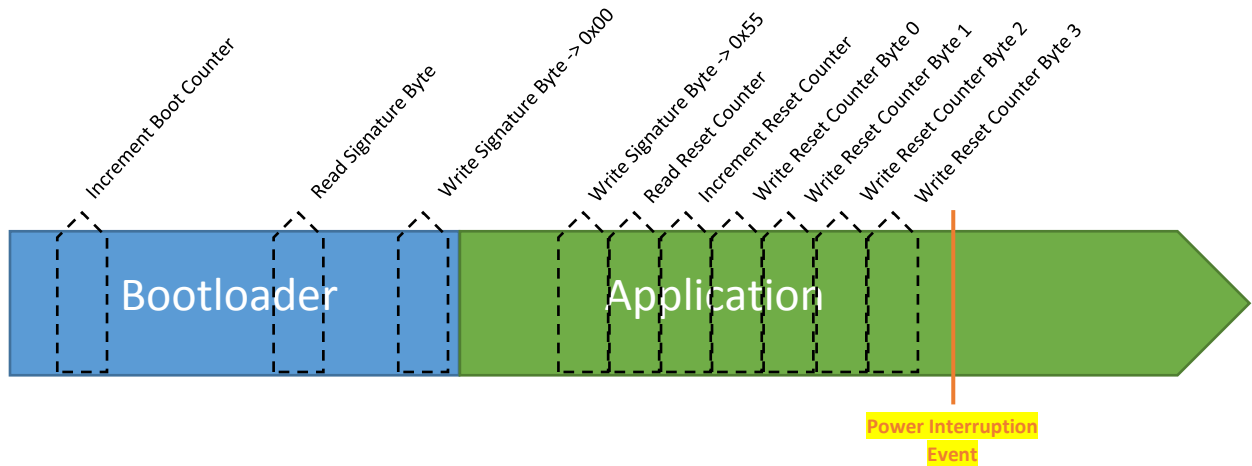
Figure 11 - Category 4 Power Interruption Event

Category 4 is the correct operation of the robot – the Power Interruption Event happens after the portions of the software involving writing the Reset Counter, Boot Counter, and Signature Byte have had a chance to execute. Both Boot Counter and Reset Counter values are incremented during the first power-on, then again during the second reboot. In Figure 11, a successful reboot event is shown.

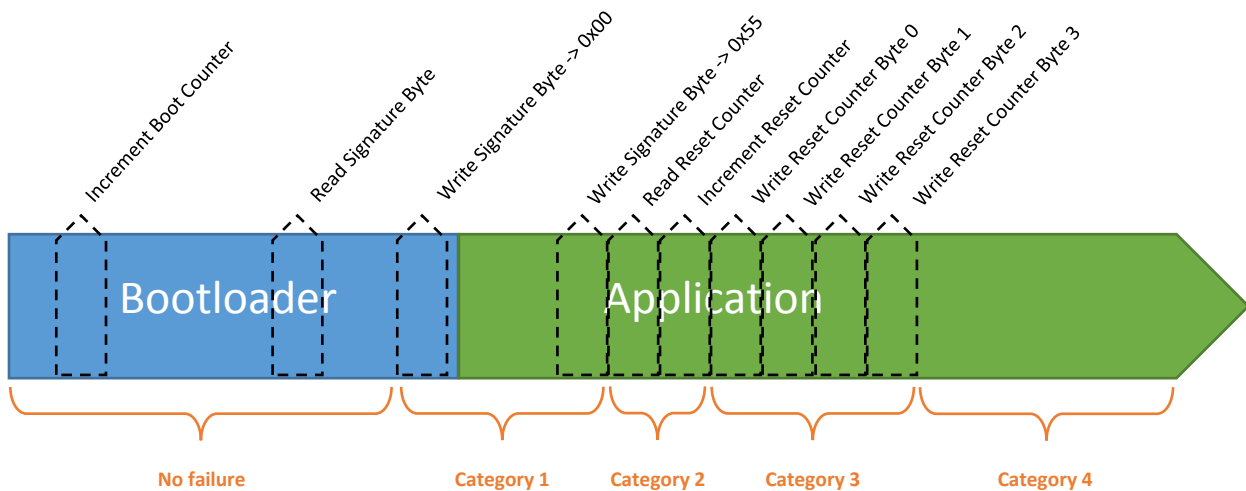
Figure 12 - All Four Categories Together in Sequence

The window of vulnerability was found to exist in the Category 1 area and results in a robot system failure – the Mobility board remains in bootloader.

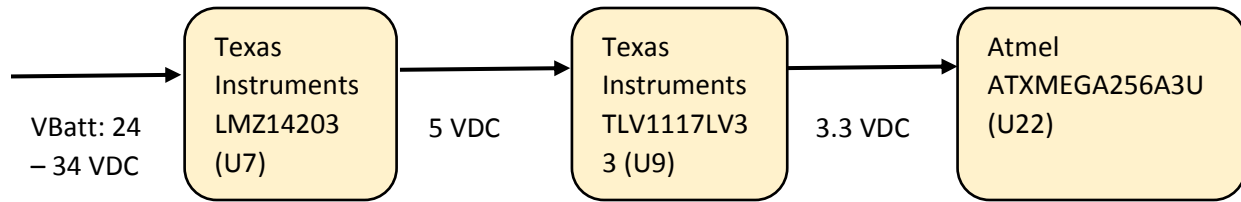
Figure 13 - Mobility Board Power Hardware Architecture

Another difference lies in the hardware design between the two boards. It is possible the dip in voltage that causes the Mobility Board to reset does not cause the same problem in the Flipper Board. The architectures of the two power systems are similar but not exactly the same. The differences can be seen by comparing Figure 13 and Figure 14, which represent the Mobility Board and Flipper Board respectively.

In addition to the one DC-DC converter chip that is different – LMZ14203 vs LMZ14203H – the supporting hardware of resistors and capacitors is also different since the voltage conversion levels are different between the two designs. It is suspected that these electrical hardware differences result in the Flipper Board being more robust to momentary dips in voltage – either the timing, duration, or the “depth” of the voltage dip. This was not confirmed.
