# Payload Inrush Investigation

GVR-BOT Technical Report

Tyrus Valascho, Kayla Gomes  
3-10-2017

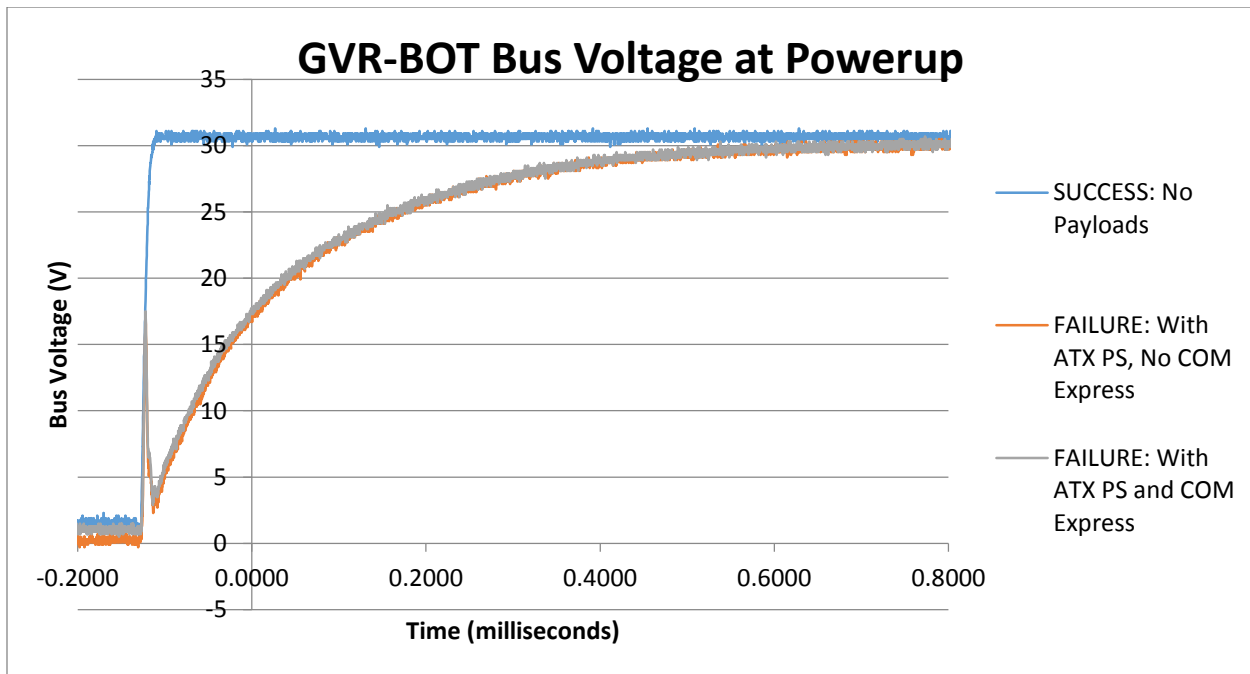
Figure 3 - GVR-BOT Bus Voltage using Different Payload Combinations

This initial testing established that the issue was being caused solely by the ATX Power Supply and the presence of a payload “upstream” of the power supply was not related to the problem. It also showed that within the first millisecond of powering on the robot, the presence of the ATX Power Supply was pulling the GVR-BOT Bus Voltage down below 5 VDC (Volts Direct Current).

A plot of the three combinations tested and the resulting bus voltage values over time is presented in Figure 3.

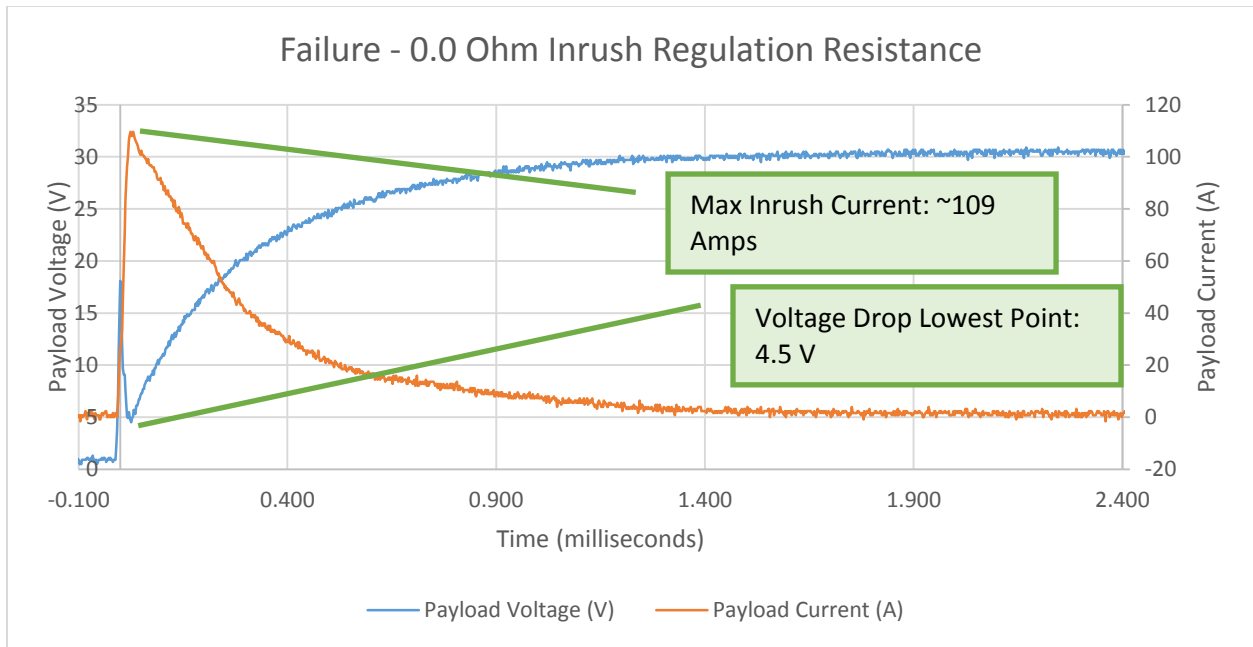
Figure 7 - Inrush Current and Voltage during Failure Event

The inrush current of the ATX Power Supply was found to be causing the voltage to drop to an unacceptably low value during system startup. To give a better understanding of the relationship between inrush current and bus voltage, data from an unsuccessful test run is provided in Figure 7, with the max inrush current and lowest voltage drop identified.

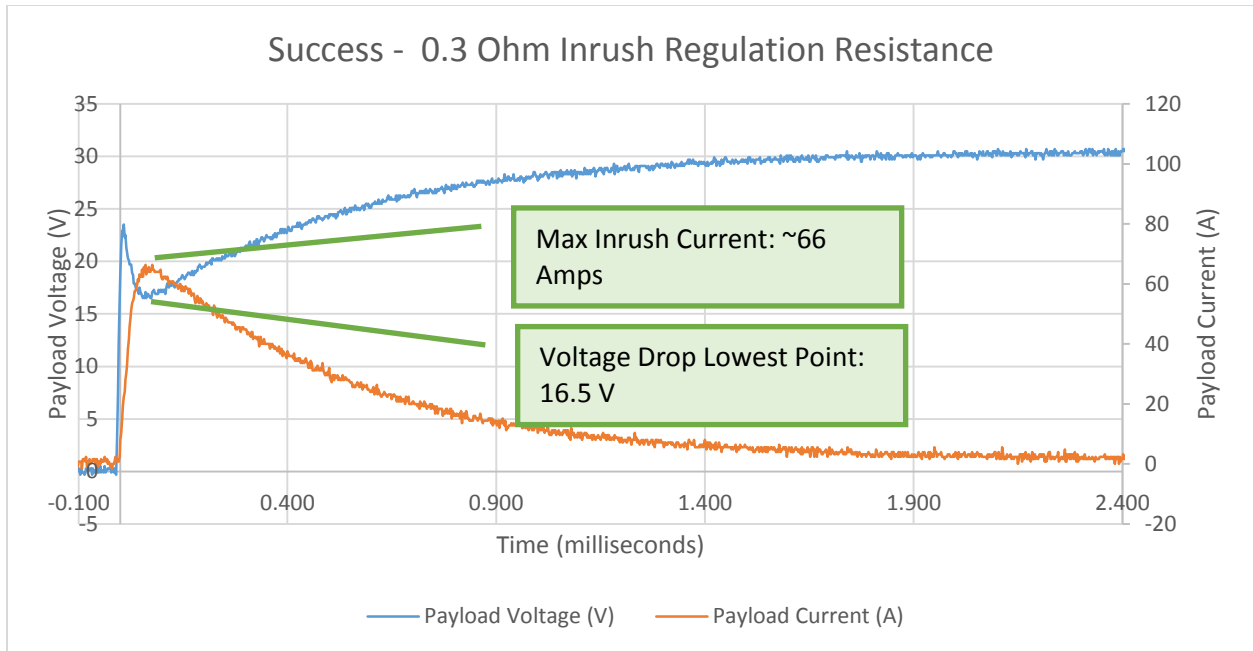
Figure 8 - Inrush Current and Voltage during Successful Event

By contrast, a plot of a successful test run using 0.3 Ohm inrush current limiting resistance is provided in Figure 8.

These two graphs show the effect of even a small resistance on the inrush current that is being supplied by the robot. This resistance reduces the amount of inrush by about 40%, which appears to be enough to reliably fix the issue on the one robot it was tested on.

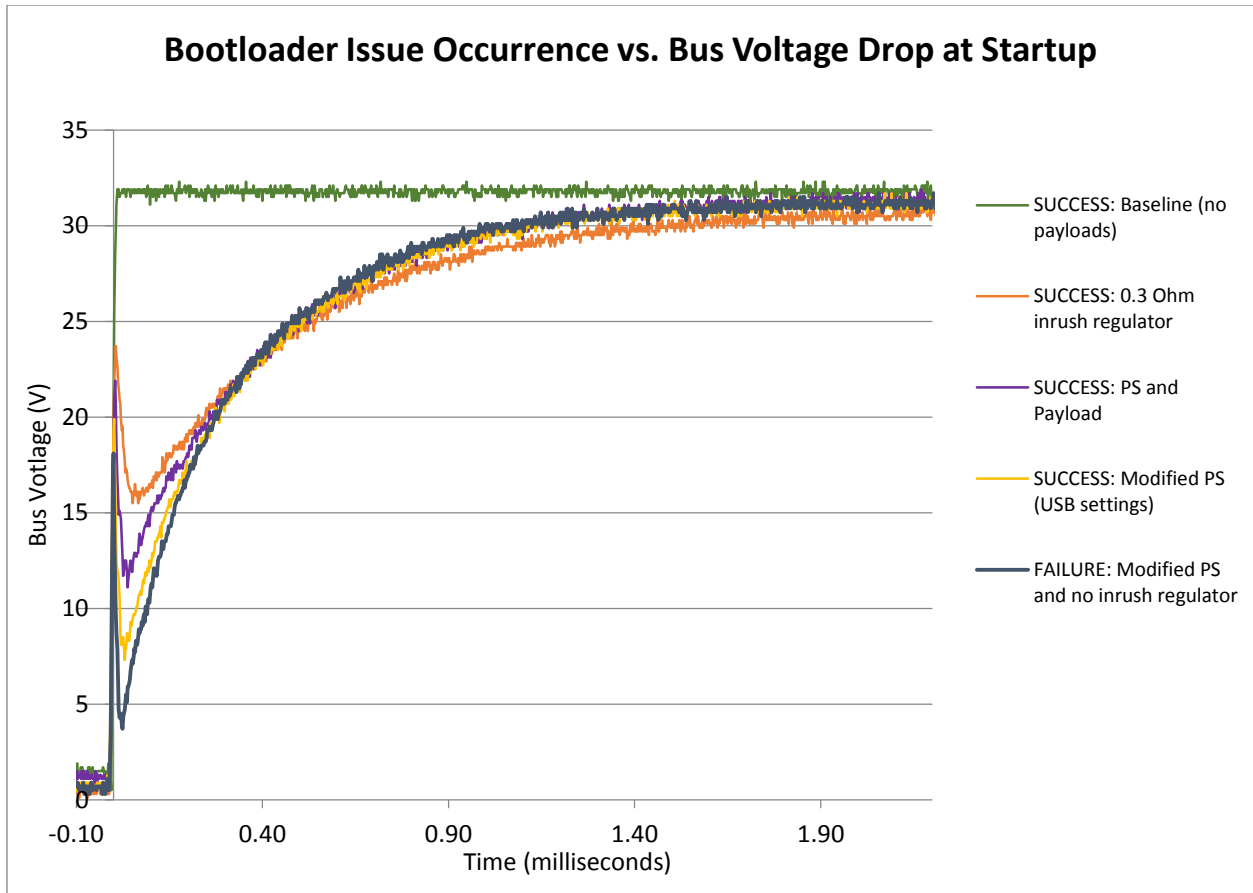
Figure 9 - Bootloader Issue Occurrence vs. Bus Voltage Drop during Startup

As can be seen by the plots, every test run where the robot's Bus Voltage falls below 7 VDC during system boot results in a failure. All test runs where this voltage does not fall to that level is a successful power up.

At this point in the investigation, it still could not be determined if the failure is due to the actual voltage level that the system dips down to, the timing of that dip in voltage, or some other factor.

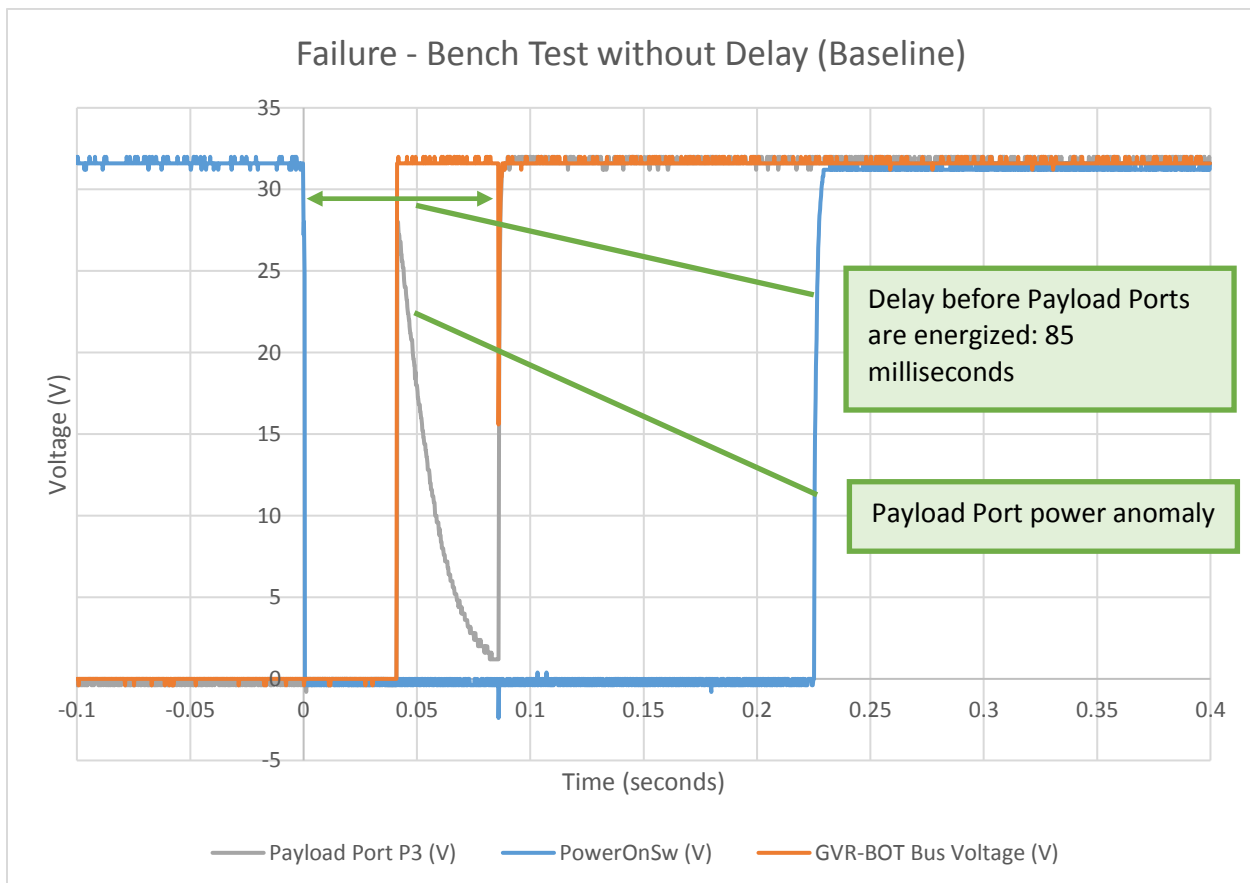
Figure 11 - Bench Test with Baseline Software

The control of these Power MOSFETs is performed by the SW10 Power Management software. In the most recent release of SW10 Power Management software, Release 0.2.4, the four Payload Port MOSFETs are enabled almost immediately when the application software begins. The GVR-BOT Bus Power MOSFETs are enabled by the bootloader software so that the Main Processor is powered on whether the Pwr Mgt Board is in bootloader mode (waiting for reprogramming) or application mode. In this software release, all 6 MOSFETs are enabled within 100 milliseconds – the GVR-BOT Bus is enabled at about 50 milliseconds after PowerOnSw is activated, and the Payload Port MOSFETs at about 90 milliseconds after PowerOnSw is activated. This behavior is demonstrated in Figure 11, which is an example of a failed attempt to boot the system with the ATX Power Supply attached – the Mobility board during this test did not go to application mode.

An unexplained issue that was observed in this testing was the appearance of a brief, un-intended enabling of the Payload Port which occurs simultaneously with the GVR-BOT Bus Voltage becoming

active. This should not be happening and the Payload Port power appears to be quickly disabled, but the voltage decay takes about 40 milliseconds. Further testing determined this anomalous behavior was being experienced at all four Payload Ports.

In addition, an unusual Payload Port power anomaly was found that resulted in a brief enabling of Payload Port power, then disabled. The entire event lasts about 50 milliseconds, but appears on every Payload Port during every power up of the system. It is recommended that the root cause of this anomaly be found.

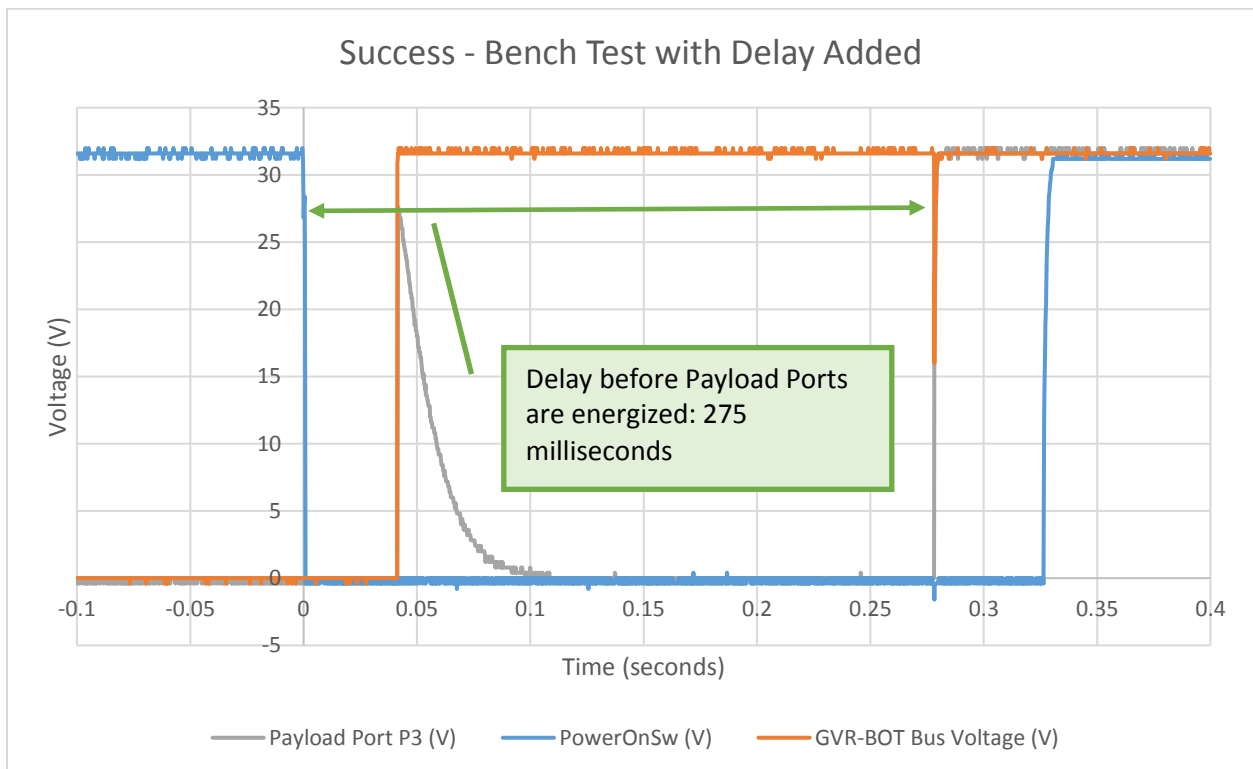
Figure 12 – Bench Test with Delayed Payload Port Enabling

The solution was tested 12 times using Configuration 3. It was then tested 3 times on GVR-BOT-037 and 3 times on GVR-BOT-004. This change appeared to fix the bootloader issues experienced by the robot in all cases tested. An example plot of a successful test is provided in Figure 12.

In this graph, the delayed Payload Port activation is clearly seen when compared with the baseline graph in Figure 11. The amount of time between system start and energizing of the payload ports went from 85 milliseconds to 275 milliseconds.

A software change was tested where enabling of the Payload Ports MOSFET was delayed by about 200 milliseconds, giving a chance for “internal inrush” current within the GVR-BOT system to abate before any additional inrush from the payload ports is experienced by the system.

Of these three, the software delay was found to have the least impact on the customer and is recommended to be the chosen solution.
