**NAVAL
POSTGRADUATE
SCHOOL**

THESIS

**A PROBABILITY RISK ASSESSMENT TO SUPPORT A
DEFENDABLE AND QUANTITATIVE SAFETY ASSESSMENT
OF THE ASSAULT AMPHIBIOUS VEHICLE**

September 2018

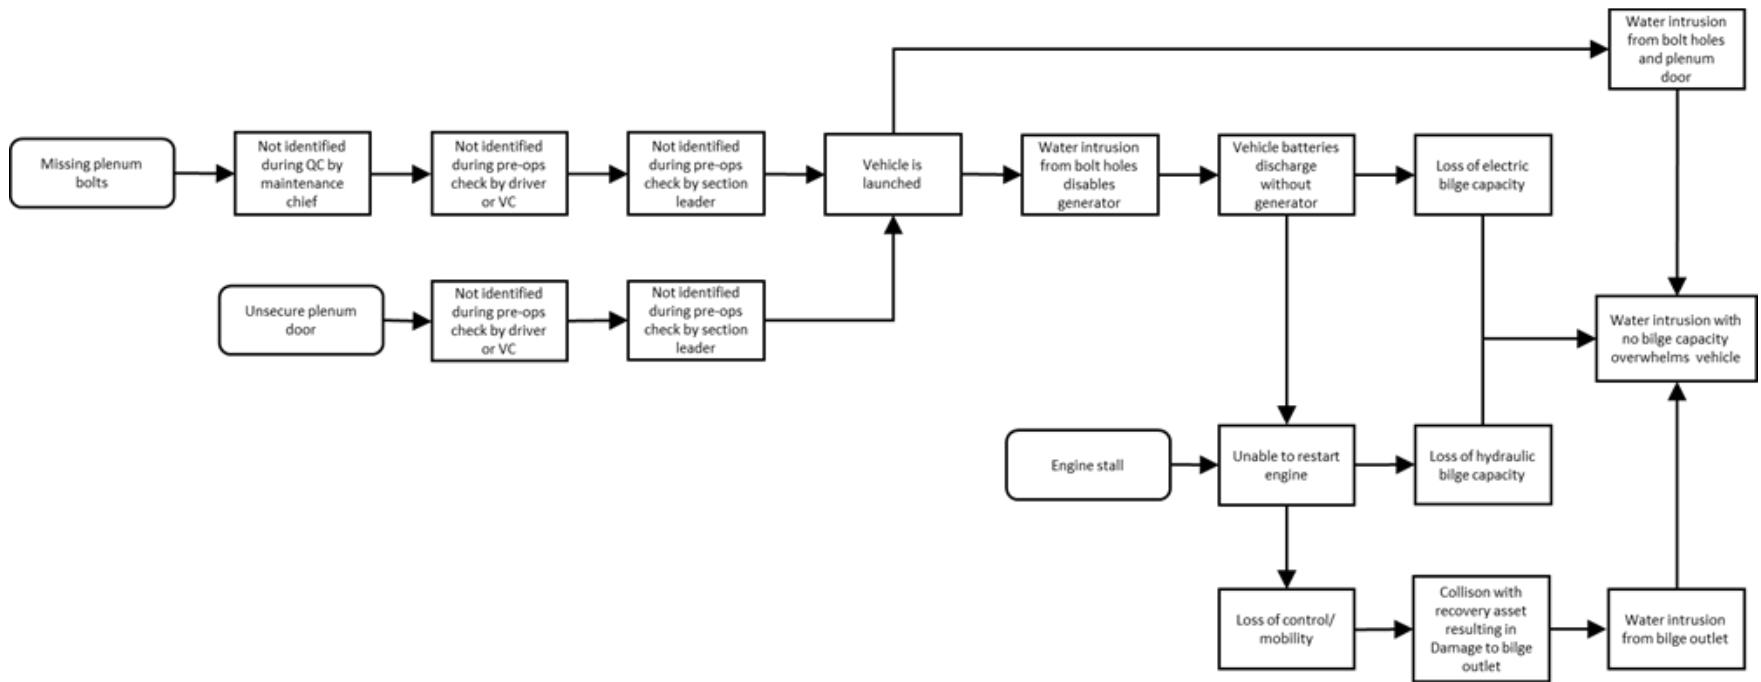
Figure 2. Mishap #2 Scenario

The decomposition of the collected data is important to this step. Figure 2 illustrates a constructed mishap scenario of mishap #2. The mishap scenario development follows the mishap report decomposition process described in Section 3.C. This mishap scenario is a graphical depiction of the key elements identified from the decomposition that led to the mishap.

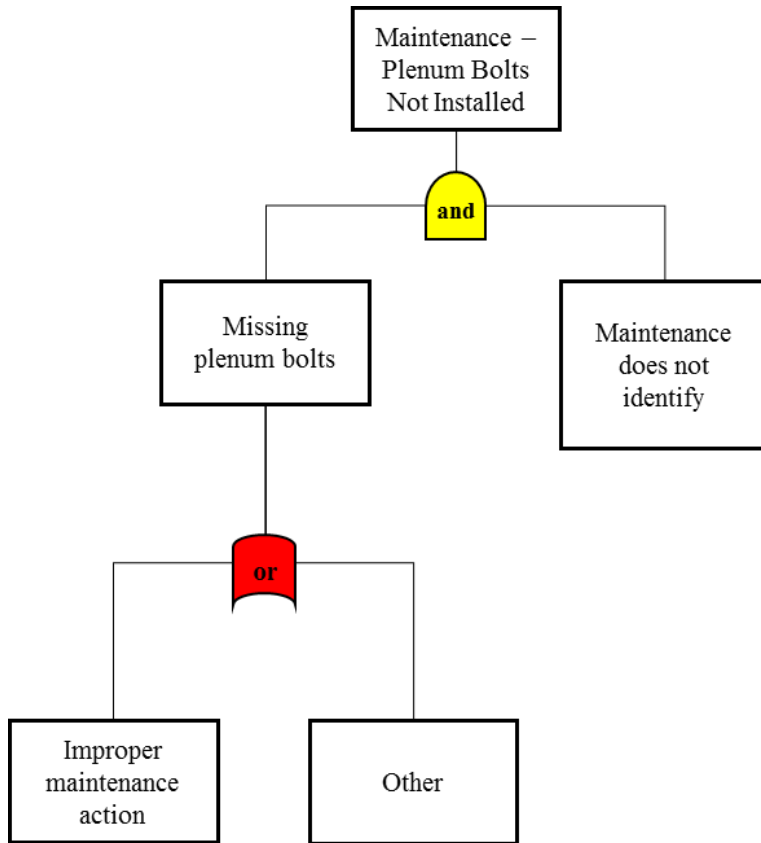
Figure 3. Maintenance—Plenum Bolts Not Installed FTA

- a. The holes from the missing bolts on the plenum housing and cargo hatch
 - i. Poor quality control/maintenance operations.
 - ii. Failure to conduct pre-operations check/pre-water operations check.

3. Failure event—Larger than normal intake of water Causal Factor
 - a. Exhaust grill and plenum housing not properly secured.

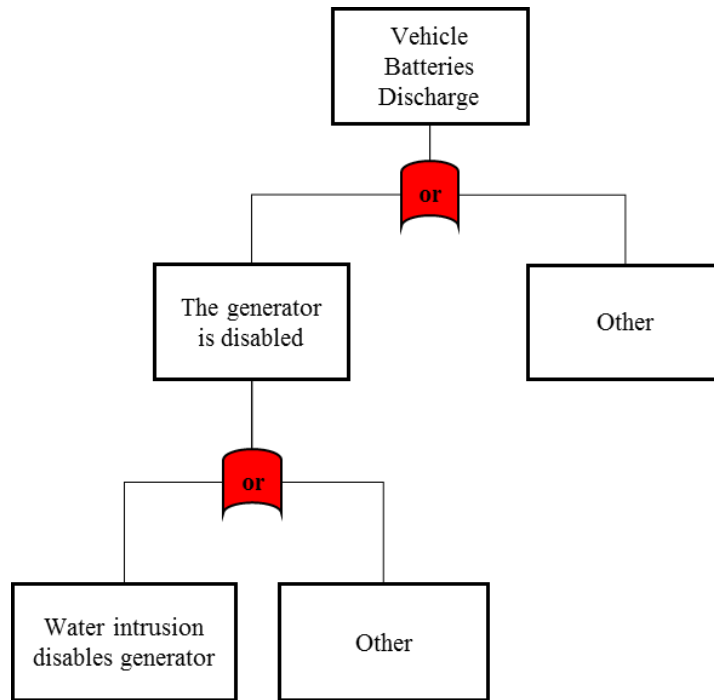
Figure 5. Vehicle Batteries Discharge FTA

1. Unknown engine stall on stern gate
 2. Inability to restart the engine
 - a. Discharged battery bank
 - i. Generator failure
 1. Water intrusion from missing bolts

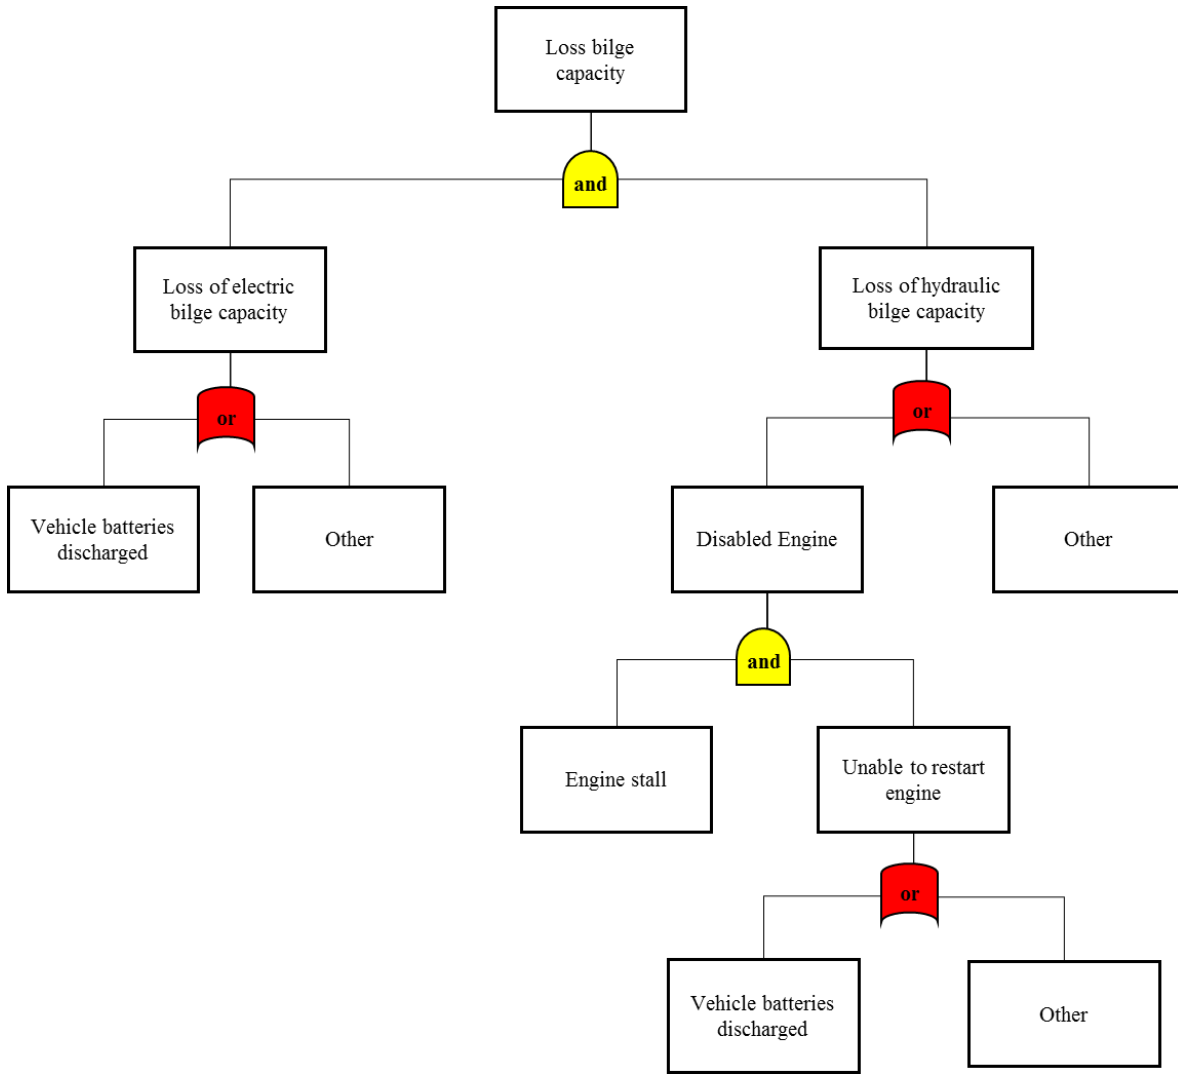
Figure 6. Loss of Bilge Capacity FTA

- i. Poor quality control/maintenance operations.
 - ii. Failure to conduct pre-operations check/pre-water operations check.
 - 4. Failure event—Larger than normal intake of water
 - a. Degraded electric bilge capacity
 - i. Discharged battery bank
 - 1. Generator failure
 - a. Water intrusion from missing bolts
 - i. Poor quality control/maintenance operations.
 - ii. Failure to conduct pre-operations check/pre-water operations check.
5. Failure event—Larger than normal intake of water
 - a. No hydraulic bilge capacity
 - i. Unknown engine stall on stern gate
 - ii. Inability to restart the engine
 - 1. Discharged battery bank
 - a. Generator failure
 - i. Water intrusion from missing bolts
 - 1. Poor quality control/maintenance operations.
 - 2. Failure to conduct pre-operations check/pre-water operations check.
