NAVAL FACILITIES ENGINEERING SERVICE CENTER  
Port Hueneme, California 93043-4370

## **SITE SPECIFIC REPORT SSR-2525-SHR**

### **PIPELINE COATING CONDITION ASSESSMENT AND INSTALLATION ASSESSMENT, SAN NICOLAS ISLAND**

November 1999

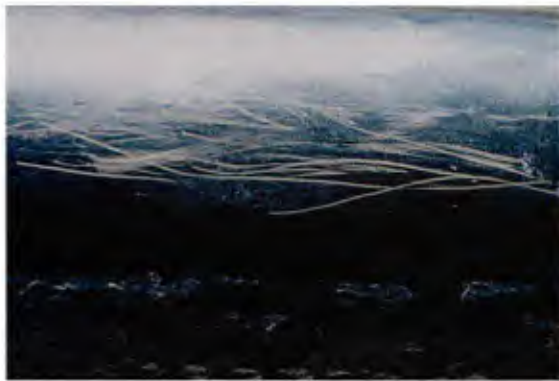
In an attempt to quantify soil and rock abrasion on the coating, representative rock and soil samples, taken from the island, were lightly rubbed against the coating. The resulting scratches were visually matched to equivalent sandpaper scratches made from known grit sizes. San Nicolas Island rock and soil produced coating scratches equivalent to 60 – 400 grit sandpaper. In the laboratory investigation, the sandpaper equivalent of island soils and rocks were used (see section titled "Abrasion Resistance").

Light rubbing using shell embedded soil on coating: Sandpaper equivalent, 60 – 80 grit.

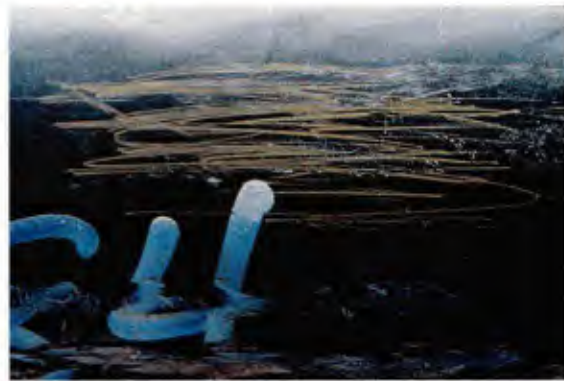
Light rubbing using a pumice type rock on coating: Sandpaper equivalent, 60 grit.

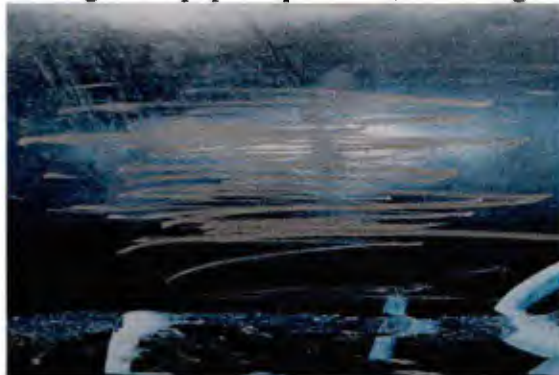
Light rubbing using sand stone on coating: Sandpaper equivalent, 80 grit.

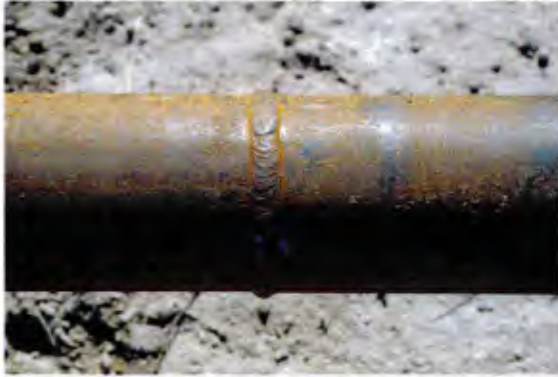
Close-up of pipe weld: Notice flash rusting.

The majority of pipe requiring a field coating contained visually significant quantities of flash rusting. Prior to coating, flash rusting requires complete removal by re-blasting. Flash rusting decreases the adhesion of coatings to steel and results in a reduced coating service life. On San Nicolas Island, flash rusting is good indication that chloride ions have contaminated steel surfaces. If chloride ions are not removed to acceptable concentrations (less than 7 ug/cm<sup>2</sup> of chloride ion contamination), chloride ions will attract water of a lower chloride ion concentration into contaminated surfaces. The chloride ion effect will not stop until the contaminated steel surface is at equilibrium with surrounding liquids. Prior to the field application of coatings, exposed pipe surfaces should be washed with hot potable water followed by grit blasting to produce a 2 – 4 mil anchor profile. All field applied coatings where the above procedure was not employed may experience reduced performance.

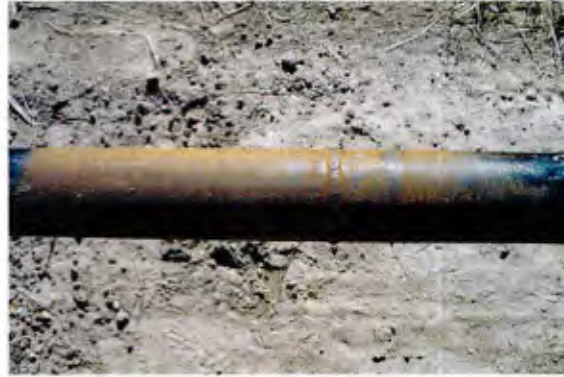
Pipe surface requiring field coating.

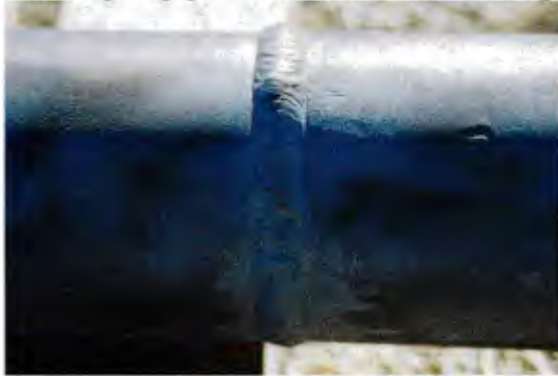
Grit blasted pipe weld.

Field surface preparation consists of a combination of #60 grit blasting, wire wheel abrading, and power grinding. Power grinding and wheel abrading are acceptable techniques for coating removal; however, they are unacceptable when used to prepare steel surfaces for coatings requiring immersion service. Only grit blasting is capable of producing the required angular anchor profile. Furthermore, the contractor's choice of #60 grit appeared to be producing a 1 – 2 mil anchor profile in lieu of the desired 2 – 4 mil anchor profile. Larger grit is required to produce a 2 – 4 mil anchor profile.

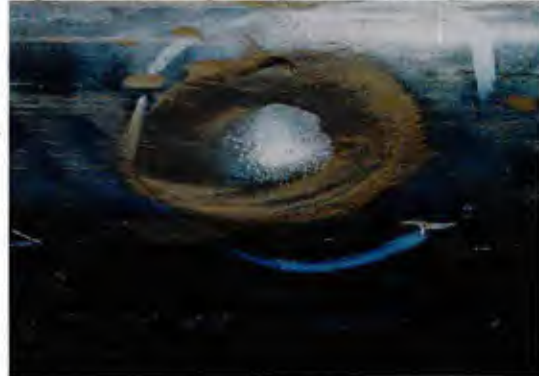
Holiday surface preparation.

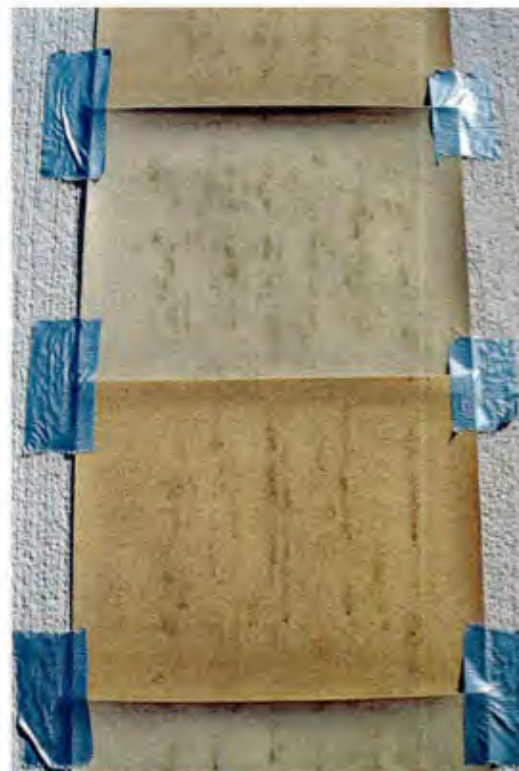
Resulting sandpaper surfaces after nine pulls: Notice black coating deposits

*Results:* 1) Coating weight loss, 0.76355 g (over a 7.854 in<sup>2</sup> area), and 2) Coating thickness loss, 5 – 10 mils (0.0194436 – 0.0097218 g/mil, in<sup>2</sup>).

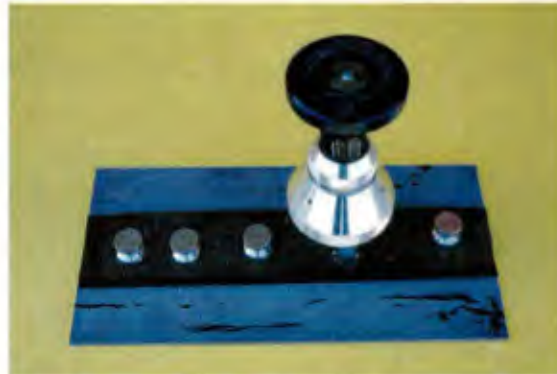
Coal tar urethane sample with 3/4" pull-off coupons and adherence tester.

Five adhesion tests in accordance to ASTM-D-4541 were performed on 80 mils of coating applied to grit blasted steel. The test was performed at 45 hours coating cure and, based upon a Shore A Hardness value of 95, represents a fully cured coating. Each adhesion test produced a cohesive failure in the coating at an average value of 716 psi. The resulting average adhesion is 59 % lower than the average value reported by the coating vendor's testing laboratory. The above adhesion value represents the coating's maximum shear bond strength.
