RUNWAY FRICTION MEASUREMENTS AND PAVEMENT CONDITION  
SURVEY, NPTC EL CENTRO, CALIFORNIA, by

R. B. BROWNIE,

SEPTEMBER 1976,"

## CIVIL ENGINEERING LABORATORY

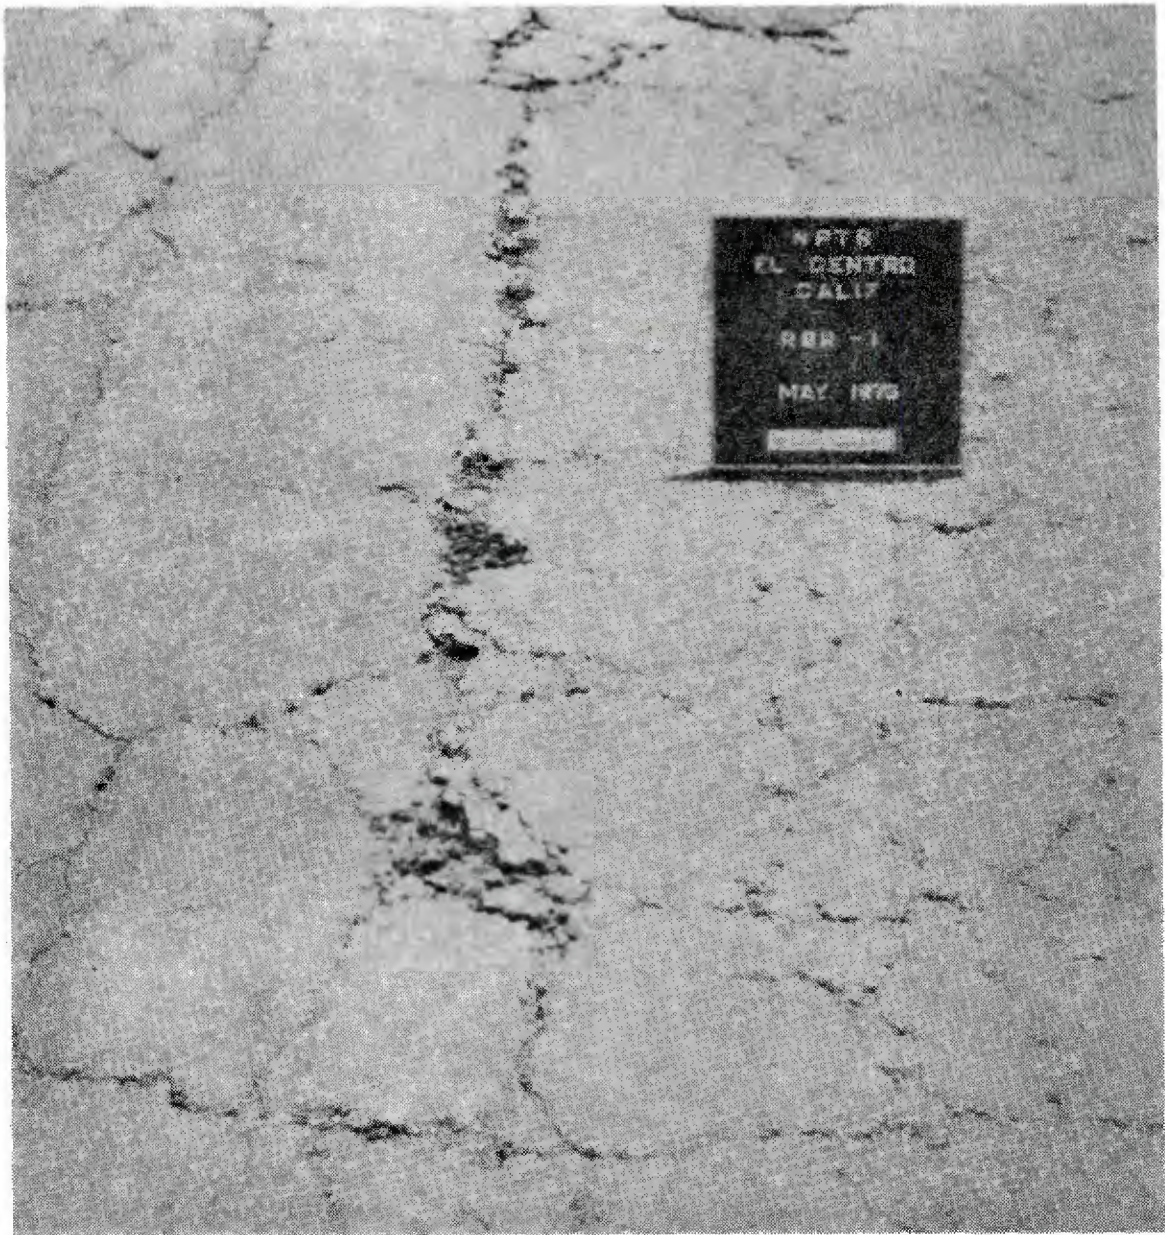
R8R-1: The substantial increase in pattern cracking is attributed to continued aging of the pavement surface. Many of the cracks tallied as longitudinal cracks in 1969 are now included in pattern cracking.

Figure 2. Severe pattern cracking and raveling,  
Discrete Area R8R-1.

This seldom-used runway shows the effects of aging and little maintenance. The pattern cracking is mainly caused by shrinkage and hardening of the asphalt binder. Raveling is occurring along the cracks. See Figure 2.

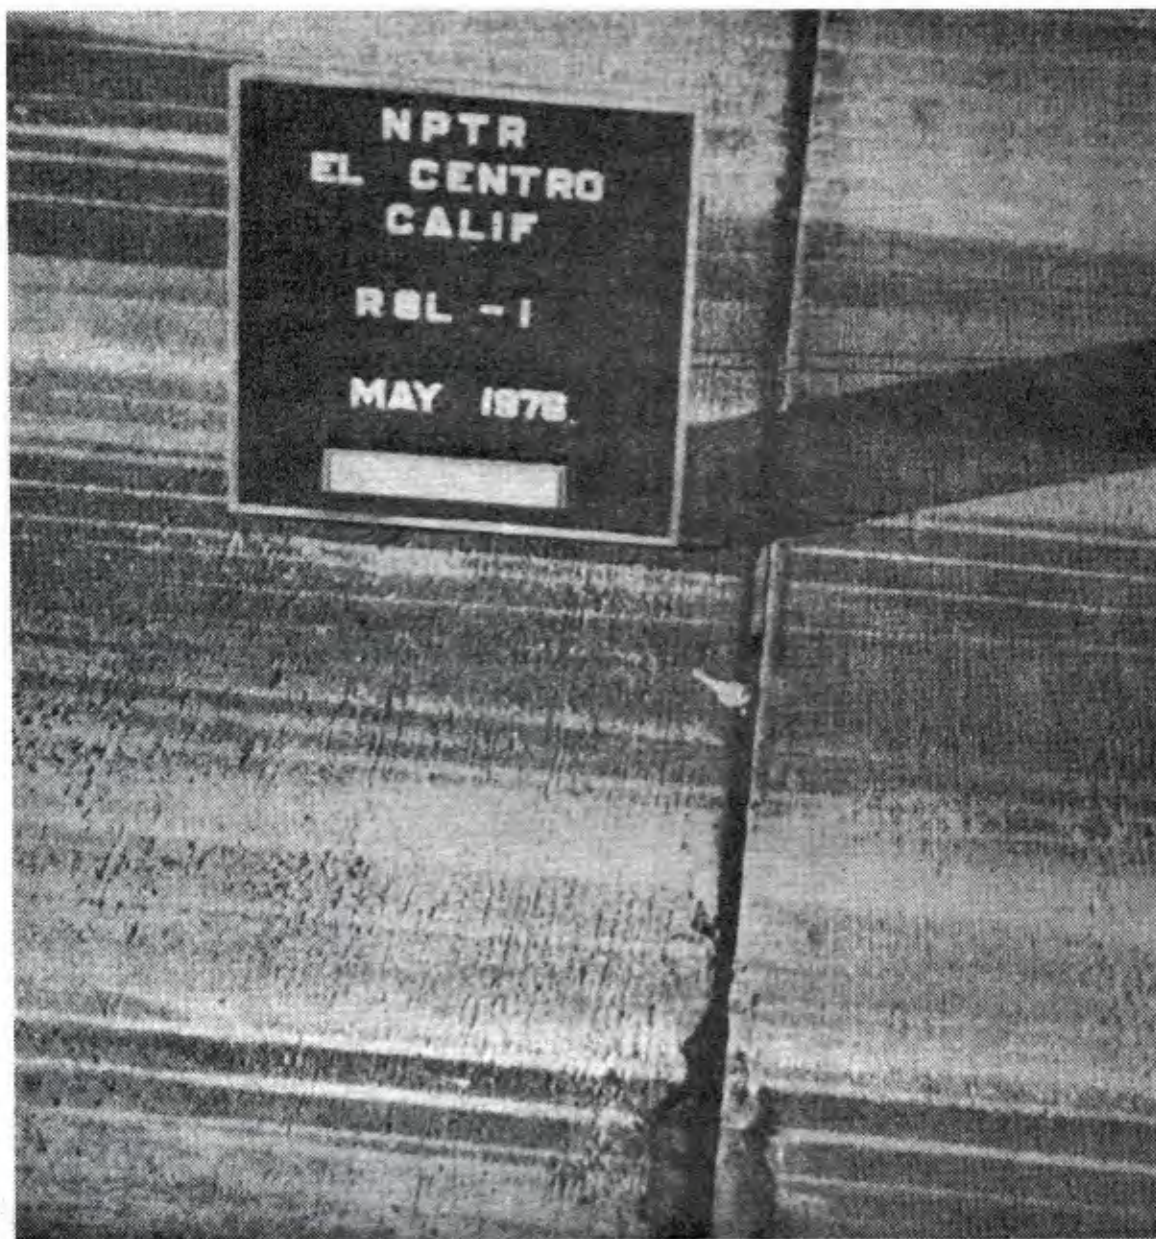
R8L-1: The largest change in defect quantities since 1969 was defective joint seal. This is typical of deterioration and oxidation of joint seal which is 17 years old.

Figure 4. Missing joint seal, Discrete Area R8L-1.

| Defect Type | No. of Sample<br>Slabs w/Defect | Total Slabs<br>w/Defect:<br>c x a/b | Defect<br>Density<br>(per slab)<br>d/a | Defect<br>Severity<br>Weight | Weighted<br>Defect<br>Density<br>e x f |
|---|---|---|---|---|---|
| Joint seal was hardened and often had missing sections. See Figure 4. Spalls were generally small with one or two exceptions. | | | | | 4.47 C *** |

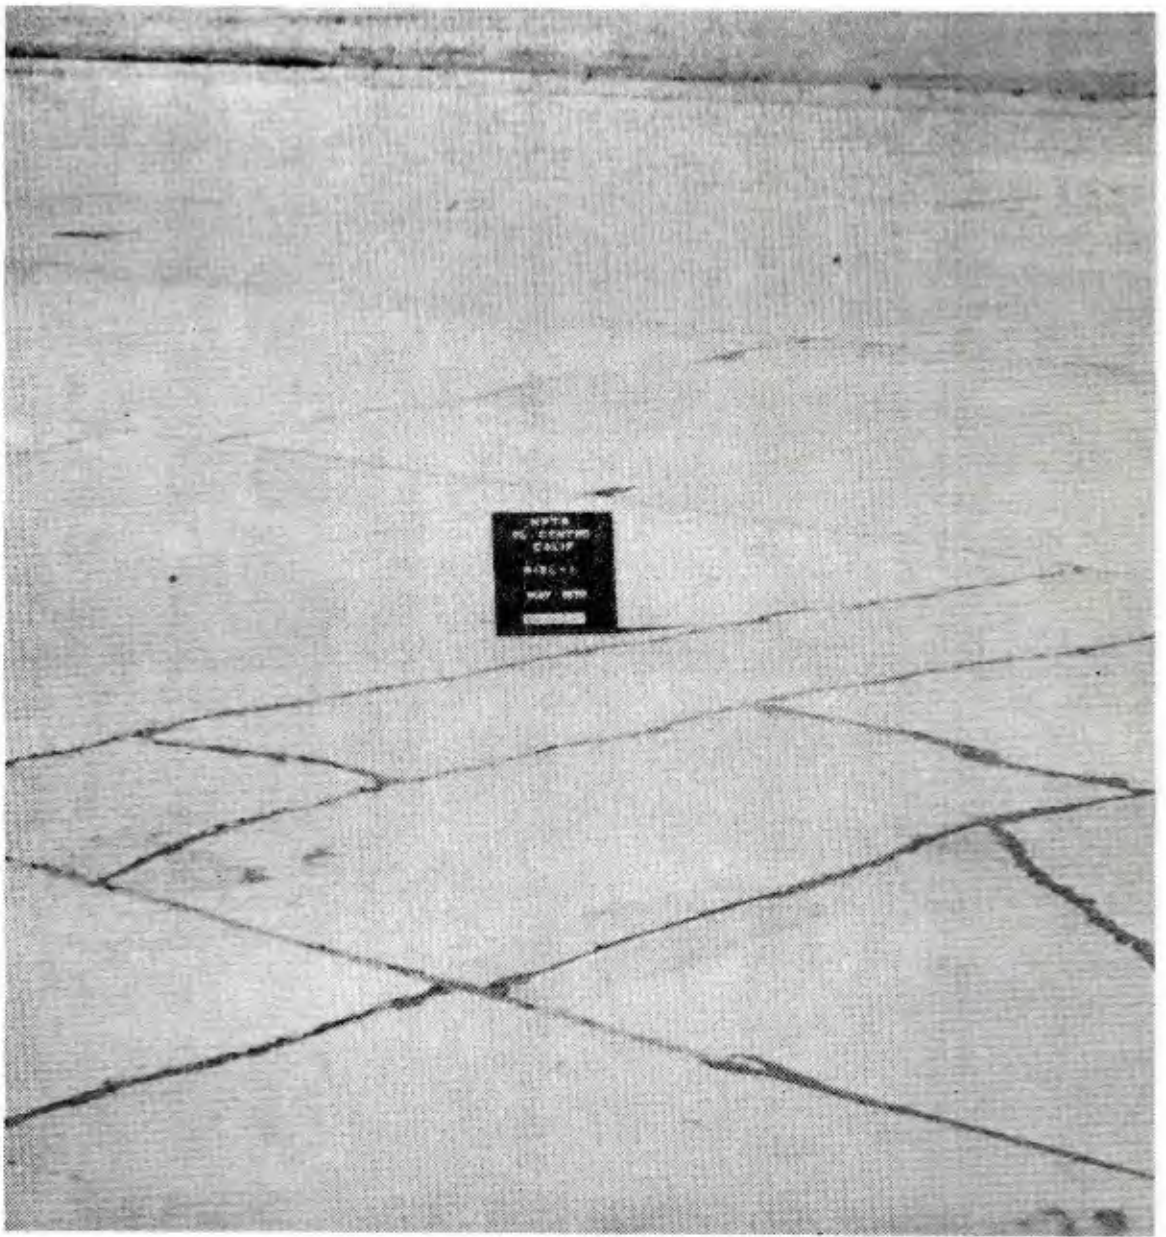
R12L-1: A repair project was completed on this section just before this condition survey. This project accounts for the drastic reduction in spalls and defective joint seal. As in discrete area R8L-3, the large number of transverse cracks is essentially unchanged confirming that these cracks occurred shortly after construction as a result of defective load transfer devices (Reference 3).

Figure 5. Shattered slab, Discrete Area R12L-1.

| Defect Type | No. of Sample Slabs w/Defect | Total Slabs w/Defect:<br>c x a/b | Defect Density<br>(per slab)<br>d/a | Defect Severity Weight | Weighted Defect Density<br>e x f |
|---|---|---|---|---|---|
| <p>The few spalls remaining after the recent repair project were relatively minor. Station forces plan to repair these as funds become available. Generally, the cracks were sealed. See Figure 5.</p> | | | | | |
