# TECHNICAL MEMORANDUM

" EVALUATION OF RUBBER-ASPHALT BINDER FOR SEAL COATING  
ASPHALTIC CONCRETE, NPTR EL CENTRO, CALIFORNIA,  
MARCH 1974 - JULY 1977, by

WESTERN DIVISION, NAVAL FACILITIES ENGINEERING COMMAND

## CIVIL ENGINEERING LABORATORY

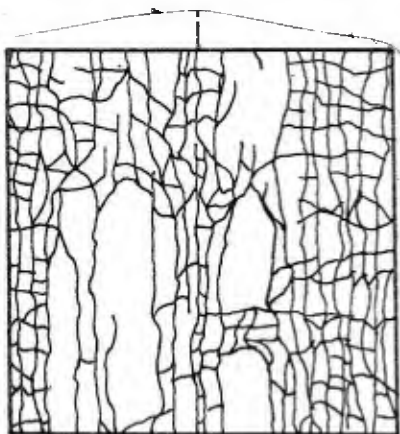
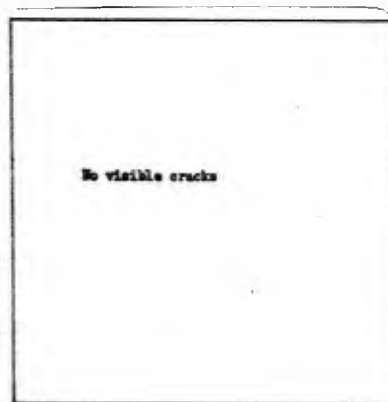
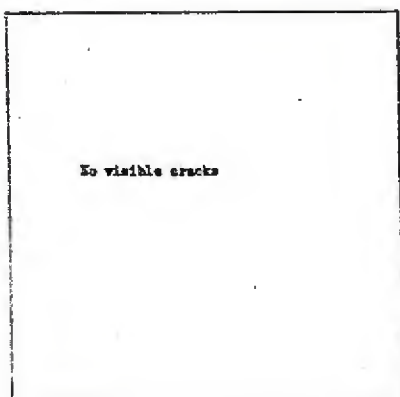
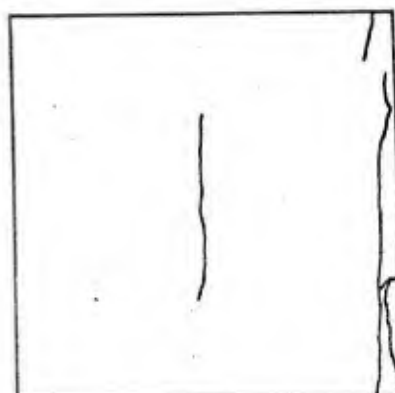
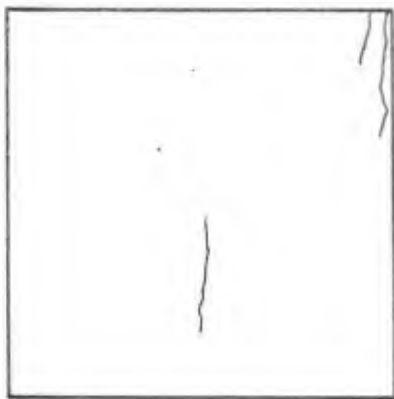
Figure 2. Crack Survey Plots, Taxiway A  
NPTR El Centro, California

these severely distressed areas is planned in the near future by NPTR El Centro. Test plot 1 of Taxiway A and test plot 1 of Taxiway D exhibited the "self-healing" effect noted in Reference 1, and this is shown graphically in Figure 8.

1. The rubber-asphalt seal coat is still functioning over fatigue-type cracking where the pavement has not begun to fail under the load. Deflections occurring under load on Taxiway B apparently cause higher tensile stresses than the rubber-asphalt binder can sustain.
2. At test plot 1 of Taxiway A and test plot 1 of Taxiway D, the seal coat was "self-healing", as shown in previous inspections (Reference 1).

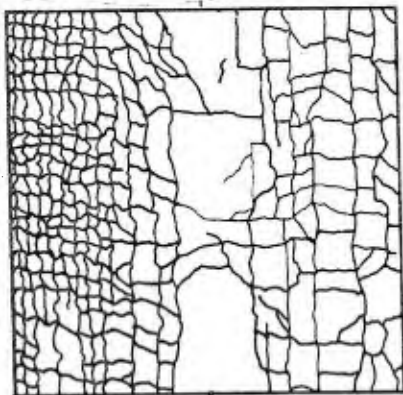
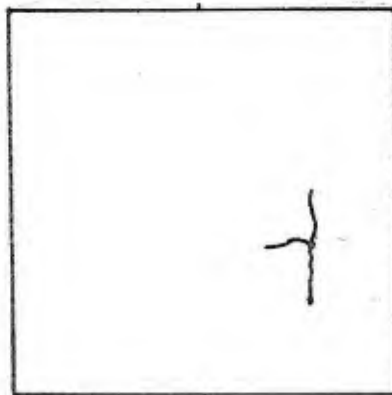
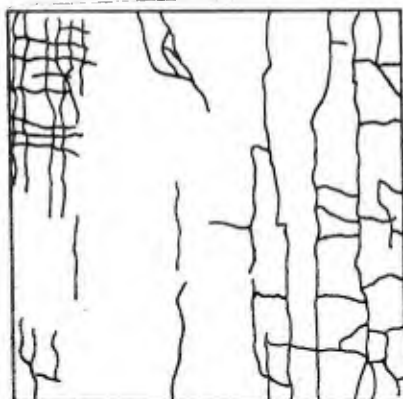
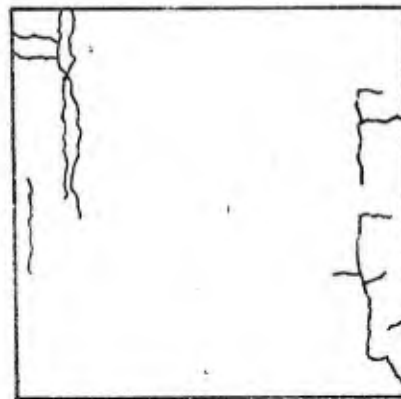
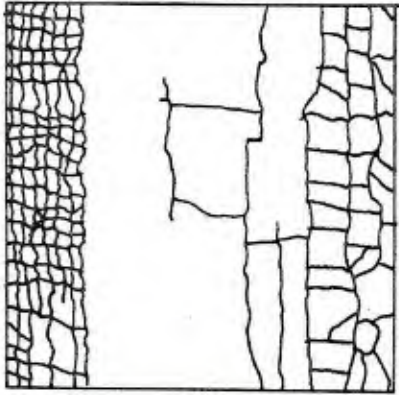
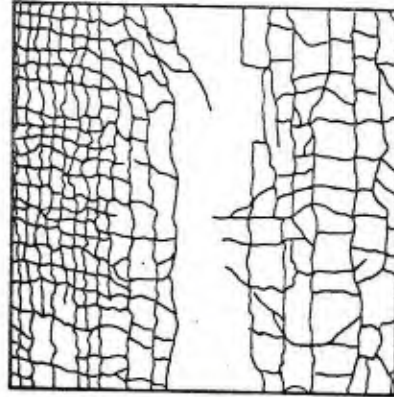
Figure 4. Crack Survey Plots, Taxiway B  
NPTR El Centro, California

At NPTR El Centro, the majority of cracking was fatigue-type pattern cracking with a few longitudinal construction joint cracks. As shown in Table 1 and Figure 8, reflection cracks began to appear after the seal coats were 6-13 months old. The amount of reflection cracking has been cyclic, reaching a peak in mid-winter and then dropping dramatically during the summer until the July 1977 inspection. All test plots on Taxiway B and test plot 2 of Taxiway A showed increased reflection cracking in the summer of 1977. All of these areas exhibited substantial amounts of rutting and evidence of incipient load-related failures (Figures 9 and 10). Replacement of

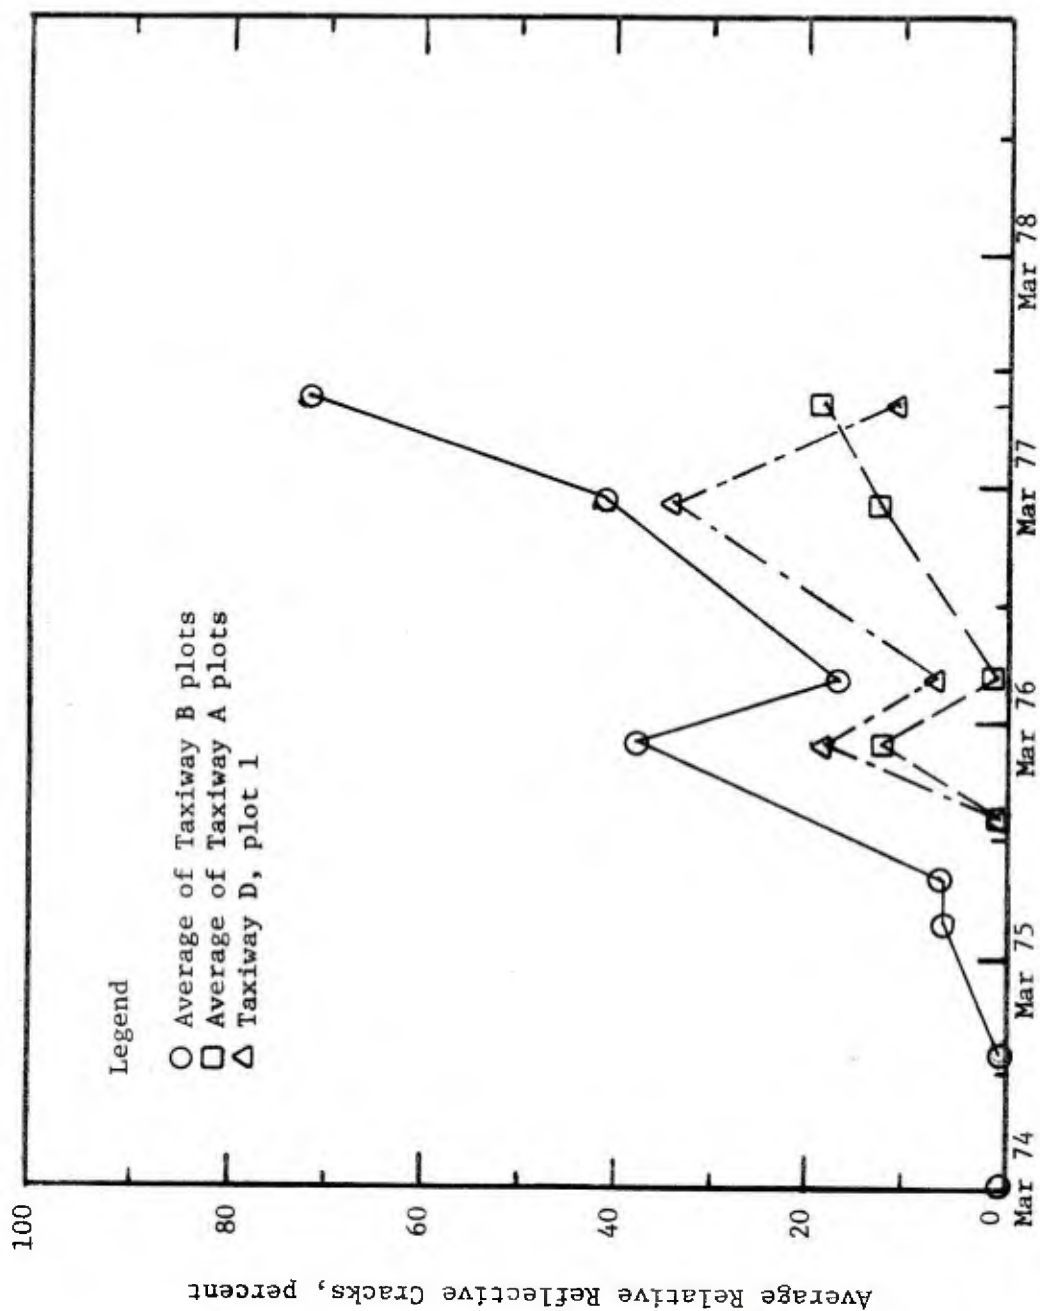
Figure 8. Average Relative Reflected Cracks versus Time, NPTR El Centro, California

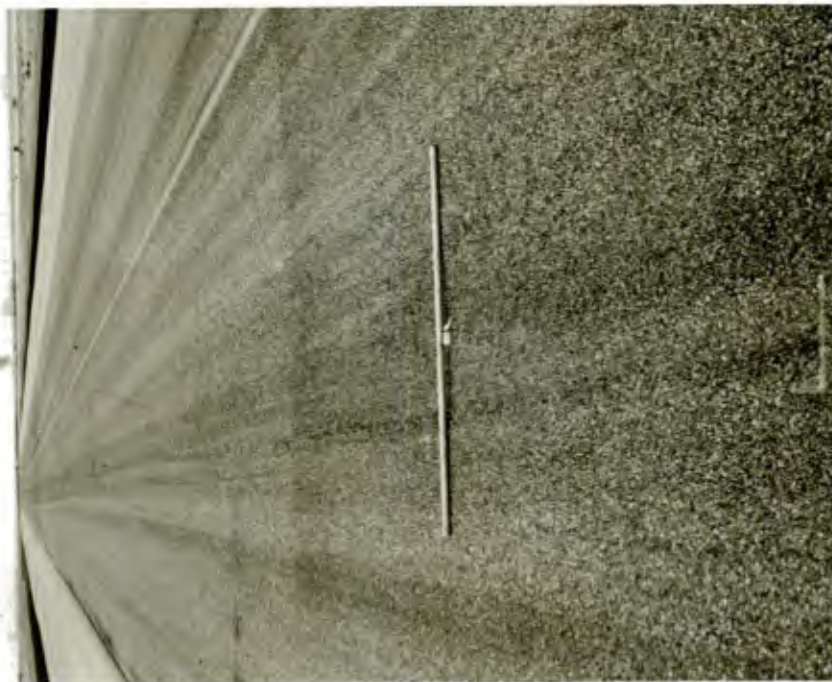
Figure 9. One-inch deep rutting in wheelpath of Taxiway B.

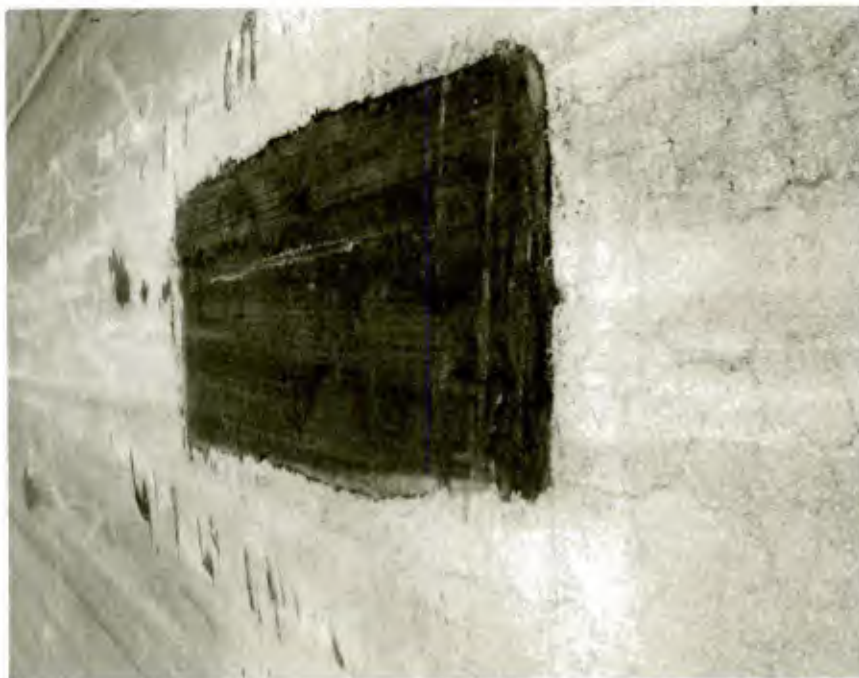
Figure 10. Patched load failure and associated pattern cracking.
