## **Geophysical Investigation at Eielson Air Force Base, Alaska**

Subsurface Features Influencing Building 6385

June 2019

Final Report

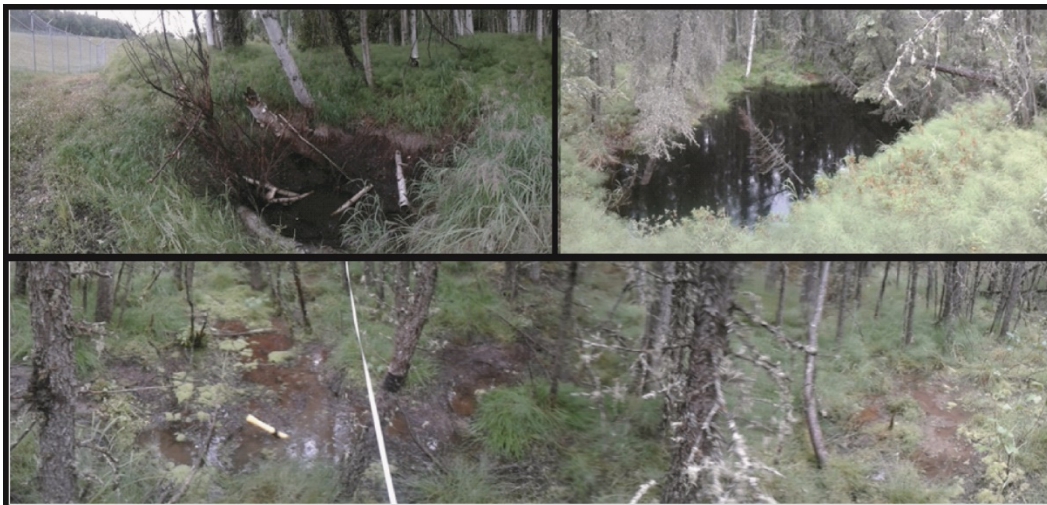
Figure 3. Thermokarst features in the study area north of Quarry Road.

Construction in the area has modified the surficial geology, organic mat, and thermal regime, resulting in permafrost degradation. Thermokarst degradation features are clearly visible in the study area north of Quarry Road (Figure 3).

ERT Transects 1 and 2 travel through frost boils, small thermokarst ponds, and filled pits and gullies. Evidence of forest fires within the last 10 years is present in the north part of the study area, which suggests that damage to the thermal insulating organic mat has occurred, further disrupting the

thermal regime on-site. The dominant factors driving permafrost degradation on-site appear to be damage to the insulating organic mat in cut areas; pooling of groundwater against embankments and structures; lack of positive drainage; and clearing of trees, resulting in excess warming of the surface during summer months.

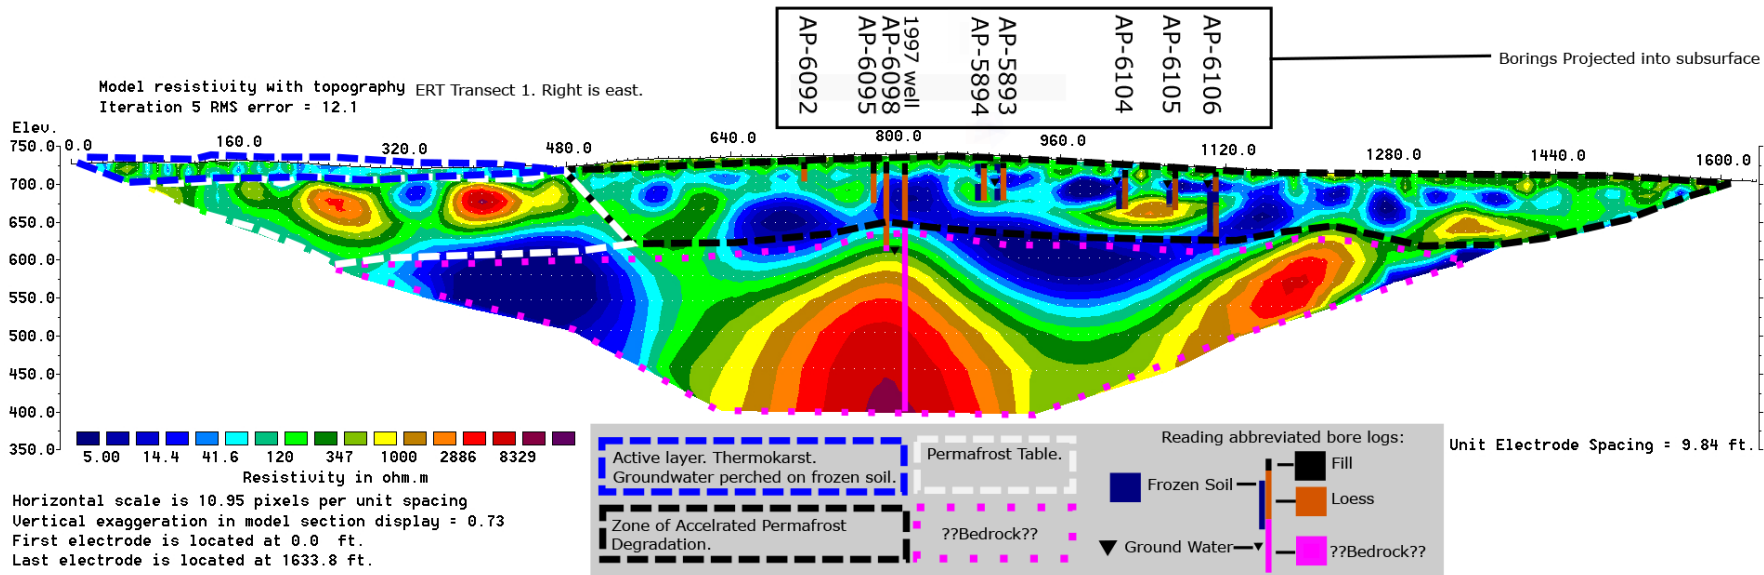
Figure 9. Interpreted ERT Transect 1.

This transect was run within the cleared and disturbed area that parallels the perimeter fence around Building 6385. As a result, frozen ground in the pseudosection is mostly thermally degraded. The following summarizes the four distinct geomechanical units, their engineering properties, and how they present in the pseudosection:

- **Active layer, thermokarst, and groundwater perched on frozen soil**—This unit is delineated by blue dashed lines in Figure 9. The surface expression in this unit is wet and moist soil that is easily compressed and poorly drained. Evidence for thermokarst development and damage to the insulating organic mat (caused by old forest fires) was documented in the field within this unit. Building on this unit would likely result in highly differential settlement. This unit presents in the pseudosection as relatively low resistivity signals (thawed wet soils) depicted in shallow downward-trending signals that are perched on higher resistivity signals (permafrost).

- **Zone of accelerated permafrost degradation**—This unit is delineated by black dashed lines in Figure 9. The most recent borings drilled on the project are projected into the pseudosection in Figure 9, and all borings are shown in Figure 8. As previously discussed, borings drilled in 1995 show frozen soil that is now thawed in borings drilled in 2016, 2017, and 2018. This is typical of areas in interior Alaska where structures have been built on permafrost, especially where the organic mat has been stripped and cuts have been excavated. In this zone, isolated remnants of frozen soil exist within a patchwork of thawed and frozen soil with variable moisture contents. Frozen soil in this interval will often have water perched on top of it, which accelerates phase degradation of frozen soil beneath. Because of thermal instability, building on soils depicted in this zone will likely result in differential settlement. This zone presents in the pseudosection as large “blob-like” resistive signals (areas where frozen soil remains) surrounded by conductive signals (thawed soil with varying moisture contents).

- **Permafrost table**—This unit is delineated in Figure 9 with dashed white lines. Material within this unit is frozen year-round and will remain stable as long as it remains in a frozen state. Boring data suggests that frozen soil in the area is relatively ice-poor and, therefore, thaw stable. Resistivity data suggests that frozen soil in the subgrade is a

- **Bedrock**—This unit is delineated in Figure 9 with dashed pink lines and question marks to illustrate uncertainty. Bedrock in the area was encountered by the well drilled in 1997, AP-6098, and possibly AP-6097 (Figure 8). In the pseudosection, bedrock is shown as broad, generally high resistive areas with signals trending up from depth. There is localized low resistivity within this interval that is likely related to the groundwater in the fractured upper interval of the bedrock. Conductivity in this unit correlates with saturated fractures intercepted by the well log at a depth that is consistent with the change from low to high resistivity in the pseudosection. Based on this pseudosection, it appears that the bedrock has a shallow west apparent dip. AP-6098, AP-6097, and the 1997 well log have bedrock encounter depths that support the interpretation that the top of bedrock, as it is shown in Transect 1, has an apparent shallow west dip.

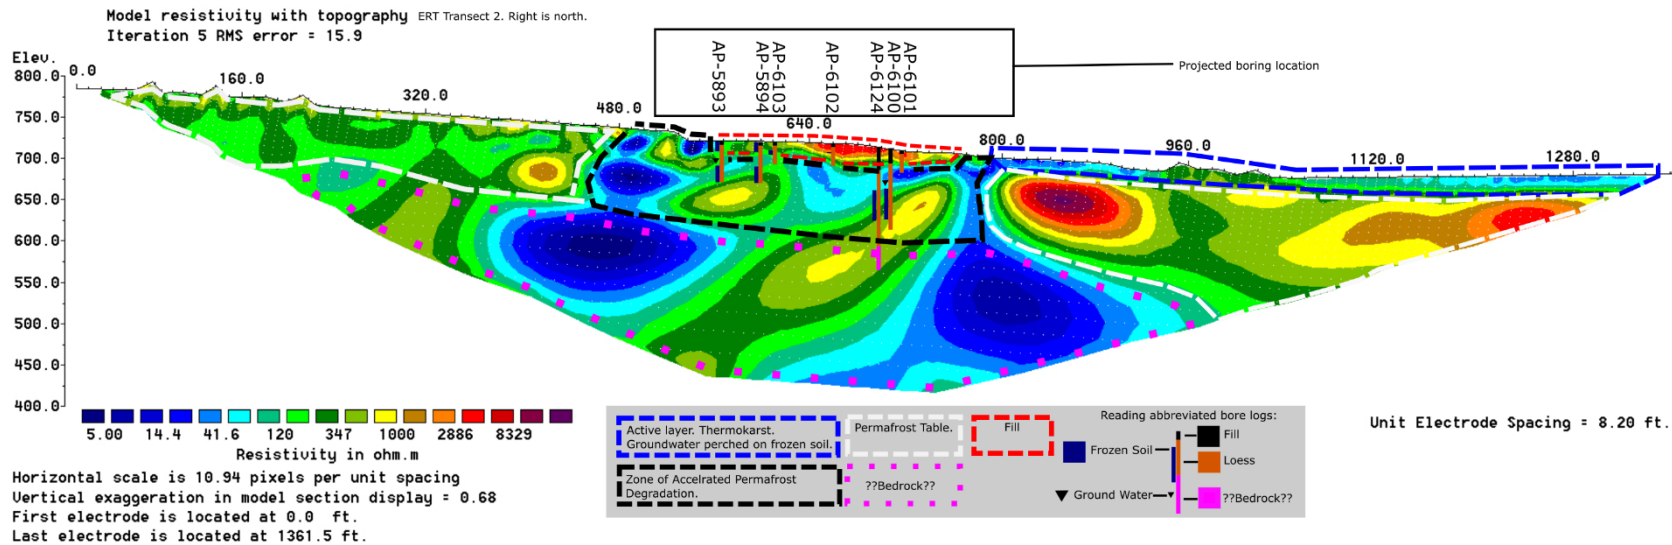
Figure 10. Interpreted ERT Transect 2.

This transect runs through undisturbed ground on the south side with natural drainage (that is not modified by construction), through the developed lot parallel to the concrete apron on the east side, over Quarry Road, and back into undisturbed ground (with surface drainage patterns that are heavily modified by construction) on the north side. The following summarizes the five distinct geomechanical units, their engineering properties, and how they present in the pseudosection:

- **Active layer, thermokarst, and groundwater perched on frozen soil**—This unit is delineated by blue dashed lines in Figure 10. The surface expression in this unit is wet and moist soil that is easily compressed and poorly drained. Thermokarst features are common within this interval (Figure 3). Building on this unit would likely result in high differential settlement. This unit presents in the pseudosection as relatively low resistivity signals (thawed wet soils) depicted in shallow downward-trending signals that are perched on higher resistivity signals (permafrost).

- **Zone of accelerated permafrost degradation**—This unit is delineated by black dashed lines in Figure 10. The most recent borings drilled on the project are projected into the pseudosection in Figure 10, and all borings are shown in Figure 8. As previously discussed, borings drilled in 1995 show frozen soil that is now thawed in borings drilled in 2016, 2017, and 2018. This is typical of areas in interior Alaska where structures have been built on permafrost, especially where the organic mat has been stripped and cuts have been excavated. In this zone, isolated remnants of frozen soil exist within a patchwork of thawed and frozen soil with variable moisture contents. Frozen soil in this interval

will often have water perched on top of it, which accelerates phase degradation of frozen soil beneath. Due to thermal instability, building on soils depicted in this zone will likely result in differential settlement. This zone presents in the pseudosection as large “blob-like” resistive signals (areas where frozen soil remains) surrounded by conductive signals (thawed soil with varying moisture contents).

- **Permafrost Table**—This unit is delineated in Figure 10 with dashed white lines. Material within this unit is frozen year-round and remains stable as long as it remains in a frozen state. Boring data suggests that frozen soil in the area is relatively ice-poor and therefore thaw stable. Resistivity data suggests that frozen soil in the subgrade is a patchwork of ice-rich and ice-poor soil, with more ice on the west and north side of the project area. This suggests that the subgrade is generally thaw stable with localized thaw-unstable soils, particularly in the west and northwest. This unit is illustrated in the pseudosection as high resistivity signals within a zone of moderate resistivity.

- **Vegetation correlation**—The pseudosection for Transect 2 (Figure 10, Figure 3, and Figure 1) shows well defined changes in resistivity that correlate with vegetation type. The north part of this transect (north of Quarry Road) is mostly vegetated by black spruce and other evergreen tree species. North of Quarry Road, there is also thermokarst topography (Figure 3). The pseudosection for Transect 2 shows higher resistivity (more ice-rich soil) beneath the “evergreen” vegetation and thermokarst in the north end and slightly lower resistivity (less ice in soil) on the south end of the transect (south of the fence) where there is primarily deciduous trees and no thermokarst topography.

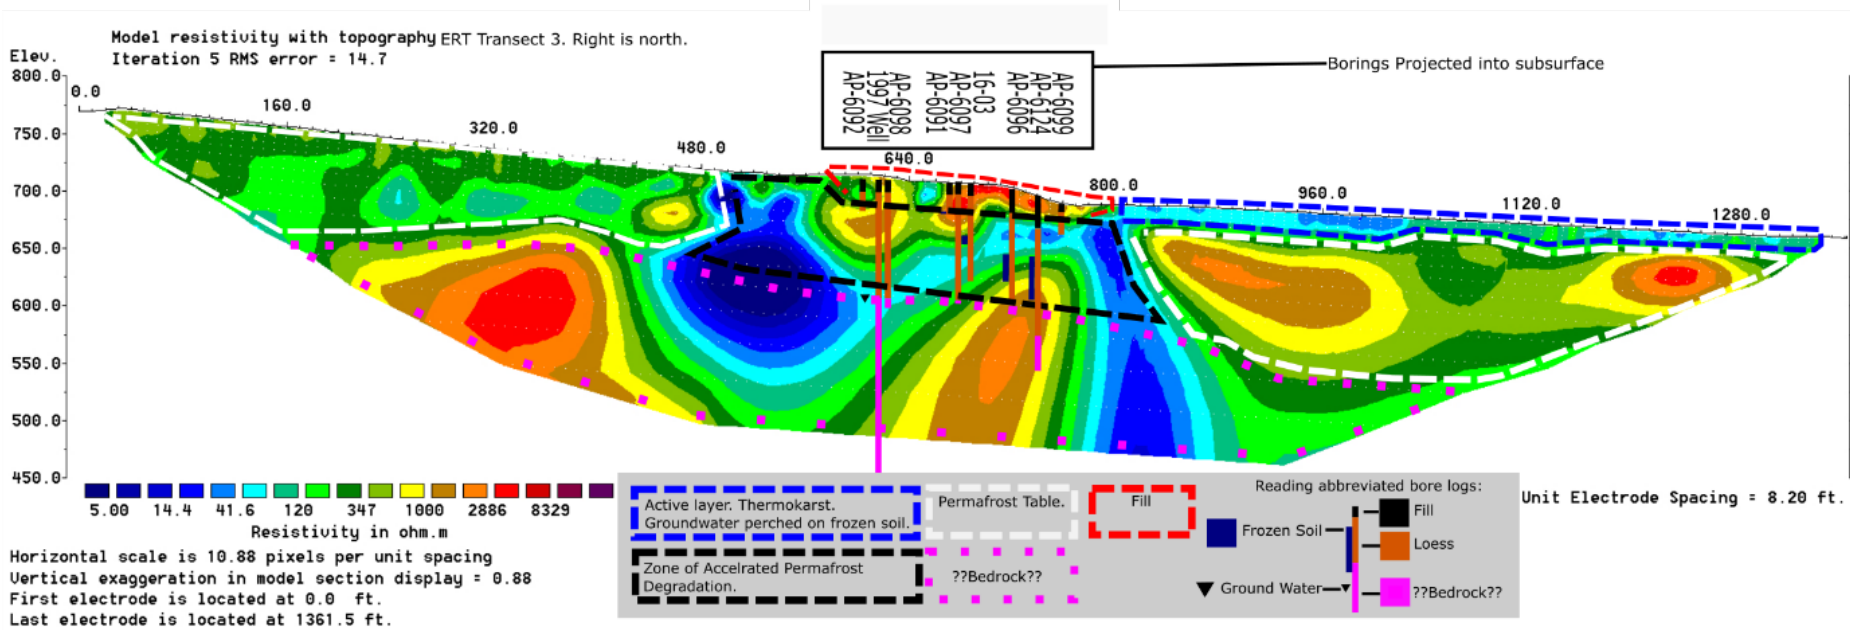
Figure 11. Interpreted ERT Transect 3.

Excess fill thickness on the west side of the building and the degraded permafrost as described in borings drilled in the west apron suggest permafrost degradation and settlement. This shows clearly in the pseudosection for ERT Transect 3, which shows considerably thicker fill than ERT Transect 2. Subgrade in this area is generally composed of loose, thawed, dry silt with scattered localized wet areas that are likely compressible.

- **Construction fill**—This unit is delineated by orange dashed lines in Figure 11. The surface expression in this unit is well-graded and poorly graded alluvial gravel fill material that is texturally and compositionally mature and dry. CRREL researchers had to soak electrodes with electrolyte water in this unit because it was too dry to achieve signal lock in its in situ condition. The silicic and dry nature of this material results in its being very resistive; and therefore, it shows as very high resistivity in signals that trend downward from the surface.

- **Active layer, thermokarst, and groundwater perched on frozen soil**—This unit is delineated by blue dashed lines in Figure 11. The surface expression in this unit is wet and moist soil that is easily compressed and poorly drained. Thermokarst features are common within this interval (Figure 3). Evidence for damage to the organic mat from forest fires is present in this unit. Building on this unit would likely result in high differential settlement. This unit presents in the pseudosection as relatively low resistivity signals (thawed wet soils) depicted in shallow downward-trending signals that are perched on higher resistivity signals (permafrost).

- **Zone of accelerated permafrost degradation**—This unit is delineated by black dashed lines in Figure 11. The most recent borings drilled on the project are projected onto the pseudosection in Figure 11, and all borings are shown in Figure 8. As previously discussed, borings drilled in 1995 show frozen soil that is now thawed in borings drilled in 2016, 2017, and 2018. This is typical of areas in interior Alaska where structures have been built on permafrost, especially where the organic mat has been stripped and cuts have been excavated. In this zone, isolated remnants of frozen soil exist within a patchwork of thawed and frozen soil with variable moisture contents. Frozen soil in this interval

- will often have water perched on top of it, which accelerates phase degradation in the frozen soil beneath. Because of thermal instability, building on soils depicted in this zone will likely result in differential settlement. This zone presents in the pseudosection as large “blob-like” resistive signals (areas where frozen soil remains) surrounded by conductive signals (thawed soil with varying moisture contents).

- **Permafrost Table**—This unit is delineated in Figure 11 with dashed white lines. Material within this unit is frozen year-round and remains stable as long as it remains in a frozen state. Boring data suggests that frozen soil in the area is relatively ice-poor and therefore thaw stable. Resistivity data suggests that frozen soil in the subgrade is a patchwork of ice-rich and ice-poor soil, with more ice on the west and north side of the project area. This suggests the subgrade is generally thaw stable with localized thaw-unstable soils, particularly in the west and northwest. This unit is illustrated in the pseudosection as high resistivity signals within a zone of moderate resistivity.

- **Bedrock**—This unit is delineated in Figure 11 with dashed pink lines and question marks to illustrate uncertainty. Bedrock in the area was encountered by the well log drilled in 1997, AP-6098, and possibly AP-6097 (Figure 8 and Figure 11). In the pseudosection, bedrock shows as broad, generally high resistive areas with signals trending up from depth. There is localized low resistivity within this interval, which is likely related to the groundwater in fractured bedrock that was intercepted by borings at a depth that is consistent with the change from low to high resistivity. Based on this pseudosection, it appears that the bedrock has a shallow north apparent dip. This interpretation for bedrock orientation is supported by 1997 well log data and AP-6098, AP-6124, and AP-6097.

Lack of positive drainage throughout the project area has led to further permafrost degradation, especially beneath Quarry Road and the northern Building 6385 fore slope, which shows in Figures 10–11 as conductivity beneath the ditch on the south side of Quarry Road adjacent Building 6385. The combination of completed recommended drilling and resistivity provides a generalized description of bedrock orientation beneath the project area as shown in Figures 9–11. Completing the recommended drilling in Table 1 will help ascertain if the north embankment slope has destabilized due to drainage-related permafrost degradation and hydraulic mobilization of loess at the toe of the slope in the ditch adjacent to Quarry Road.
