## **Guided-Wave Inspection of California Department of Water Resources Tainter Gate Trunnion Rods**

Inspection of Oroville Dam, Thermalito Bypass, and Pyramid Dam

Jason D. Ray, Richard D. Brown, and James A. Evans

September 2019

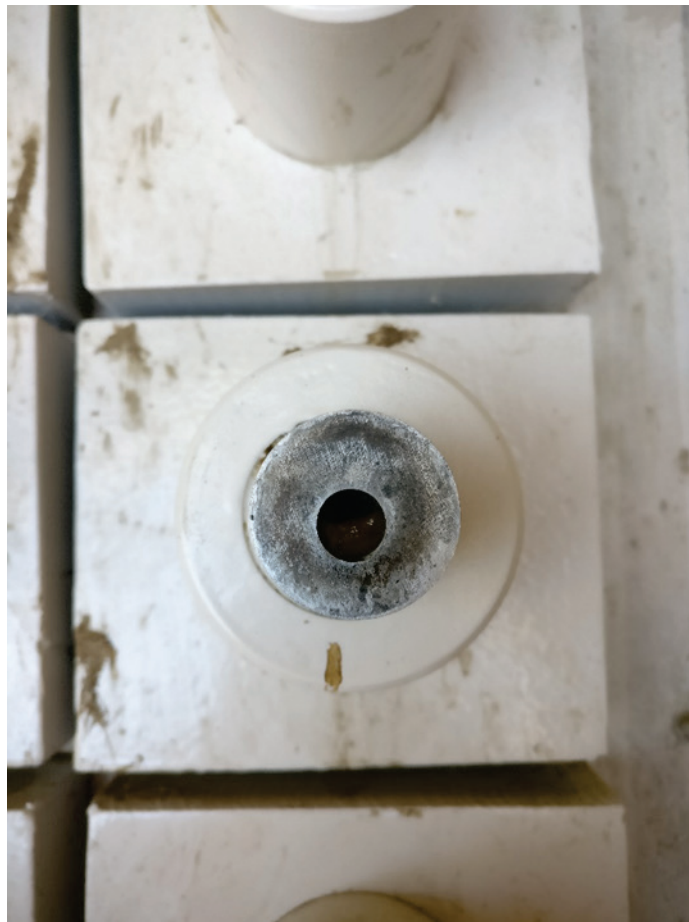
Initial photos of the tendon ends showed the first possible issue (Figure 2). Each rod contains a drilled out end of varying depth and location on the rod face. The guided wave technology relies on a flat surface for the ultrasonic transducer to couple with. Any anomalies in the rod surface directly affects the resulting signal response.

Figure 2. Drilled tendon at Oroville Dam.

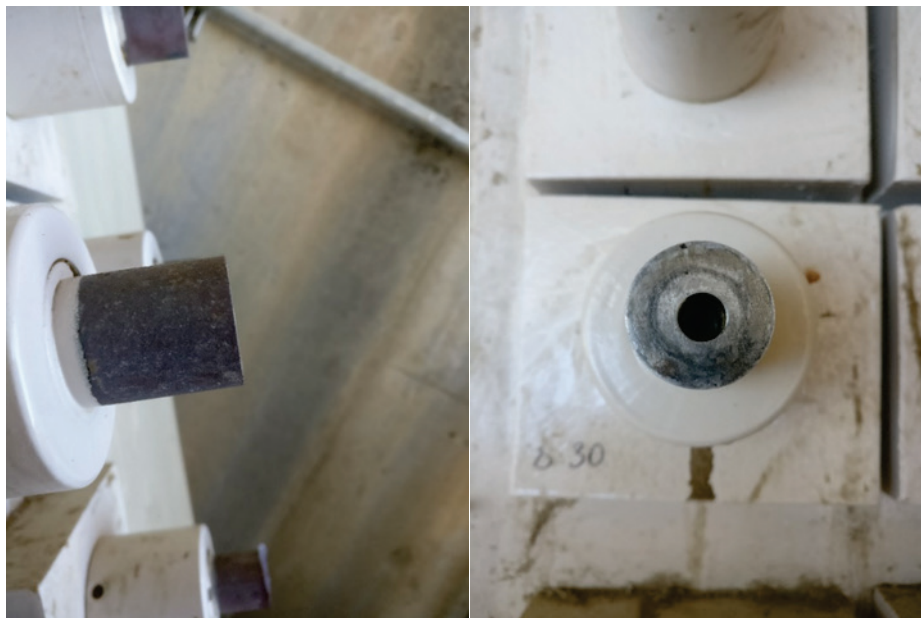
In addition to the drilled tendons as previously discussed, the smoothness of the rod end and how perpendicular the surface is with the length of the rod are major factors in how much energy is able to cross the air gap between the transducer and rod surface. Upon arrival, the rod ends were found to be in overall good shape. The ends were smooth and mostly perpendicular. Examples are shown in Figure 7.

Figure 7. Oroville Dam rod condition.

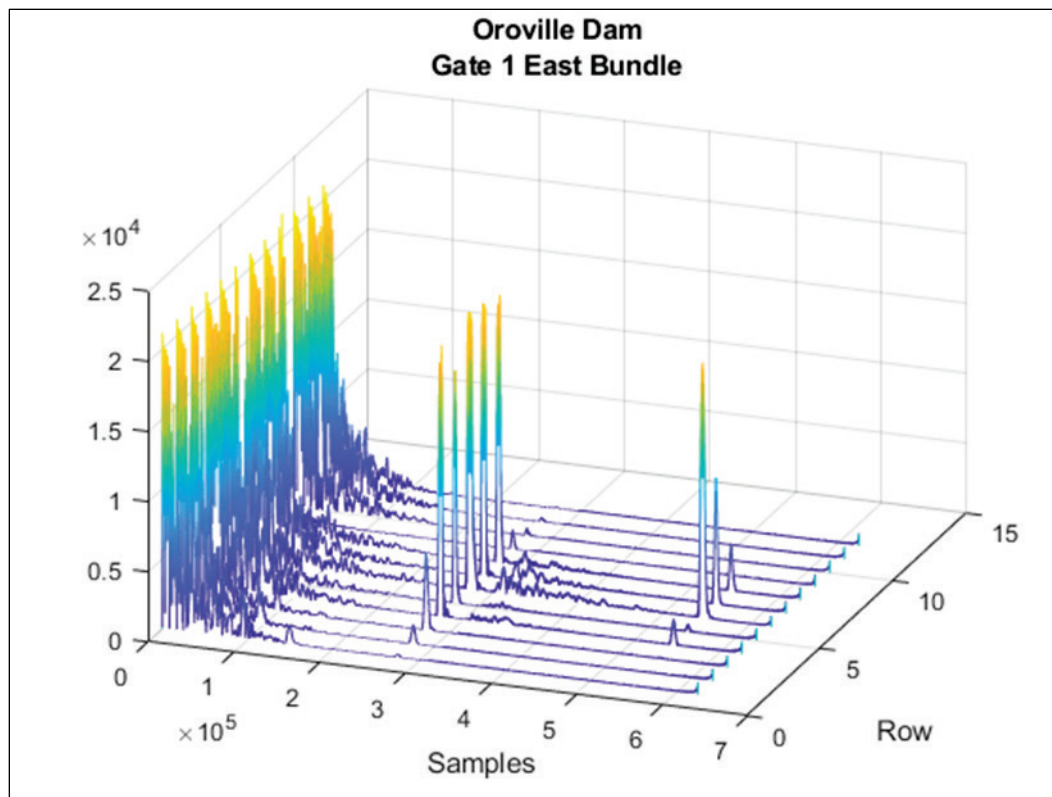
The rod curvature resulted in more issues than originally expected. As the bend of the rod increased (the upper and lower rows of rods), the signal attenuated at a faster rate. For example, the results of each row from a single column at Oroville Dam is show in Figure 9.

Figure 9. Oroville Dam rod curvature effects.

The right axis of Figure 9 represents the row number within the bundle. The middle most rods often result in a response that clipped the input of the oscilloscope requiring the overall gain to be reduced. The larger responses allow for multiple end of rod rebounds to occur, often resulting in three total. In every sample, at least one end of rod rebound was obtained, however, for the upper and lower limit rods, the response was very small.

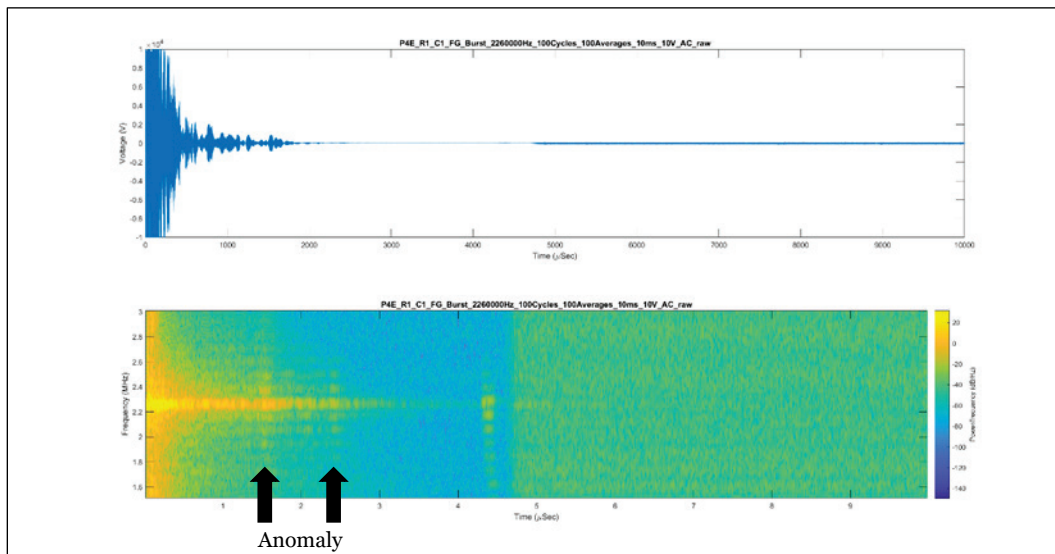
**Figure 12. Oroville Dam: Gate 4, west; Row 1, Column 1; anomaly.**

These two rods are a part of Gate 4 different bundles. Figure 12 is on the west bundle; Row 1, Column 1. Figure 13 is on the east bundle; Row 12, Column 2. The location of these anomalies is roughly the same for each case shown in the results section. Due to how frequent the anomaly appears, these rods are not labeled as damage.

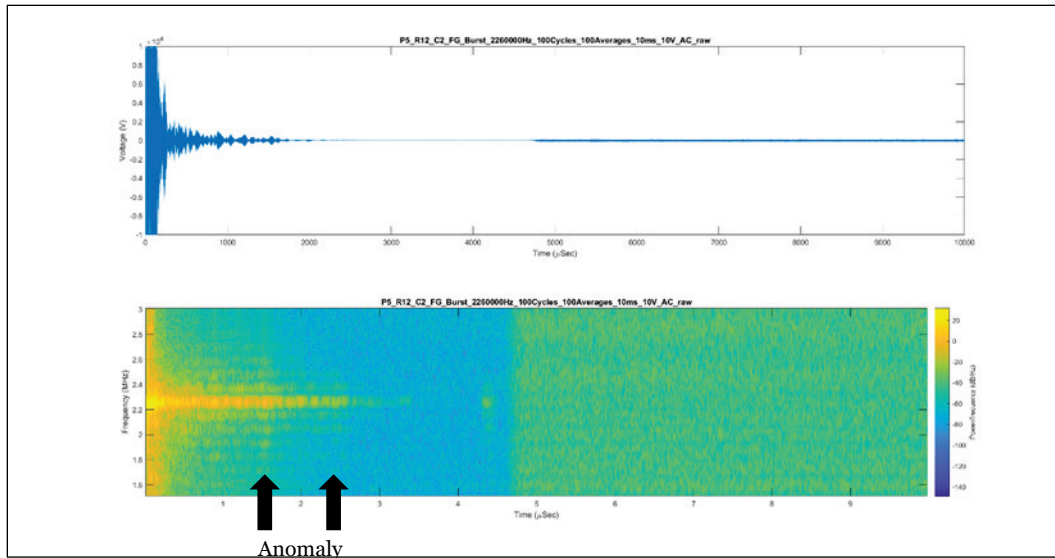
Figure 13. Oroville Dam: Gate 4, east; Row 12, Column 2; anomaly.

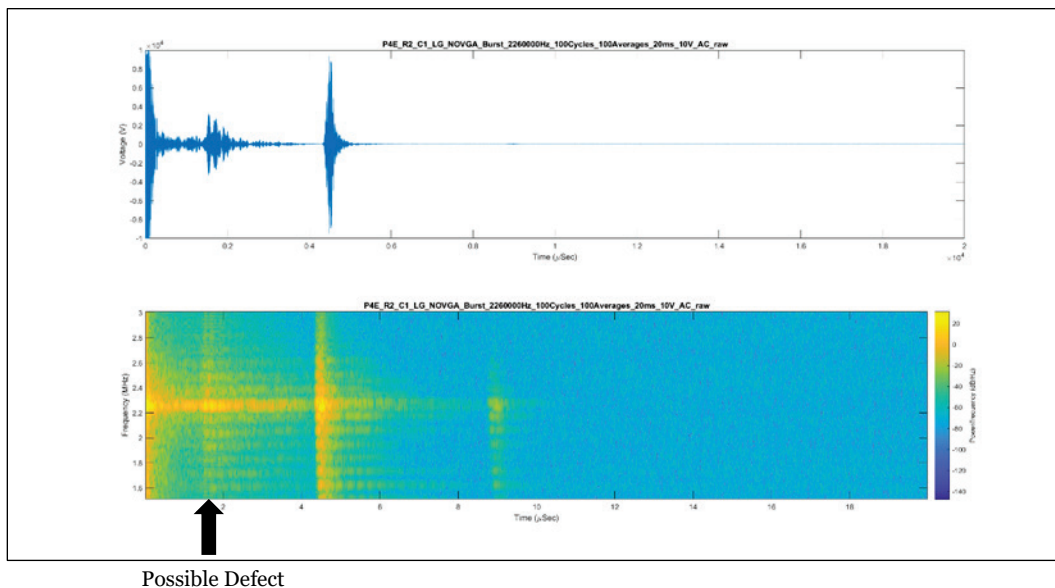
Of the 384 rods tested, two rods are labeled as possible defects — Gate 4, west bundle; Row 2, Column 1, and Gate 7, west bundle; Row 2, Column 2. The responses of these two rods are shown in Figure 14 and Figure 15.

Figure 14. Oroville Dam: Gate 4, west; Row 2, Column 1; possible defect.

Of these two, Figure 14 shows the greatest possibility of being an actual defect. Both the time-voltage and time-frequency plots show a strong signature similar to that of the end of rod response. In Figure 15, the time-frequency signature looks similar to the anomalous rods though the time-voltage plot has a stronger response than other anomalous rods. For this reason it is being classified as a possible defect.

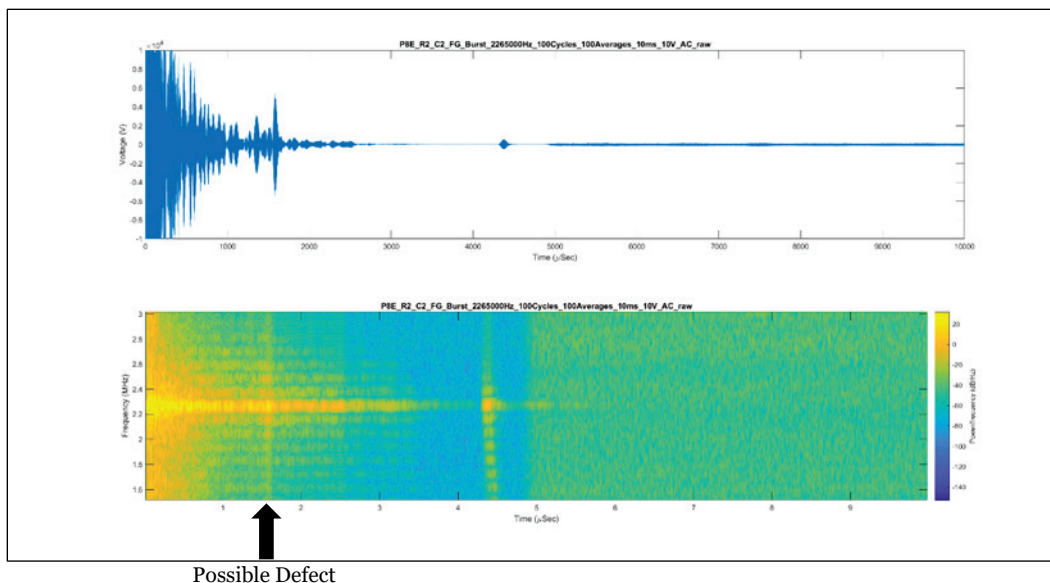
Figure 15. Oroville Dam: Gate 7, west; Row 2, Column 2; possible defect.

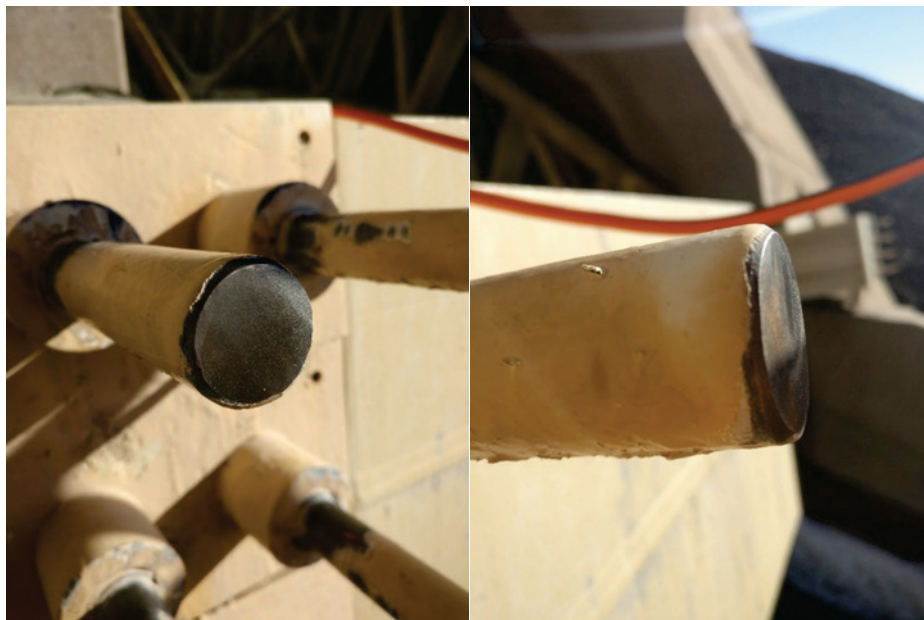
Figure 25 shows the condition of the rods at the time of testing. Although the rod ends look smooth, there are irregularities in the surface which could lead to poor transducer contact. However the irregularities here are minor and the coupling grease fills in the imperfections to provide good surface contact with the transducer.

Figure 25. Thermalito bypass rod condition.

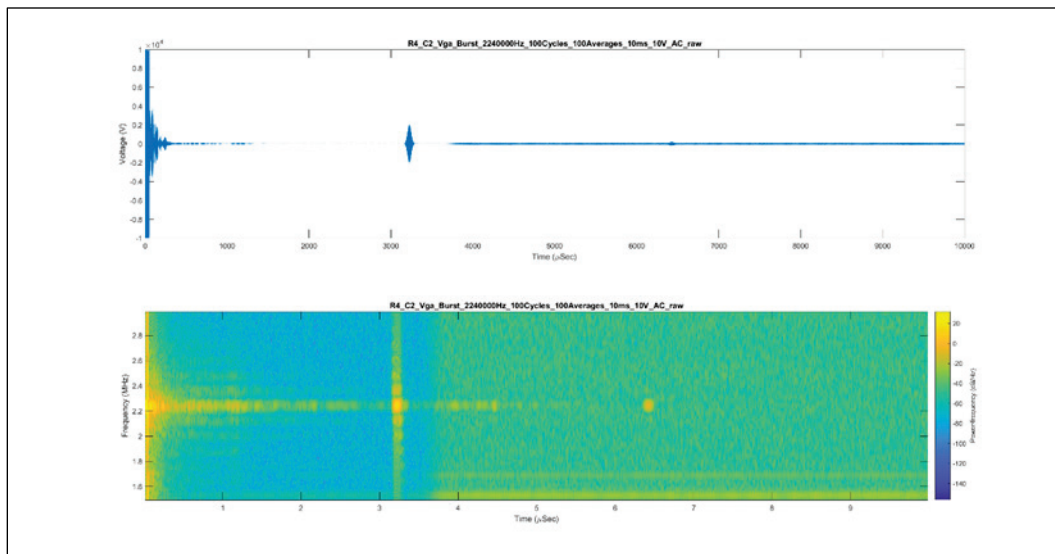
As with Oroville Dam, the more curved rods showed evidence of reflectors while the straighter rods came back with no evidence of issues. 16 rods were tested, Figure 26 shows the results of one of the rods showing No Issue. Figure 27 shows the results of one of the rods being labeled as an anomaly.

Figure 27. Thermalito Bypass: east; Row 4, Column 2; anomaly.

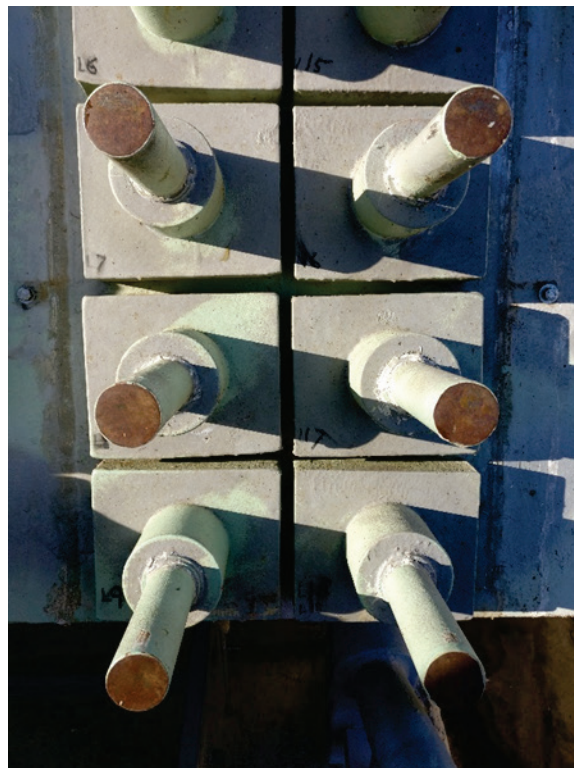
That rods at Pyramid Dam were both smooth and perpendicular to the length of the rod. No issues were seen with coupling. Figure 29 shows the condition.

Figure 29. Pyramid Dam rod condition.

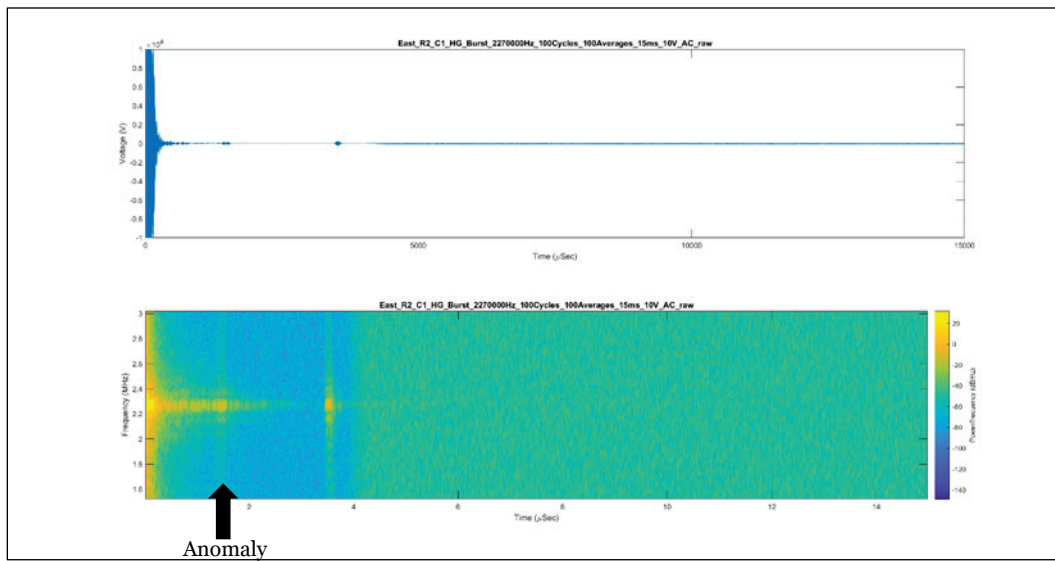
Figure 31 is an example of a rod showing No Issues. Further evidence supporting the theory that rod curvature causes anomalies in the data; the rods at Pyramid Dam exhibited reflectors on the rods that bend upward and downward within the dam. This effect is seen in Figure 32.

Figure 32. Pyramid Dam: east; Row 2, Column 1; anomaly.

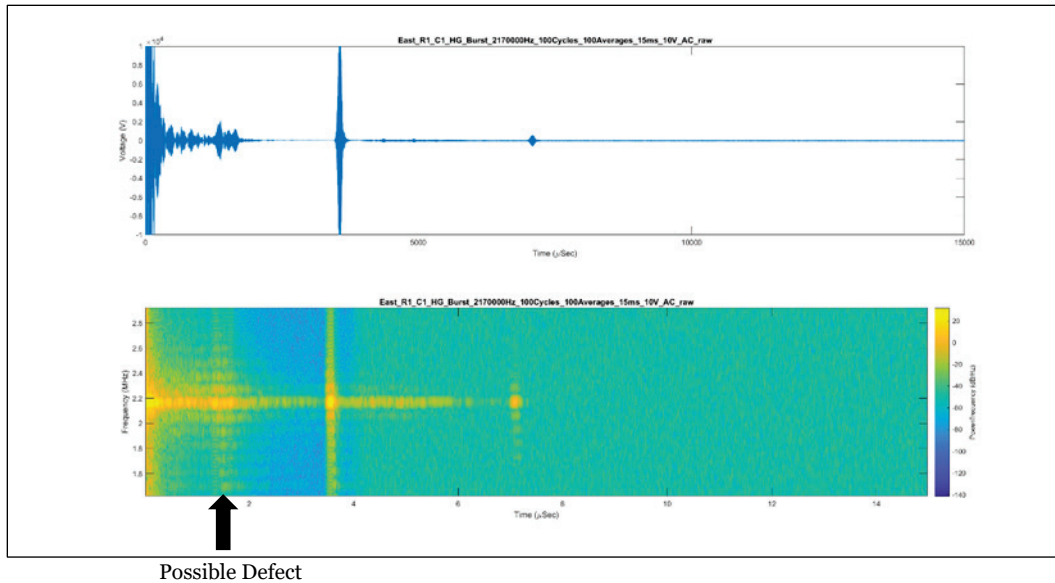
Figure 33. Pyramid Dam: east; Row 1, Column 1; possible defect.

Very similar to the Oroville rod response of Figure 14, Figure 33 shows a possible defect on rod east bundle; Row 1, Column 1. Even though the response time of this anomaly is similar to the other curved rods, the amplitude is much greater than the others.
