# **FINAL REPORT**

## **Demonstration and Validation of LHE Zn-Ni Plating Process**

**ESTCP Project WP-201107**

**May 2018**

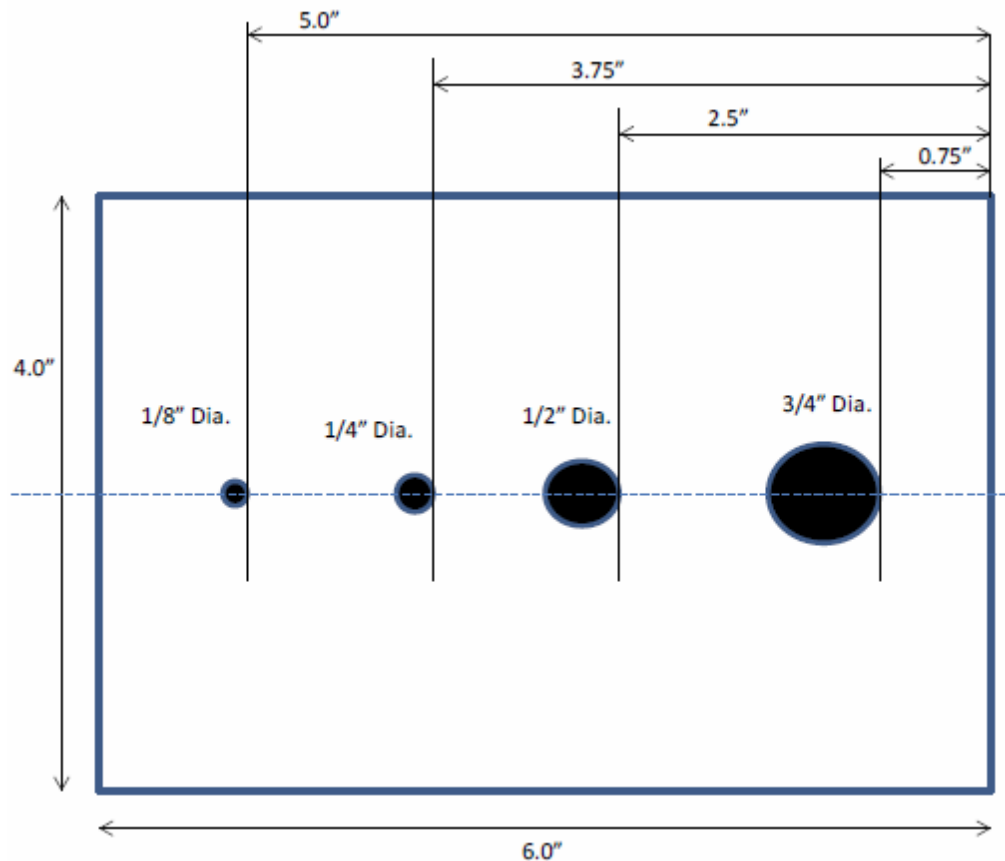
**Figure 14: Galvanic Corrosion Test Panel (LHE Zn-Ni Removed in 4 Locations)**

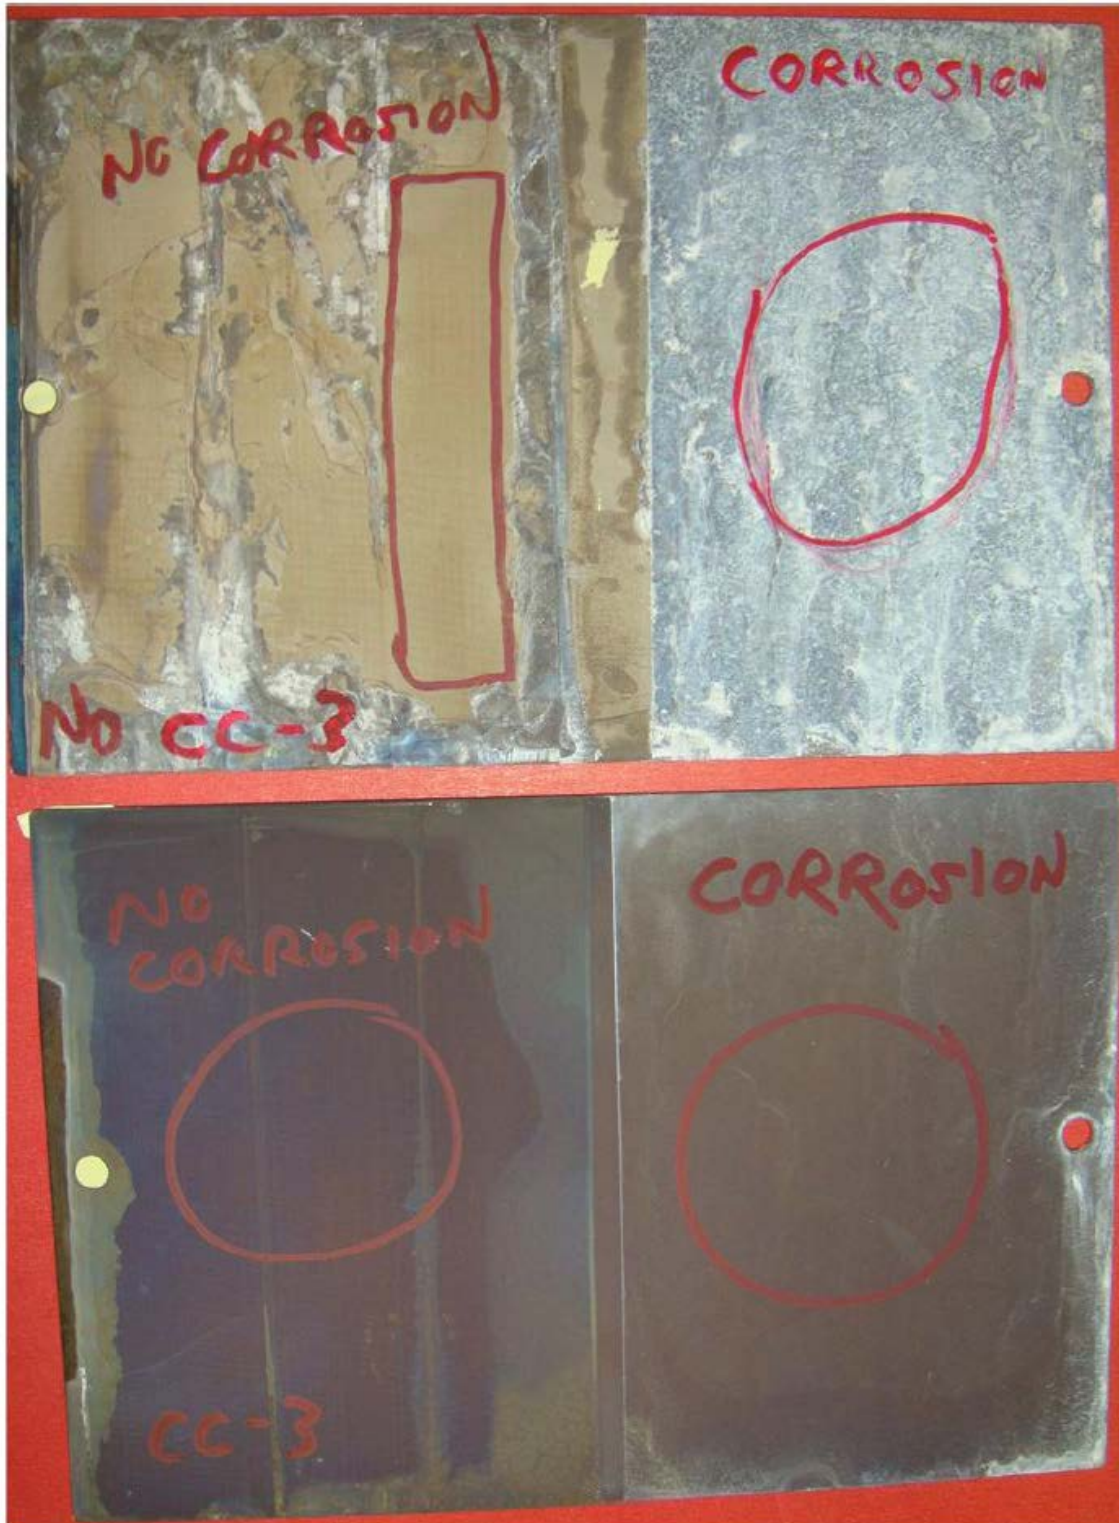
Figure 24 shows pictures of NO-CC-3 and CC-3 after 4 weeks salt spray exposure. The maskant on NO-CC-3 had some leakage and the no corrosion area was very small but of sufficient size to perform XRF chemical analysis of the un-corroded LHE Zn-Ni plating. CC-4 and NO-CC-4 were severely corroded after one week in the ASTM G 85 SO<sub>2</sub> salt spray (see Figure 25) and XRF analyses could not be performed on the corroded side of these test panels.

**Figure 24: Corroded and Un-corroded areas of LHE Zn-Ni Panes CC-3 (bottom) and NCC-3 (top) after 4 Weeks in ASTM B117 Salt Spray**

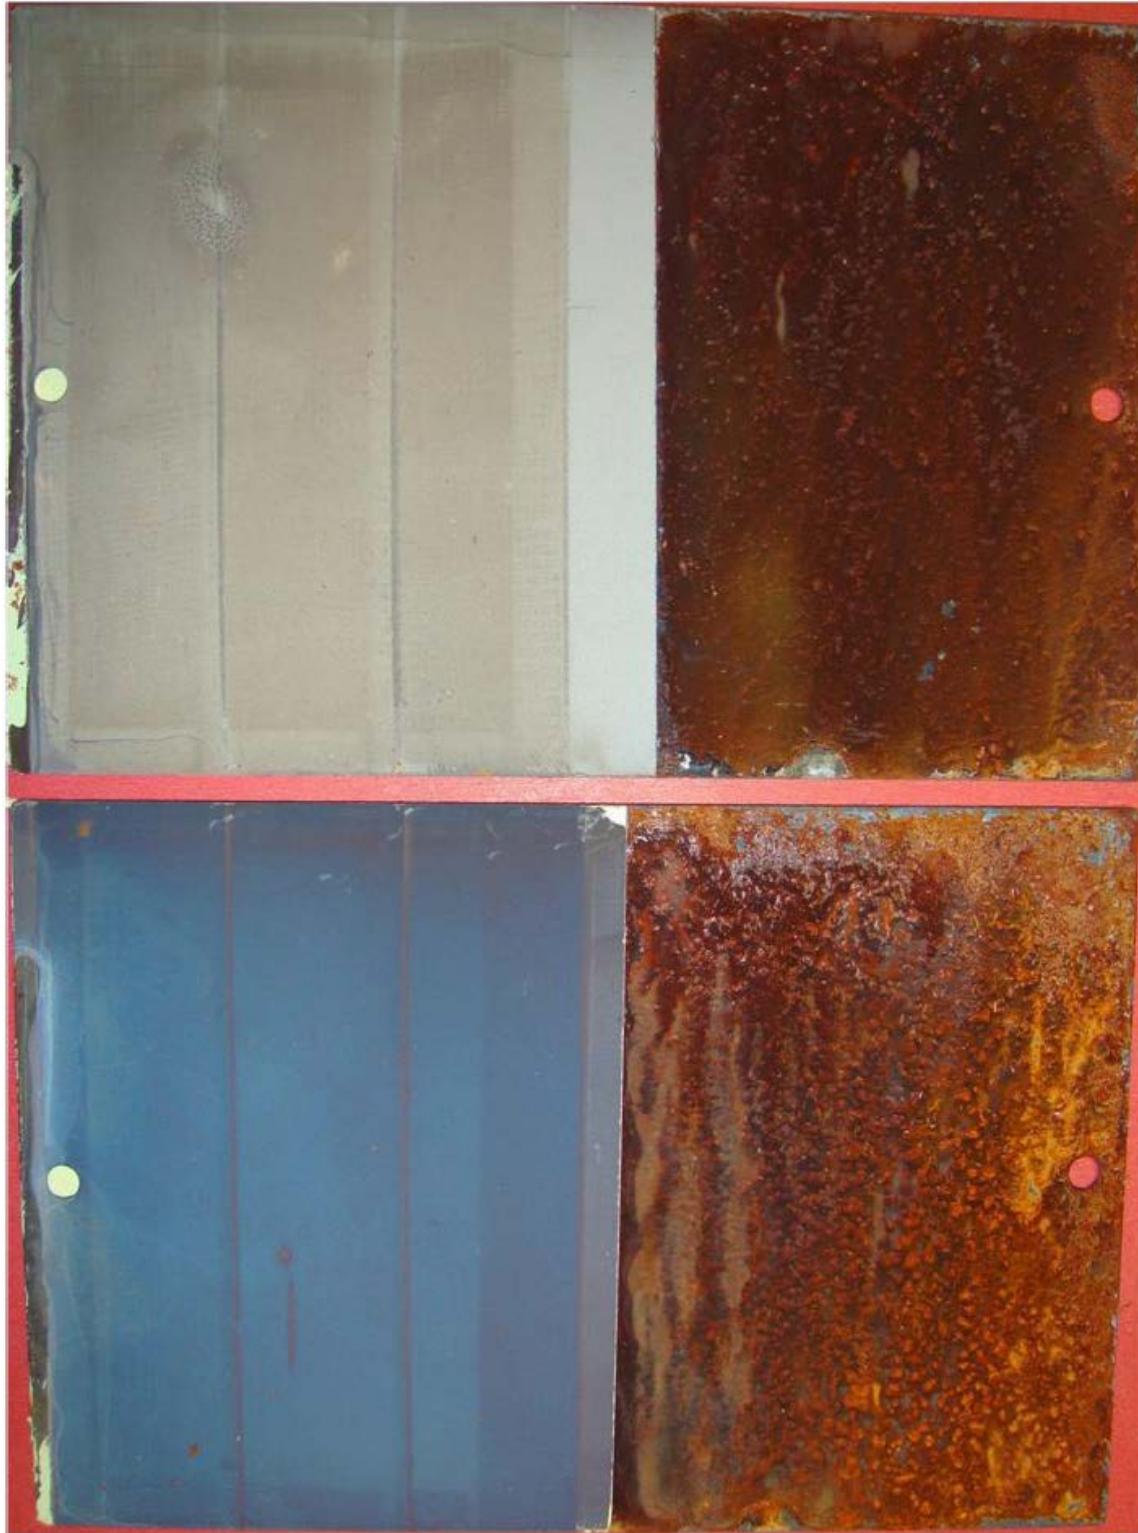
**Figure 25: Corroded and Un-corroded areas LHE Zn-Ni Panels CC-4 (Bottom) and NCC-4 (Top) after 1 week in ASTM G85 SO<sub>2</sub> Salt Spray**

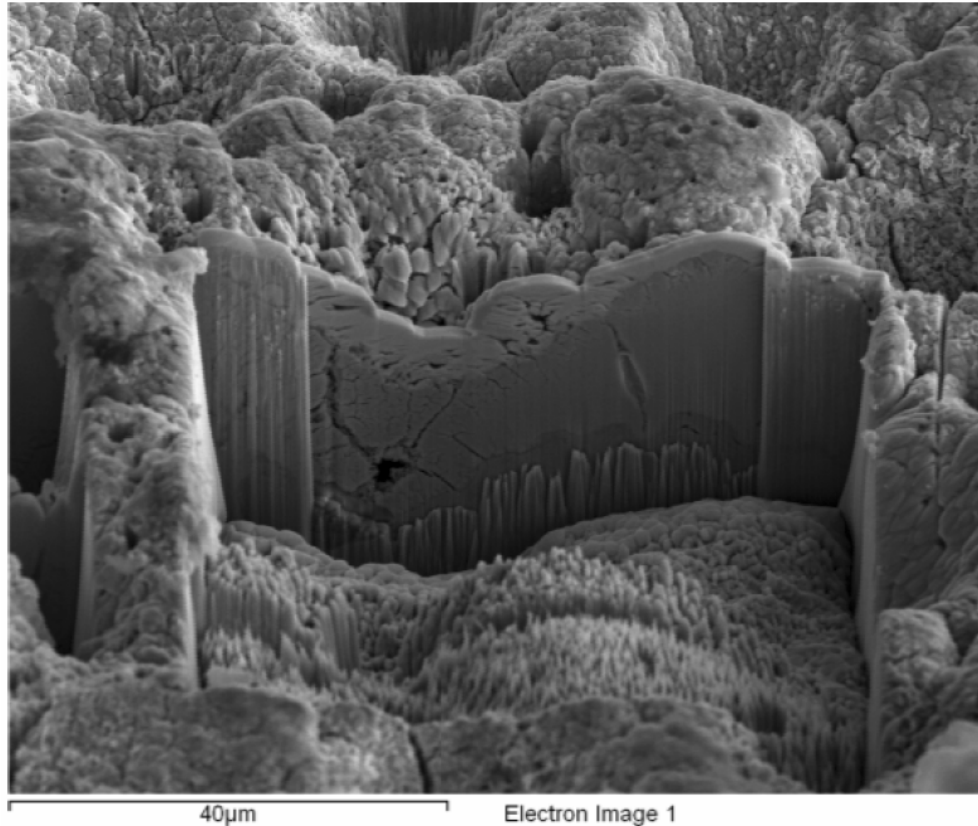
The plating was cross sectioned using FIB in corroded and un-corroded regions of the samples along with EDS chemical analysis to determine the LHE Zn-Ni ratio in the cross-sectioned areas. This showed the LHE Zn-Ni composition change with depth due to corrosion. The EDS area scans shown in Figure 29 and Figure 30 show uniform stable distribution of Zn and Ni. There are no concentrations of either element rather a homogeneous structure of Zn and Ni.

**Figure 28: Non Conversion Coated (NCC) Electron Beam Image (Corroded Area)**

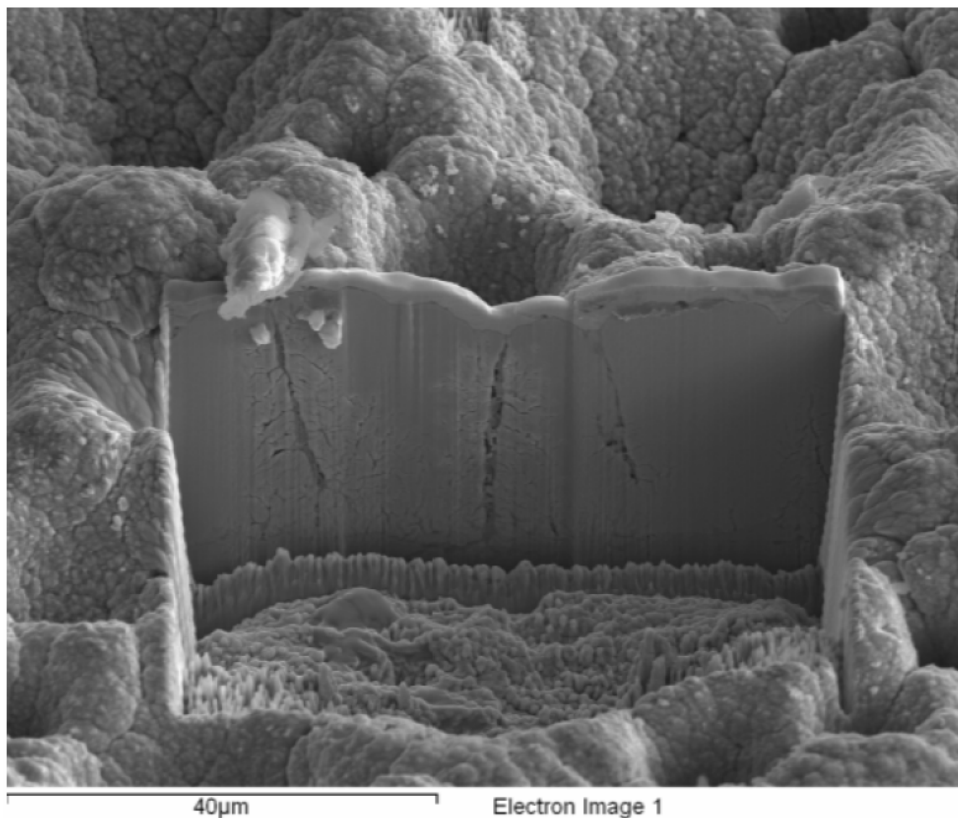
**Figure 31: Conversion Coated (CC) Electron Beam Image (Corroded Area)**

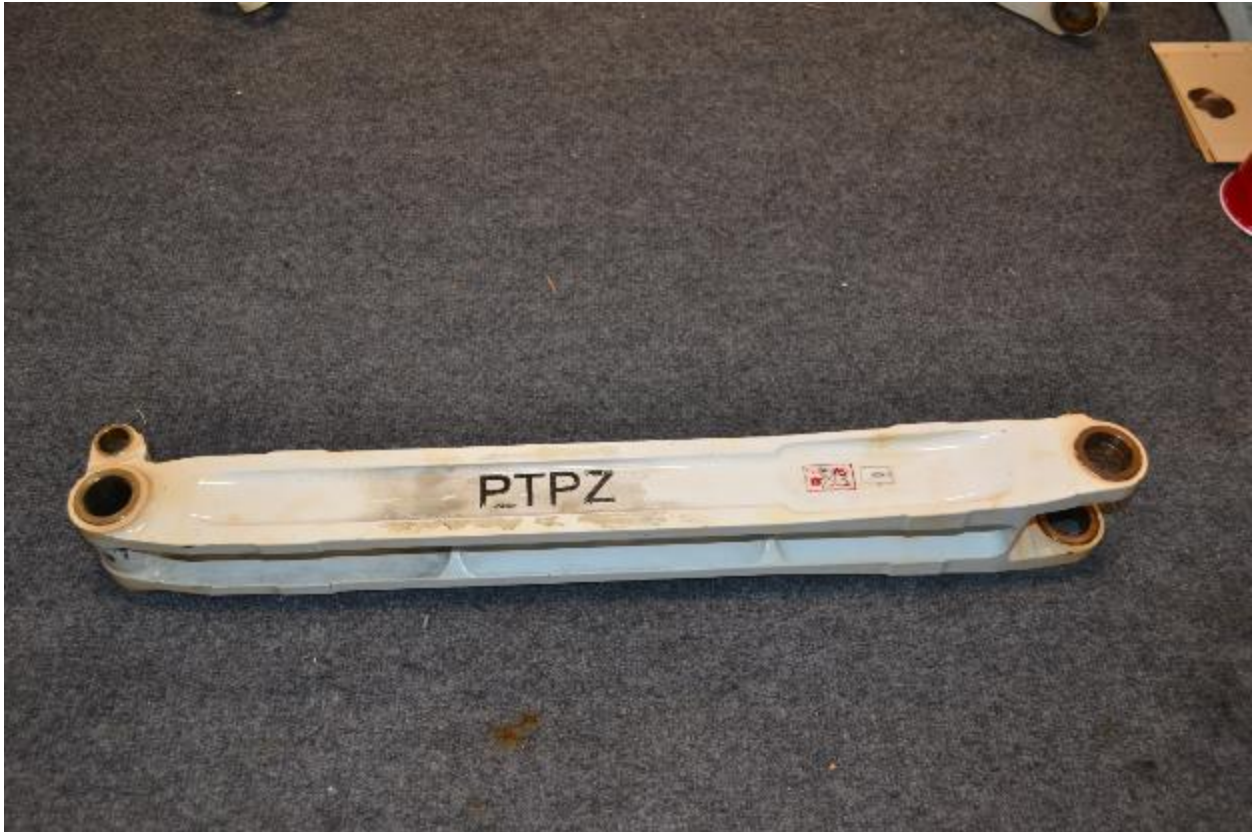
**Figure 86: LHE Zn-Ni Component Brake Fire Inspection (4/16/2016)**
