*U.S. Air Force Rapid Airfield Damage Recovery (RADR) Program*

## **Full-Scale Testing of Commercially Available Cementitious Backfill and Surface Capping Materials for Crater Repairs**

May 2020

# **Full-Scale Testing of Commercially Available Cementitious Surface Capping Materials for Crater Repairs**

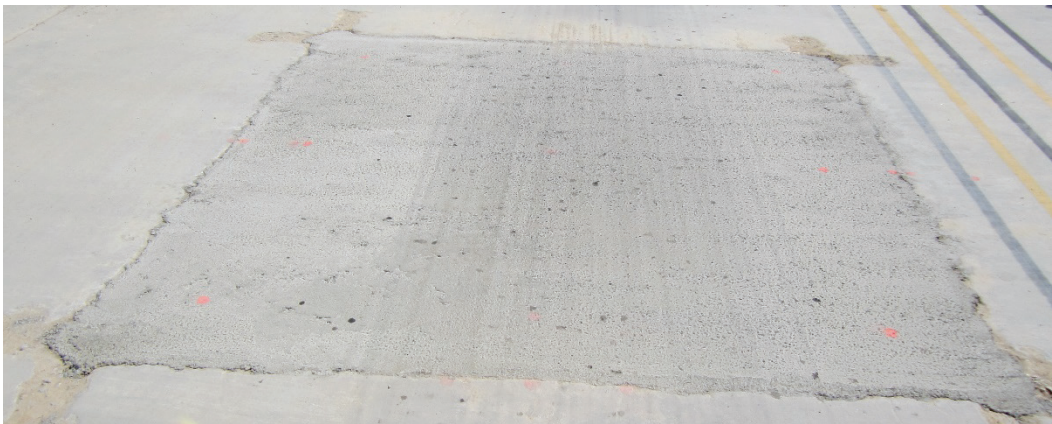
simultaneously, and Repair 3 was completed separately. Figures 19, 20, and 21 show Repairs 1, 2, and 3, respectively, after 112 passes. The boundaries of Repair 3 are outlined in orange. As shown, no notable distresses were observed for Repair 1. Repair 2 showed only some debris near the front right edge that was due to cured, excess material around the repair breaking up under traffic. Repair 3 exhibited no distresses with the exception of a small rough area that was not finished before the material reached initial set (Figure 22). This area did not appear to deteriorate under traffic.

Figure 19. Repair 1, overall, 112 passes.

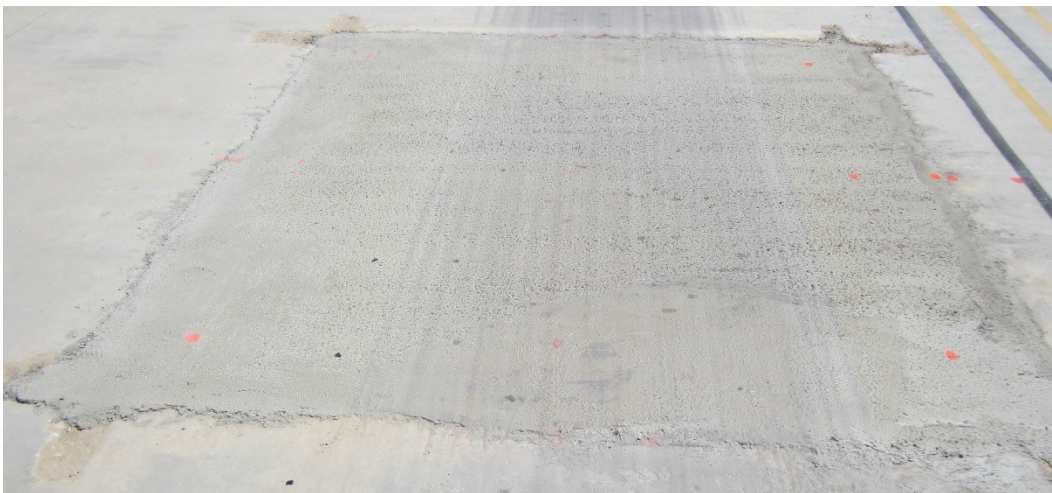
Figure 20. Repair 2, overall, 112 passes.

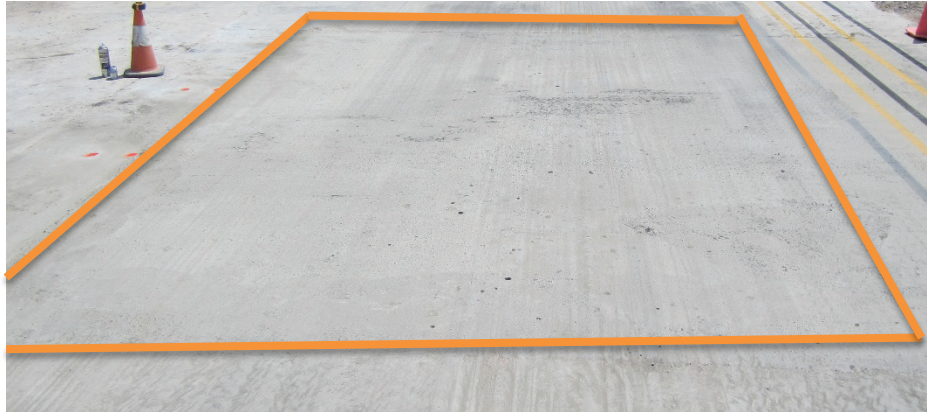
Figure 21. Repair 3, overall, 112 passes.

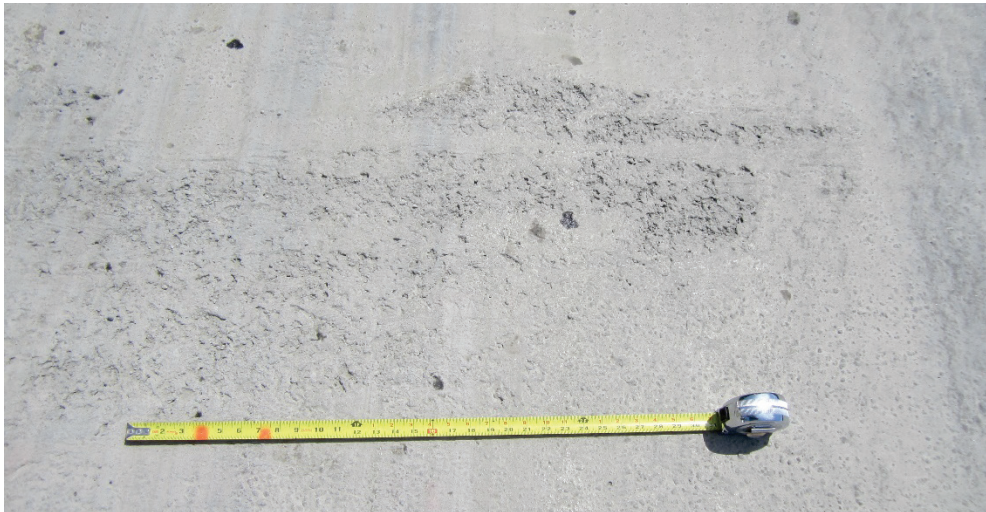
Figure 22. Repair 3, small rough area, 112 passes.

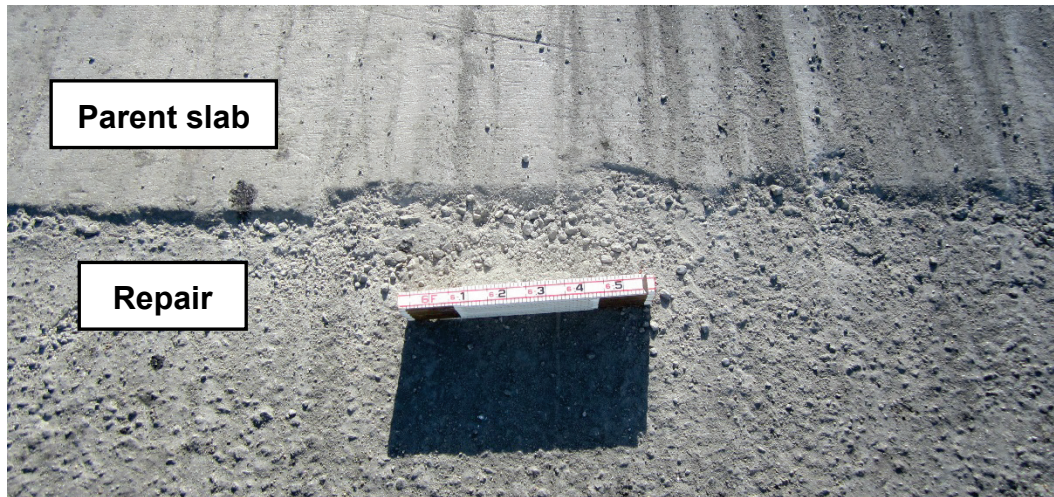
After 1,000 passes, none of the repairs exhibited any major distresses, but some deterioration near the edges was apparent. Figures 23 and 24 show the rear edges of Repairs 1 and 2, respectively. For repair 3, some medium-severity spalling and cracking was observed on the rear edge (Figure 25).

Figure 23. Repair 1, rear edge deterioration, 1,000 passes.

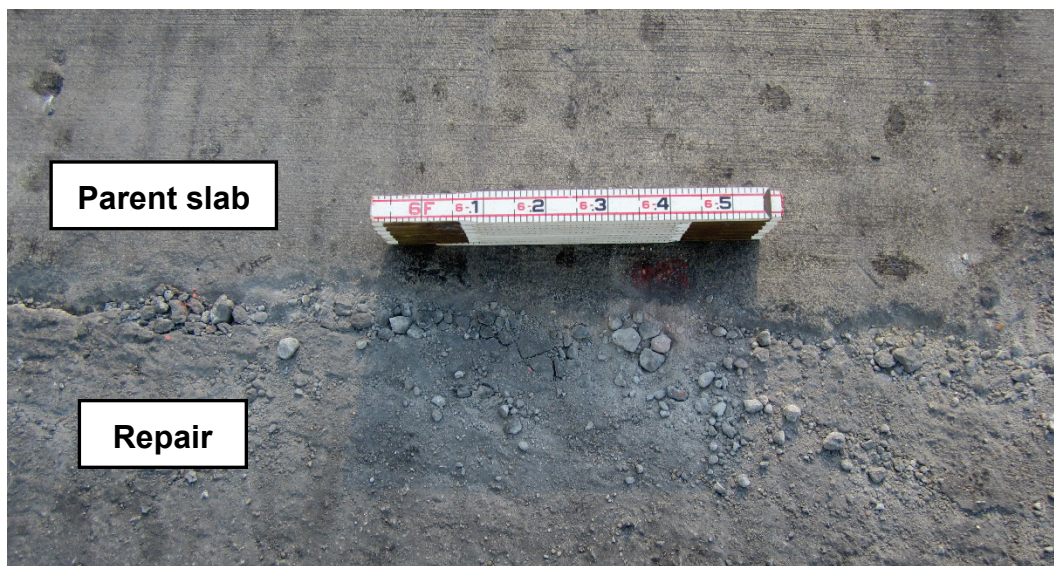
Figure 24. Repair 2, rear edge deterioration, 1000 passes.

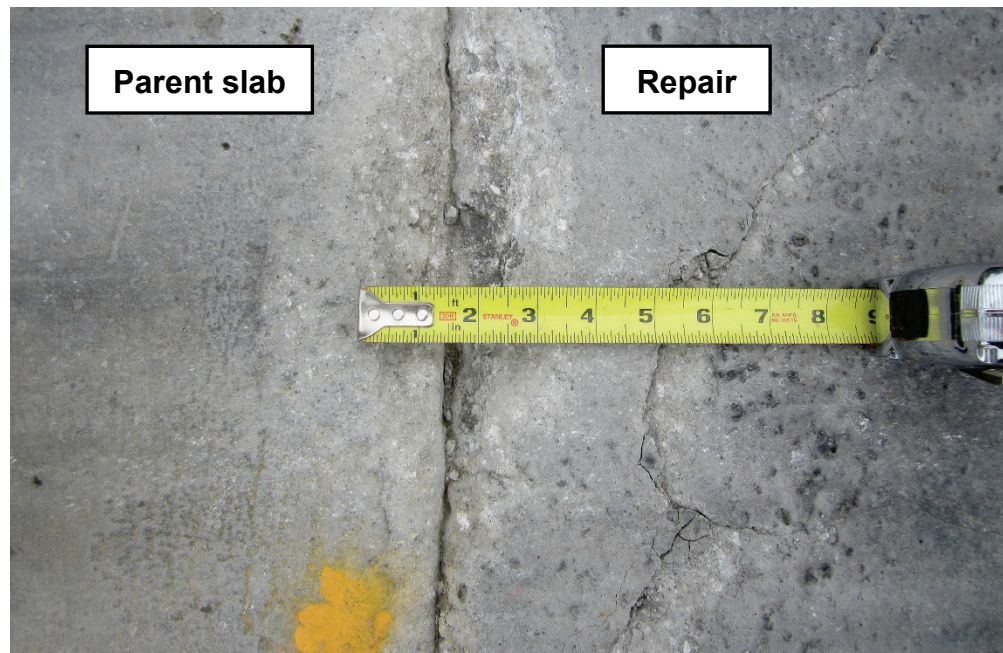
Figure 25. Repair 3, Spalling and cracking on rear edge, 1,000 passes.

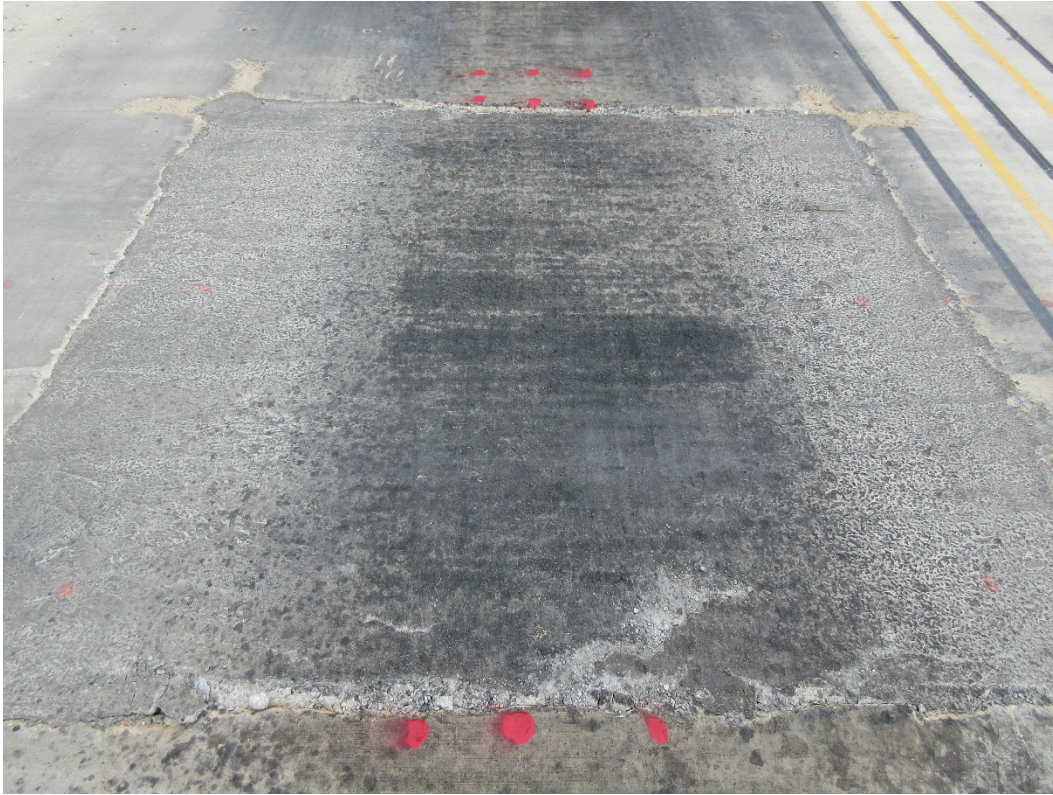
After 2,000 passes, all repairs exhibited considerable distress in the form of high-severity joint spalling on both the front and rear edges. Table 9 provides the spall measurements for each repair. Figure 26 shows an overall photo of Repair 1 after 2,000 passes, and Figures 27 and 28 show the front and rear edge of the repair, respectively. High-severity spalling can be seen on both edges with some cracking extending into the repair on the front edge. Figure 29 shows Repair 2 overall with Figure 30 showing the high-severity joint spalling on the rear edge. Figure 31 contains an overall photo of Repair 3 after 2,000 passes, and the high-severity joint spalling observed on the rear edge is shown in Figure 32. At 2,000 passes, the spall measurements for all repairs capped with Fastrac 246 exceeded the high-severity spall criterion, so the repairs were considered failed.

Figure 26. Repair 1, overall, 2,000 passes.

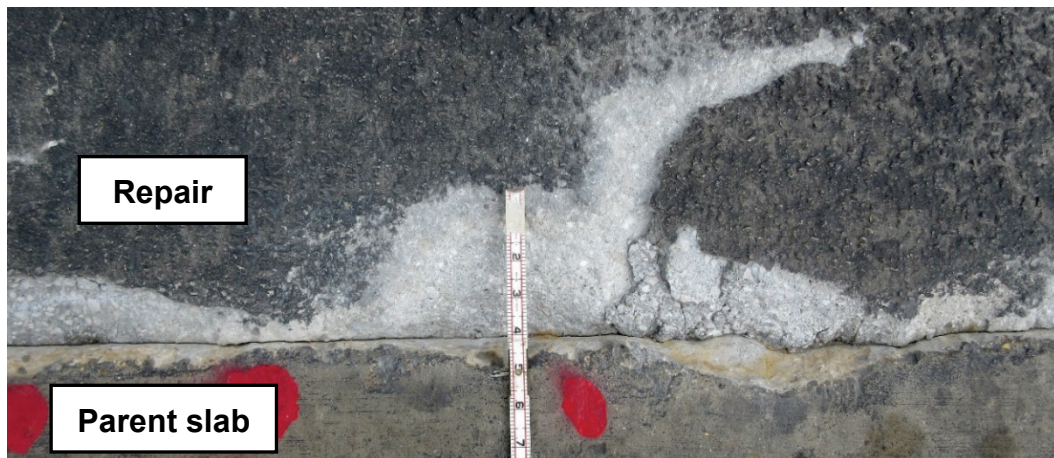
Figure 27. Repair 1, front edge, 2,000 passes.

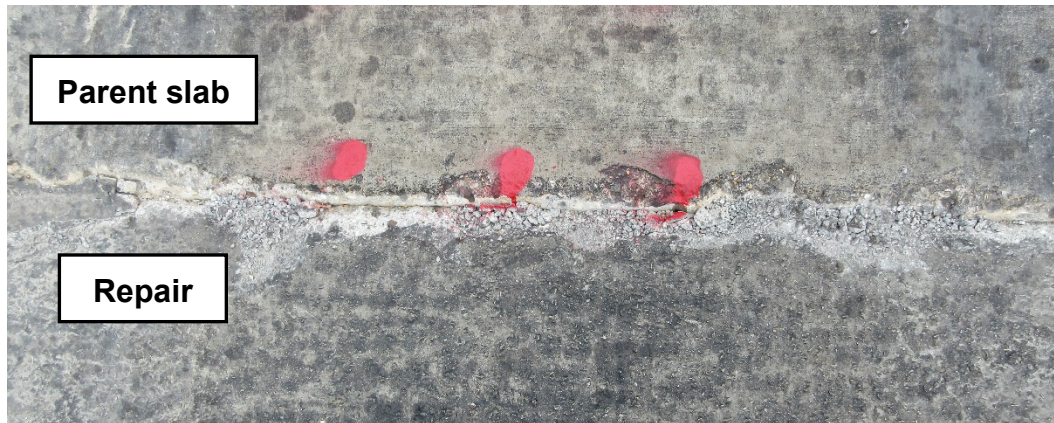
Figure 28. Repair 1, rear edge, 2,000 passes.

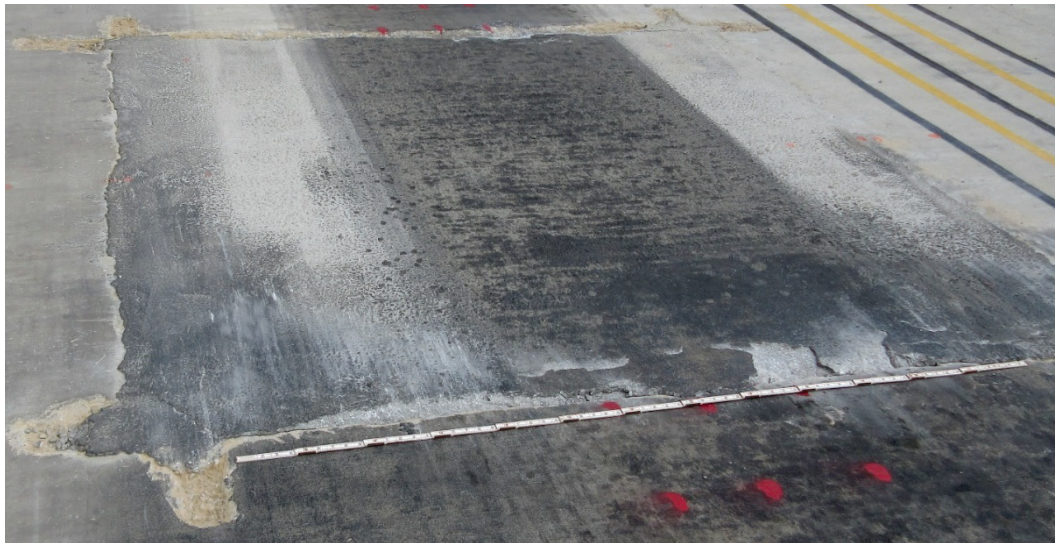
Figure 29. Repair 2, overall, 2,000 passes.

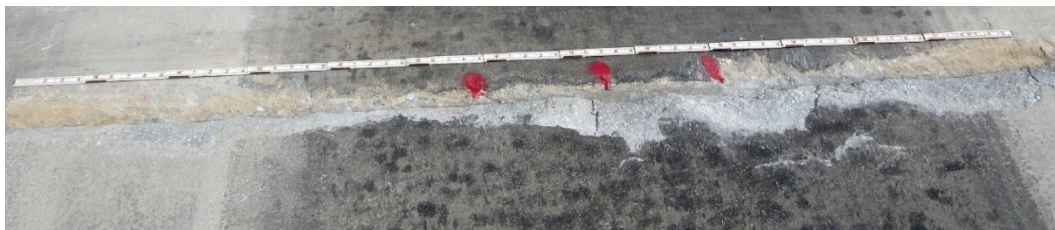
Figure 30. Repair 2, rear edge, 2,000 passes.

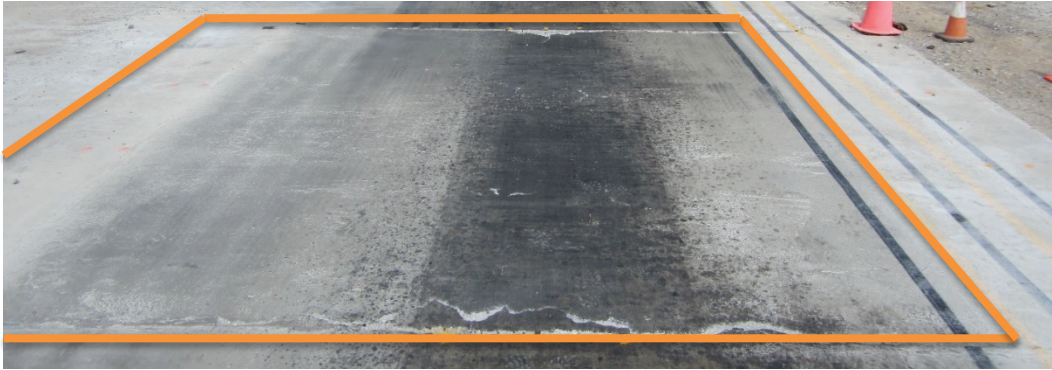
Figure 31. Repair 3, overall, 2,000 passes.

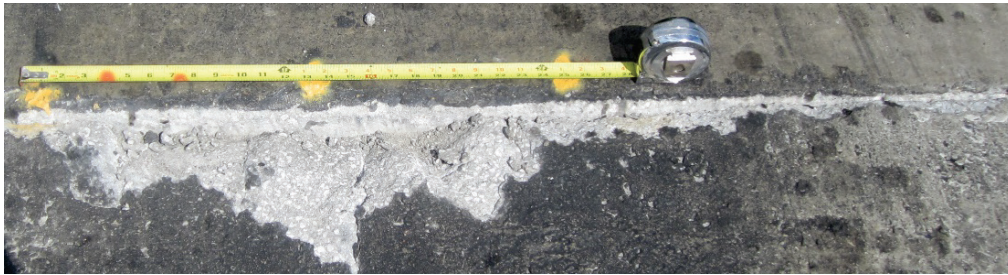
Figure 32. Repair 3, high-severity joint spalling on rear edge, 2,000 passes.

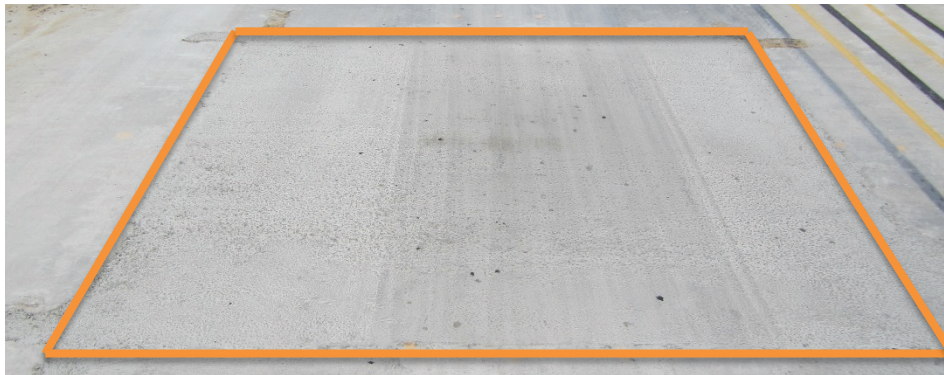
Visual observations were first obtained after 112 passes for Repairs 4, 5, and 6. Repairs 4 and 5 were conducted and trafficked together, while Repair 6 was performed separately. Figures 33 and 34 show Repairs 4 and 5, respectively, after 112 aircraft passes. No notable distresses were observed for Repairs 4, 5, and 6 at this pass level.

Figure 33. Repair 4, overall, 112 passes.

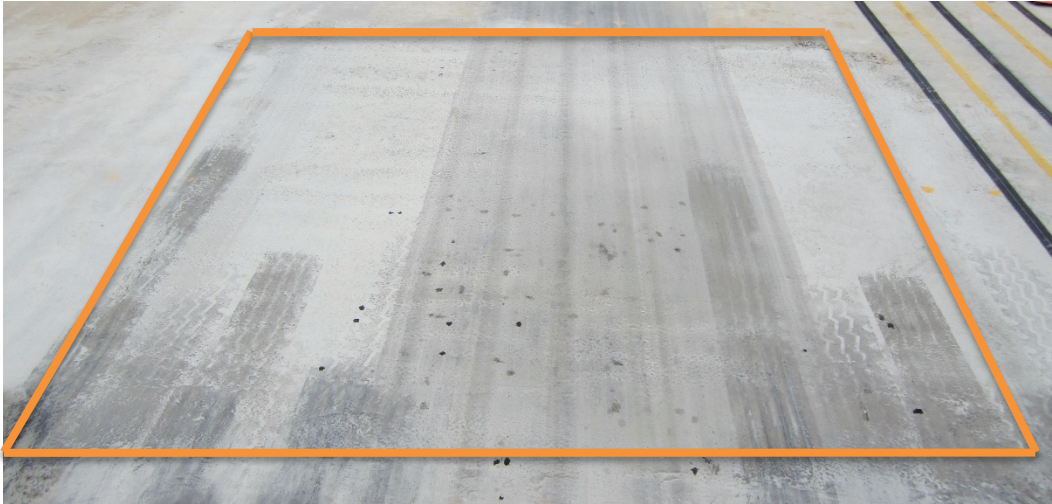
Figure 34. Repair 5, overall, 112 passes.

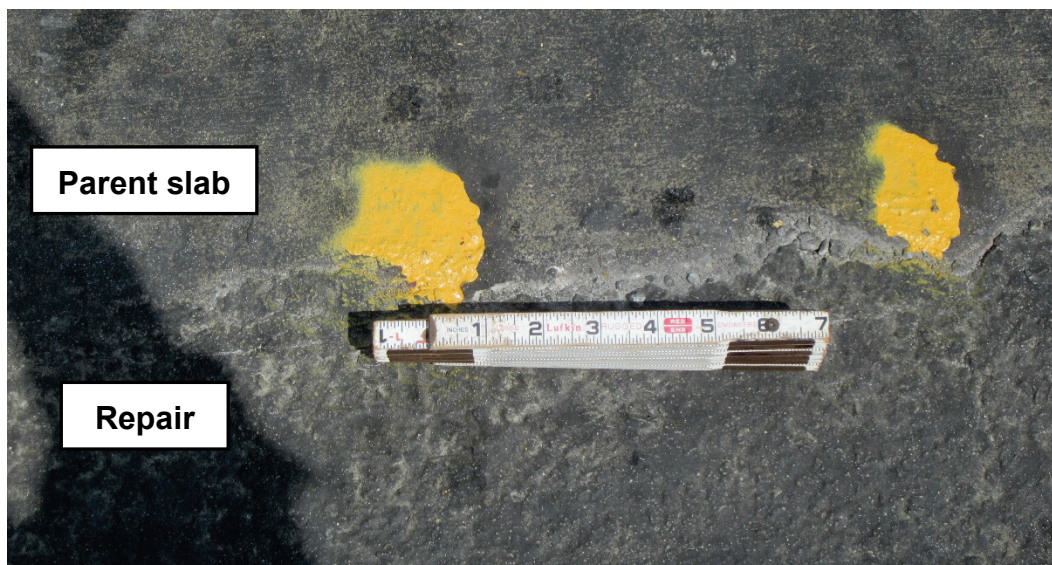
After 2,000 passes, Repairs 4 and 5 showed much less deterioration than Repairs 1 and 2. Figure 35 shows the rear edge of Repair 4 at 2,000 passes, and Repair 5 edges appeared visually similar. Repair 6 did exhibit more distress than Repairs 4 and 5 as evidenced by the spalling shown in Figure 36.

Figure 35. Repair 4, rear edge, 2,000 passes.

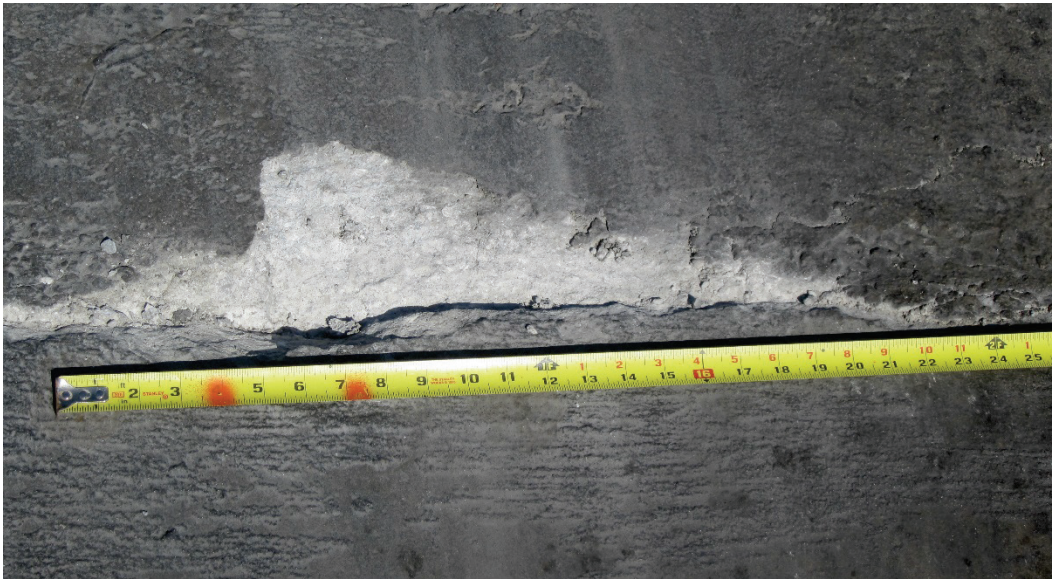
Figure 36. Repair 6, front edge, 2,000 passes.

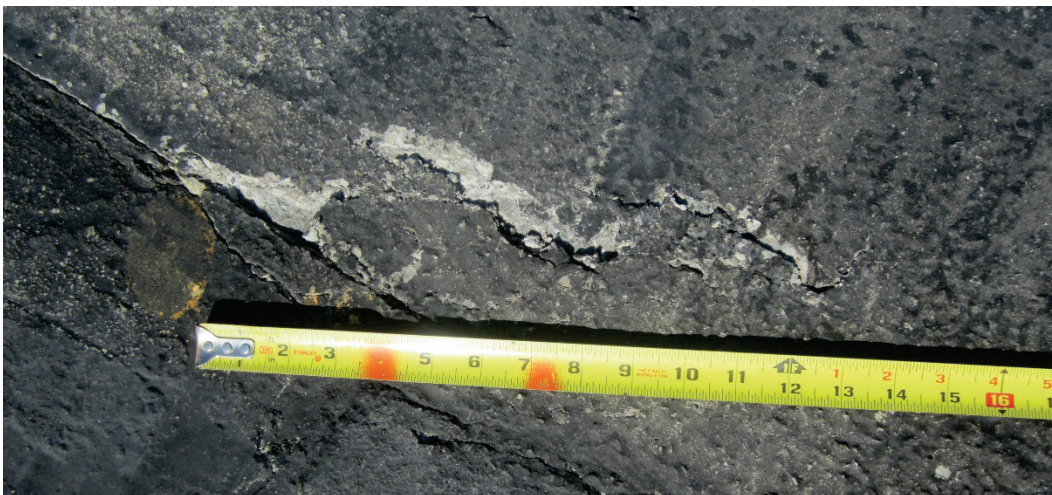
Trafficking and data collection continued periodically for Repairs 4, 5, and 6. After the target number of passes (3,500) was reached, trafficking was discontinued. After 3,500 passes, Figures 37 and 38 show some minor spalling on Repairs 4 and 5, respectively. Repair 6 again showed the most distress of the Ulti-Pave3® repairs with a high-severity spall that was 33 in. long, 3.25 in. wide, and 1.5 in. deep (Figure 39). These results were within the high-severity spall criteria, so Repair 6 was not considered failed at this pass level.

Figure 37. Repair 4, medium-severity spalling, 3,500 passes.

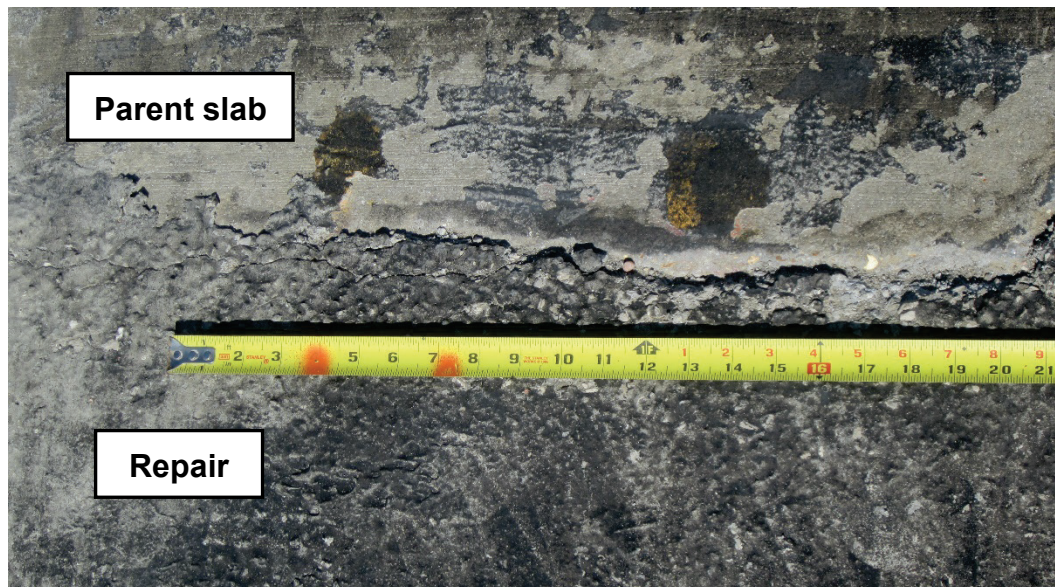
Figure 38. Repair 5, low-severity spalling, 3,500 passes.

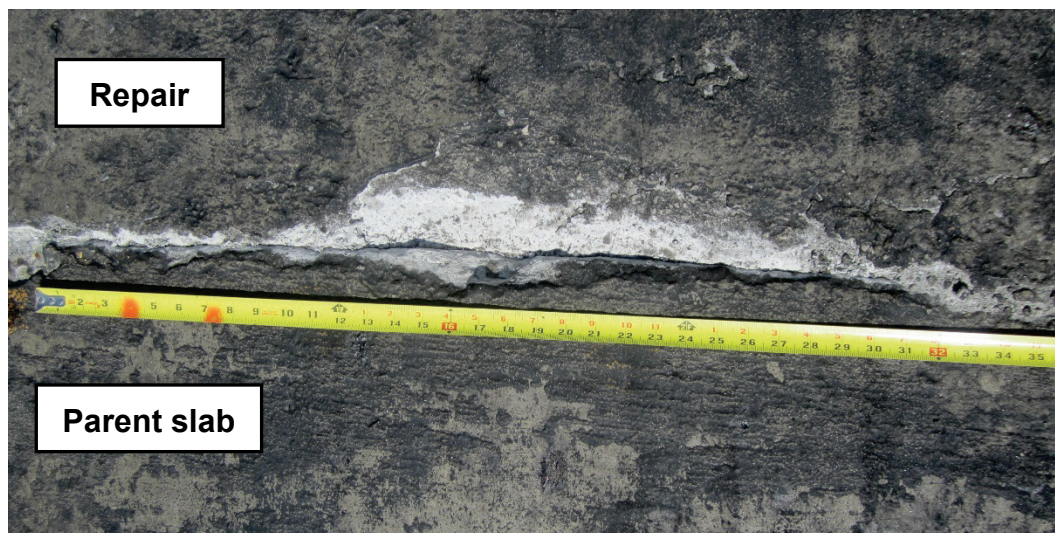
Figure 39. Repair 6, high-severity spalling, 3,500 passes
