# Contribution of Two Eroding Banks to Multipurpose Pool Sedimentation at a Midwestern Reservoir

**PURPOSE:** This US Army Corps of Engineers (USACE) National Regional Sediment Management Technical Note (RSM-TN) documents the sediment contribution of two eroding banks to multipurpose pool sedimentation at Kanopolis Lake, KS. The analysis is based on a 2009 LIDAR and an August 2019 unmanned aircraft systems (UAS)-based structure from motion survey.

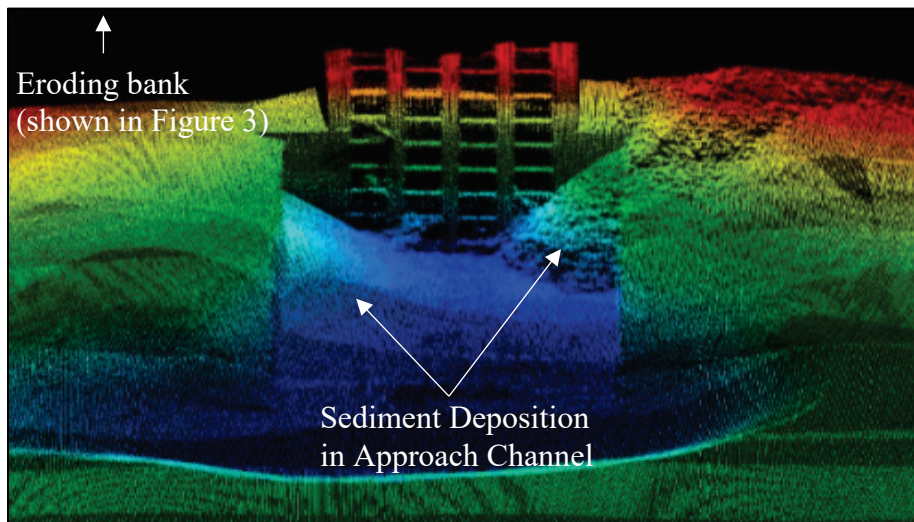
In addition to chronic problems caused by diminishing storage, sediment accumulation has caused expensive problems with gate operations at Kanopolis Lake. In 2010, so much sediment had accumulated in the control tower's conduit and approach channel that the emergency gate could not be fully deployed within the gate slots. The Kansas City District undertook a \$1.1M dredging project to clear out 5,000 yd<sup>3</sup> of sediment from near the control tower. A second dredging project was undertaken in 2019 at a cost of approximately \$2.5M to clear sediment that had again deposited (Figure 2). The first dredging project occurred after 62 years. The second was needed after only seven additional years. A tall bank to the left of the tower has visibly eroded in recent years and is thought to be the source of the sediment that accumulates in the approach channel (Figure 3).

Figure 2. Multibeam survey of Kanopolis Lake indicating deposited sediments in the approach channel.

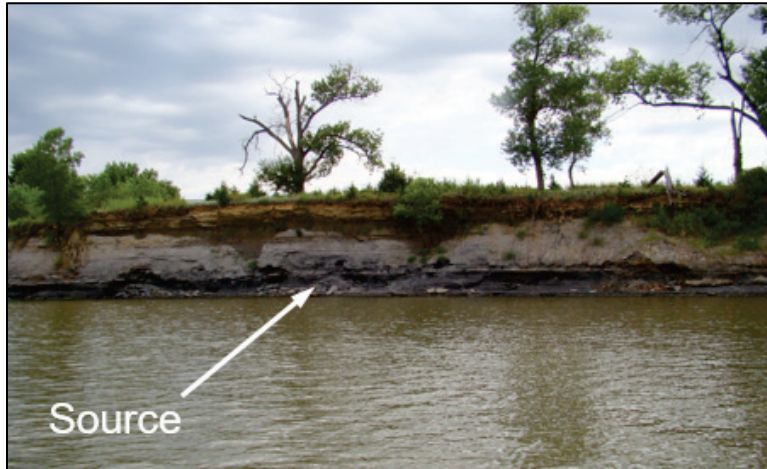
Figure 3. Eroding bank near the control tower.

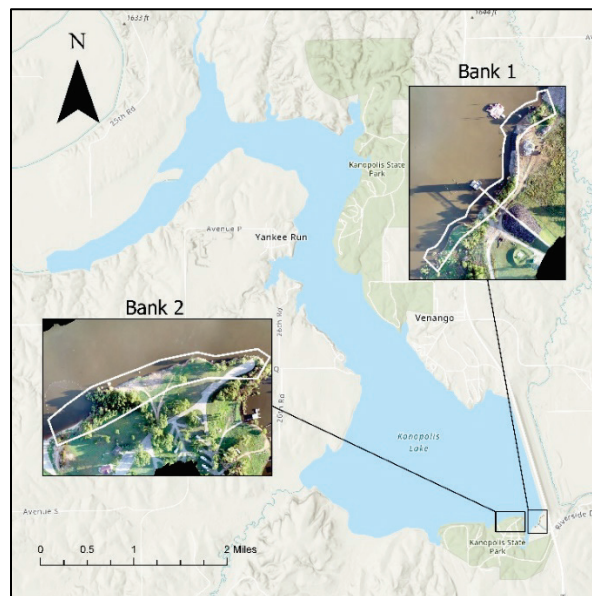
This RSM-TN documents the procedure and provides the results of a surface analysis to compute the volume of bank erosion from two eroding banks, as shown in Figure 4. Bank 1 is immediately behind the control tower, including the eroding bank shown in Figure 3. Bank 2 is nearby to the right at the toe of Kanopolis State Park. A subsequent report will document the cumulative contribution of all the banks.

Figure 4. Eroding banks analyzed in this RSM-TN.

Table 1. Results of the analysis.				
Bank	Measured Erosion (yd <sup>3</sup> )	Estimated Erosion (yd <sup>3</sup> )	Total Erosion (yd <sup>3</sup> )	% Estimated
Bank 1	4,350	1,785	6,135	29%
Bank 2	2,483	9,349	11,832	79%

The combined contribution from these two eroding banks is 17,968 yd<sup>3</sup> from 2009 to 2019, or an average annual contribution of 1,797 yd<sup>3</sup>/year. This equates to 0.26% of the 1946 to 2007 annual average accumulation of 678,748 yd<sup>3</sup>/year. At this time, the number of erosion sites on Kanopolis has not been quantified. However, the small percentage for these two banks suggests that reservoir bank erosion has been a minor contributor to multipurpose pool sedimentation at Kanopolis Lake.

1. Re-fly the UAS survey after the pool has dropped to the multi-purpose pool elevation so more of the erosion can be measured instead of estimated.
2. Repeat the analysis for the remaining banks at Kanopolis.
3. Repeat the analysis using two LIDAR data sets (LIDAR was flown in late 2018, but it has not yet been processed and made available) and compare to the rates generated using the SfM survey.
4. Compare the contribution of bank erosion to a more recent annual estimate for reservoir sedimentation. Other reservoirs in the watershed have indicated that the current rates of reservoir sedimentation may be much less than the long-term rates. Thus, recent bank erosion may be a larger percentage of recent sedimentation.

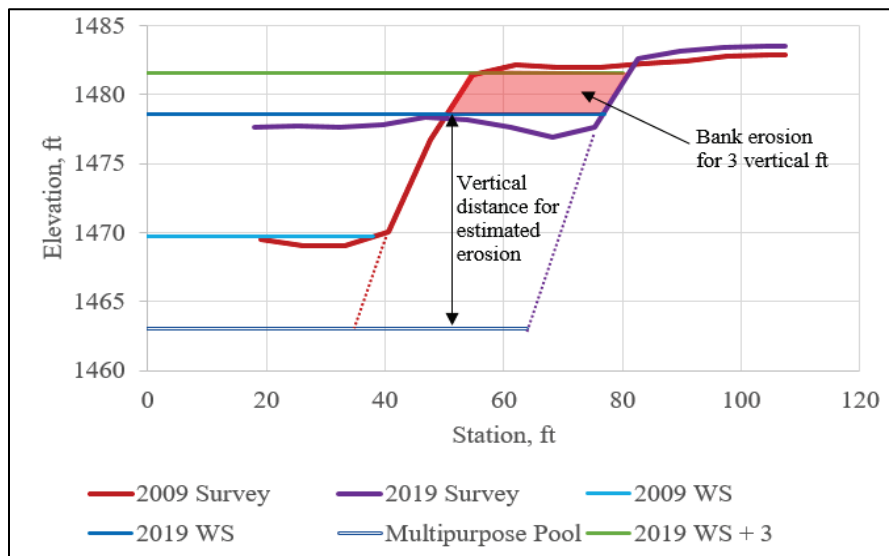
The resulting measured volume change does not represent the total eroded volume; it represents the volume eroded from the bank above the water surface elevation of the 2019 survey. The pool elevation varied over the course of the 2019 SfM survey but was 1478.6 ft at the two subject banks, which is 15.6 ft above the multipurpose pool elevation of 1463 ft. Thus, a significant amount of the eroded bank was underwater during the SfM survey and therefore was not included in the change analysis. However, this area can be estimated by assuming the rate of erosion per vertical foot is the same above the water surface as below, which is true if the 2009 and 2019 bank slopes remain parallel to each other down to the multipurpose pool level. This un-counted volume was estimated by multiplying the unit volume of bank erosion per vertical foot by 15.6 ft, the distance between the water surface and the multipurpose pool. The unit volume was computed as the eroded volume in the first 3 ft vertical slice above the SfM pool level (from 1478.6 to 1481.6 ft) divided by 3. Figure 7 illustrates this concept in cross section view at Bank 2. As seen in Figure 7, at Bank 2 the high pool on the day of the 2019 survey necessitates estimating most of the erosion.

Figure 7. Conceptual illustration for estimating the unmeasured area at Bank 2.
