# Evaluation of Reentry Effects of Delta II Second Stage Propellant Tanks

March 21, 2018

Gary L. Steckel<sup>1</sup> and Paul M. Adams<sup>2</sup>

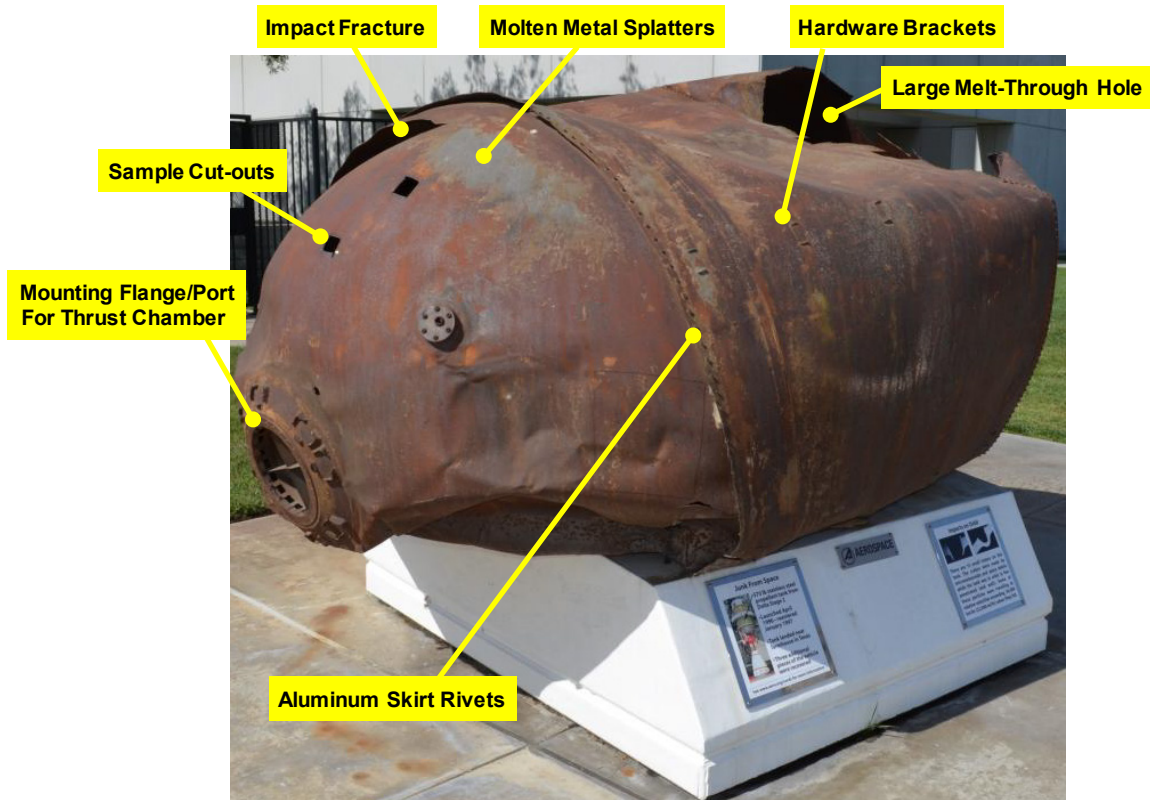
Figure 3. Photograph of Delta II 2nd Stage propellant tank that reentered in 1997 and landed in Texas.

A large hole with an area around  $0.5 \text{ m}^2$  was present on the upper side of the forward dome. It was concluded from the presence of resolidified metal around the perimeter of the hole that the stainless steel skin had melted at this localized area during reentry. However, such gross melting of the stainless steel skin, which occurs at approximately  $1500^\circ\text{C}$ , was not observed at any other location on the tank. There were, however, splatters of various sizes of resolidified molten metal at several locations on the tank surface. It was determined from SEM/EDS analyses that these splatters were primarily aluminum. It was concluded that aluminum hardware attached to the Stage II tank had melted during reentry and landed on the tank surface. Since aluminum alloys melt at approximately  $660^\circ\text{C}$ , it was concluded from these observations that the peak reentry temperature of the tank was at least  $660^\circ\text{C}$ , but less than  $1500^\circ\text{C}$ .

Many small, circular holes ranging from 2 to 3 mm dia. were observed on the tank skin. A total of 17 holes were found, 15 on the aft dome and 2 on the cylindrical section. Four of the 17 holes penetrated through the tank skin, while most of the holes were crater-like depressions. It was concluded that the small holes were the result of impacts by micrometeoroids or tiny space debris while the tank was in orbit.

Other observations included erosion or partial melting of stainless steel rivets, where aluminum alloy hardware was attached around the forward and aft ends of the cylindrical section and brackets at various locations around the cylindrical section. The melting or erosion was attributed to extreme aerodynamic heating at these irregularities on the tank surface.

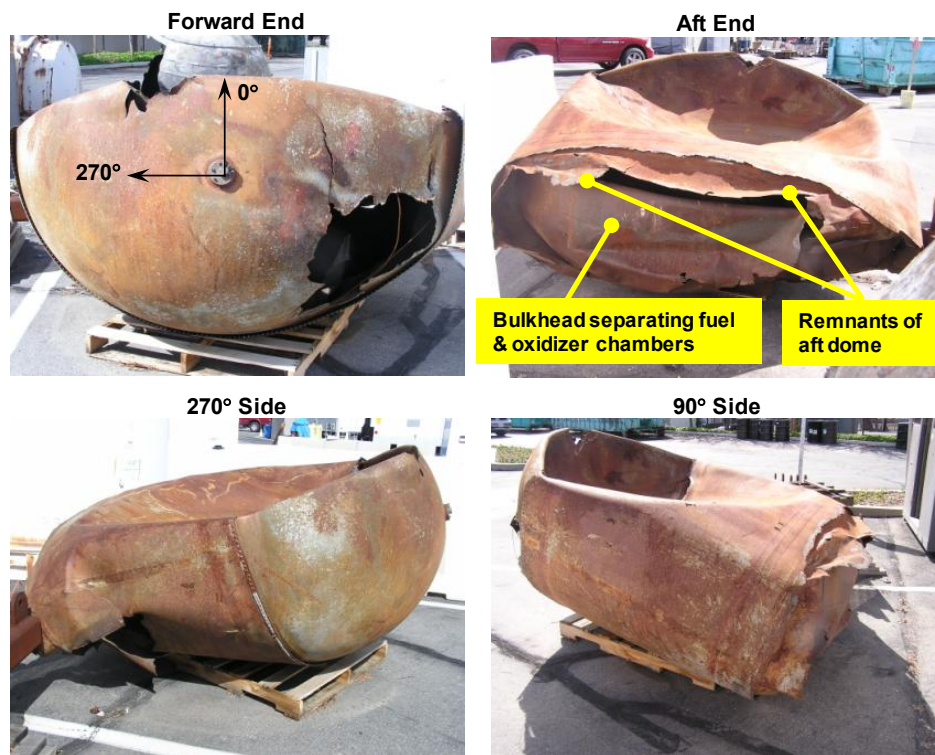
Figure 4. Photographs of Delta II 2nd Stage propellant tank that reentered in 2009 and landed in Mongolia.

A set of four photographs in Figure 4 show the forward and aft ends and opposing side views of the Mongolia propellant tank. The tank was more grossly deformed than the Texas and South Africa tanks. One side totally collapsed into a concave bowl shape; it is assumed that initial Earth impact was on this side. An arbitrary coordinate system, as shown on the forward end photo, was used to define relative angular positions around the cylindrical tank. The center of the concave side was defined as 0°. Figure 5 shows a second set of four photographs taken with the concave side facing downward. These photos show very little deformation on the upper side of the tank at the forward end, but at the aft end they show flattening into an oval shape. The aft end photos in Figures 4 and 5 show that the aft dome was almost completely missing and the bulkhead that separated the fuel and oxidizer chambers was pushed outward through the remnants of the aft dome. The jagged edge of the dome remnants suggest that the dome fractured circumferentially a short distance behind the welded interface to the cylindrical section. Heating damage was observed around much of the fracture surface, suggesting that the dome probably fractured during breakup of the Stage 2 vehicle in the early stage of reentry. This likely occurred when the thrust chamber and engine were ripped away from the tank. Whereas clean separation between the tank and thrust chamber occurred at the mounting flange for the Texas and South Africa tanks, separation for the Mongolia tank occurred by failure of the stainless steel dome skin. The structural integrity of the tank was greatly diminished by removal of the aft dome. This probably allowed the tank to collapse into a concave shape upon Earth impact.

A large melt-through hole was observed on the forward dome, as shown in the forward end photo in Figure 4. The hole was similar in size ( $\cong 0.5 \text{ m}^2$ ) and location to the melt-through hole on the Texas tank. Furthermore, the perimeter of the melt-through hole consisted of resolidified metal, appeared to have aluminum splatters on the external surface, and was curled outward. All observations were consistent with the hole on the Texas tank. A second, smaller melt-through hole is visible in Figure 4, near the center of the forward dome at the rim of the concave deformation. It is not surprising that the melt-through holes for both tanks were on the forward dome. As shown in Figure 1, a large aluminum housing joining the propellant tank to the guidance section is riveted to the forward end of the cylindrical section, while only a short aluminum skirt is riveted to the aft end. Thus, the potential for heavy molten aluminum splatters and aluminum burning is much higher for the forward dome.

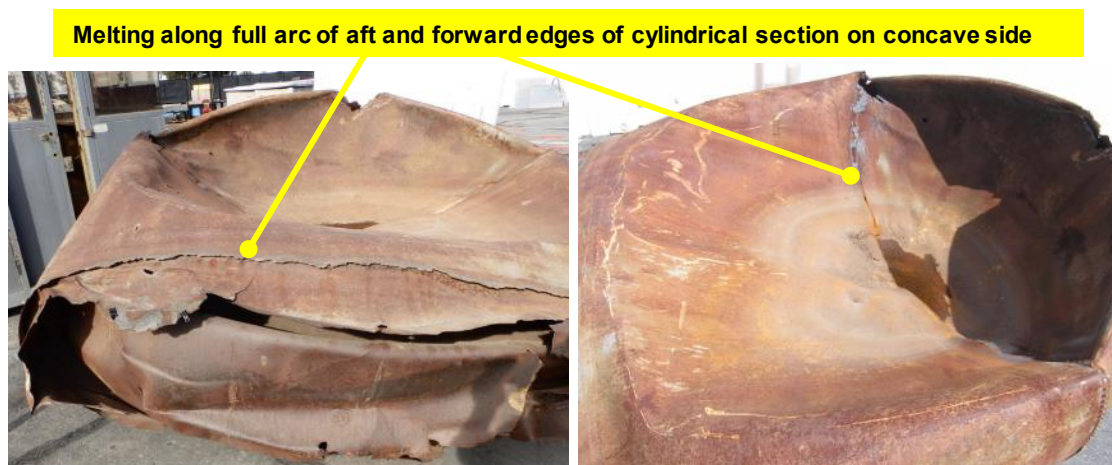
Figure 6. Melting along ends of cylindrical section on concave side of Mongolia tank.

Widespread melting or erosion of the forward and aft ends of the cylindrical section back through the stainless steel rivets occurred on the concave side of the tank (Figure 6). On the other hand, very little melting or erosion of cylinder ends occurred around the opposite side ( $\cong 70^\circ$ – $290^\circ$ ). Furthermore, as shown in Figure 7, residual aluminum remained under the rivets, along a portion of the forward end of the cylindrical section.

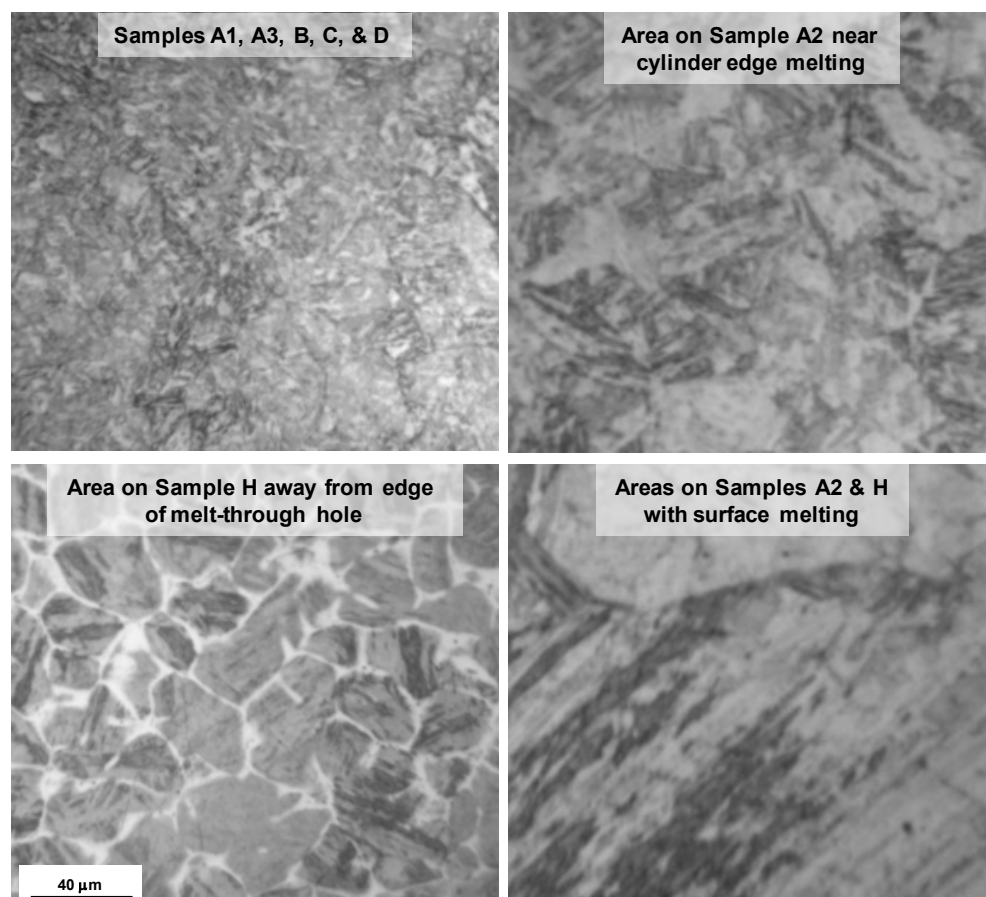
Figure 8. Optical micrographs showing martensitic microstructures at various locations on the Mongolia tank.

Seven of the eight samples listed in Table 2, excluding Sample J, were cross-sectioned, mounted, polished, and etched for evaluation of post-reentry microstructures by optical microscopy. Figure 8 shows four micrographs that represent the microstructures observed for the samples from the seven different tank locations. The upper left micrograph in Figure 8 is representative of all the areas on the tank that had no melting of the stainless steel during reentry (Sample Nos. A1, A3, B, C, and D). This is the lath martensite structure typical of 410 stainless steel. The orientation of the lathes differs for individual prior austenite grains. It follows that the prior austenite grains had diameters in the range of 20 to 40  $\mu\text{m}$ . The upper right and lower right micrographs show the same microstructure as the upper left, but with larger prior austenite grain sizes. The upper right micrograph is of an area near the cylinder wall edge that melted during reentry, but with no surface melting. The lower right micrograph represents areas with surface melting. Progressively higher peak temperatures at the locations of the upper left to upper right to lower right micrographs caused increasing amounts of austenite grain growth. Prior austenite grain diameters were around 30 to 50  $\mu\text{m}$  for the upper right microstructure, and over 150  $\mu\text{m}$  for the lower right micrograph.

The lower left micrograph shows a unique microstructure observed near the melt-through hole on Sample H. The dark areas are lath martensite, and the white areas are retained austenite at the prior austenite grain boundaries that did not transform during post-reentry cooling. This microstructure clearly shows the prior austenite grain size, similar to that in the upper right micrograph. The cause of the retained austenite was not pursued, but could be due to carbon or chromium depletion at the grain boundaries.

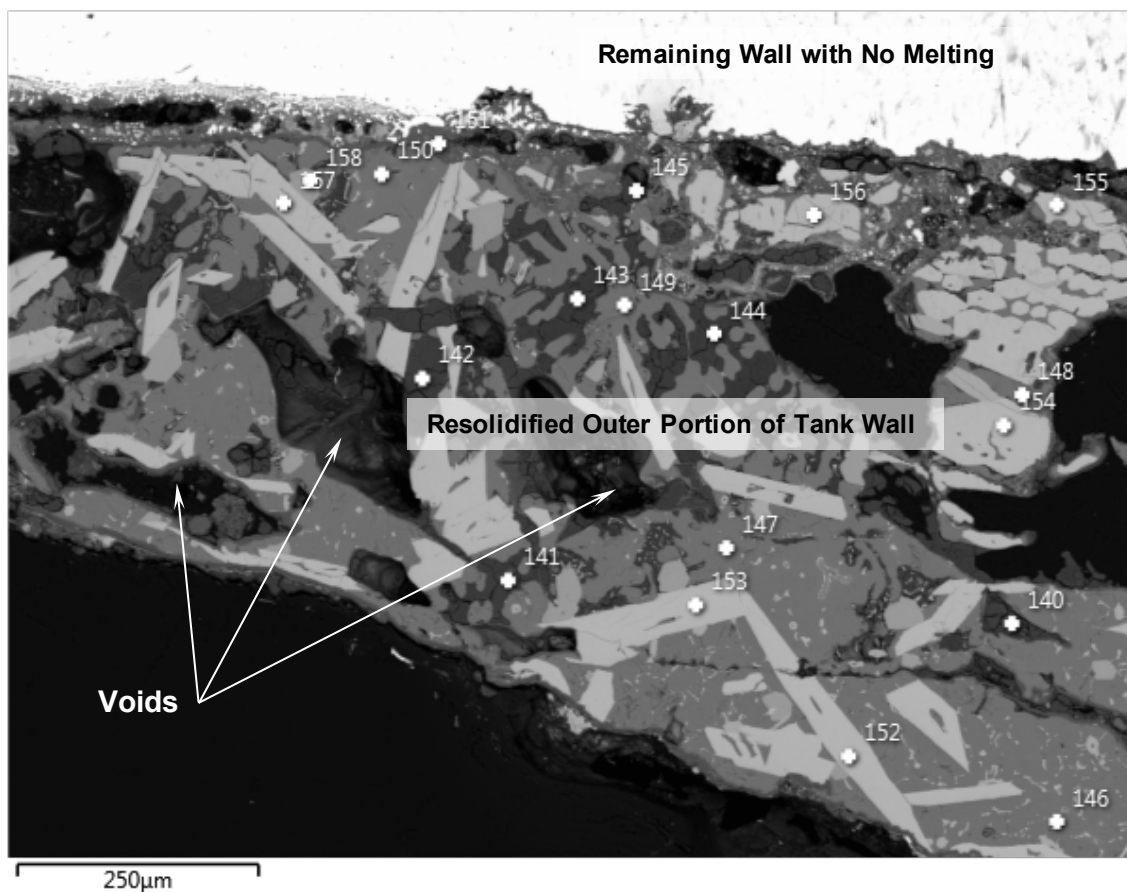
Figure 9. SEM/LBE image of an area on outer surface of tank cross-section at perimeter of melt-through hole.

The polished cross-section of Sample H was analyzed in the SEM using EDS to determine the chemical composition of the resolidified metal near the edge of the melt-through hole on the outside and inside surfaces of the tank wall. Figure 9 is a low-angle backscatter electron (LBE) image of an area on the outside surface. The image is centered 3 mm to the left of the edge of the hole.

In this backscatter electron image, high atomic number constituents appear brighter than lower atomic number constituents. The bright area at the top of the image is an interior region of the stainless steel tank wall that did not melt during reentry. The porous material below the remaining wall is a layer of resolidified metal on the outer surface of the tank wall. It is composed of three different phases, with differing atomic weights yielding three distinct shades of gray in the image. The primary phase is a

neutral gray tone with patches of a dark gray phase having a dendritic appearance and a light gray phase having mostly a platelet morphology. The black areas within the porous resolidified metal are voids. EDS spectra were taken at 19 points within the resolidified metal labeled points 140 – 158. Table 4 shows the tabulated results of the EDS analyses. The primary phase (neutral gray areas, Points 146–150) consisted of essentially elemental aluminum with small amounts of iron, chromium, and silicon from the stainless steel wall and around 3 at.% oxygen. The dark gray phase (Points 140–145 & 151) consisted of fully oxidized aluminum ( $\cong$  37 at.% Al and 61 at.% O). The light gray platelet phase consisted of an alloyed mixture of aluminum and 410 stainless steel consisting of approximately 77 at.% Al, 20 at.% Fe, and small amounts of Cr and Si.

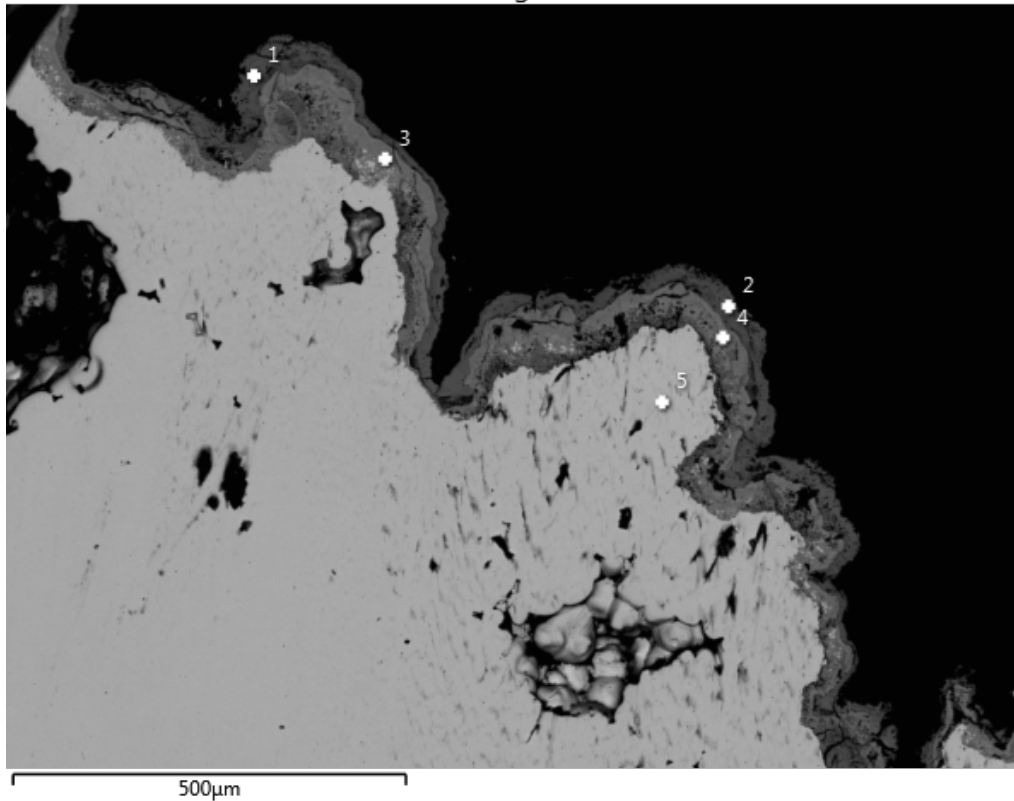
Figure 10. SEM/LABE image of an area on inner surface of tank cross-section at perimeter of melt-through hole.

Figure 10 shows an SEM/LABE image of an area on the inside of the tank wall approximately 5 mm from the edge of the melt-through hole. Table 5 presents the results of EDS spectra at Points 1–5. The light gray area represented by Point 5 consists of remaining unmelted stainless steel wall. The gray inner layer of resolidified material ( $\cong$  30–80  $\mu$ m thick, Pts. 3 & 4) was highly oxidized with equal amounts of iron and chromium. The darker gray outer layer ( $\cong$  10–40  $\mu$ m thick, Pts. 1 & 2) was mostly iron oxide. The inner surface of the tank was not accessible to molten metal splatters, so very little aluminum was present. The

high concentration of Cr in the inner oxide layer can probably be attributed to the fact that  $\text{Cr}_2\text{O}_3$  has a much lower free energy of formation at the melting temperature of 410 stainless steel than any of the potential iron oxides ( $\text{FeO}$ ,  $\text{Fe}_2\text{O}_3$ , or  $\text{Fe}_3\text{O}_4$ ). Thus, an oxide layer rich in Cr formed first. Once the available Cr was all oxidized, free Fe atoms diffused through the inner oxide layer to react with oxygen to form the outer oxide layer.

The SEM/EDS results for the resolidified metal on the outside and inside surfaces of the tank cross-section at the perimeter of the melt-through hole are consistent with those reported by Wan [3] for the Texas reentry. Thus, the current results support his hypothesis that aluminum hardware attached to the propellant tank melted and splattered onto the forward dome of the tank, subsequently caught on fire due to rapid oxidation by the air stream, and generated sufficient heat to cause localized melting through the tank dome.

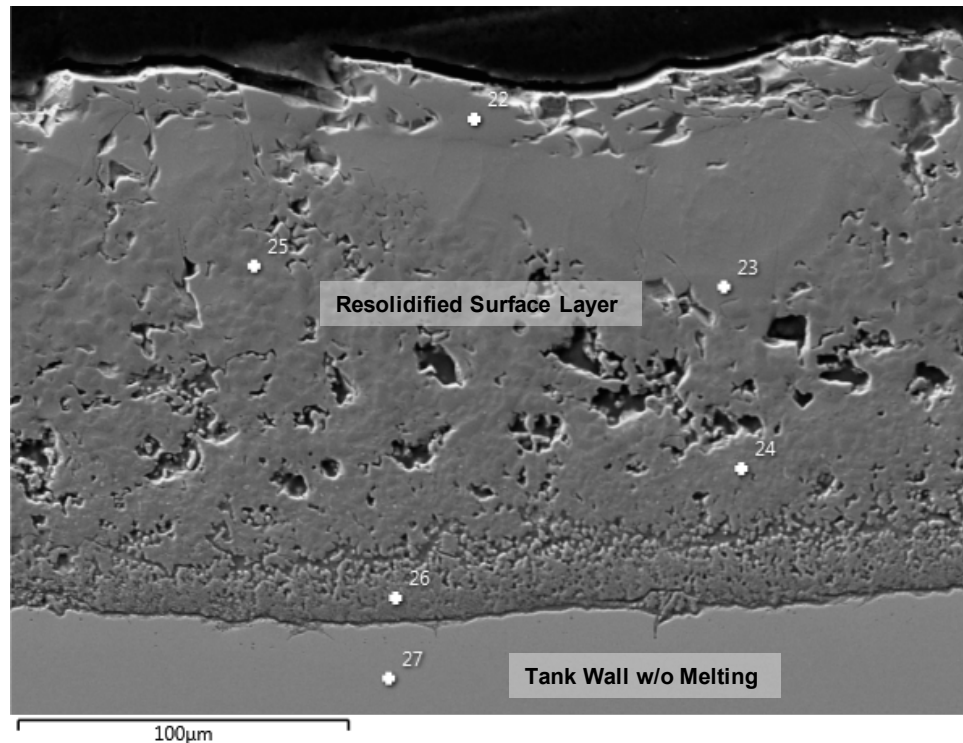
Figure 11 shows an SEM/LABE image of a polished cross-section of Sample A2 from the forward edge of the cylindrical section. The lower area consists of remaining wall thickness that did not melt, and the porous upper area consists of resolidified metal on the outside surface. The results of EDS spectra taken at Points 22–27 are tabulated at the bottom of the figure. The resolidified metal was highly oxidized throughout the thickness, but was mostly iron oxide near the free surface (points 22, 23, & 25), with higher concentrations of chromium present near the remaining tank wall (Points 24 & 26). Although some aluminum was present, the concentrations were low, and there was no evidence of aluminum burning contributing to the tank melting. Similar results were obtained at five other areas on the cross-section. The results were consistent, with the assumption that melting was due to enhanced aerodynamic heating at the exposed cylinder edge.

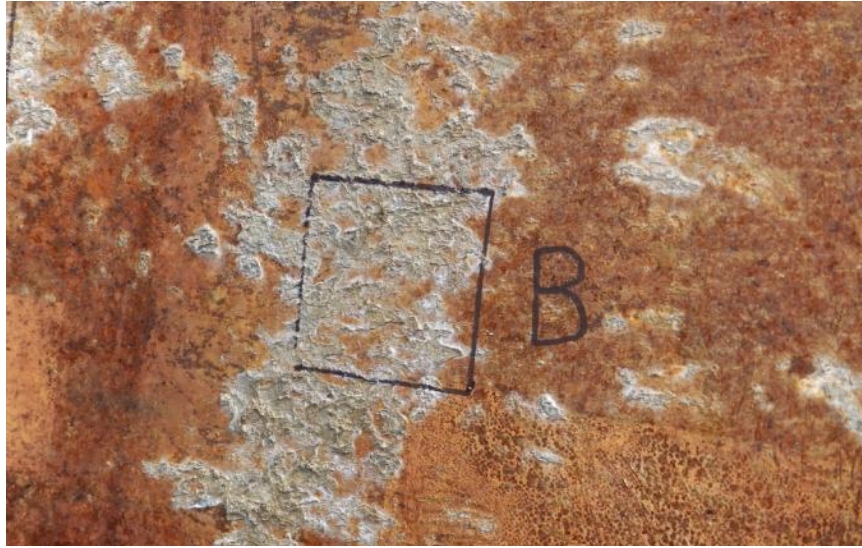
Figure 12. Photograph of Sample B before cutting from region with resolidified metal splatters.

Samples A1, A3, B, C, and D were selected for SEM/EDS analyses to determine peak reentry temperatures at different locations on the tank surface. These samples were selected because they all appeared to have molten aluminum splatters on the outside surface of the tank. The extent of alloying between the aluminum and stainless steel tank was the basis for the peak temperature estimates. All four samples appeared to have moderate splattering, with the aluminum having a white fluffy appearance, as shown in Figure 12 for Sample B. The tank surface surrounding the aluminum splatters has a rusty appearance due to atmospheric corrosion that occurred after reentry during outdoor storage.

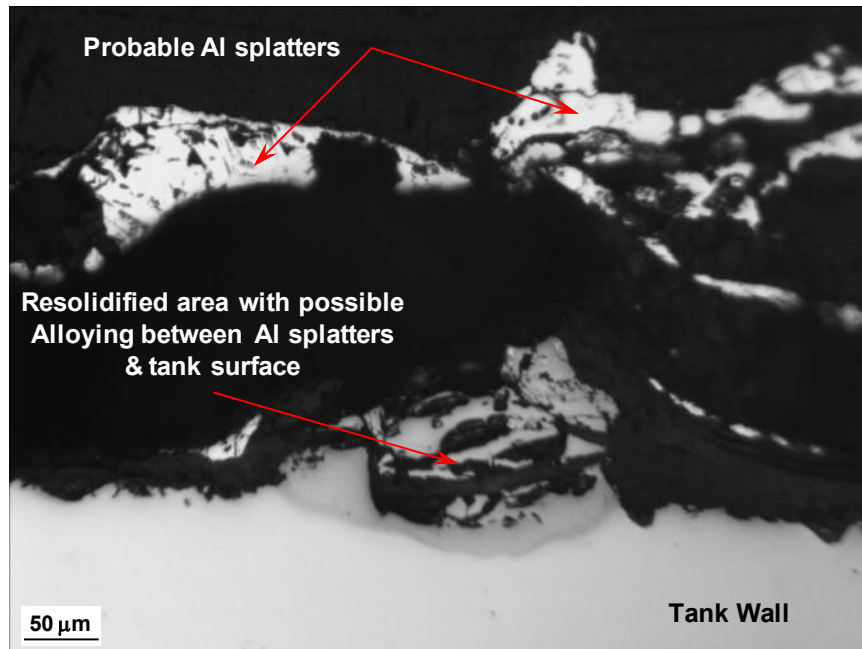
Figure 13. Optical micrograph of cross-section of Sample B showing possible alloying between Al splatters and tank wall.

Polished cross-sections of the four samples were examined by optical microscopy to identify areas with possible alloying between the aluminum splatters and stainless steel tank surface. An example of an area selected for analysis is shown in the optical micrograph in Figure 13. This area appeared to have resolidified aluminum splatters on the tank surface and a resolidified area that appeared to be bonded to the tank surface—an indication of alloying between the aluminum and stainless steel. Figure 14 presents a SEM image of the same area, along with EDS elemental maps showing the locations of Al, Fe, and Cr (red, yellow, and green, respectively). The Al map verified the presence of Al splatters on the tank surface. The Fe and Cr maps clearly highlight the stainless steel tank wall. Most importantly, the maps verified the presence of Al, Fe, and Cr within the resolidified material that appeared to have a continuous bond with the tank wall. Thus, the mapping verified alloying between the Al splatters and stainless steel wall, making this a suitable area for more detailed SEM/EDS analyses to determine the peak reentry temperature at this location on the propellant tank.

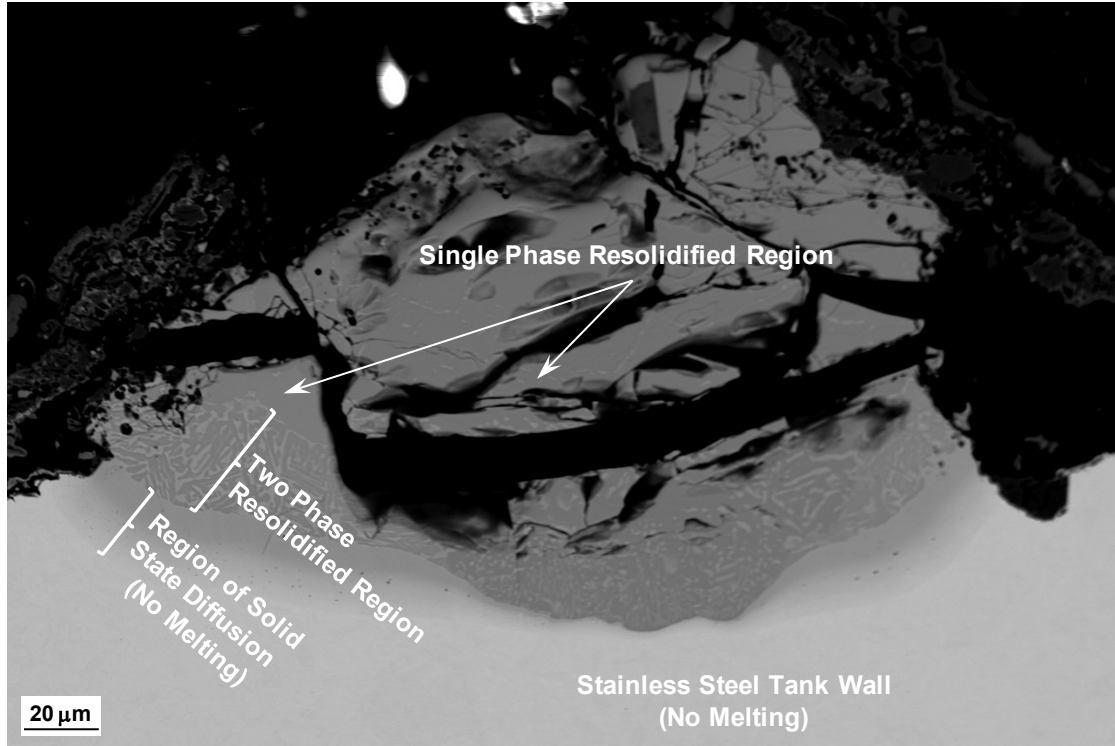
Figure 15. SEM/LABE image of polished cross-section showing region with alloying between Al splatters and tank wall.

A higher magnification SEM/LABE image of the area of interest in Figure 15 shows that the resolidified material consists of a single-phase region and a two-phase region. Both these areas were fully or partially melted at the peak reentry temperature for this location. A region of solid-state diffusion joins the resolidified material to tank wall. The diffusion zone is highlighted by increasing LABE image brightness across the zone from the two-phase region (low atomic mass) to the tank wall (higher atomic mass). The diffusion zone and remaining tank wall did not undergo any melting during reentry.

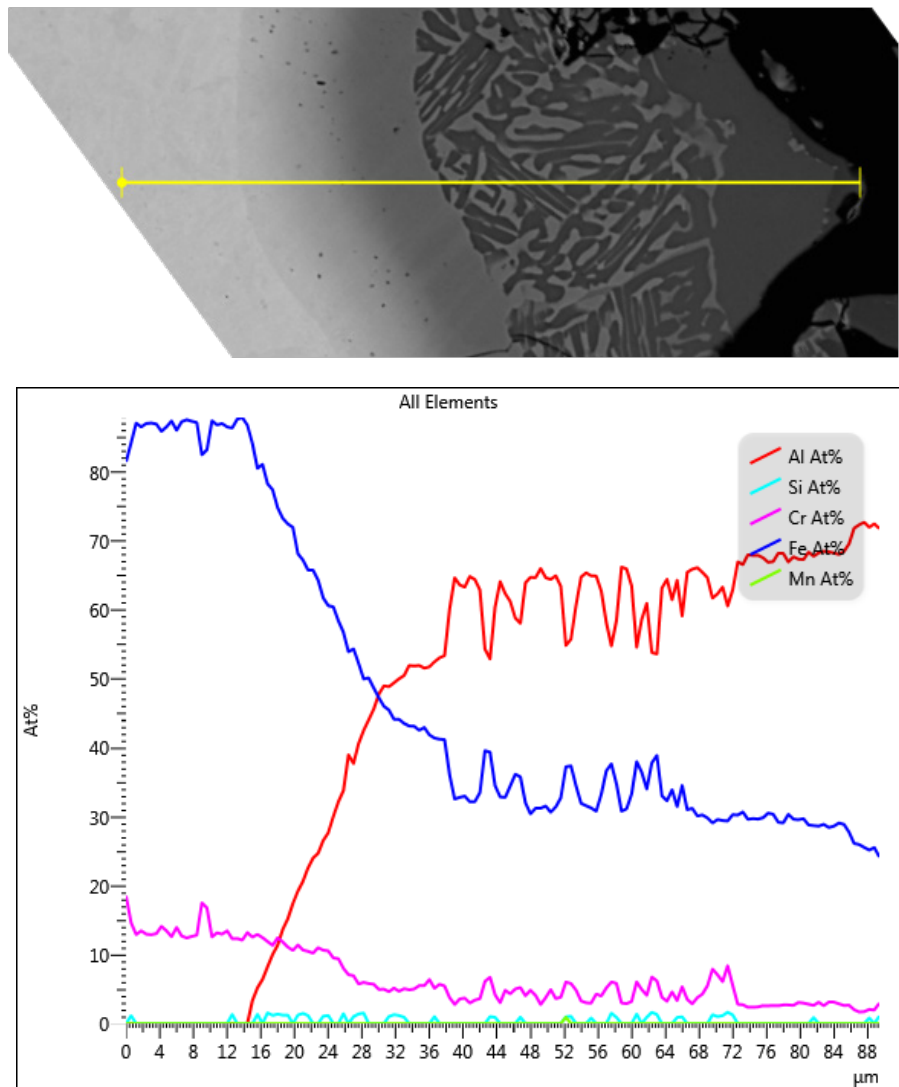
Figure 18. SEM/EDS elemental line across region with alloying between stainless steel tank and aluminum splatters.

An EDS elemental line scan was made across the diffusion zone, the two-phase resolidified region, and into the single-phase resolidified regions (Figure 15), as shown in Figure 18. The line scan included the elements Al, Si, Cr, Fe, and Mn, but the only elements of interest for our analysis are Al and Fe + Cr. The line scan was initiated within the unalloyed region of the 410 stainless steel, with the typical Fe and Cr compositions of 87 and 13 at. %, respectively. At 13  $\mu\text{m}$  along the scan, the beginning of the diffusion zone was reached, as indicated by slight darkening of LBE image. The Fe and Cr content continually decreased across the diffusion zone while the aluminum content increased. At the end of the diffusion zone just before reaching the two phase resolidified region, the Al content was 53 at. %. This is the maximum Al content for the portion of the tank thickness that did not melt. From the phase diagram (Figure 17), an alloy with 53 at. % Al melts at the peritectic temperature of 1215°C. Thus, the peak reentry temperature at this location on the tank did not exceed 1215°C.

As the line scan proceeded across the two-phase region, the Al content varied between approximately 67 and 54 at. %, the respective compositions of the dark and light phases. At approximately 72  $\mu\text{m}$ , the scan entered the single-phase resolidified region, and the Al content stabilized at approximately 67 at. %. A

large area EDS scan of the two-phase resolidified region gave an Al content of 61 at. %, the weighted average for the two phases. From the phase diagram, at temperatures below 1092°C, an alloy with 61 at. % Al (as indicated by the red line) has a microstructure consisting of  $\alpha_2$  with an Al content of approximately 55 at. % (light phase in Figure 18) and  $\xi$  with an Al content around 66 at. % (dark phase). For 61 at. % Al, melting initiates at 1075°C. Thus, the peak reentry temperature at this location on the tank was at least 1075°C, but did not exceed 1215°C.

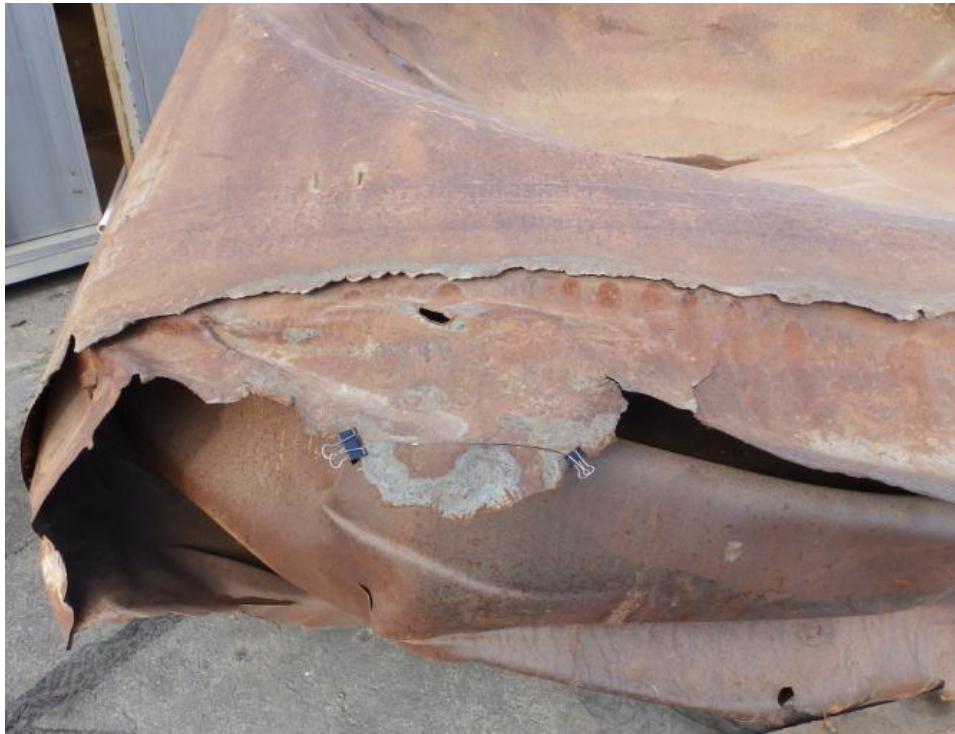
Figure 19. Photograph of Sample A1 secured to aft dome by binder clips after removal from Mongolia tank.

Sample A1, shown in Figure 19, was cut from the aft dome of the propellant tank along the path where the dome fractured during breakup. It was originally cut from the tank for evaluation because the light gray pattern on the outside surface suggested that a thick layer of molten aluminum had splattered along the fracture path during reentry. However, once the sample was removed, it was discovered that a matching gray pattern was also present on the inside surface (Figure 20). SEM/EDS spectra were taken on the surfaces of the gray area as well as the reddish area. No aluminum was detected on the gray area, and

both surface areas were predominantly iron and oxygen. The reddish iron oxide was representative of most of the tank surface, resulting from atmospheric corrosion due to outdoor storage following reentry.

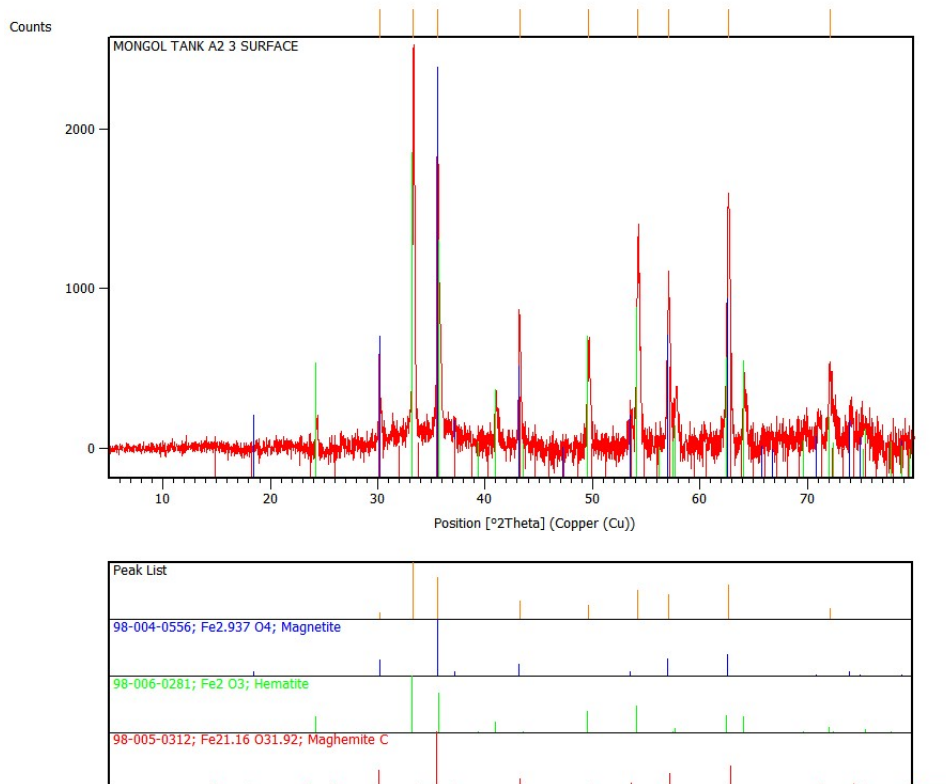
Figure 22. X-ray diffraction spectrum obtained from gray oxide on Sample A1.

Figure 22 shows the diffraction pattern for the gray area. Magnetite and/or maghemite plus hematite ( $\alpha$ -Fe<sub>2</sub>O<sub>3</sub>) matched the diffraction peaks. Hematite and magnetite are both stable at room temperature, and the gray area is likely a combination of these two oxides. At temperatures below 570°C, iron oxidizes

with an inner layer of magnetite and outer layer of hematite [11]. Therefore, hematite probably caused the gray color. Similar color patterns were observed at a few locations along the forward and aft edges of the cylindrical section. Thus, it was only observed near tank edges. It was assumed that the hematite formed during reentry, but only at locations having favorable temperature and air flow characteristics.

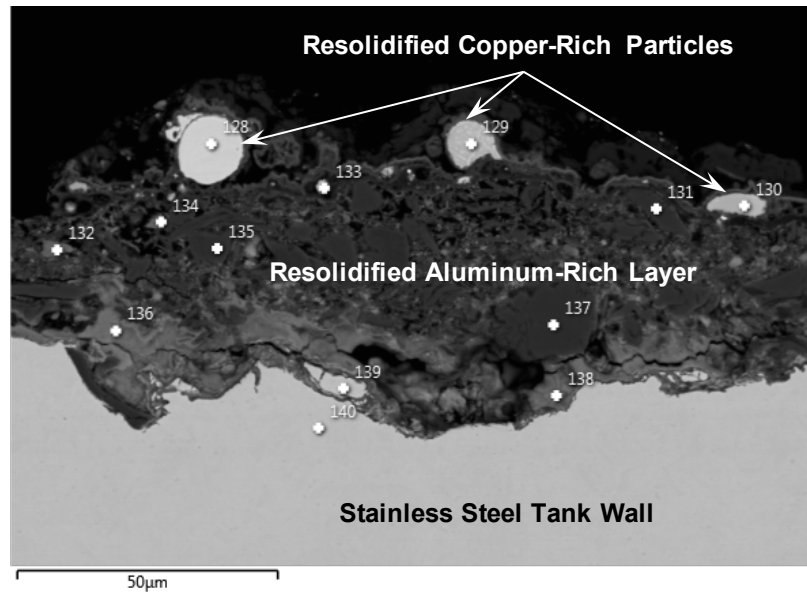
Figure 23. LBE image of Cu-rich particles on top of aluminum splatters on Sample A3.

Molten metal splatters on the Mongolia tank were primarily aluminum, with small concentrations of common aluminum alloying elements such as magnesium and silicon. Copper was also detected by SEM/EDS at several locations. Figure 23 is a LABE image of a typical area with Cu-rich particles on the cross section of Sample A3. The particle on the left was 70 at. % Cu and 25 % Al and the other two particles were 45 at. % Cu + 40 % Al + 10 % Fe. All the splatters observed with high copper concentrations also had significant aluminum concentrations. However, we were primarily looking at cross-sections of areas with obvious aluminum splatters. Thus, it is quite possible that copper splatters were present at other locations in the absence of any aluminum. For the samples that were analyzed, Cu-rich particles were usually on the surface of the resolidified aluminum splatters, but were occasionally imbedded in the Al-rich layer. The Cu-rich particles were usually similar in size (10–20  $\mu\text{m}$  across) to those in Figure 23, but often had a more irregular cross-section than did the round particles in the figure. The copper probably originated from electrical wiring attached to propellant tank that melted and splattered onto the tank surface.
