# **NAVAL POSTGRADUATE SCHOOL**

## **THESIS**

**A SYSTEMATIC APPROACH TO IDENTIFYING  
OPPORTUNITIES FOR MAKING SYSTEMS CONTEXT  
AWARE TO ADDRESS SAFETY HAZARDS**

September 2020

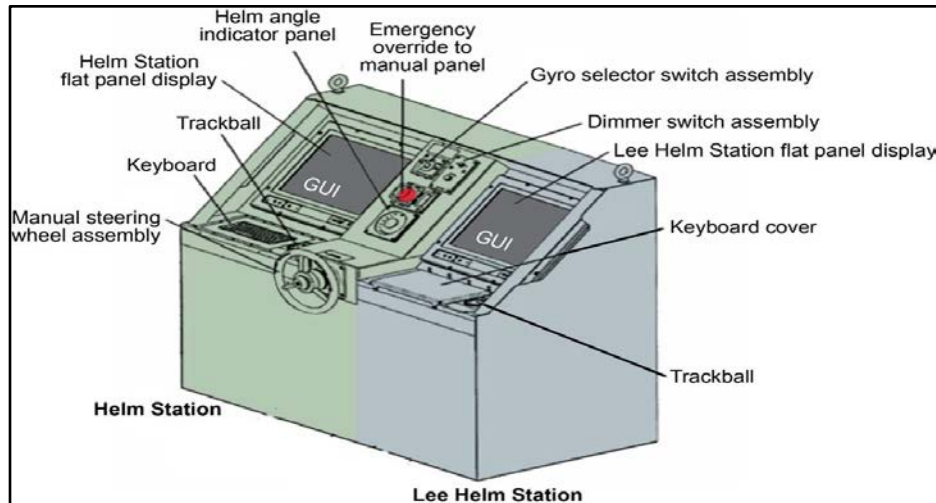
Figure 6. USS *John S. McCain* SCC. Source: [6].

The CO had good intentions by ordering the splitting of the responsibility of thrust and steering control. Up to this point, the Helmsman was also the Lee Helmsman. Steering and thrust control was all done by one person on one console. In Figure 6 the green shaded portion is the Helm station, and the blueish grey portion is the Lee Helm station.

Once a sailor had assumed the Lee Helm position, the sailor began the thrust control transfer from the helm station to the lee helm station. Thrust control transfer is done in a similar fashion as steering control transfer. The one difference for thrust control transfer is that control of each shaft is done one at a time. The JSM is a dual-shaft ship. The relinquishing station (Helm Station) initiated the transfer of the port shaft, and the gaining station (Lee Helm Station) accepted the transfer. At this point, the Lee Helm has control of only the port shaft. Right before the Helmsman initiates the transfer of the starboard shaft, he determines he no longer has control of steering. In line with proper watch standing, the Helmsman announces that he has a loss of steering.

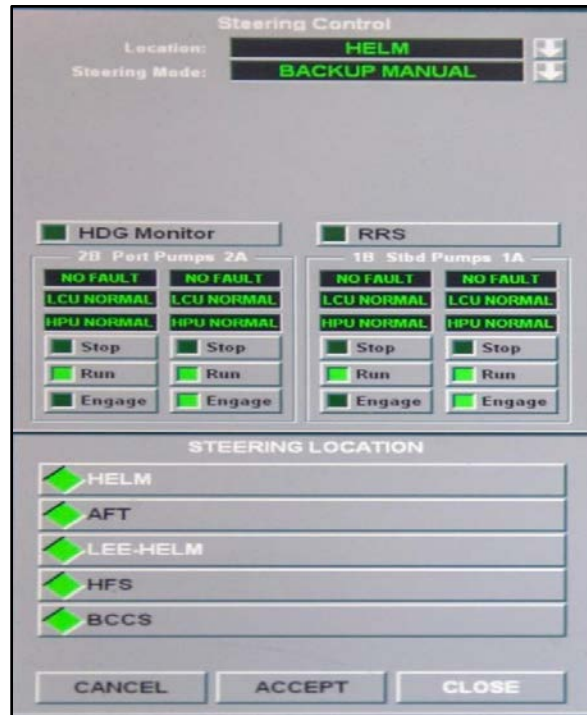
Figure 7. Image of a portion of the IBNS console onboard USS *John S. McCain*. Source: [6].

Analysis of video logs that time stamp all transfers and configuration changes revealed that the steering was transferred to the Lee Helm station around the same time that the two stations (Helm and Lee Helm) were conducting the thrust transfer. Figure 7 shows how the SCC displays the current location of steering control and the mode of steering.

According to the Helmsman, the steering console will sound an alarm when there is a loss of steering at that station. The alarm notifying the Helmsman of a loss of steering is a safety constraint that can immediately bring the steering loss to the attention of the Helmsman. This is especially helpful if the Helmsman is operating in a more automated mode (i.e., less hands on), which may eliminate the typical haptic feedback one would get if steering control was lost. The video logs show no loss of steering and that it was actually transferred to the Lee Helm station; this raises some concern. Software defects can be challenging to find in complex systems, but the evidence presented in the accident reports makes a strong case for concluding that steering control transfer was done unbeknownst to the Helmsman. Since the SCC was in backup manual mode, the unilateral transfer of steering was possible.

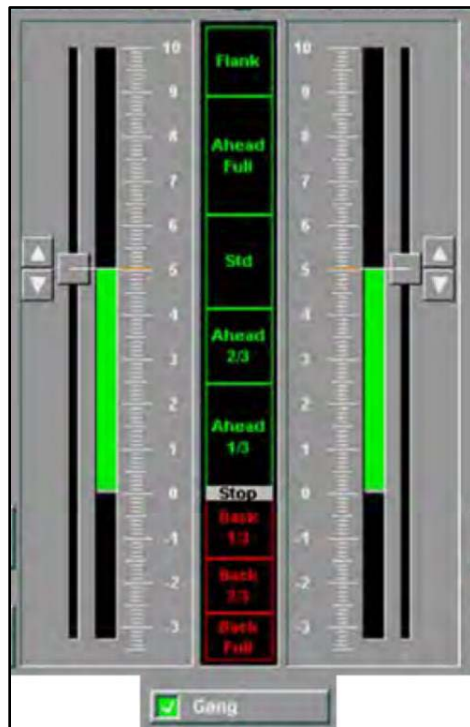
Figure 8. IBNS thrust control GUI. Source: [6].

interrupted due to a perceived loss-of-steering event. During the commotion, the Lee Helmsman completed the transfer of the starboard shaft by himself. Prior to the port thrust transfer, when the Helmsman had control of both steering and thrust, the shafts were ganged. The term ganged refers to the control mechanism that is utilized to adjust shaft speed. When the shafts are ganged, any adjustment made to one shaft will also be made automatically on the other. Figure 8 shows what the IBNS thrust control screen looks like.

The Lee Helmsman acknowledged the speed change order, and adjusted the port shaft accordingly in order to achieve the 10kts. The Lee Helmsman had intended to adjust both shafts, but the shafts became un-ganged and the Lee Helmsman was unaware of this when he adjusted the speed. The Lee Helmsman told the NTSB investigator that he had re-ganged the shafts after the transfer. Since only one shaft's speed was adjusted, the ship started to drift to port. The slower speed on the port shaft and the faster speed on the starboard shaft essentially put JSM into a port-twist. When transferring thrust from one

is the subject of non-compliance. It is noted that touch-screen controls are not appropriate for continuous control functions. The throttle control falls into this category. The non-compliance is probably driving the quick reaction by Naval engineers to re-introduce the physical throttles to the bridge.

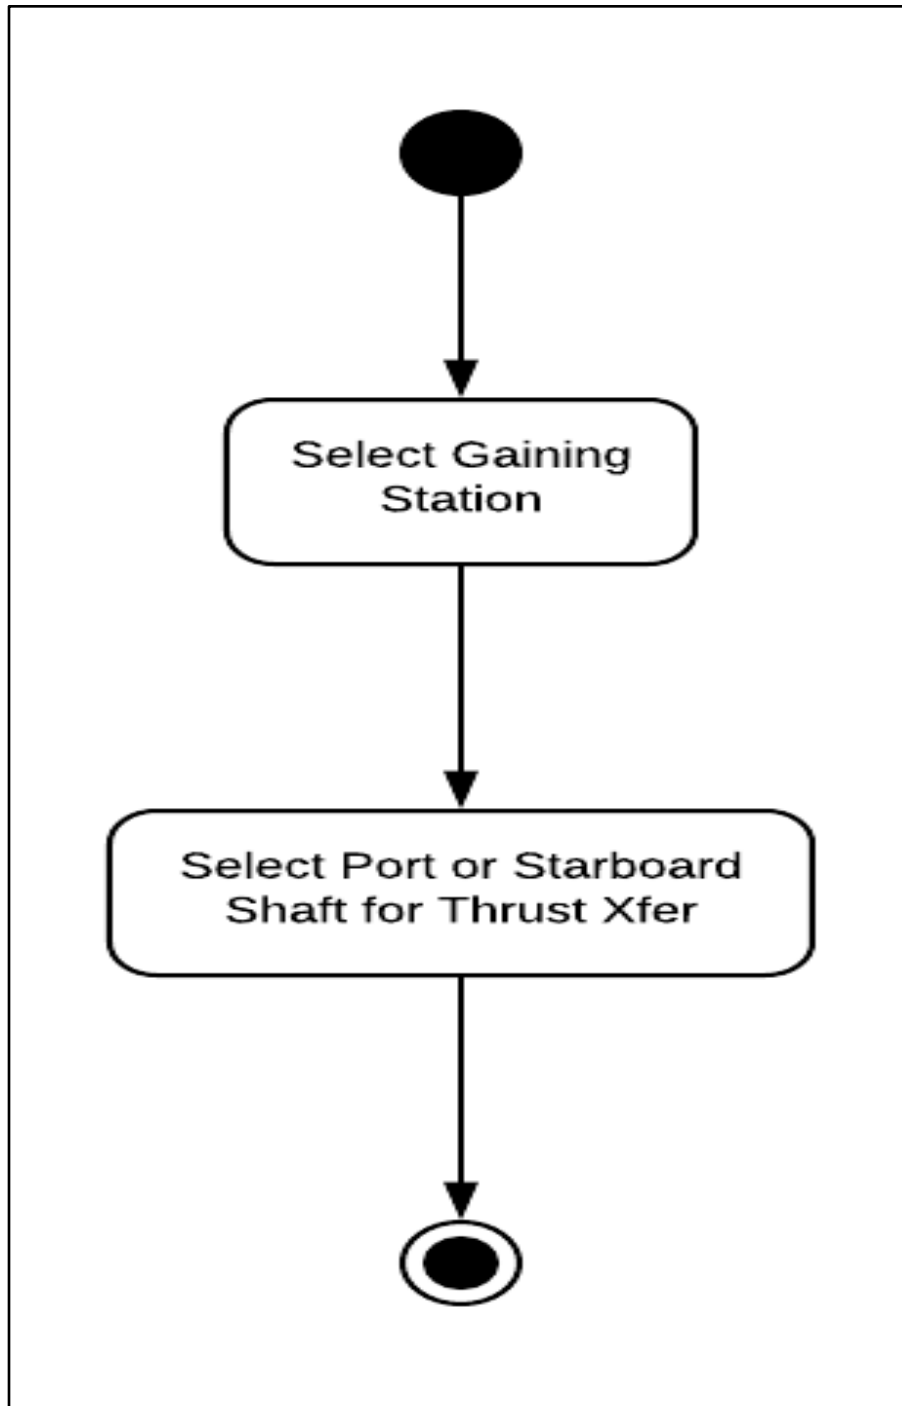
Figure 11. Control actions taken to transfer thrust in backup manual mode.

Figures 9 and 10 show the control actions required for thrust control transfer in both computer-assisted manual mode as well as backup manual mode. It is quite clear that thrust transfer in backup manual mode has significantly less safety-control measures in place. The most significant safety-control measure in place when operating in computer-assisted manual mode is that the transfer must be initiated by the station that currently has thrust control, and acknowledged by the station that is gaining. This process will be completed twice, once per shaft.

One recommendation that seems appropriate is a deeper look at safety constraints in place when operating in backup manual mode. The initial design scheme allows the unilateral transfer to any station which can be useful in the event there is a casualty and only one station is accessible. That scenario is still valid, and that functionality should remain, but there can be another layer that requires the user to acknowledge the unilateral request. This could be a simple software modification that would add a safety-constraint in backup manual mode.

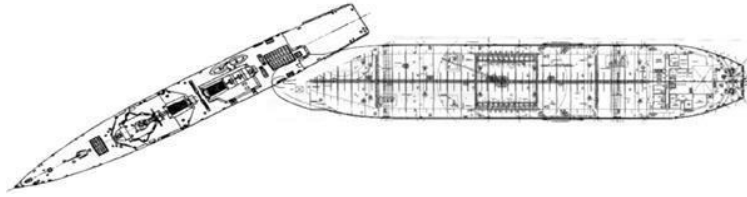
Figure 7 – Approximate Geometry and Point of Impact between USS JOHN S MCCAIN and ALNIC MC

Approximately three minutes after the reported loss of steering, JOHN S MCCAIN regained positive steering control at another control station, known as Aft Steering, and the Lee Helm gained control of both throttles for speed and corrected the mismatch between the port and starboard shafts. These actions were too late, and at approximately 0524 JOHN S MCCAIN crossed in front of ALNIC's bow and collided. See Figure 6.

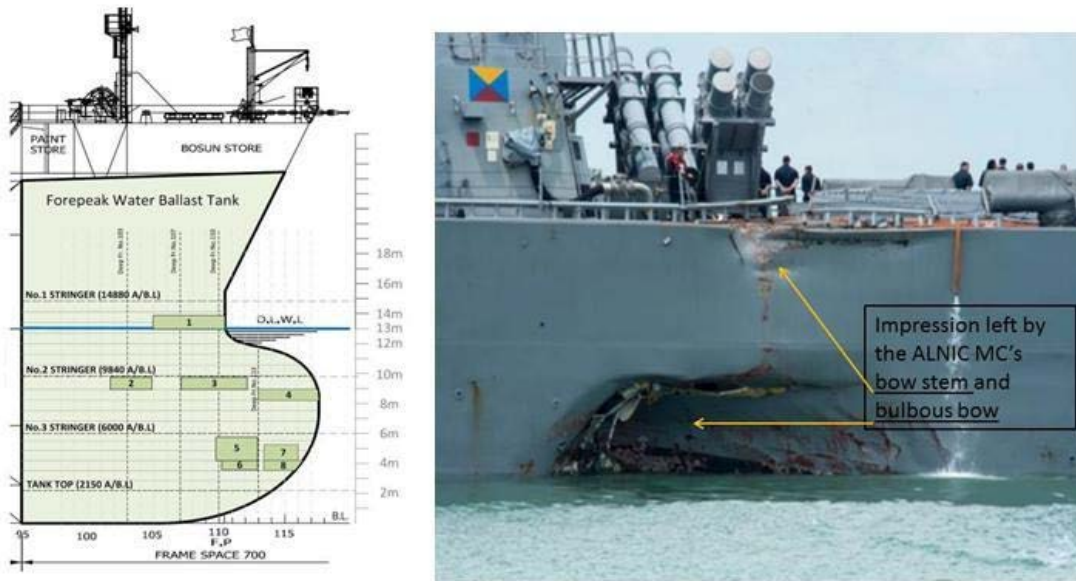
Figure 8 – Bulbous bow of Figure 9 – Point of impact on JOHN S MCCAIN ALINIC MC and damage to from ALINIC MC hull from bow to stern

The bulbous bow of ALNIC MC impacted JOHN S MCCAIN on the port (left) aft side. The impact created a 28-foot diameter hole both below and above the waterline of the JOHN S MCCAIN. See Figures 7, 8, and 9.

The point of impact was centered on Berthings 3 and 5 as noted in Figure 9. All significant injuries occurred to Sailors that were in Berthing 3 at the time of the impact. All ten of the fallen Sailors were in Berthing 5 at the time of impact.

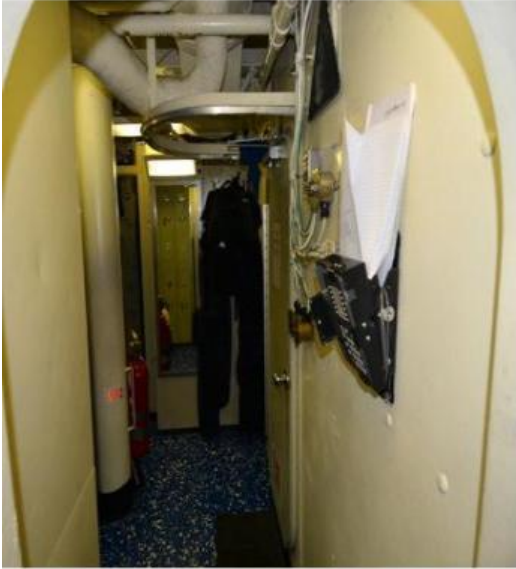
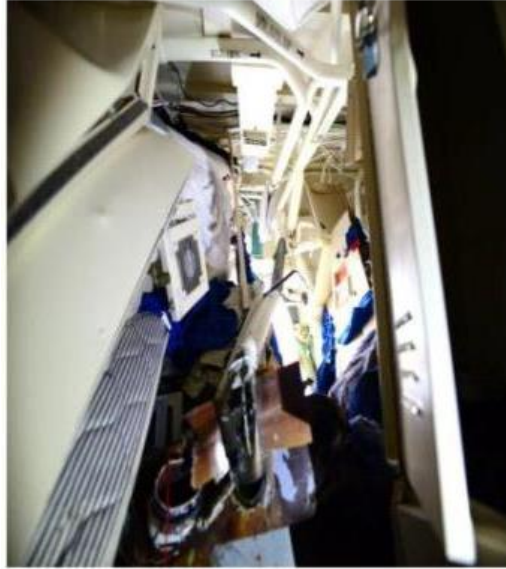
Figure 15 – Berthing 3 facing port Figure 16 – Berthing 3 facing port after collision

At 0530, the DCA began receiving reports of a ruptured fire main and water and fuel flooding into Berthing 3. The port side of Berthing 3 suffered substantial damage, including a large hole in the bulkhead. See Figure 13. Racks and lockers detached from the walls and were thrown about, leaving jagged metal throughout the space. Cables and debris hung from the ceiling.

Hearing reports that Sailors were trapped in Berthing 3, the Executive Officer and a group of Sailors, including some who evacuated Berthing 7, went to check on their shipmates. Several Sailors were pinned in their racks as a result of the collision, but, as the two ships pulled apart, the twisted metal shifted and most of the Sailors in Berthing 3 were able to escape as the debris moved. One of these Sailors was pinned in his rack underneath two racks that had collapsed and a number of lockers that became dislodged during the collision. He was able to escape after ALNIC MC detached. See Figures 14 and 15.

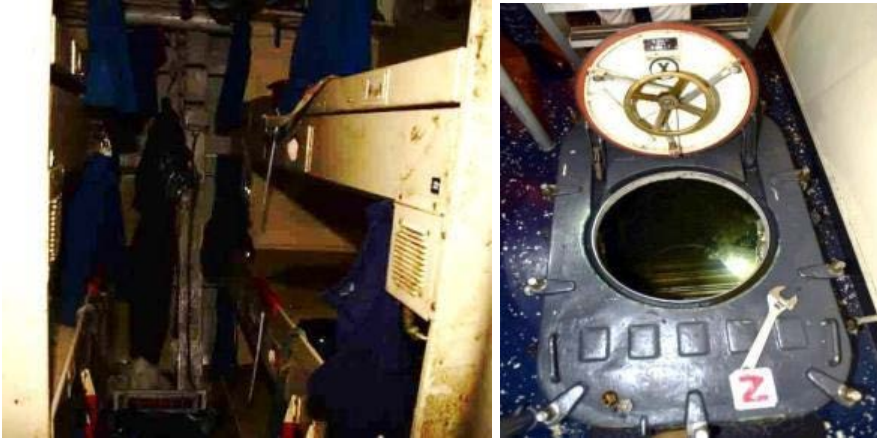
Figure 17—Scuttle and hatch into Figure 18—Berthing 4 racks after Berthing 4 showing the space dewatering completely flooded

All Sailors in Berthing 4 were able to evacuate. At 0544, Sailors reported 4 inches of water on the deck in Berthing 4. Sailors in Berthing 4 were thrown about their racks by the force of the collision. By 0627, the berthing space was lost. See Figures 16 and 17.

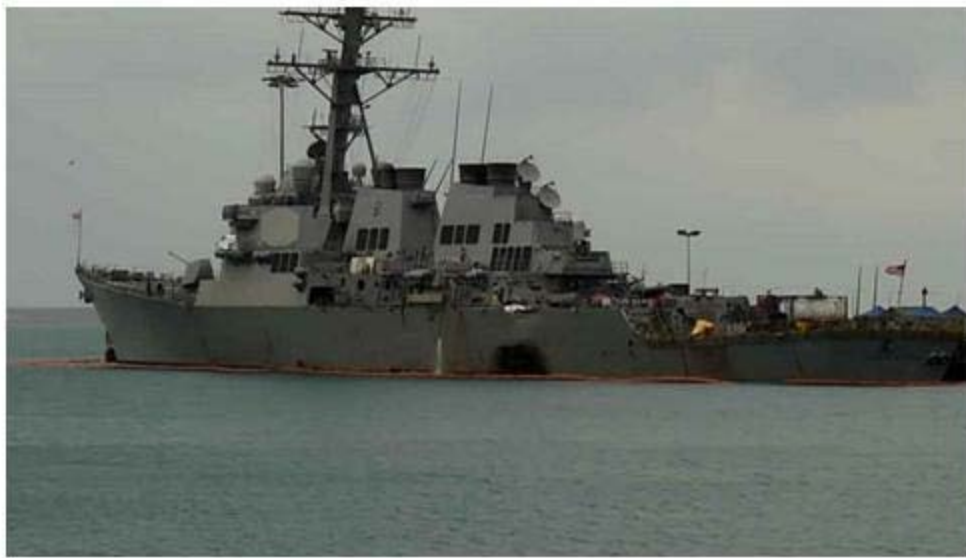
Figure 19 – Port side of JOHN S MCCAIN post-collision

A team of Navy Divers arrived on JOHN S MCCAIN as the ship entered the harbor in Singapore at approximately 1200 on 21 August 2017. They began inspecting the ship to determine how best to proceed with a dive inside the ship. The leader of the dive team inspected Berthing 3 and saw waves breaking into the ship. The divers discovered the hole in the port side of JOHN S MCCAIN that was approximately 28 feet wide. See Figure 18.

By approximately 1435, JOHN S MCCAIN was moored and divers were in the water looking for places to enter the hull of the ship. The hole in the port side penetrated
