Lock Operation Improvements

Stuart D. Foltz and Daniel E. Hooks

April 2021

Final Technical Report

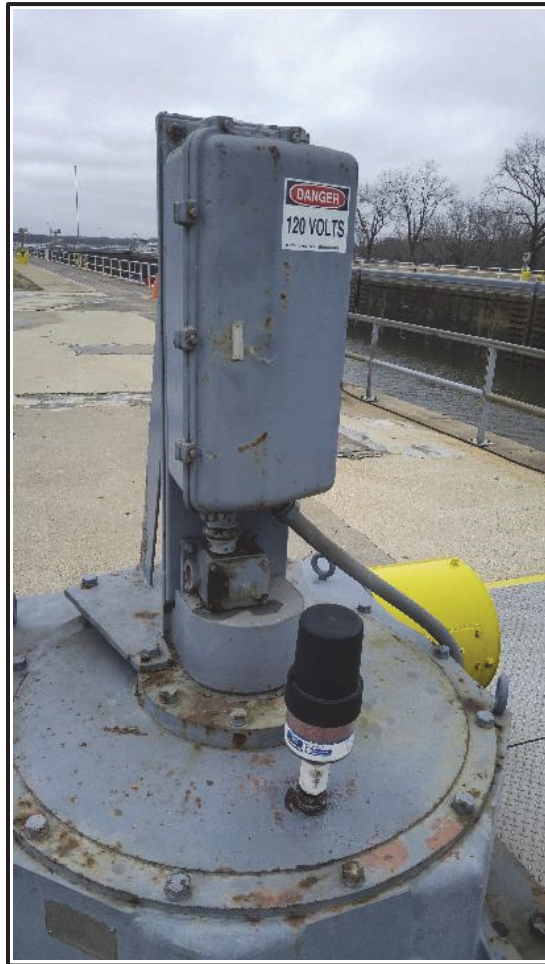
Figure 9. Old cam-operated limit switch gearbox at Brandon Road Lock.

The cam switches replaced at Lockport Lock have rubber rollers that, over time, became grooved by wear. This wear causes them to roll faster than they were originally calibrated to do. As the rollers become grooved, they lose some of their accuracy. The cam switches rotate and accumulate dust and moisture, which causes the switches to sometimes move incorrectly and to lose some of their ability to properly hold their position and to correctly connect with the switch they are supposed to trip. Historically, this has shown itself to be the cause of many disasters and “near-misses” at such sites as Mel Price Lock and Brandon Road Lock. Note that gearbox covers at the Lockport Lock gate used to be twice as tall when the old cam-operated limit switches were in use (See, for example, Figure 9).

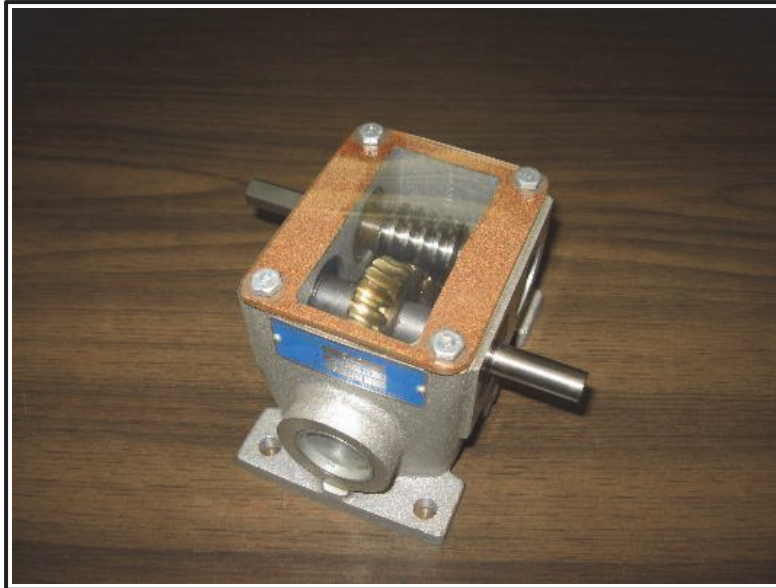
Figure 10. Gearbox with two vertical shafts, one horizontal shaft, and six total bearings.

Figure 10, for example, depends on a total of six bearings. These failures usually cause the bull-gear to drive off the drive gear, due to the gear teeth skip, throwing the cam-operated limit switches out of calibration. This can result in catastrophe. A forensic analysis done after a failure at Lockport Lock revealed that the gearbox bearings had been manufactured in Taiwan. Even before this failure, records showed that the gearbox had a high failure rate of these replacement bearings. All locks need good, quality metering proximity switches. This will not prevent cam switch failures but will prevent associated accidents. Based on this experience, it is recommended that bearings from Japan be ordered, as they are more reliable and will make the gearboxes for the cam switches last much longer.

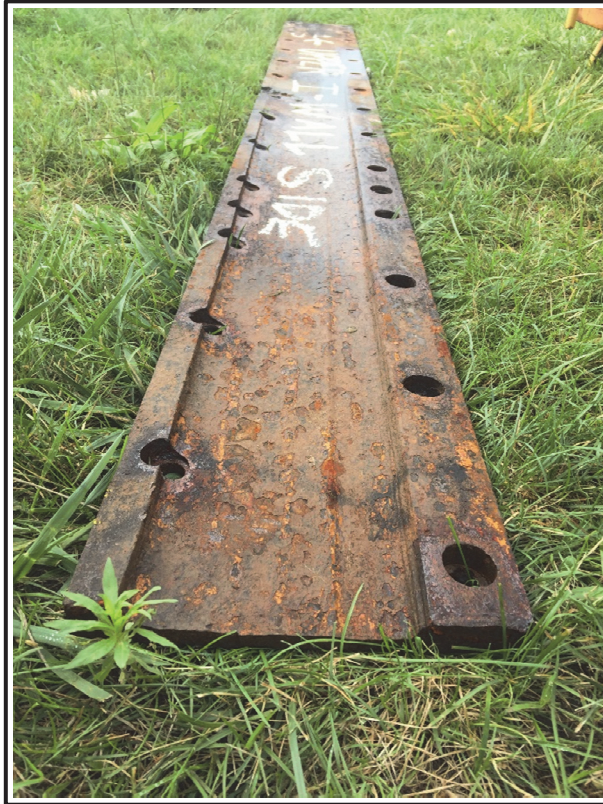
Figure 22. Lower valve wear tracks at Lockport Lock.

Hardened steel is an effective way to address the problem of valve wear tracks becoming worn (as seen in Figure 22), which ultimately puts valves out of service. The upper valves at Lockport Lock have used hardened steel for 10 years now, and they are still working well with no valve problems or high hydraulic pressures noted. The hardened steel, often called “Australian Steel,” has deep-hardening. It is special ordered and takes 3 months to obtain. Deep-hardening is preferable to layered hardening as it lasts longer. Upper valve wear tracks were finally replaced, but deep-hardening work best.

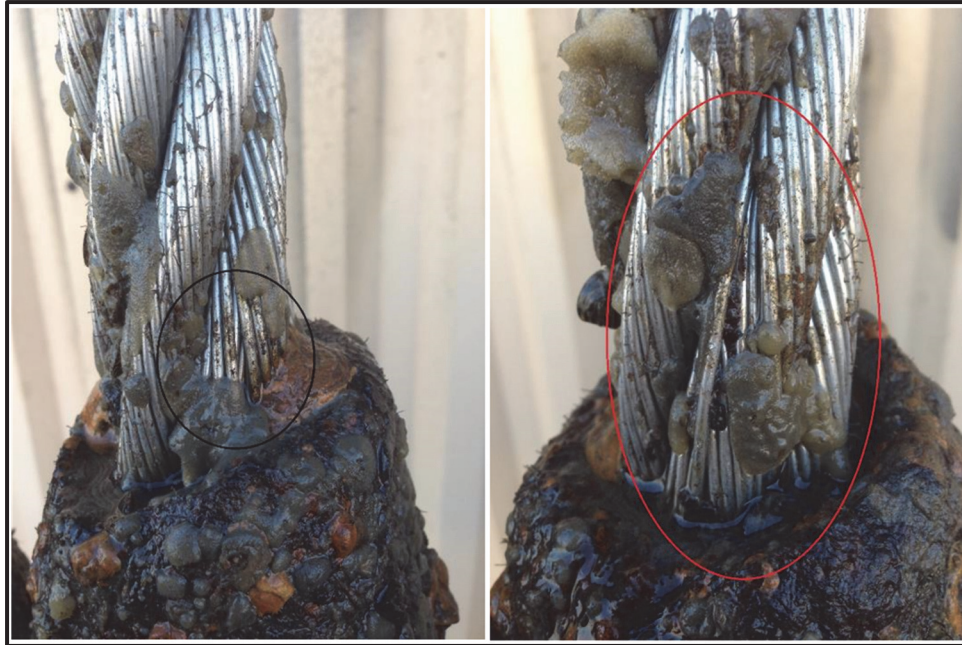
Figure 24. Lockport Lock emergency gate corrosion photos.

Corrosion is common on submerged strong back connections. An alternative to consider would be to use stainless epoxy spelter sockets on the submerged ends, which would not corrode. Figure 24 shows Lockport Lock emergency gate corrosion on the spelter sockets. Note cables are 304 S/S.

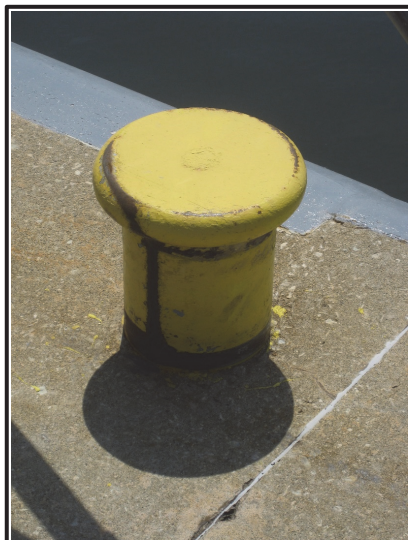
Figure 25. Old mooring bit.

In the past, lines would occasionally slip off the pin (especially lines from empty barges, which sit much higher in the water than loaded barges). Figure 25 shows the old mooring bit design. Figure 26 shows a new type of mooring bit that fixes these problems, but sharp edges were cutting lines. A key consideration when installing mooring bits is to specify contracts requiring manufacturer to grind-down sharp edges.

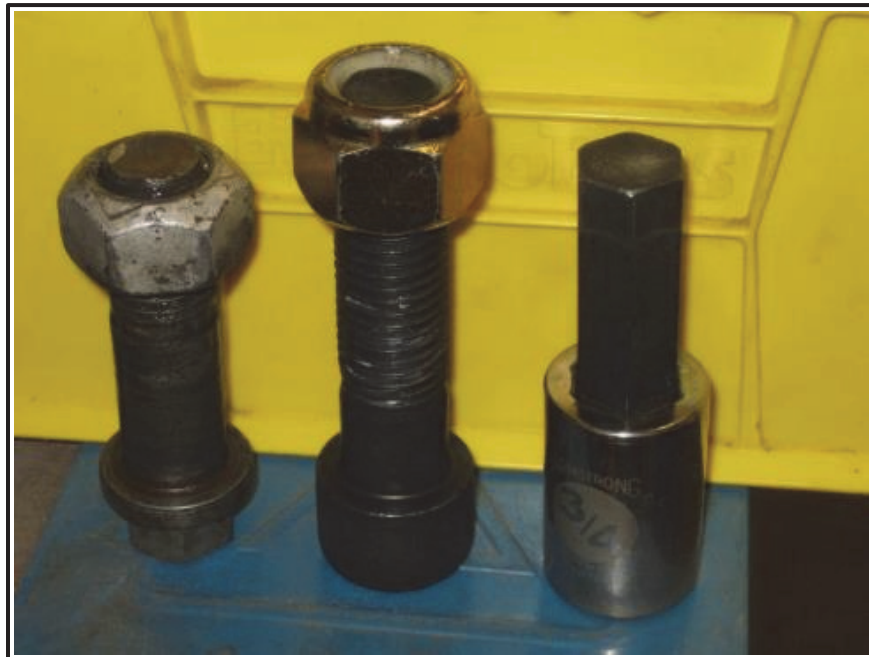
Figure 27. Non-reusable and reusable lock nuts.

Reusable lock nuts (Figure 27) are commonly used for couplings between the miter gate gearboxes and the drive gears. Alternatives include (1) single use locknuts grade 8, with a reduced head grade 8 bolt which is custom made, and (2) grade 8 nylock nuts with the longer Allen head grade 9 bolts. Nylock nuts require longer bolts because locking happens in extended top.

The problem with the use of non-reusable locknuts at Lockport Lock was that they would not stay secure when reused. This can become a critical item if too many of the old type of nuts become loose and the bolts drop out of the coupling. Lockport Lock decided to use the Nylock nuts instead and suggested to make Nylock nuts mandatory because they are reusable.

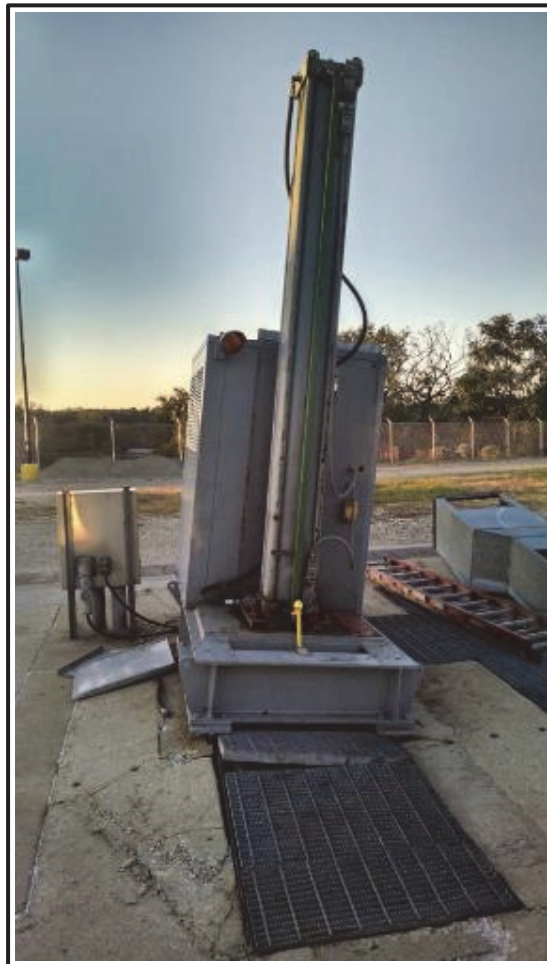
Figure 30. Brandon Road Lock CLOSED limit switch failure.

In 2014, the upper-left valve at Brandon Road Lock pushed out of the concrete (Figure 30). (This also happened twice at the Marseilles Lock in the summer of 2012.) This happens when a single closed limit switch fails, so that the valve travels too far in the downward (closing) direction until it hits bottom. The hydraulics' continued downward push turns into upward force that breaks the concrete anchors. To resolve the problem, the installation of second (or, redundant) closed limit switches were mandated at all the IWW locks. Starved Rock was the first lock gate site to implement the redundant switches. It is recommended that second redundant closed limit switches be mandated at all locks that have similar culvert valves.

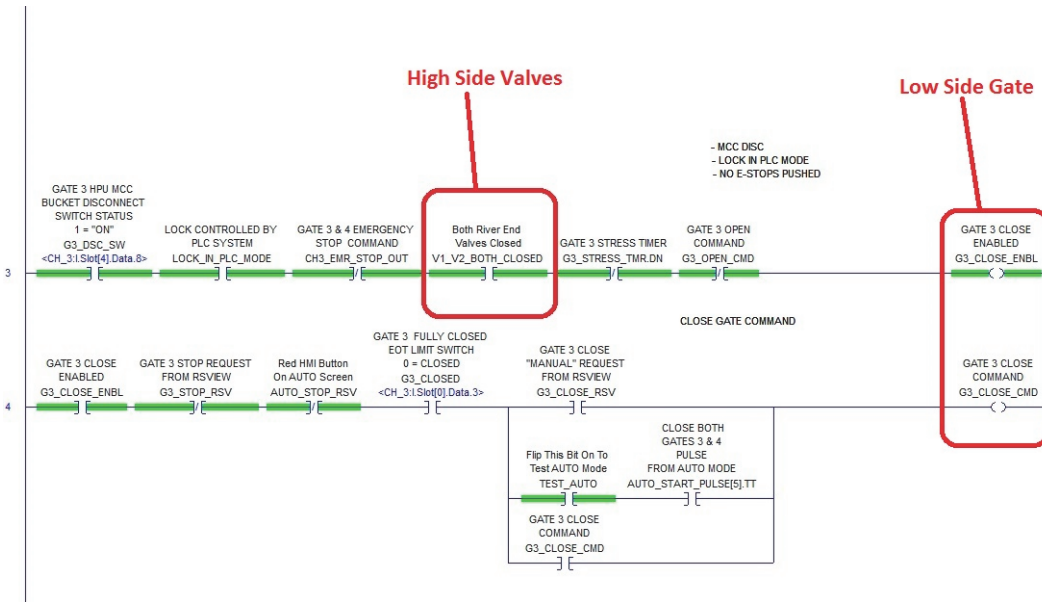
Figure 31. Minimum fix done at New Orleans District Locks after the 2009 Markland Lock miter gate calamity (fix protects lower miter gates in “interlock bypass” and normal modes).

The 2009 Markland Lock miter gate calamity appears to have been a flushing accident. If the operator used master override to flush and forgot to return the master override to off/normal before closing the lower miter gates, that would be considered a flushing accident. Even if the operator was unaware one of the upper valves was still open, the normal G-V interlocks would have prevented closing the lower miter gates in that scenario.

It is recommended that the content regarding the PLC programming be incorporated into the contracts. Contractors will be unwilling to do extra PLC programming without a contract modification. The flushing protection PLC programming should be in the IMTS interlock standards. Most Locks are currently flushing using their master override to bypass all of their interlocks. This should only be done by a supervisor. Some Locks still do not have keyswitches on their master override and should immediately install the keyswitches. Keys should be kept in the Lockmaster office key-box. At a very minimum, the master override keyswitch should still have G-V interlocks so lower gates cannot be closed while upper valves are still open.

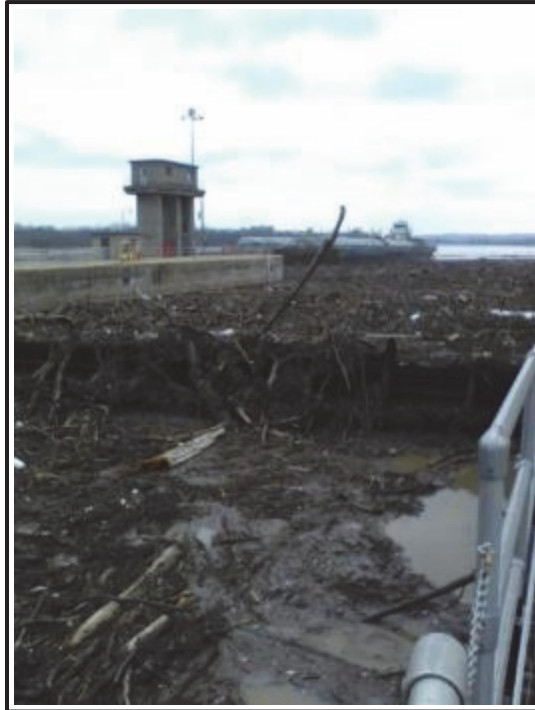
Figure 32. Debris at unknown lock gate.

According to Jeff Ross (Nashville District), the normal G-V interlocks that would have prevented the accident did not exist at the time of the accident. Therefore, there is an urgent need to make sure normal G-V interlocks are working to safely allow flushing and prevent excessive debris in lock chambers, such as that shown in Figure 32.

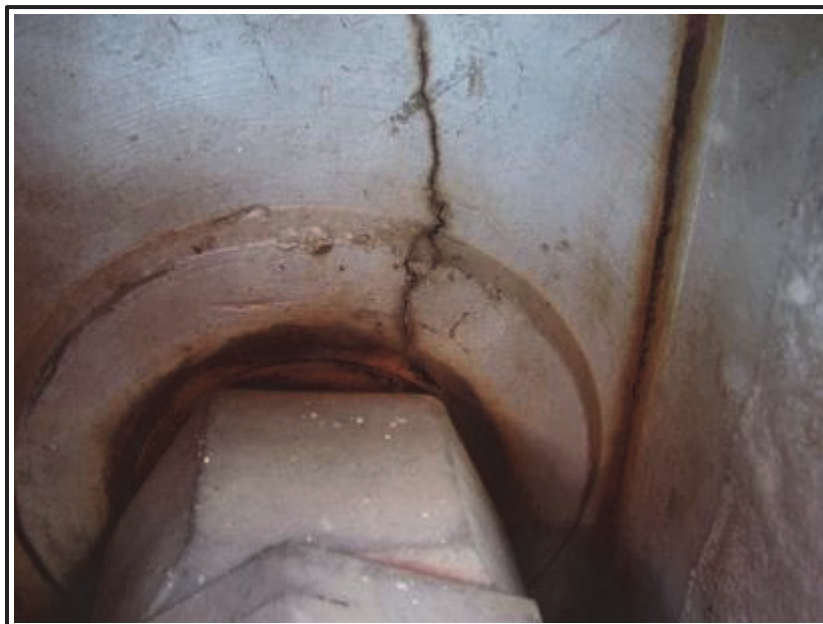
Figure 33. Crack caused by flushing accident at Lockport Lock.

Figure 33 shows a crack caused by a flushing accident at Lockport Lock. The repair crew had to replace the stem-bolt on the lower-right gate. The cracked plate on the lower-right gate was replaced by the repair crew in 2019.

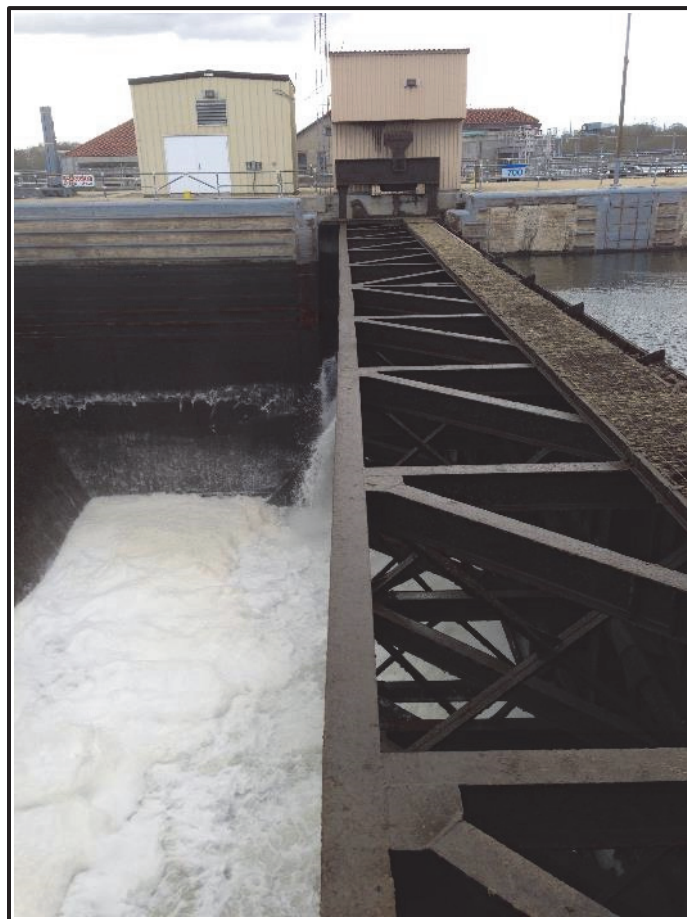
Figure 34. Lockport Lock emergency gate bent beam damage.

In March 2005, the Shift Chief on duty at Lockport Lock forgot to lower (open) the emergency gate the rest of the way after filling over it and pulled a first cut of barges into the emergency gate at full speed. After investigation, it was discovered that the gate was not full-open. Figure 34 shows the bent beam damage.

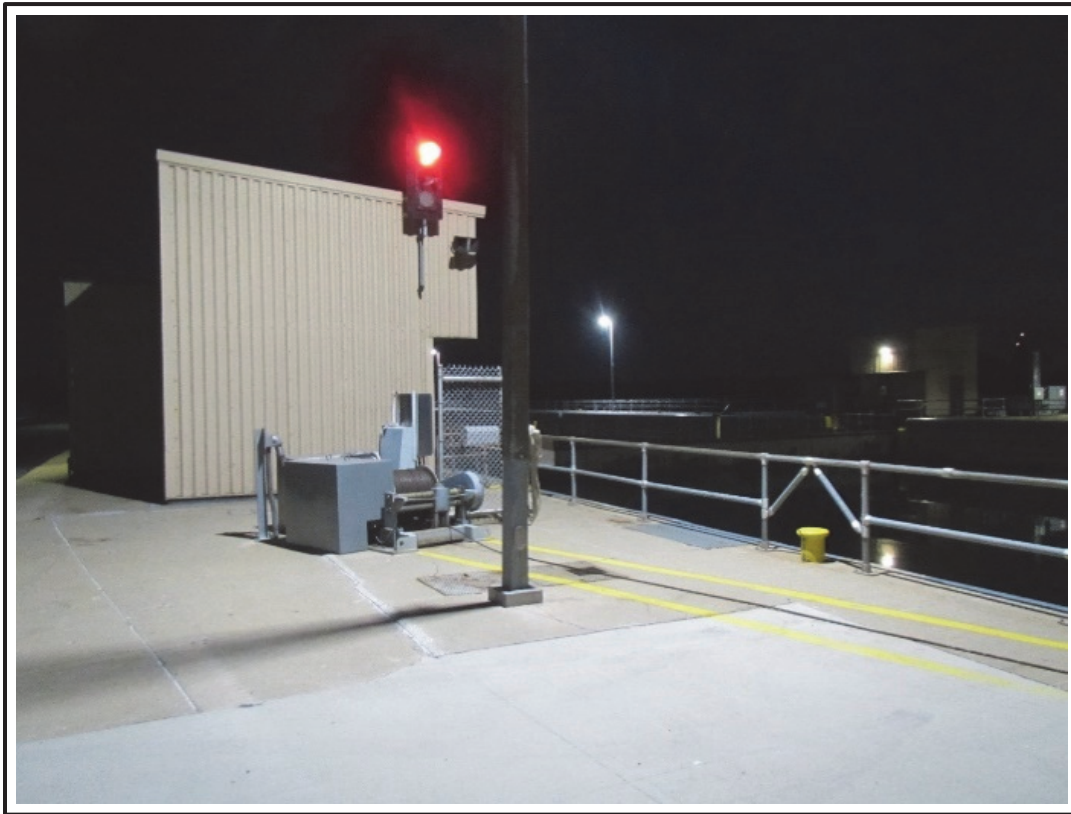
Figure 36. Hydraulic tow haulage unit at Lockport Lock.

controls unattended. A possible risk mitigation method would be to incorporate a motion switch that would time out if an operator walked away. Unsupervised operators have sometimes adopted this unsafe practice (Figure 36) that could also damage equipment (rope is used for bypassing spring-return “dead-man” safety feature).

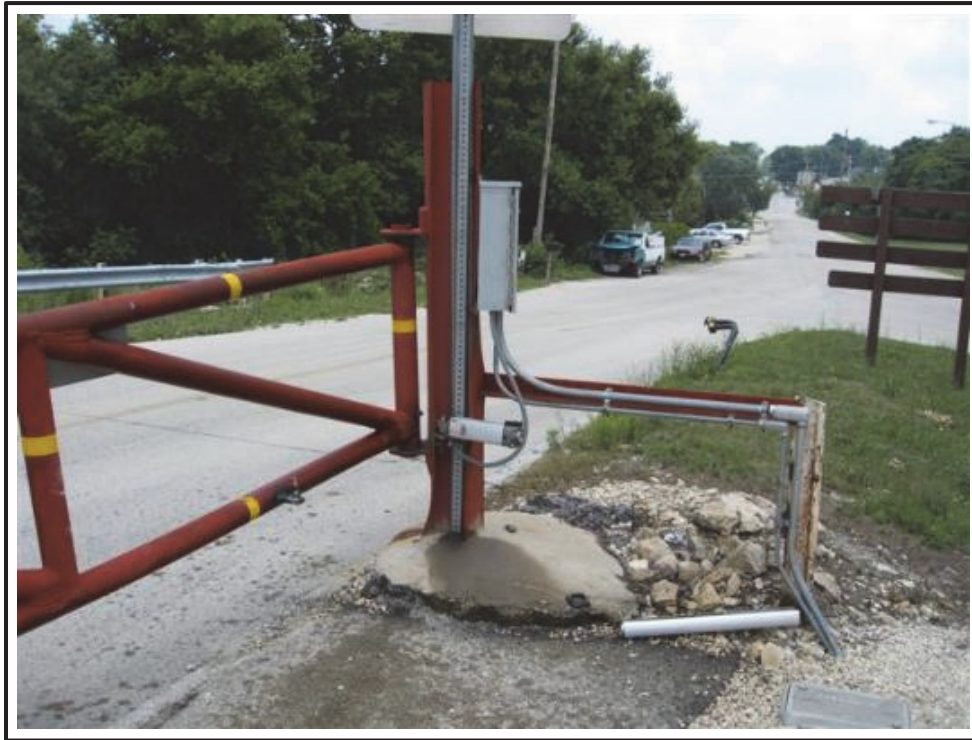
Figure 37. Bridge security gate damage at 16th Street.

In 2007, a drunk driver at Lockport Lock damaged the keypads at a security gate (Figure 37). Camera footage would have helped the investigation of this accident. However, the use of wireless cameras is prohibited, and it would be expensive to run an optic fiber across the entirety of the bridge. A workable compromise might be to install a more economical standalone camera system, which would satisfactorily meet these basic needs. It may be beneficial to include a camera Digital Video Recorder recording of the gate mitering images in future contracts. A standalone camera system was
