Geotechnical Inspection and Technical Review of Santa Margarita River Marine Corps Air Station Levee, U.S. Marine Corps, Camp Pendleton, CA, 19-20 November 2019

Lucas A. Walshire and Joseph B. Dunbar

August 2021

Final report

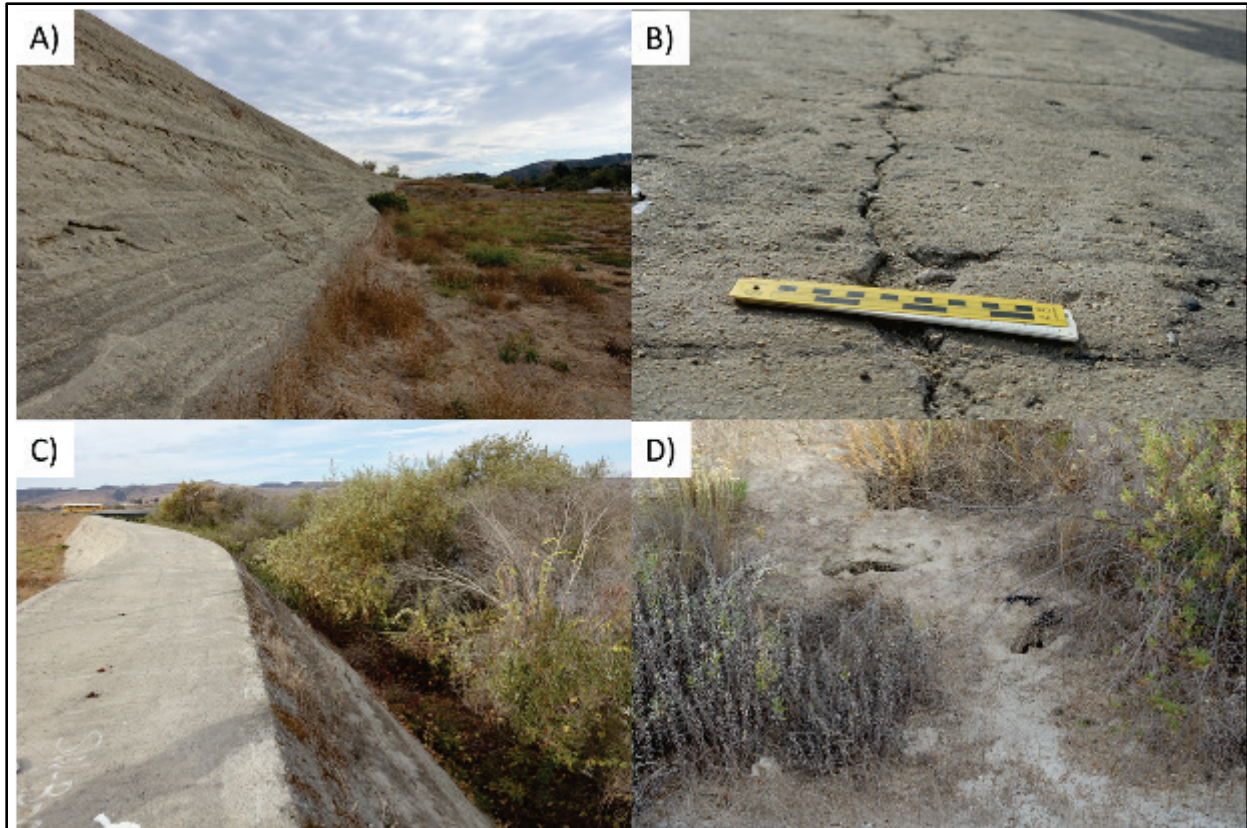
Figure 4 shows photos of the levee between the bridge and the Ranch House road (observation point at North Lat 33.3105, West Long 117.3439). Figure 4A shows the landside slope of the soil-cement levee with slight weathering. Figure 4B shows typical transverse cracking in the levee crest. Figure 4C shows the soil-cement embankment crest in very good condition. Figure 4D shows depressions at the riverside toe in the riprap revetment. The depressions varied in size with the largest being approximately 8 in. (20.3 cm) wide and 1 ft (30.5 cm) long with a depth of 8-12 in. (20-31 cm). The depressions at most locations contained riprap, but most of the soil cover was eroded away. These types of depressions were evident along the entire levee system with the density of observations being greatest along the airfield segment. In some locations, observations could not be made due to the presence of heavy vegetation.

Figure 3. East segment inspection photos in vicinity of North Lat 33.3105, West Long 117.3439: (A) landside slope with slight weathering, (B) typical transverse crack in levee crest, (C) levee crest with Basilone Road Bridge in background, and (D) observed depressions on riverside toe.

1. Vegetation is adversely impacting the levee. Instances where woody vegetation is growing out of the embankment (near the Ranch House reach) are likely causing deformation and sliding of the landside slope. The presence of woody vegetation at the riverside toe of the levee is likely causing deformation of the riprap revetment. This condition could cause preferential seepage paths that would provide concentrated seepage pathways beneath the embankment. Additionally, the presence of both woody and weedy vegetation inhibits observations during flooding and may prevent observation of levee distress that could lead to failure of the levee that otherwise might have been prevented through flood-fight methods. Levee inspections during flood conditions are critical and important to ensure levee safety.

2. Weathering of the embankment side slopes needs remediation before further loss of embankment material occurs. If left unchecked for the long term, this condition could lead to a need to replace the levee embankment entirely. Likely remediation would involve regrading the slope with the addition of soil-cement materials and/or armoring the slope with filter cloth and riprap or articulated concrete mats.

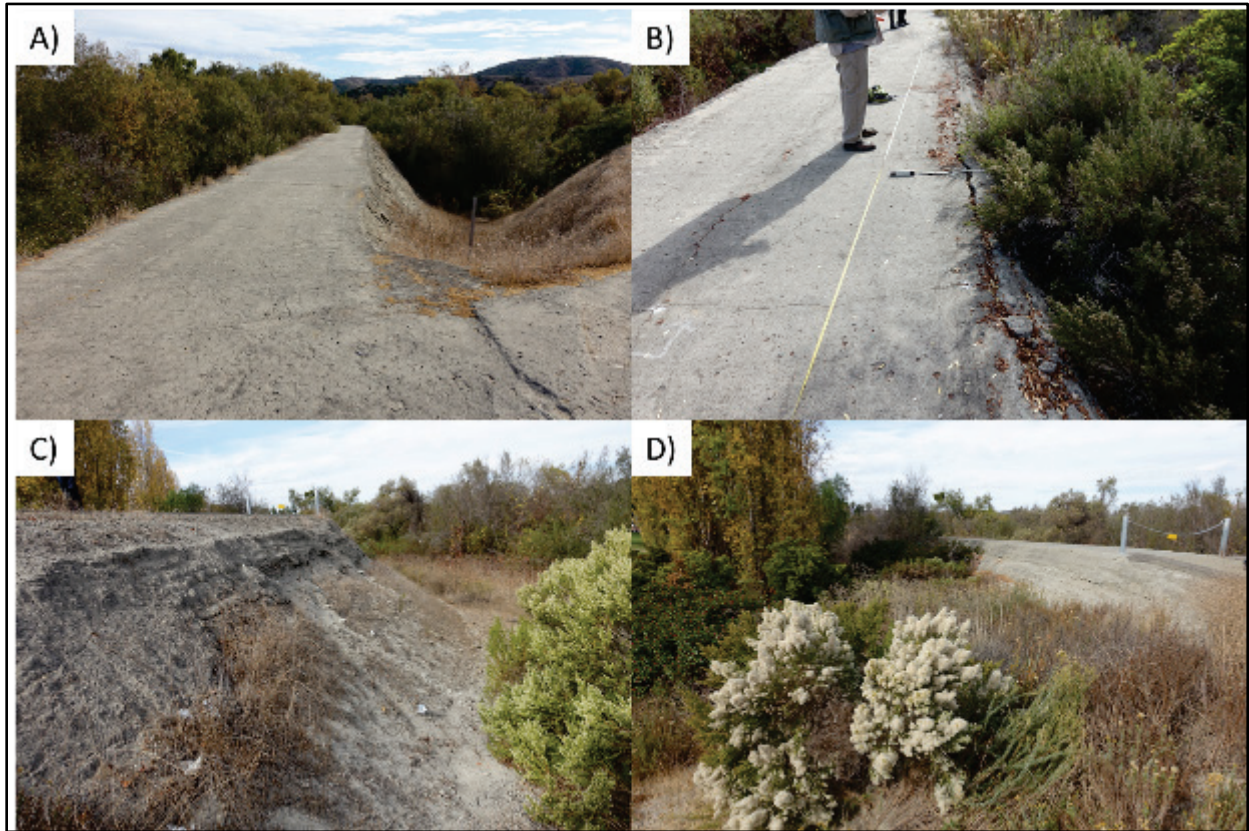
Figure 5A shows vegetation conditions where the levee guide vane meets the levee road embankment, with the presence of heavy vegetation at both toes of the levee. Figure 5B shows a longitudinal crack 46 ft (14 m) in length near the landside shoulder of the levee crest, a short distance from the road and guide vane intersection. The likely cause of the cracking is vegetation growing out of the embankment slope. Additionally, an old irrigation system was observed at the levee toe, which was used to water planted vegetation on Ranch House grounds. The system did not appear operational at the time of inspection, but watering close to the levee prism in the past may have contributed to the existing conditions. Figure 5C shows an example of more severe embankment weathering on the riverside levee slope along the Ranch House road leading to the guide vane intersection. Finally, Figure 5D shows vegetation in the vegetation-free zone at the termination of the levee at Vandegrift Boulevard. Figure 6 shows another example of severe weathering to the levee slope.

Figure 4. East levee segment: (A) location where levee and guide vane (left) meet, note heavy vegetation on both slopes of guide vane, (B) longitudinal cracking on landside shoulder of levee embankment along the Ranch House road section, (C) weathering of levee slope along the Ranch House road section, and (D) vegetation on riverside slope where the levee meets Vandegrift Boulevard.

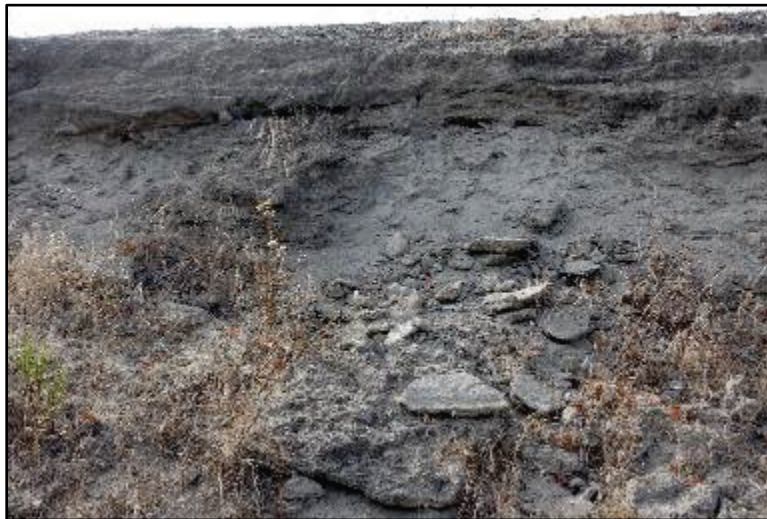
Figure 5. Example of severe embankment weathering on the riverside slope along the Ranch House road segment.

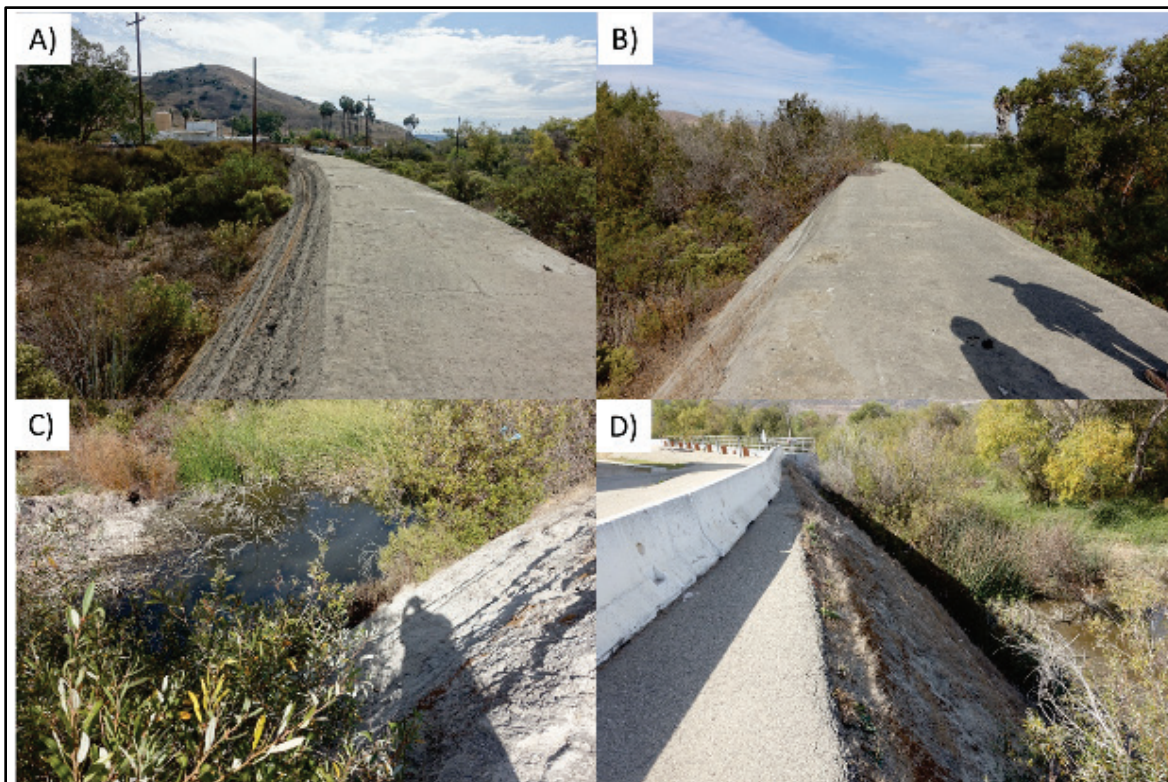
However, landside vegetation was not as dense as that observed on the riverside toe of the levee (Figures 7A and 7B). Moderate weathering of the soil-cement embankment was observed at some of the lift contacts on the riverside of the levee (Figure 7C). Near the pump station, standing water was observed at the riverside toe of the levee both upstream and downstream of the pump station (Figures 7C and 7D). Transverse cracking was identified in multiple locations, extending from the riverside toe across the levee to the landside toe. Close examination of Figure 7A shows an example of the transverse cracking that is present. The cracking was tight and did not appear to be recently formed. The presence of woody vegetation and standing water on the riverside toe restricted access and inspection of the riverside riprap revetment.

Figure 6. View of west levee segment: (A) westerly view looking toward Vandegrift Boulevard, (B) facing east with presence of heavy woody vegetation in the levee right-of-way, (C) standing water on levee toe and presence of vegetation downstream of pump station, and (D) view of right abutment of pump station outflow structure facing west.

1. Vegetation is adversely impacting the levee. The presence of woody vegetation at either toe of the levee is likely causing deformation of the riprap revetment that could cause preferential seepage paths beneath the embankment. Additionally, the presence of both woody and weedy vegetation inhibits observations during flooding and may prevent observation of levee distress that can lead to failure of the levee that otherwise may have been prevented by observation and flood fighting (e.g., sand-bagging boils).

2. Standing water on the riverside levee toe should be investigated. It is likely that the culprit is a blocked drainage ditch. Either the blockage is due to vegetation, or the ditch is silted in. Comments made by public works staff during the ERDC inspection indicated that standing water is a recent development. This condition should be investigated to ensure that good drainage is maintained to facilitate inspection during dry periods. Maintenance to restore drainage function is important as, left unchecked, this condition will create future environmental issues and establish an unwanted precedence where none previously existed.

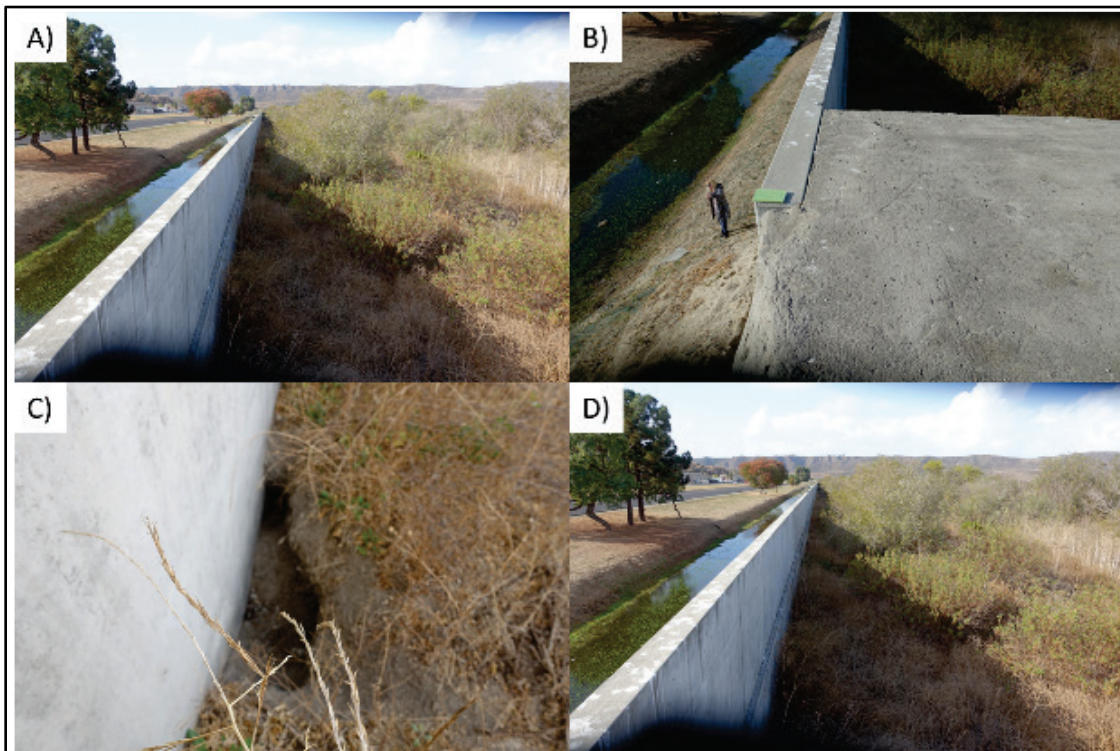
Figures 8A to 8D show the riverside and landside of the floodwall as well as the landside drainage ditch. Numerous small rodent burrows were observed within 5 to 10 ft (1.5 to 3 m) landside of the floodwall. Figure 8A shows the vegetation at the downstream levee-floodwall tie-in. Figures 8B and 8C are views looking east, while Figure 8D shows the floodwall looking west. Vegetation is growing against the riverside of the floodwall in all these views.

Figure 7. Floodwall segment inspection photos: -(A) landside of floodwall looking west, (B) floodwall tie-in to the airfield levee, (C) animal burrows or depressions at the levee tie-in with the airfield segment, and (D) landside of floodwall looking west from floodwall station 500+723.

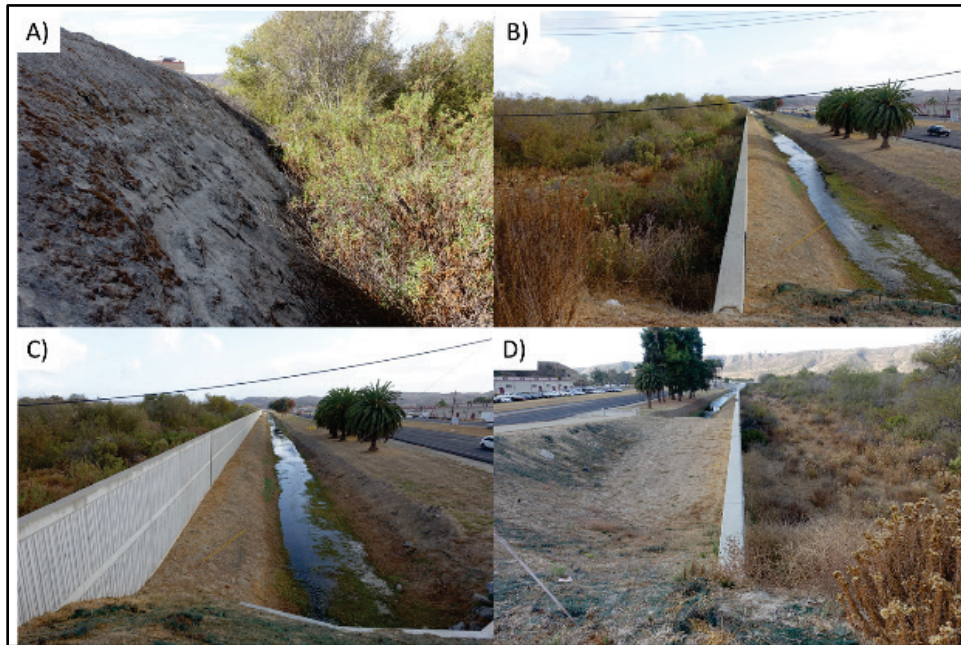
shows woody and weedy vegetation on the riverside of the floodwall. Also noteworthy at this location were large depressions in the riverside riprap revetment along the base of the floodwall. Depressions were mainly observed on the riverside of the floodwall and within a few feet of the wall. Figure 9C shows an example of the type of depressions that were observed. The largest observed depression was approximately 3.5 ft (1 m) long and 1 ft (0.3 m) wide, with a depth greater than 1 ft (0.3 m). Complete inspection of the riverside floodwall was inhibited by the presence of heavy vegetation. Figure 10B shows the overlap between the floodwall and the levee at levee station 100+729.

Figure 8. Floodwall segment inspection photos: (A) levee embankment with riverside vegetation at floodwall-levee tie-in, (B) alignment of the floodwall looking east, (C) land-side of floodwall looking east, and (D) center of floodwall.

1. Both weedy and woody vegetation on the riverside of the levee is inhibiting observation of the riprap revetment. This vegetation makes riverside inspection of the floodwall difficult.
2. Numerous depressions were observed on the riverside of the floodwall. These depressions are similar to those observed in the east segment.

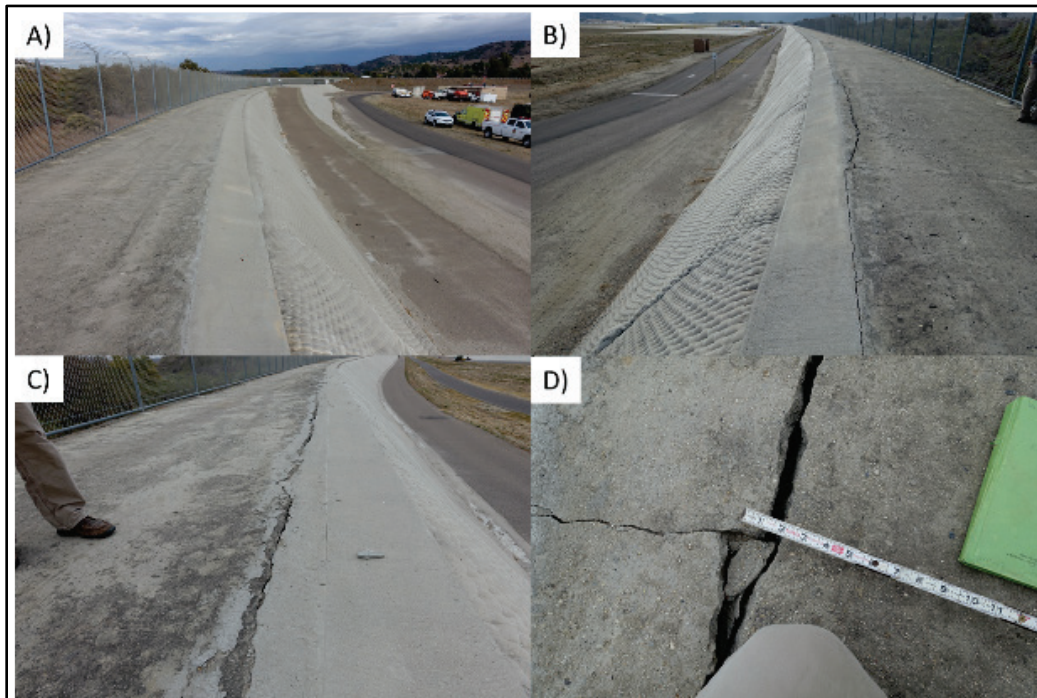
Figure 9. Air station segment inspection photos: (A) view looking east with Basilone Bridge in the distance, (B) view looking west toward hot fueling pad with landside shoulder cracking at the crest, (C) cracking at the fabric-formed concrete interface with the levee crest, and (D) closeup view of cracking at the interface between concrete at the landside crest and fabric slope protection.

Crack monitoring gauges were observed at several locations, and project personnel indicated that they were monitoring the crack dimensions: current conditions were reported to be stable.

The cracking identified in previous inspections will be addressed by the enlarging and grouting of existing cracks. The geophysical investigation provides a good idea of the extent of cracking, and project MCAS personnel have been monitoring the crack progression, both of which indicate that voids do not exist beyond the crest. Therefore, this remediation is warranted and will prolong the design life of the fabric-formed concrete located on the landside slope of the air station levee.

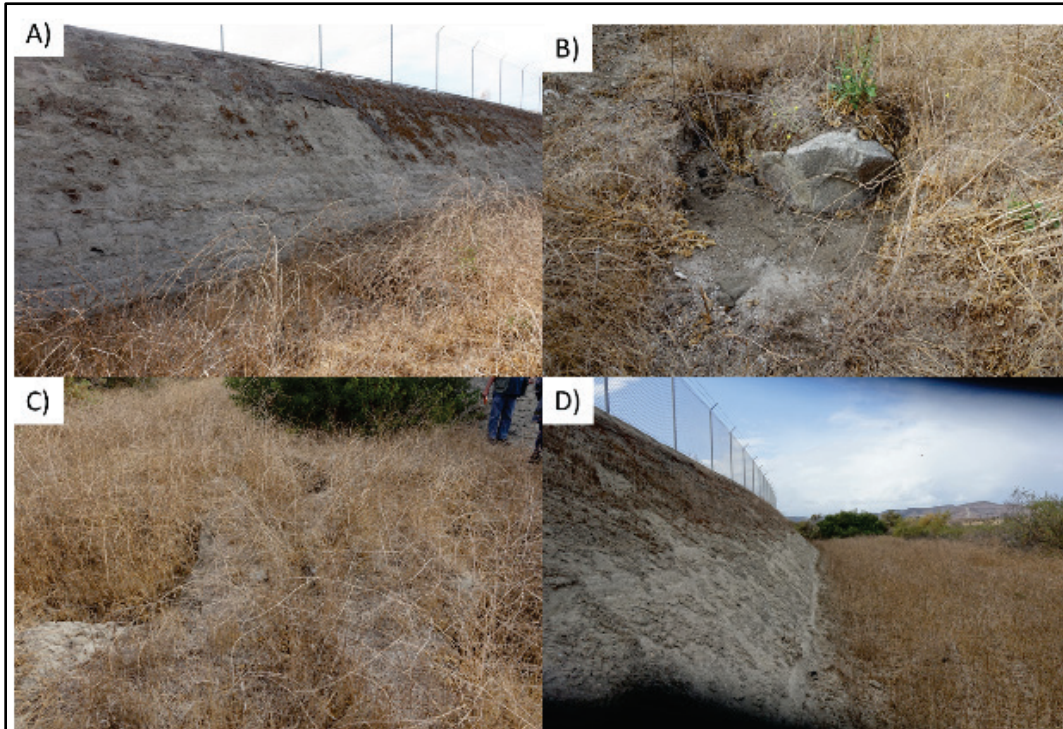
Moderate weathering of the riverside embankment slopes was observed, along with numerous depressions of the revetment where rock was absent and/or assumed to have significantly settled (see Figures 11A through 11D). Woody vegetation was observed growing in the vegetation-free zone at the riverside toe along much of this segment and from the riverside riprap revetment. Figures 11A and 11D are areas where woody vegetation is absent and permits better close inspection of riverside conditions, providing mowing of grass-covered areas is periodically performed.

Figure 10. View of riverside airfield segment: (A) slight weathering of riverside slope, (B) erosion of surface material at riverside revetment, (C) depression in riverside riprap revetment, and (D) riverside slope and vegetation-free zone at riverside toe looking east.

1. Vegetation is adversely impacting the levee right-of-way. The presence of woody vegetation on the riverside toe of the levee is likely causing deformation of the riprap revetment and could provide preferential seepage paths beneath the embankment. Additionally, the presence of both woody and weedy vegetation inhibits observations during flooding and may prevent observation of levee distress that can lead to failure of the levee that otherwise may have been prevented.
2. Crack monitoring should be continued at the interface of the fabric-formed concrete and the levee crest material.
3. Depressions in the riprap revetment should be inspected following vegetation removal, and a remediation plan should be initiated.
