REPORT NO. Bell 56

DATE 6 May 1935

Double Shaft Revolution Indicator

Pitometer Log Corporation

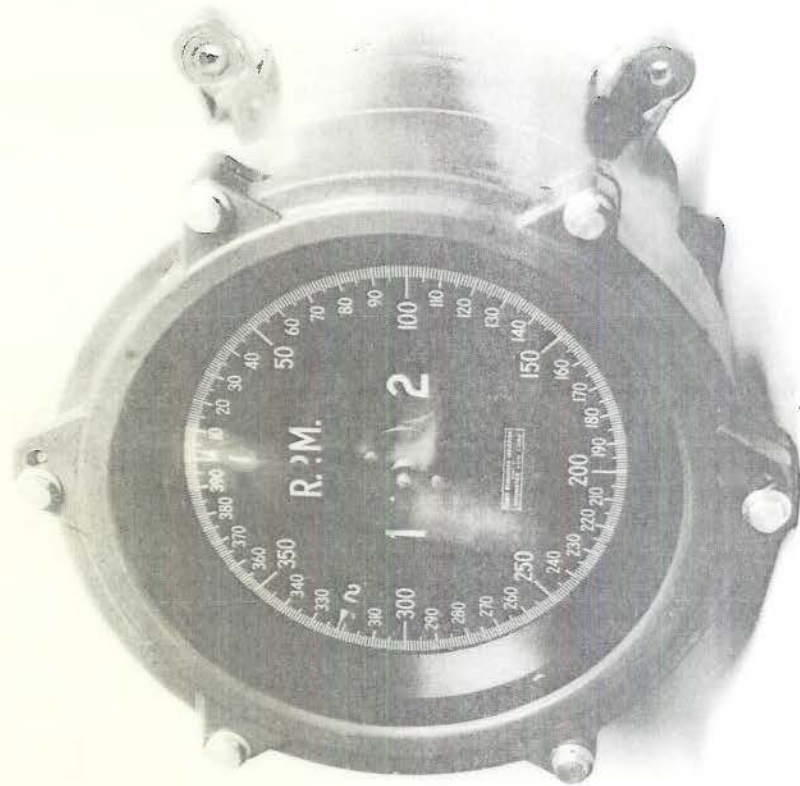
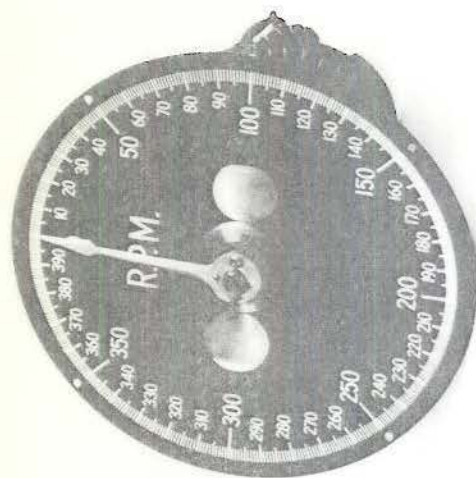
1388

11. To aid in conducting the accuracy tests on the indicator, a transmitter motor, equipped with a graduated dial, was furnished by the manufacturer. See Plate 1.

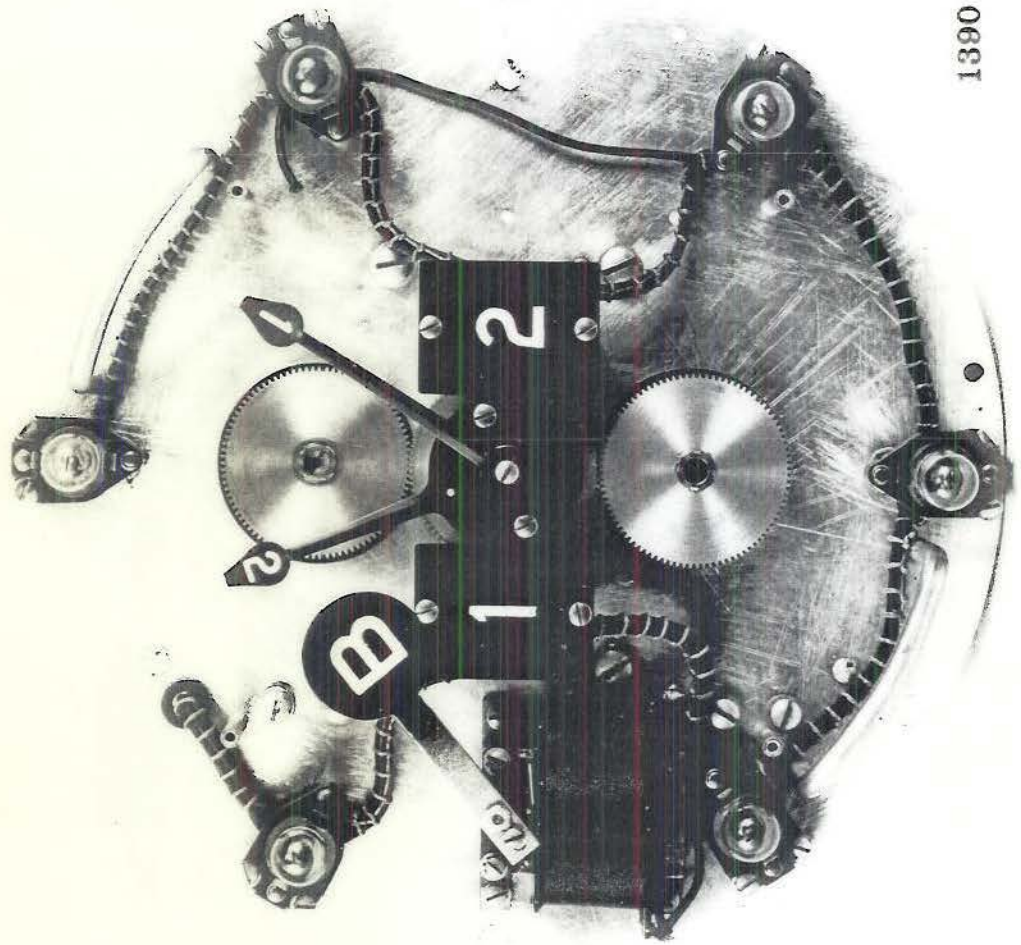
1390

15. The double indicator satisfactorily withstood the required 20-250 foot pound blows. However, the position of the starboard pointer, in relation to its shaft, shifted. This defect can be corrected by pinning the starboard pointer to its hub.
