NRL Report No. B-1203

NAVY DEPARTMENT
BUREAU OF ENGINEERING

Report
on
Test of Propeller Shaft Revolution
Indicator System
Manufactured and Submitted
by the
Electric Tachometer Corporation
Philadelphia, Pa.

NAVAL RESEARCH LABORATORY
ANACOSTIA STATION
WASHINGTON, D.C.

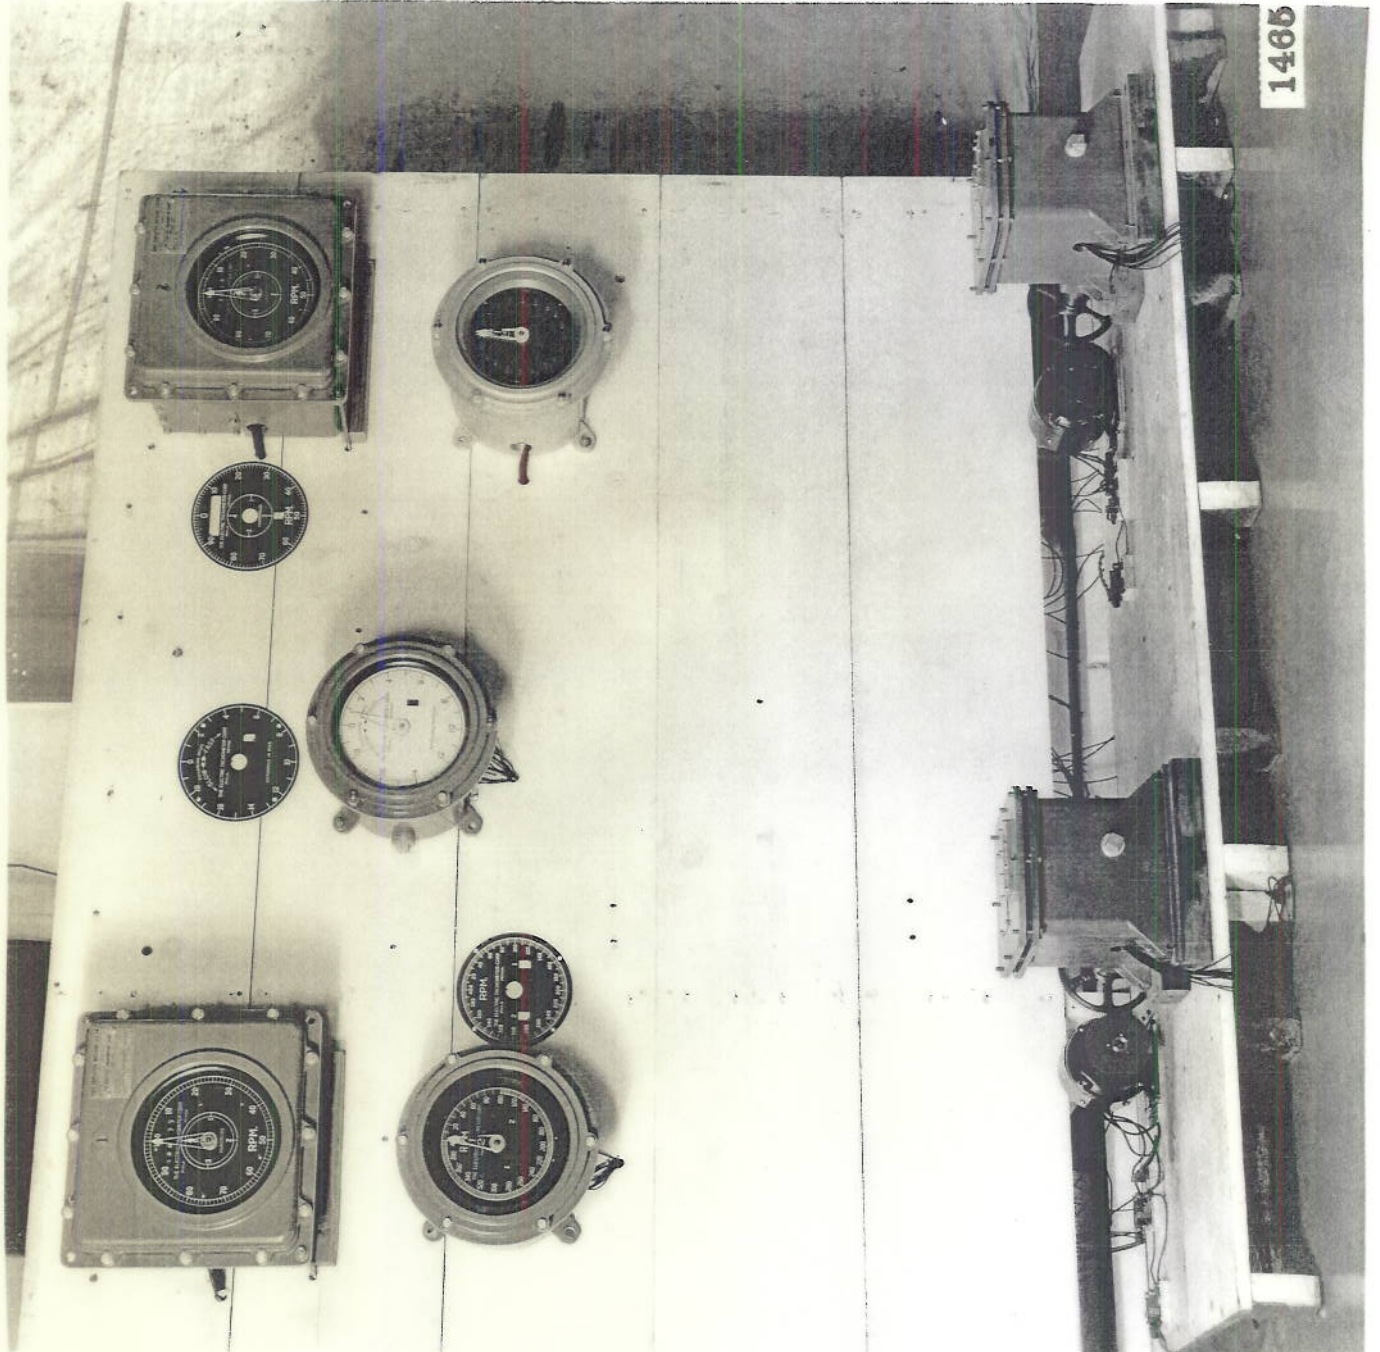
Plate 1

3. The system, shown by Plate 1, was set up at this Laboratory and closely observed while under test for conformance with specifications, reference (b). Both shaft transmitters were rotated ahead at a speed corresponding to shaft speeds of 400 r.p.m. for a period of 500 hours. The direction of rotation of both shafts was reversed for a period of one hour in every 24 hours. The total revolutions of the port and starboard shaft transmitters and the master indicator transmitters were compared daily and logged. All instruments were tested for shock integrity and examined to determine whether the material submitted was in strict accordance with the specifications.
