NRL Report No. B-1297  
BuEng. Prob. IC-93

Report of Test

Horn, Navy Type A1

E. A. Laboratories,

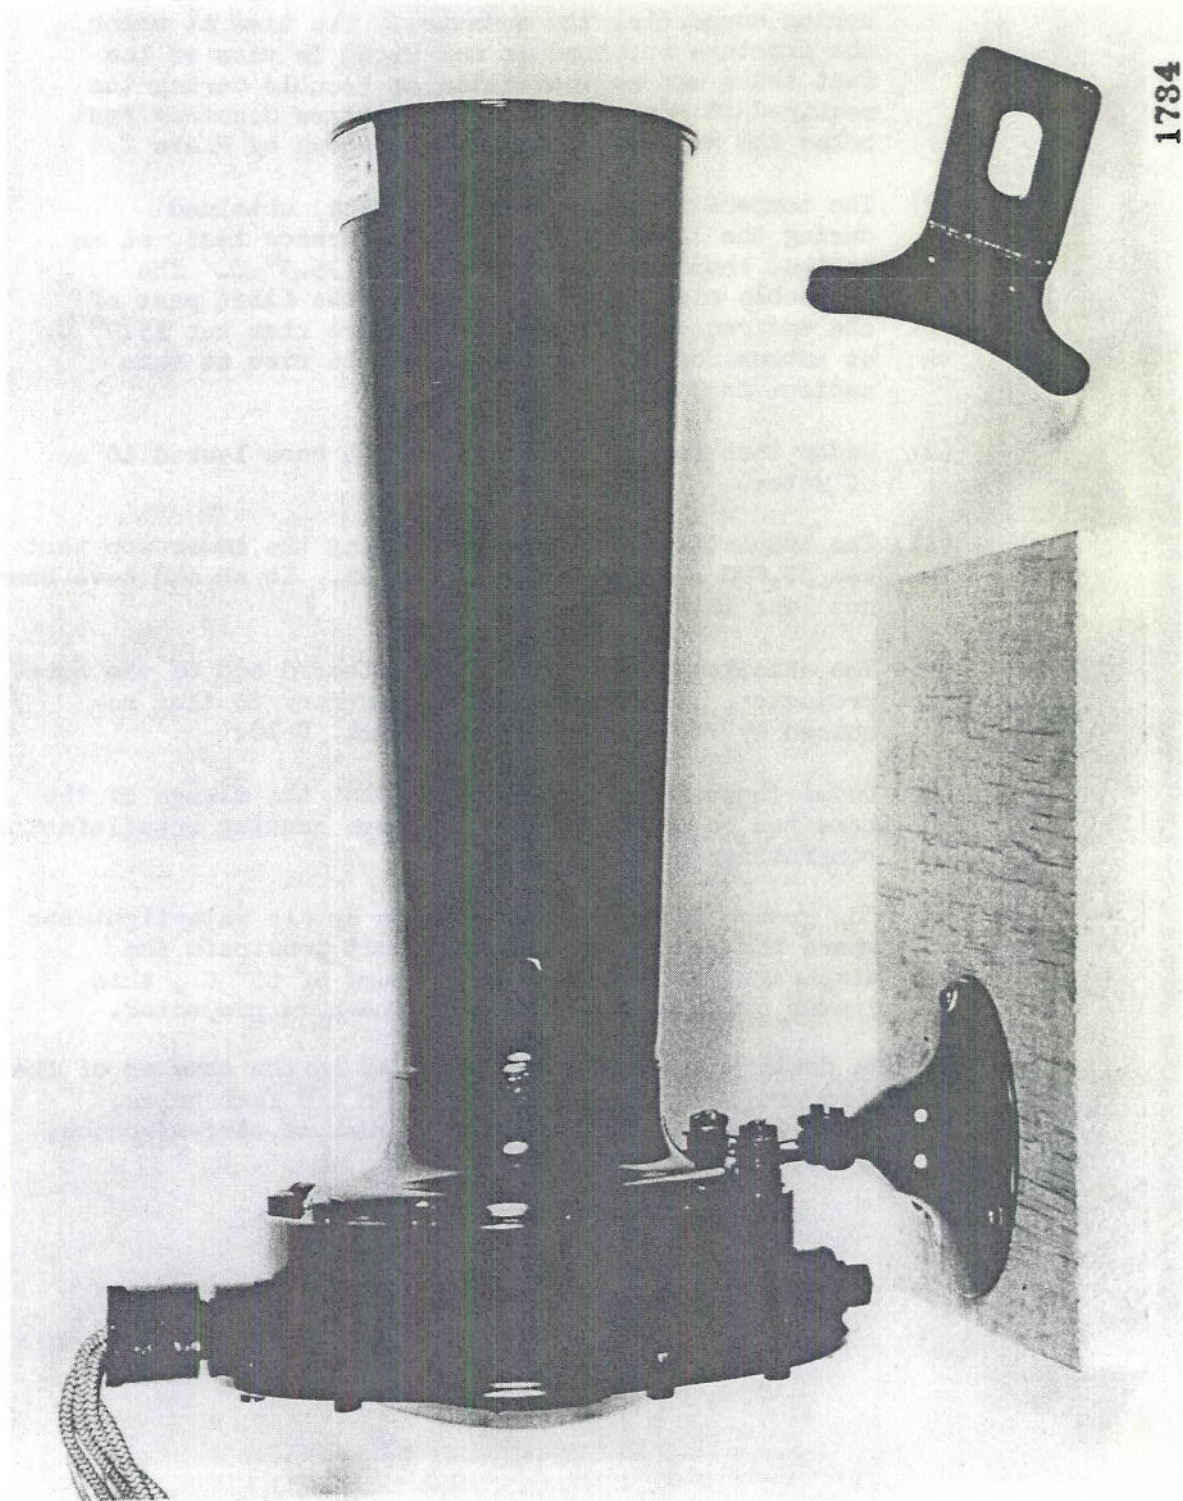
Plate 1

- (5) The nameplate, located on the outboard end of the horn projector, is of paper and is contrary to that required by the specifications, paragraph D-10.

- (5) The nameplate, located on the outboard end of the horn projector, is of paper and is contrary to that required by the specifications, para. D-10.

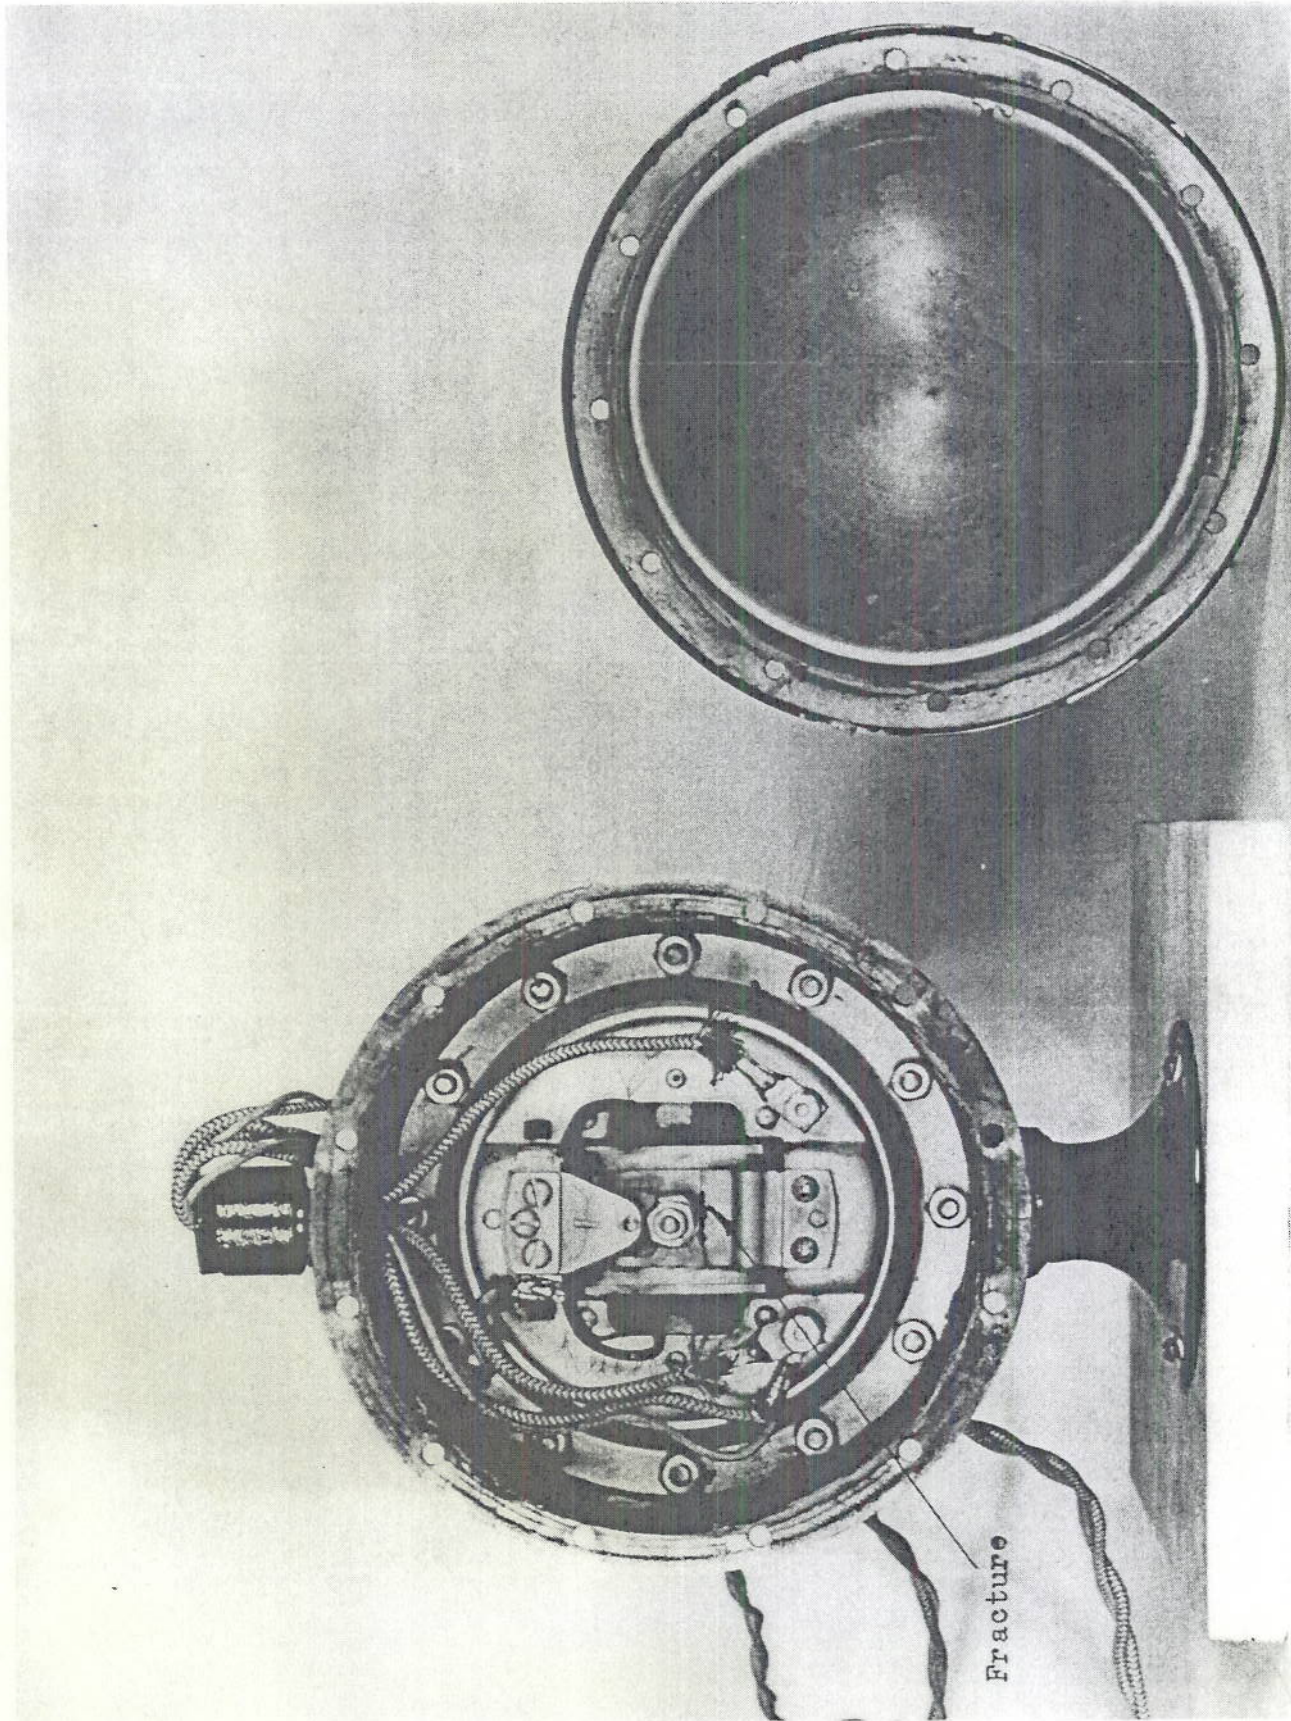
Plate 2

- (1) Under test for endurance, a fracture occurred in the spring supporting the armature. The time at which the fracture occurred is not known in view of the fact there was no indication of trouble during the required 48 hour test. This fracture occurred just below the adjustment nut and is shown by Plate 2.

Fracture

- (2) Experiment with two (2) armature springs substituted for the present single one. Both springs should be of a shape similar to, but longer than that which would be obtained by cutting the present one in half on a line perpendicular to its length. Provision should be made to allow a sliding action where they are secured to the armature. This suggestion is based on the fact that the horn operated satisfactorily after one half of the spring had become ineffective due to fracture, indicating that not all of the spring tension was necessary.
