NRL Report No. B-1313
BuEng. Prob. IC-124

NAVY DEPARTMENT
BUREAU OF ENGINEERING

Report
of
Test on Fire Alarm Equipment

Submitted by
Chas. J. Henschel and Co., Inc.,
Amesbury, Mass.

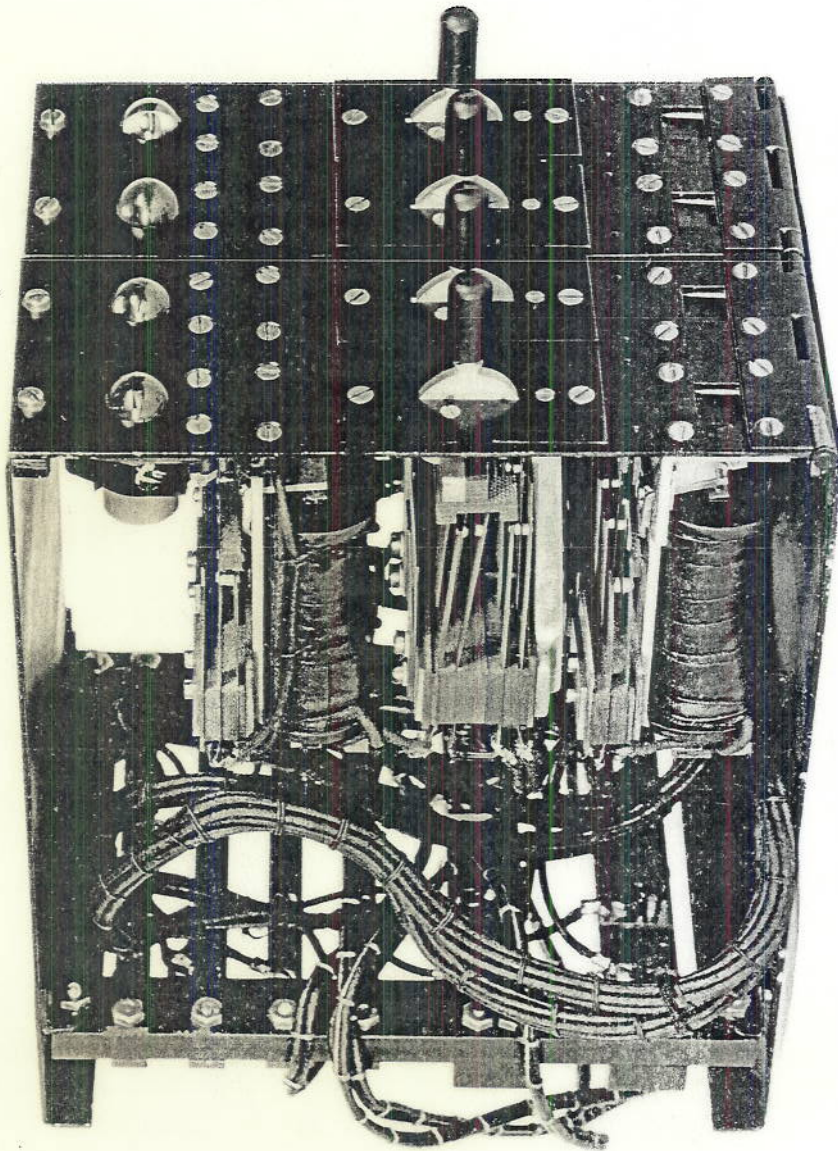
1756

Four Line Unit submitted for Test, Front Angle View Plate 1	
Same Unit, Rear Angle View	2
