NRL Report No. R-1374
BuEng Problem T5-26

NAVY DEPARTMENT
BUREAU OF ENGINEERING

Report on
Band Change Switch
of

Models TBO and TBO-1 Portable Radio Equipment
General Electric Company
Contractor

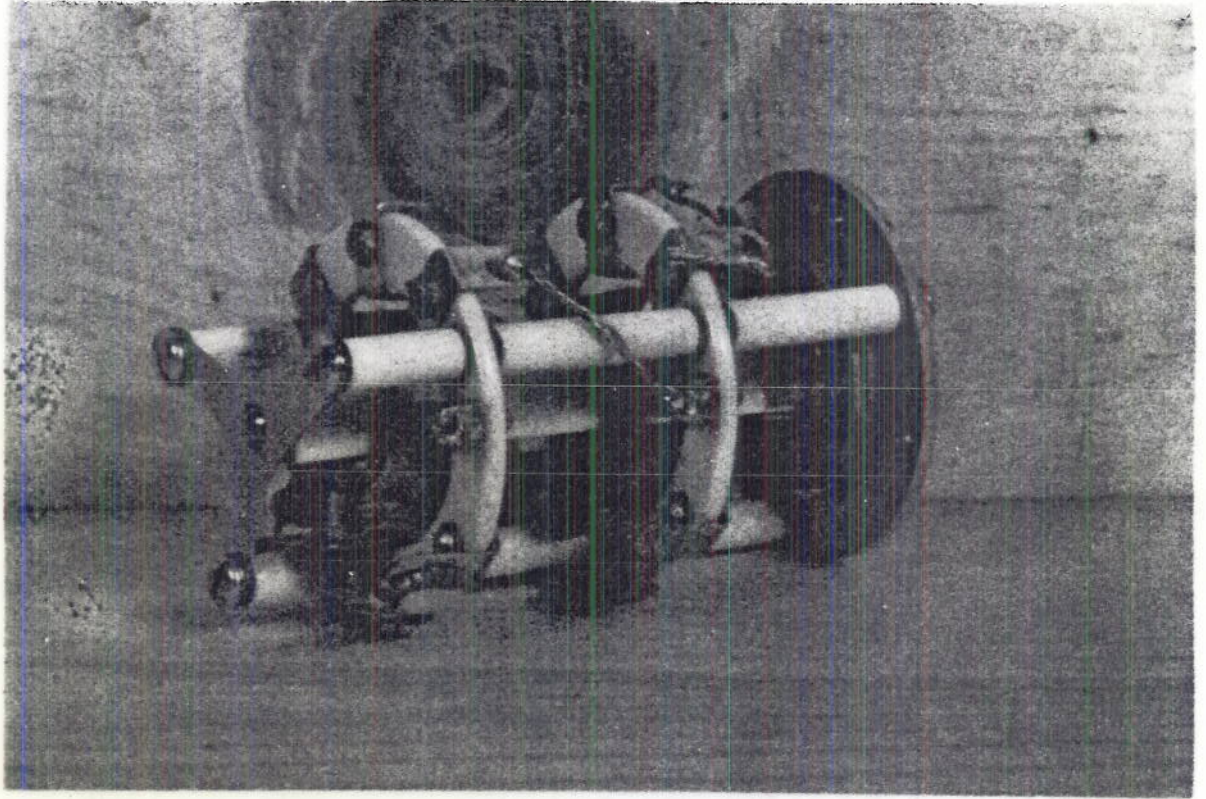
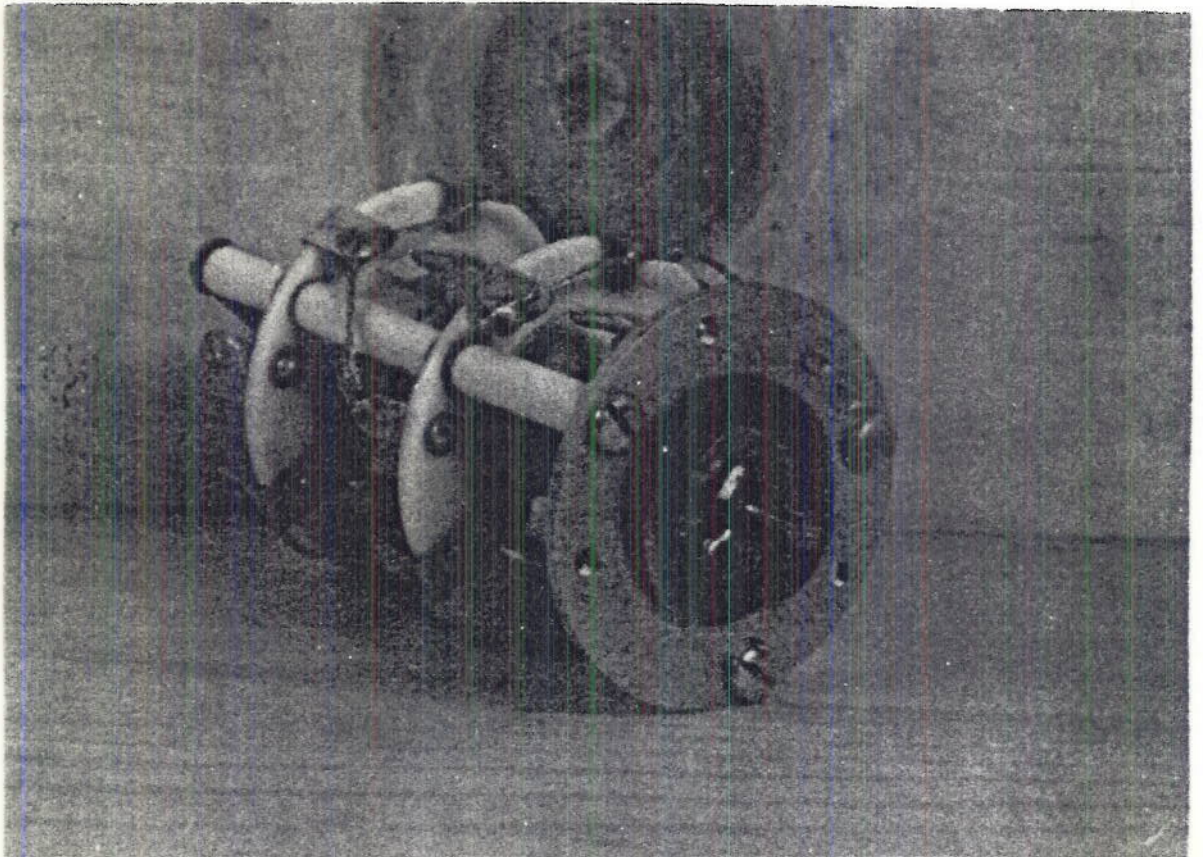
Plate 1

Photographs were then taken to show that the spring washer previously mentioned as binding on the cotter pin was broken in three places.

This shows very close agreement with the reference figures given above except for A2 which is not greatly different. 140 more revolutions under power failed to change the above figures and as inspection showed that the switch could be expected to continue to function similarly for a considerable period of time, the test was discontinued. The switch was removed from the circuit, washed in carbon tetrachloride and examined very carefully. The silver surfaces of rings "A" and "B" were worn completely through and rings "C" and "D" appeared to have retained the plating but in a polished condition. The clicker spring washer was badly broken in two places, while a third crack had already started. This washer was badly discolored from saline atmospheric exposure.

40. The breakage of the spring washer can not be considered as a defect as it was the result of rotation greater than the normal 90° rotation required for the three positions provided. It was caused by abnormal strain as the cotter pin head passed the clicker ball positions when 360° rotation was effected as in these tests. It is probable, however, that this would become a defect should this switch be employed for a greater number of steps requiring greater than 90° rotation unless the present cotter pin is replaced with some form of securing pin that does not contact the washer in rotation.

(a) The clicker spring washer be silver plated or plated with some material that will retard corrosion.
