NRL Report No. B-1363.

Report of Test

Wind Intensity and Direction Indicating
Equipment.

Chas. J. Henschel and Co.,
Amesbury, Mass.

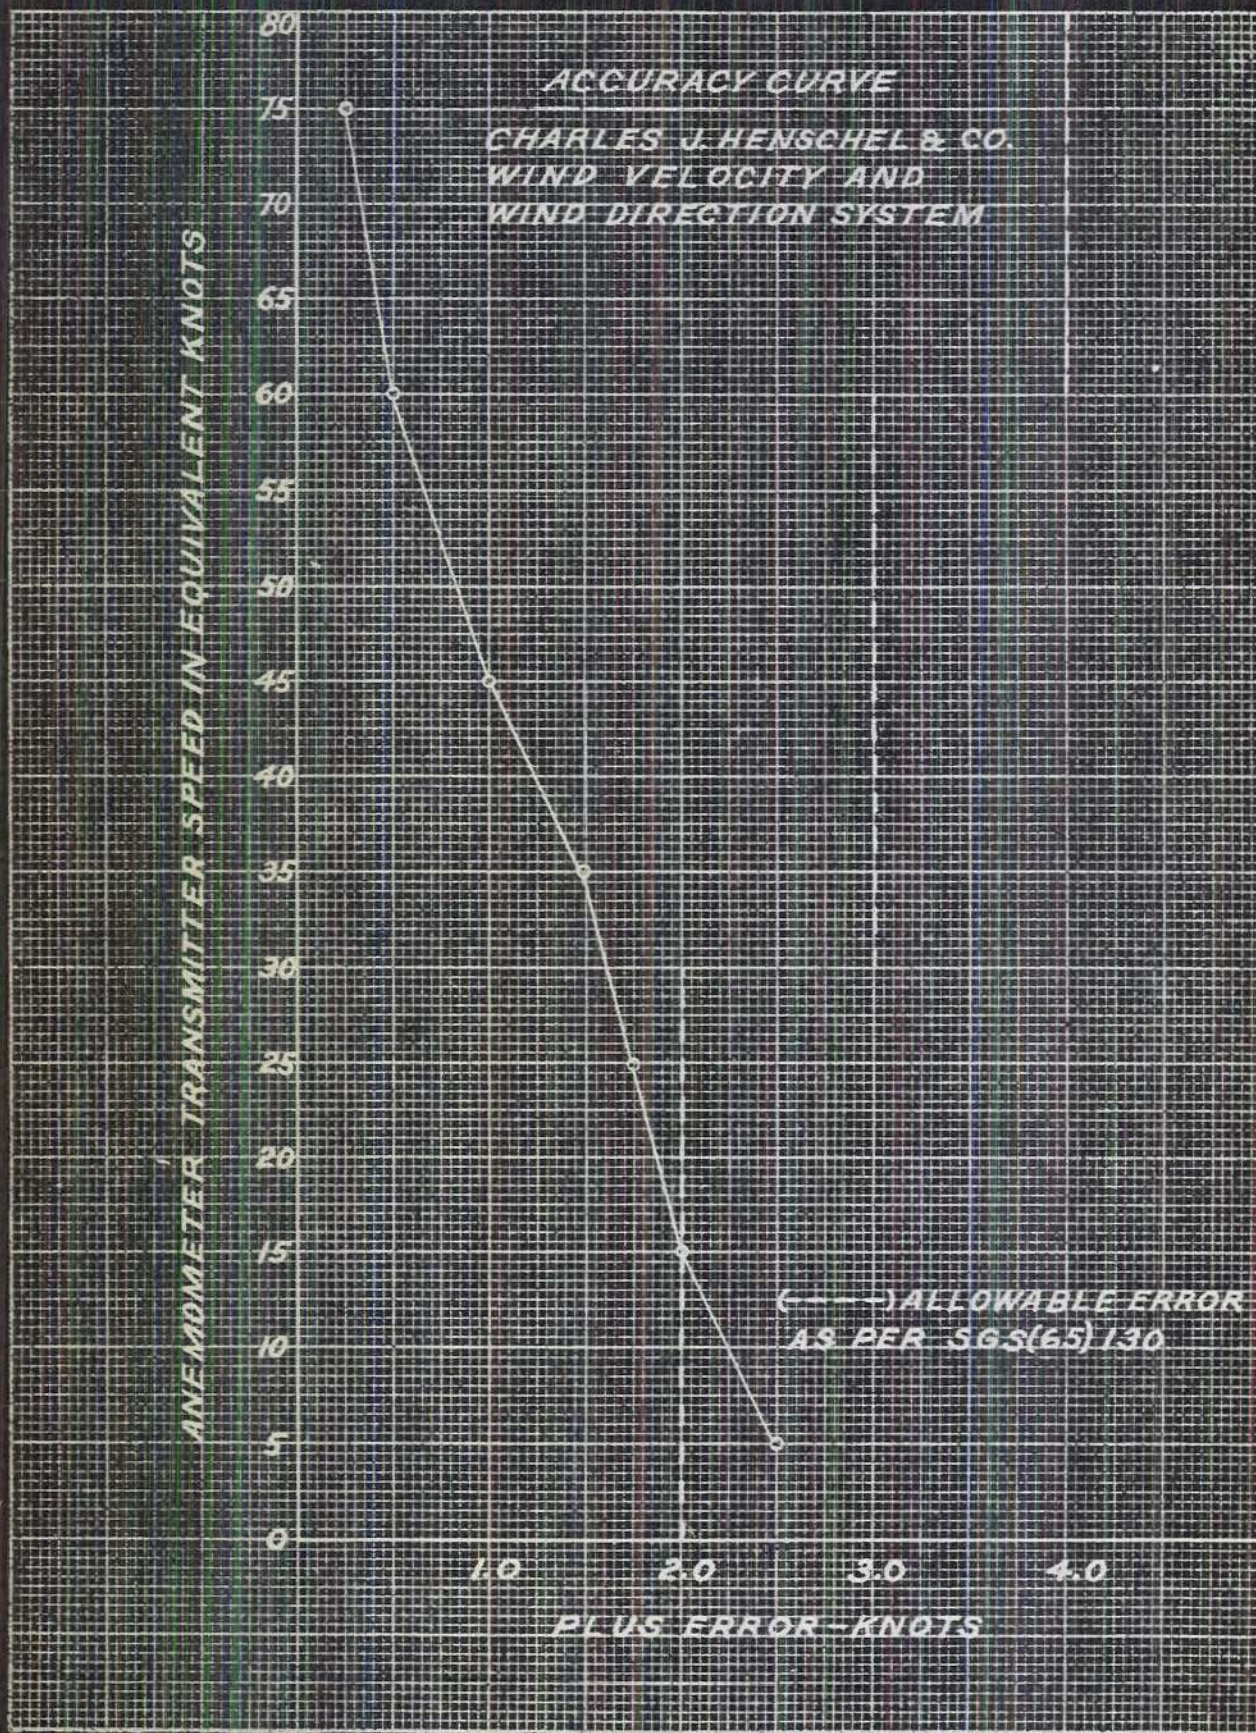
- (2) Under test for accuracy of the system, the only excessive errors observed (at an equivalent cup speed of 5 knots) were +0.5 in the master indicator-transmitter and +0.25 in the repeater indicator. See curves, Plate 3.

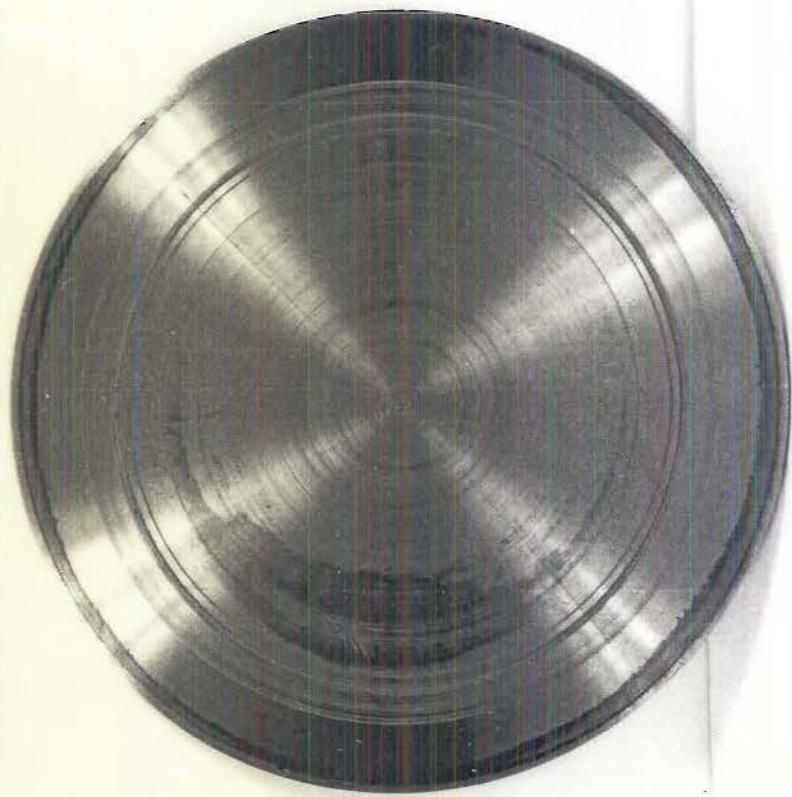
- (8) The friction disc and roller showed excessive wear. See Plate 11.
- (c) Provisions should be made to prevent the shorting of the brush springs in the self-synchronous motors, resulting from shock.

- (3) The friction disc shaft was bent causing uneven contact between the disc and the friction roller. A steel shaft should eliminate this condition.
- (4) Provisions should be made for a more positive contact between the roller and follow-up motor contact segments.
- (5) The lugs, securing the types A, B, and M motors, were bent. However, cast lugs furnished later by the manufacturer proved satisfactory.
- (6) The terminal blocks should have an additional support in the middle to insure a more rigid mounting.
- (7) Better means should be provided to prevent the zero cut-off switch screws from loosening under shock.
- (8) The friction disc and roller showed excessive wear. See Plate 11.
