NRL Report No. B-1322  
BuEng.Prob. IC-126

Report of Test

Gun Firing Transformer, 200 V. A.  
Submitted by  
Jefferson Electric Co.  
Bellwood, Illinois.

NAVAL RESEARCH LABORATORY  
ANACOSTIA STATION  
WASHINGTON, D.C.

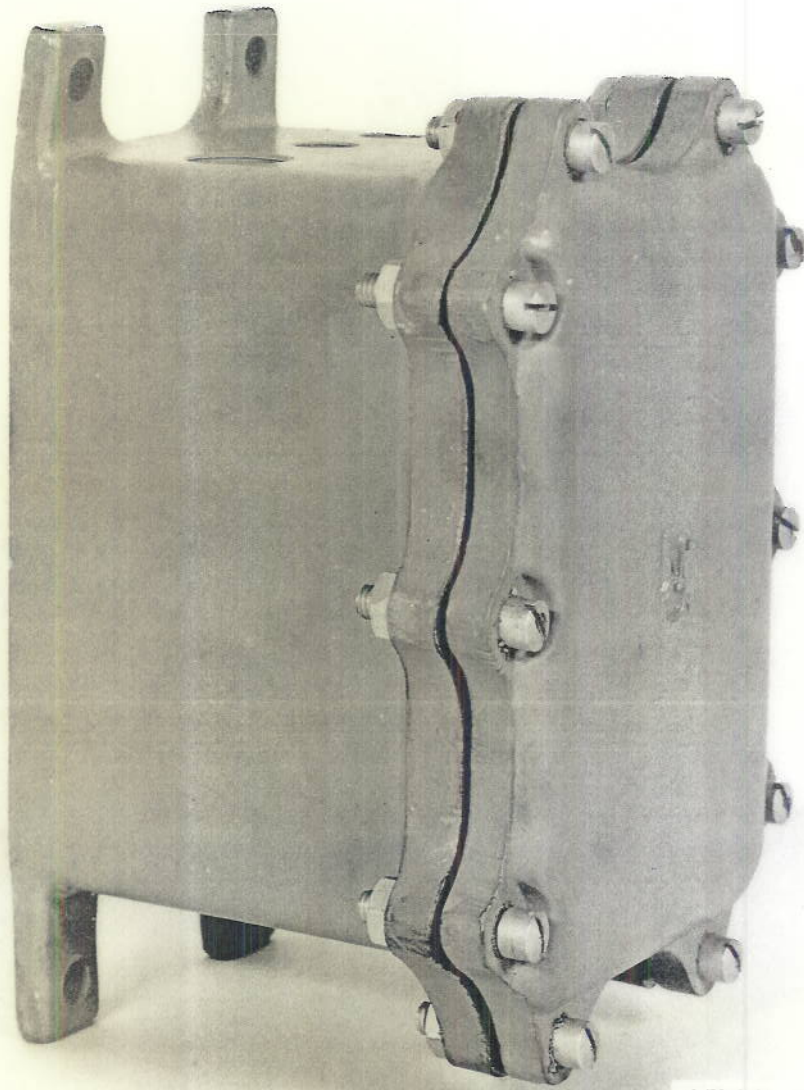
Plate 1

(c) When the complete unit was mounted on a Bureau of Engineering shock stand in the vertical plane, six inches below point of impact, and given shocks of 250 foot pounds, the transformer broke away from the case, due to the stripping of threads on the securing screws. In addition, one of the mounting lugs was found fractured. Neither the mounting of the transformer nor the design of the lugs is sufficiently rugged to withstand shocks encountered in the service. The radii of the fillets and the thickness of the lugs should be increased.

20. When the complete unit was mounted on a Bureau of Engineering shock stand in the vertical plane, six inches below point of impact, and given shocks of 250 foot pounds, the transformer broke away from the case, due to the stripping of threads on the securing screws. In addition, one of the mounting lugs was found fractured. Neither the mounting of the transformer nor the design of the lugs is sufficiently rugged to withstand shocks encountered in the service. The radii of the fillets and the thickness of the lugs should be increased.

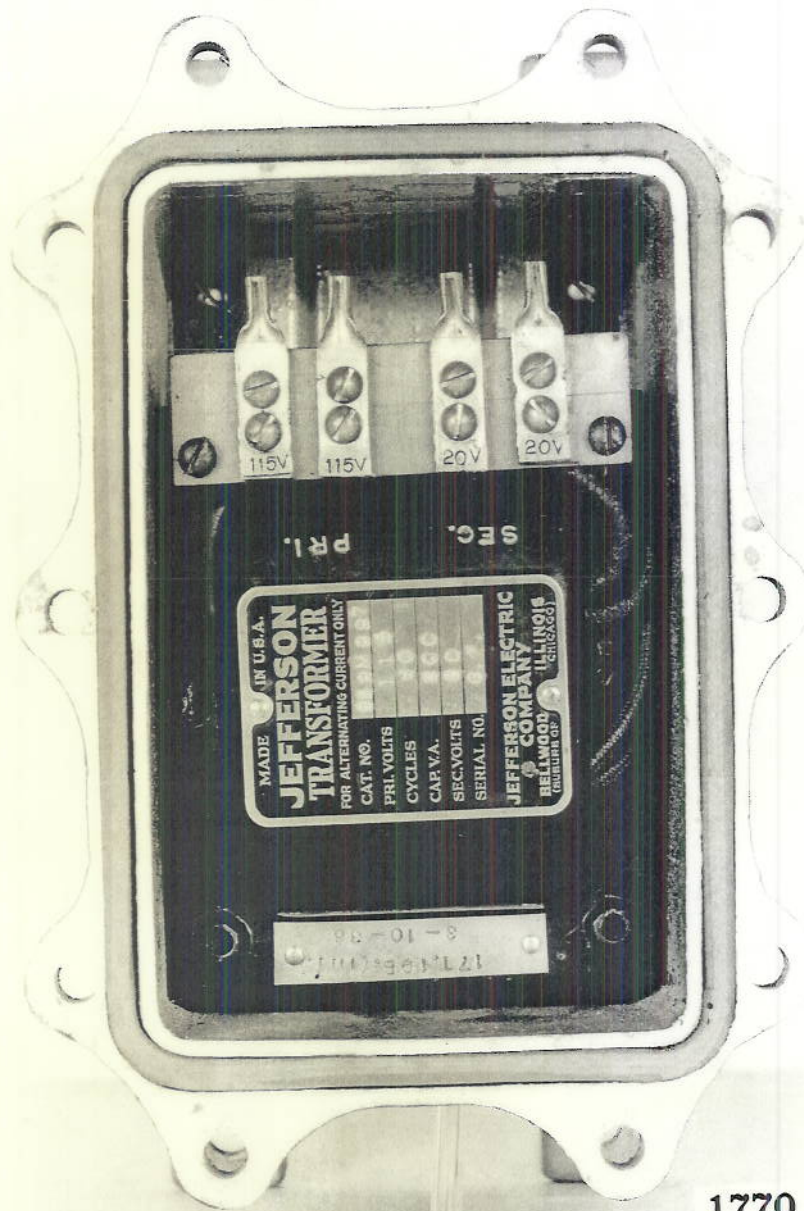
(b) Under inspection of the design and materials, it was observed that the lead wires from transformer windings to the terminal block pass through uninsulated holes in the upper transformer cover. These wires would probably become grounded or shorted under service conditions, due to vibration and the chafing of the wires. Possibly these covers could be eliminated. In addition, it was noted that no nameplate was provided on the exterior of the case for identification. This nameplate should be in accordance with specifications 17N1(INT) of 15 May 1936.

19. Under inspection of the design and materials, it was observed that the lead wires from transformer windings to the terminal block pass through uninsulated holes in the upper transformer cover. These wires would probably become grounded or shorted under service conditions, due to vibration and the chafing of the wires. Possibly these covers could be eliminated. In addition, it was noted that no nameplate was provided on the exterior of the case for identification. This nameplate should be in accordance with specifications 17N1(INT) of 15 May 1936.
