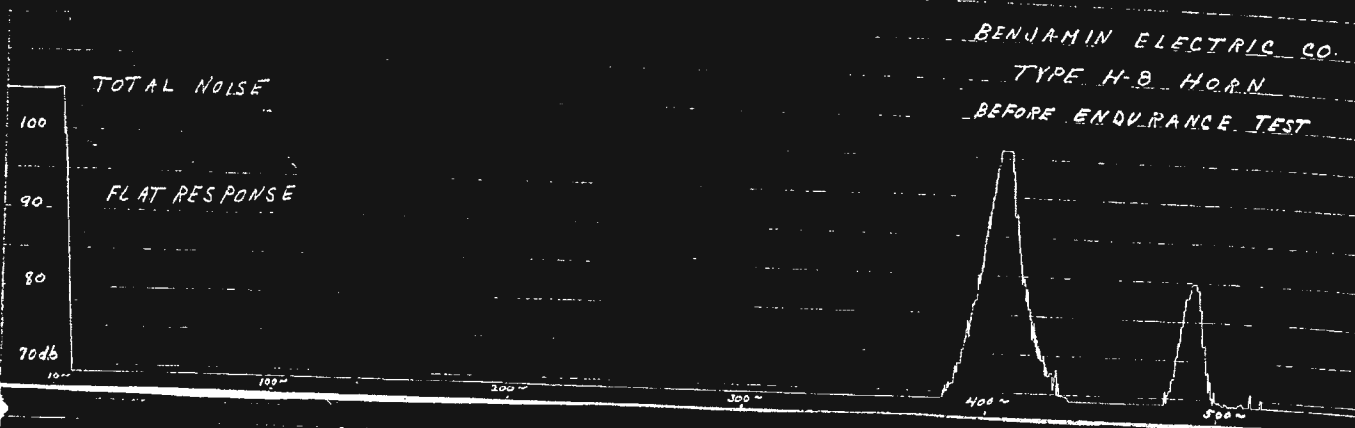
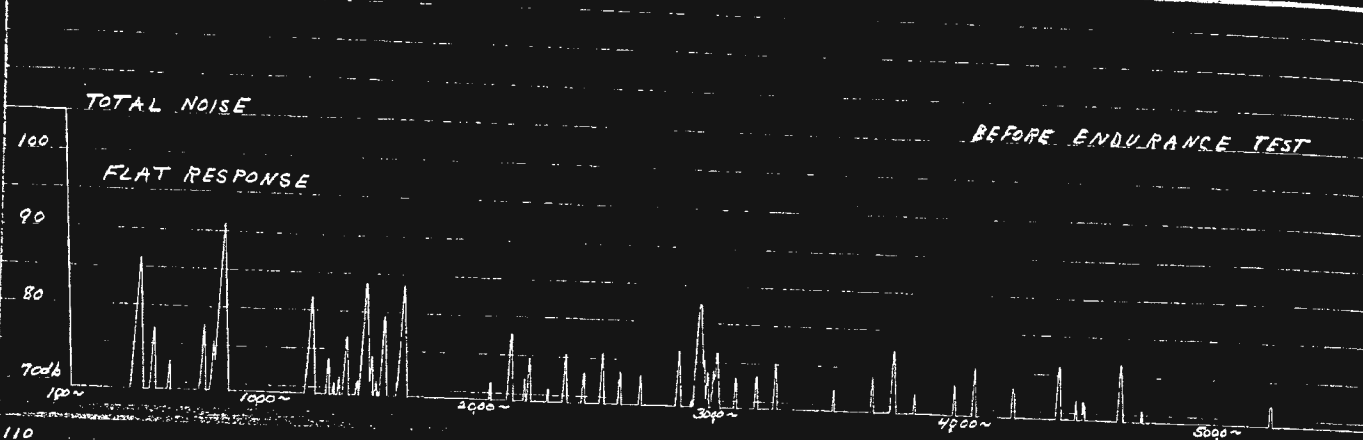
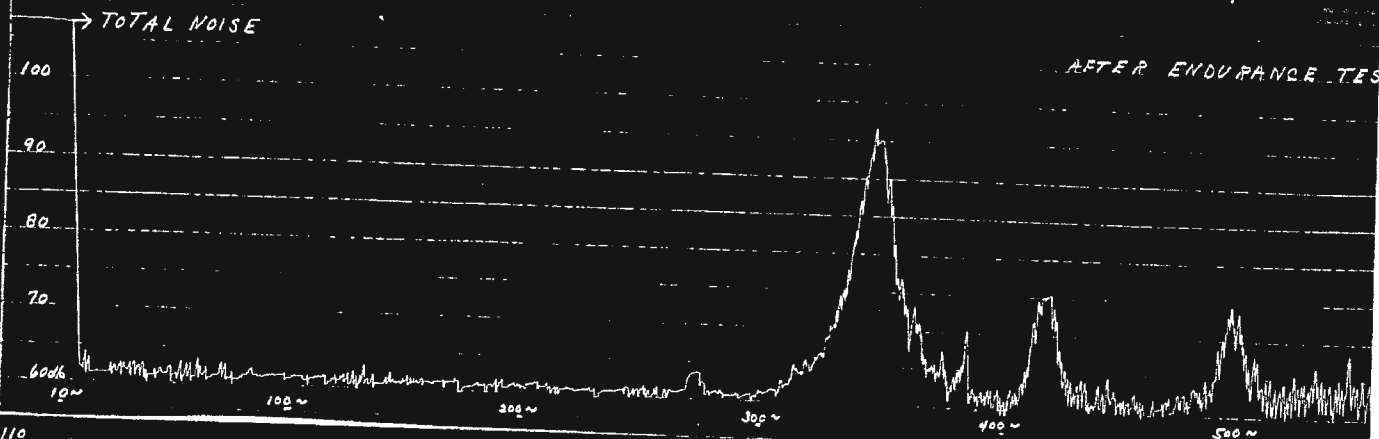
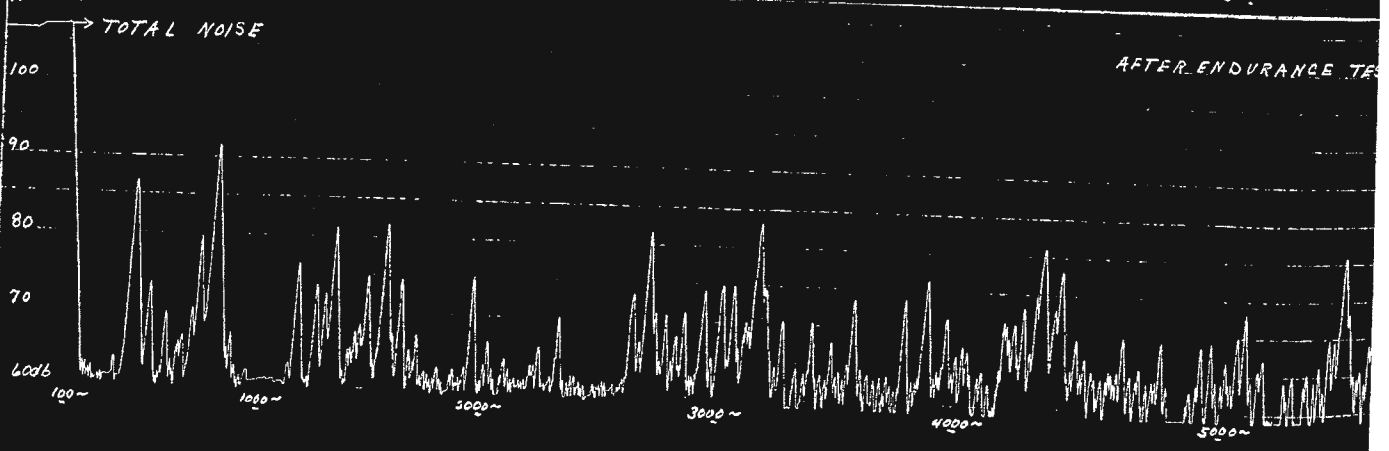
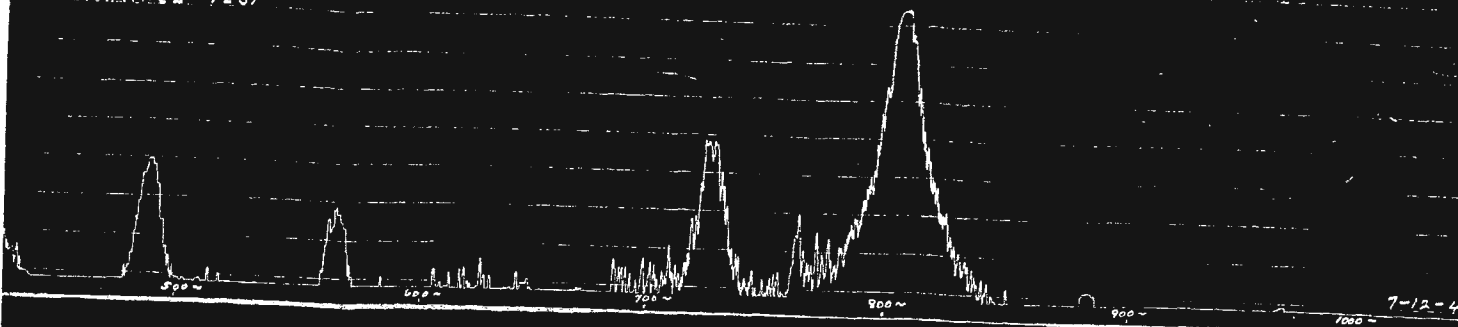
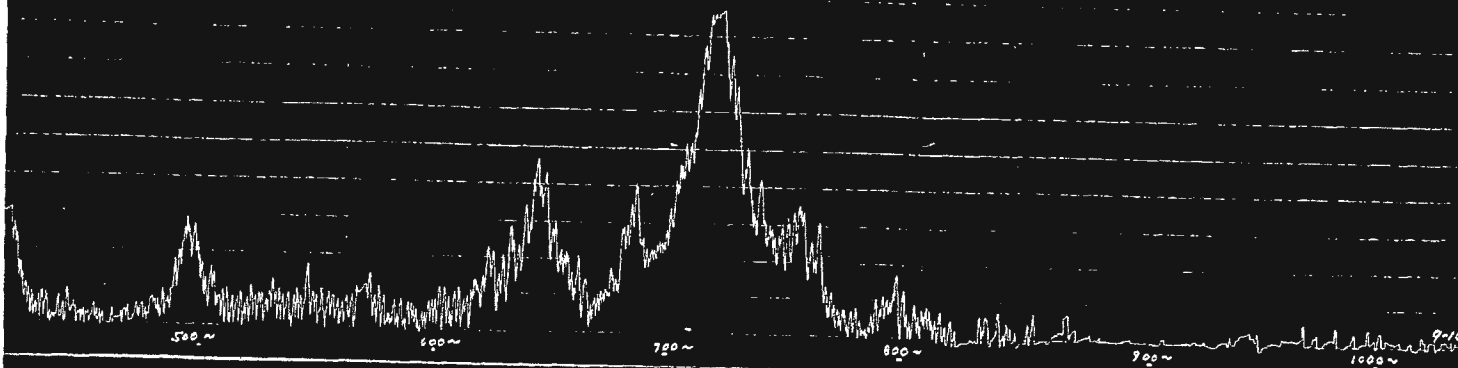
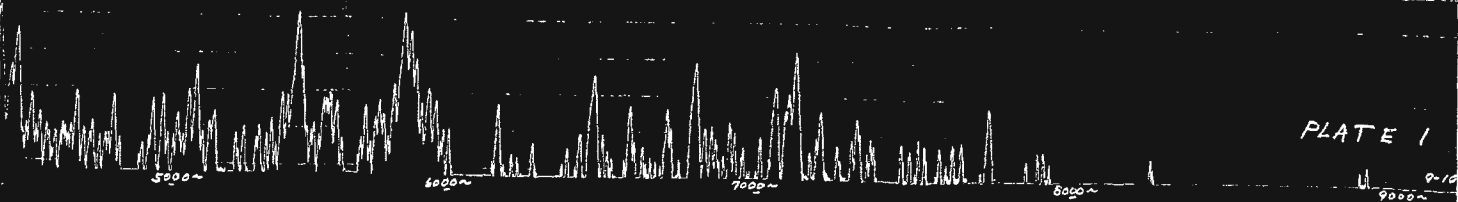
PLATE 1

<u>Requirements</u>	<u>Test Values</u>	
	<u>Type H-8</u>	<u>Type H-9</u>
Pitch of note: 100 to 600 C.P.S.	Complied. (See Plate 1)	Complied. (See Plate 2)
Inclination: Shall operate in any position when supplied with rated voltage and frequency \pm 10 per cent.	Complied.	Complied.
Endurance test: Shall operate 1500 cycles of "one minute on" and "one minute off", the first 750 cycles at 60°C. and the second at 0°C. ambient temperatures.	Complied following 3 diaphragm replacements due to fractures. (See Conclusions)	Complied following 1 diaphragm replacement due to fracture. (See Conclusions)
Temperature rise: Maximum temperature shall not exceed 115°C. during the endurance test. (55°C. rise at 60°C.)	Complied, 30.9°C. above 60°C. ambient.	Complied, 26.5°C. above 60°C. ambient.
Shock integrity: Shall withstand 20 shocks of 250 foot pounds each as specified in paragraph F-2g.	Complied.	Complied.
Vibration test: Shall be mounted on a standard Navy 3 foot pound vibration machine and subjected to six tests of 30 minutes each at 100, 150, 200, 250, 300, and 350 shocks per minute.	Complied.	Complied.

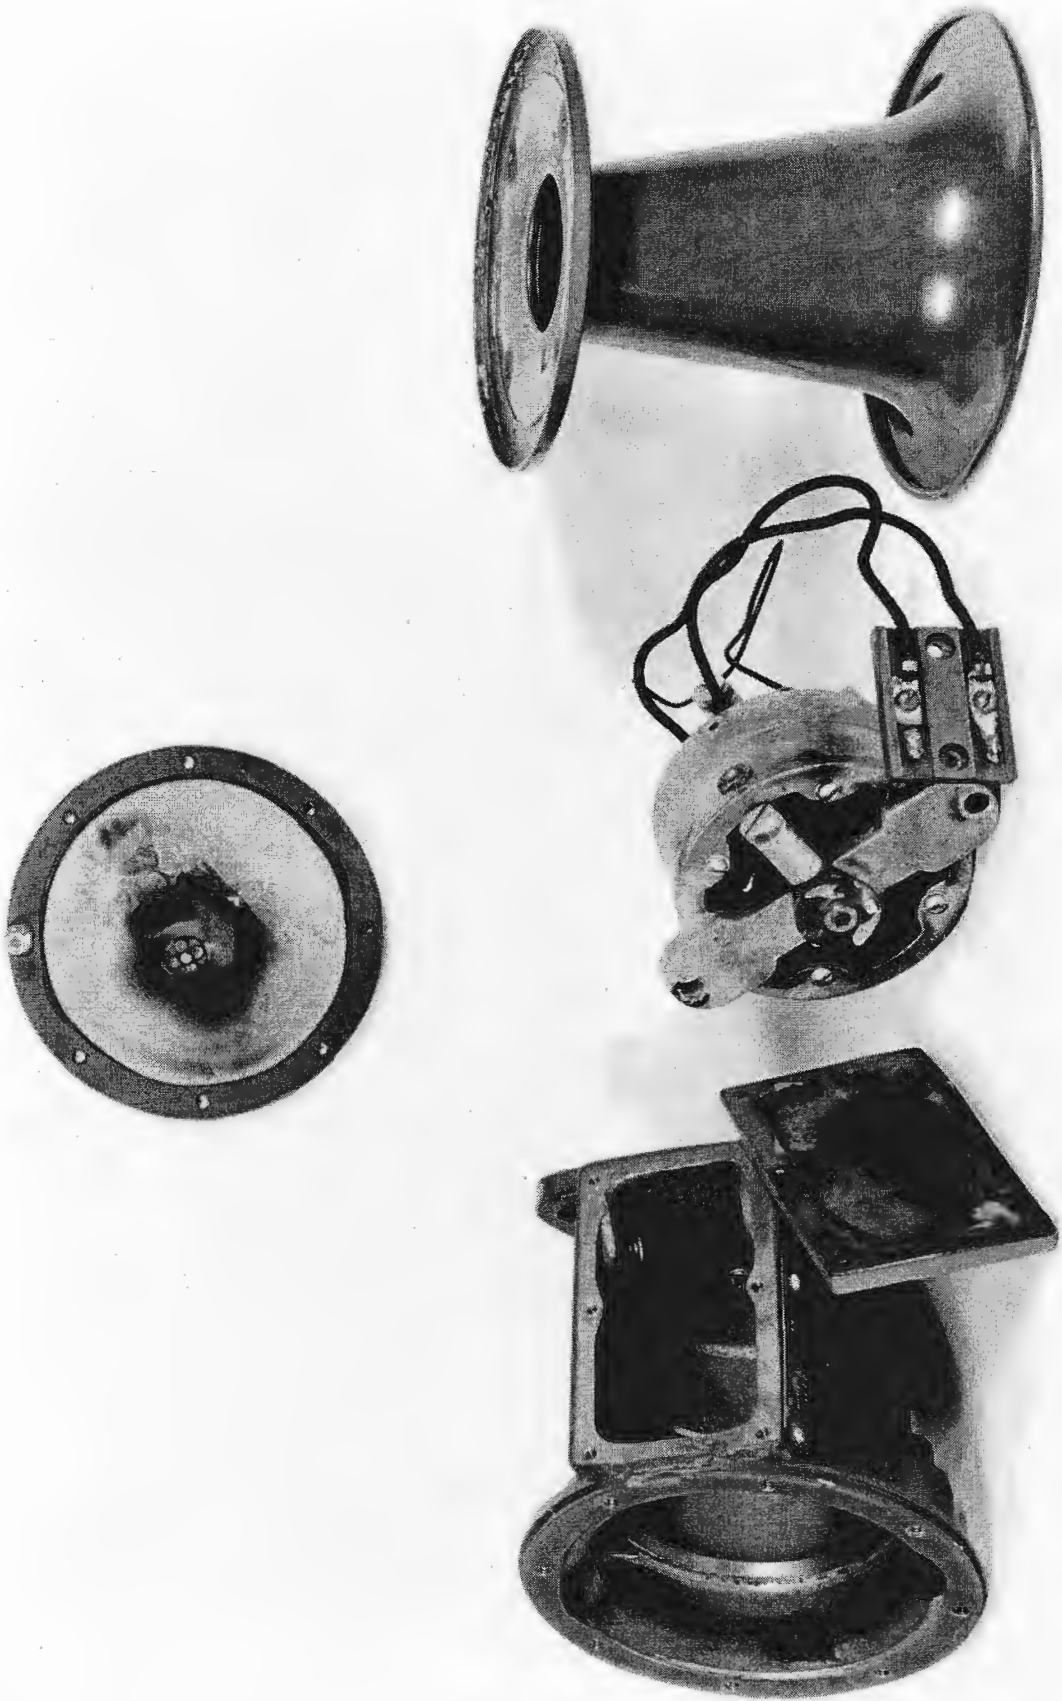
Plate 4

16. Two replacement diaphragms were furnished by the manufacturer and were installed and new tests were begun by direction of the Bureau. The diaphragm of the type H-8 horn fractured after 1-1/2 hours while the diaphragm of the type H-9 horn survived the 50 hour endurance test. However, it was necessary to readjust the horn on 3 occasions; after 19, 44, and 49 hours respectively. Ratchet (pc. 5) and diaphragm button (pc. 2) were found to be badly worn in this horn at the end of the test.
