NRL Report No. B-1645

Report of Test

Horns, Types H-8 and H-9

Submitted by Clark Cooper Company,

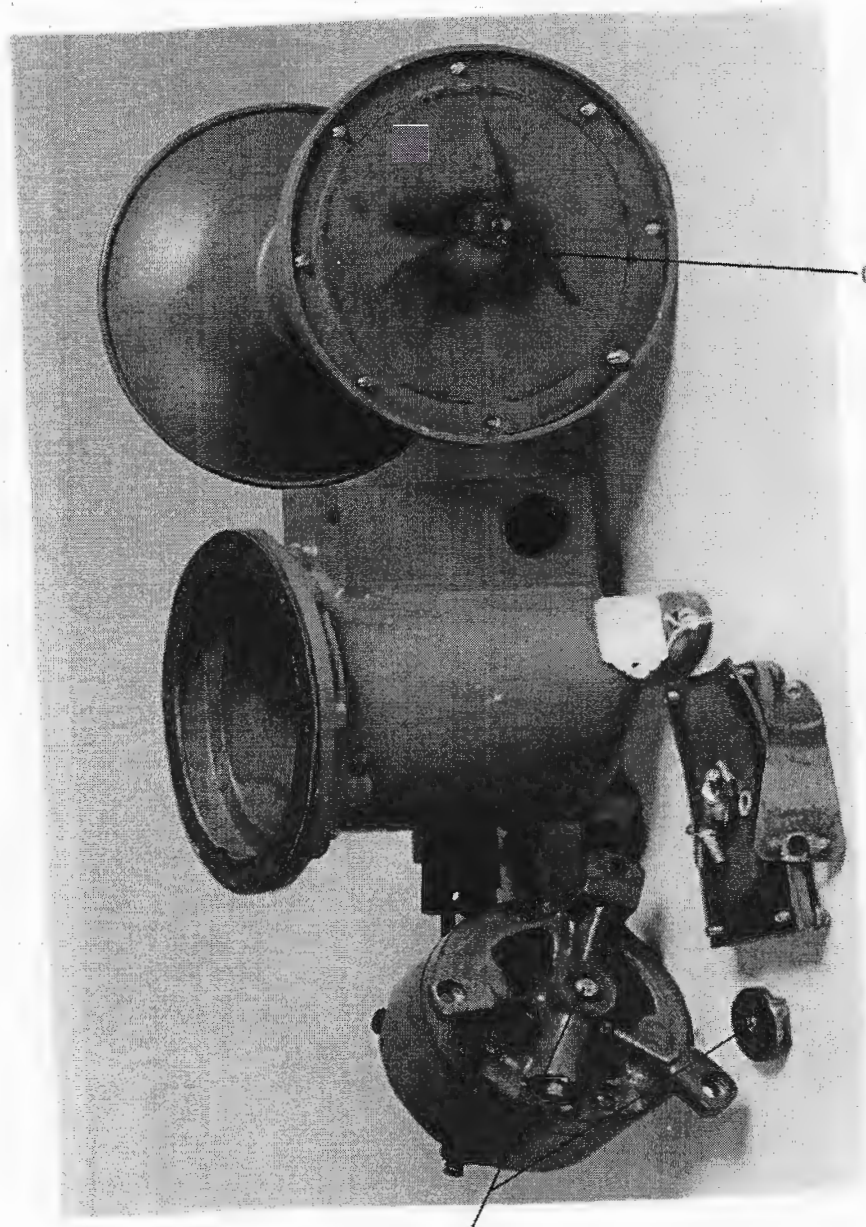
- (2) After 3 hours of operation, during the latter half of the endurance test at 0° C. (28 hours total), the type H-8 horn failed. The diaphragm was found cracked and the end of the armature shaft, to which the ratchet wheel (pc. 4) is secured, was found broken.

- (2) After 3 hours of operation, during the latter half of the endurance test at 0° C (28 hours total), the type H-8 horn failed. The diaphragm was found cracked and the end of the armature shaft, to which the ratchet wheel (pc. 4) is secured, was found broken.

Cracked diaphragm

Broken Shaft

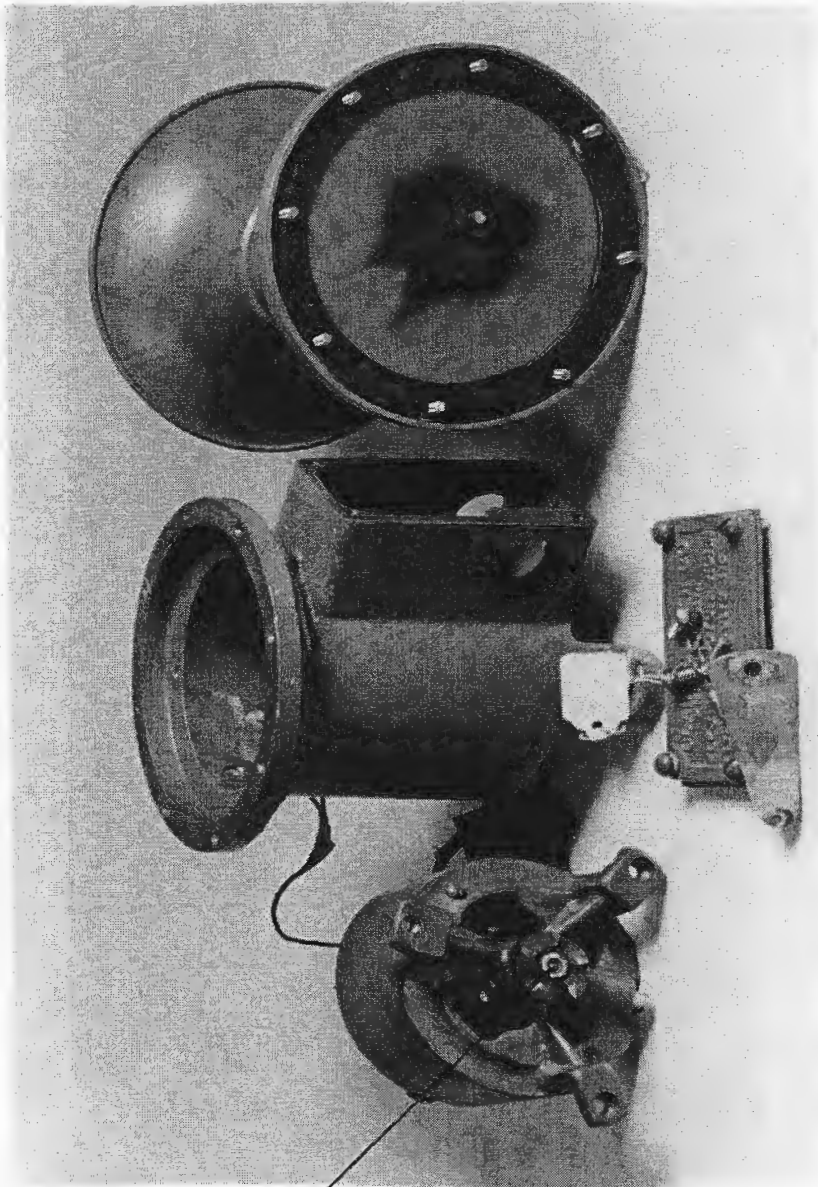
- (3) The type H-9 horn failed after 4 hours of operation at 0° C (28 hours total). The motor's stalling was apparently due to the receding of the steel ball in the end of the armature shaft, allowing spring (pc. 8) to press against the ratchet wheel (pc. 4) and produce considerable friction.

- (3) The type H-9 horn failed after 4 hours of operation at 0° C. (28 hours total). The motor's stalling was apparently due to the receding of the steel ball in the end of the armature shaft, allowing spring (pc. 8) to press against the ratchet wheel (pc. 4) and produce considerable friction.

Steel ball recessed
too deeply in armature shaft
