2020 Guided Wave Inspection of California Department of Water Resources Tainter Gate Posttensioned Trunnion Anchor Rods

Oroville Dam

March 2022

Final Report

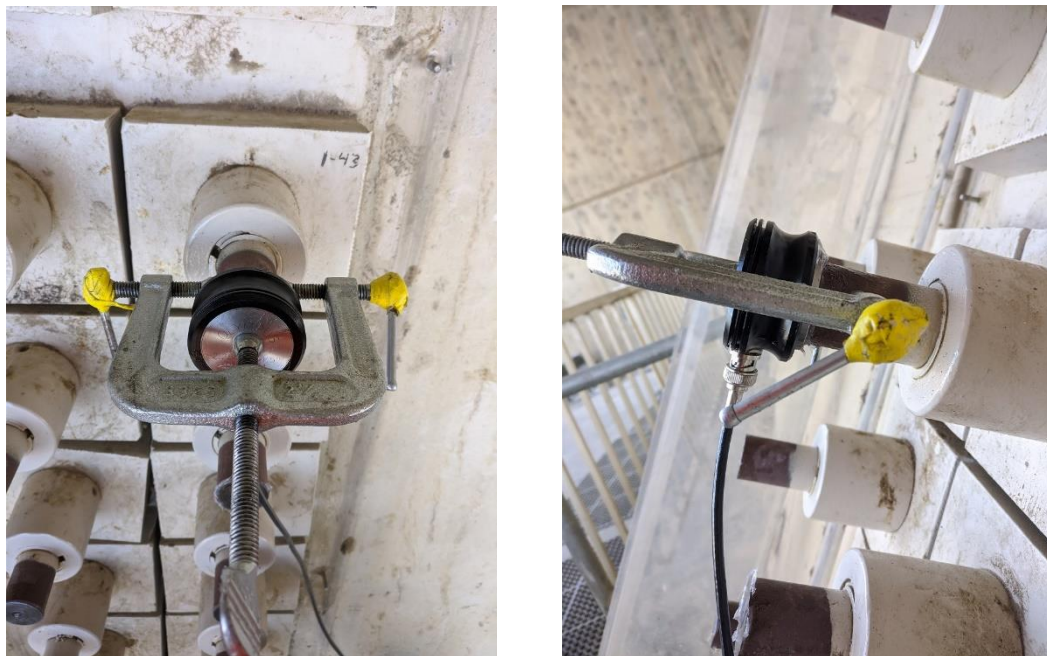
Figure 3. Transducer attached to tendon end.

The conditions of the tendon ends remain unchanged from the previous year (Figure 3). Through sufficient greasing, use of cover boxes, and overhead coverage, it is not expected that the tendon ends will change from year to year. All tendon ends have previously been ground flat and polished.

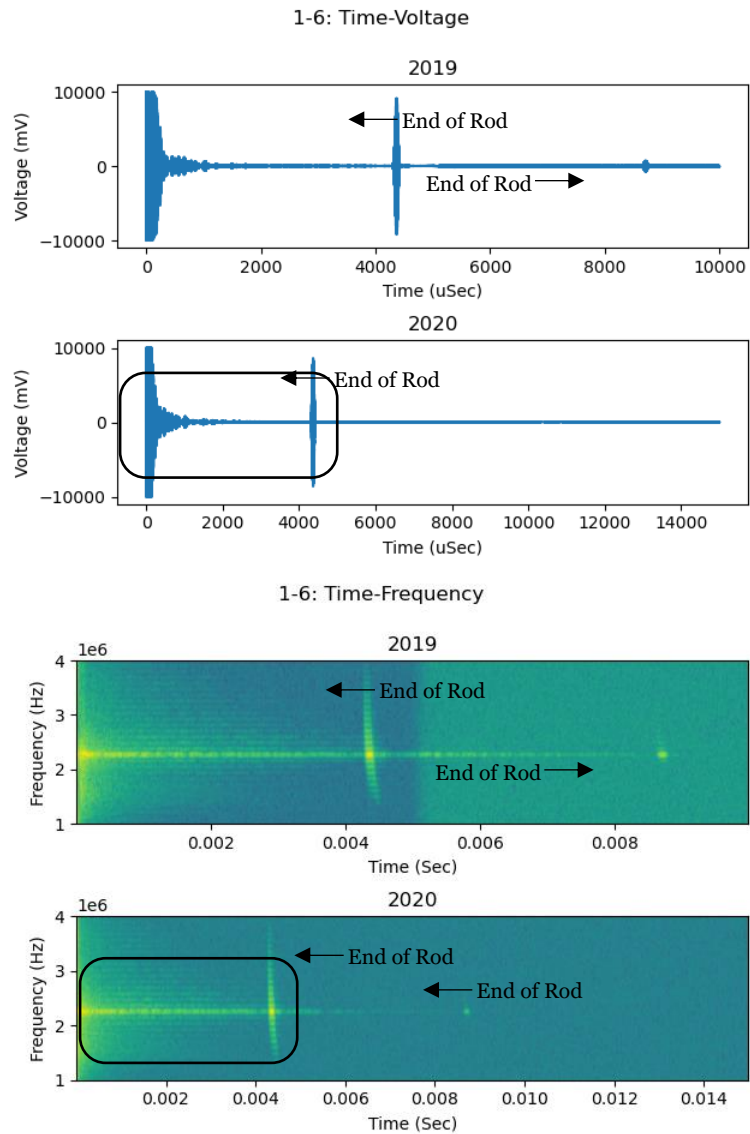
Figure 20. Example of a “No Issue” result.

The results labeled as “No Issue” mainly consist of anchors that are more centralized within the bundles. In making decisions on what category an anchor falls in, the area between the start of the test and the first rebound is primarily investigated. Any reflectors present in the tendon will appear in this area. Reflectors close to the testing end can be lost in the noise of the return signal due to the amount of energy required to propagate the full distance. Figure 20 shows an example of a “No Issue” result and illustrates the region of interest in the black rectangular area.

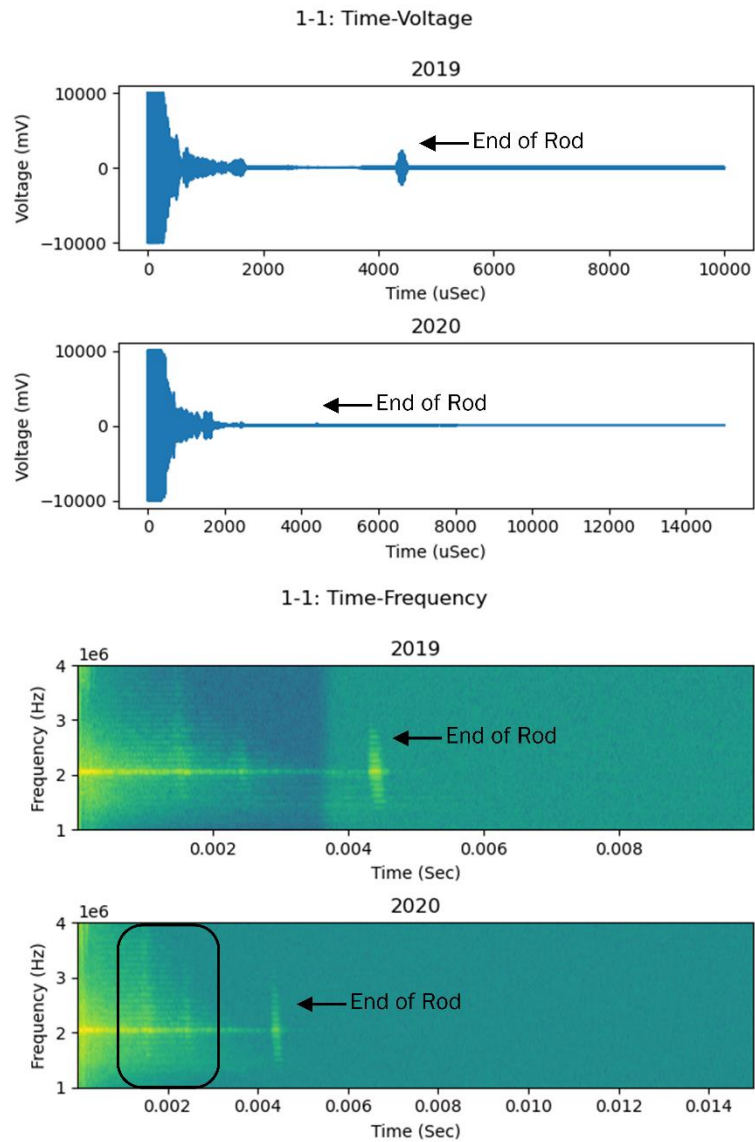
Figure 21. Example of an “Anomaly” Result.

Across the eight piers at the Oroville Complex, it has been shown over the previous two testing years that the upper and lower rods within the bundles contain reflectors in the vast majority of the collection. While not thought to be defects, something related to the rod bending in the design specifications causes both these reflectors to appear and greatly attenuate the return signal related to the end of the rod. **Error! Reference source not found.** shows an example of an “Anomaly” result and illustrates what gave it this label.

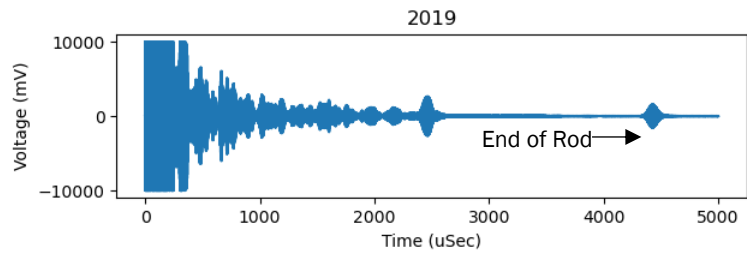
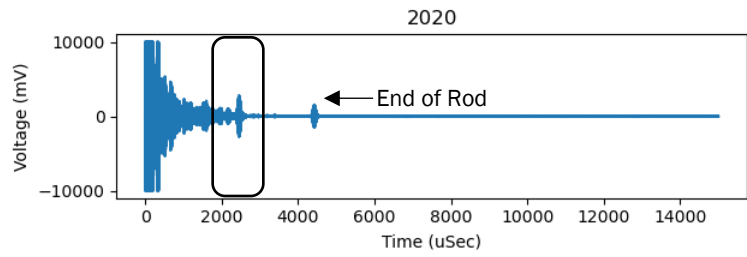
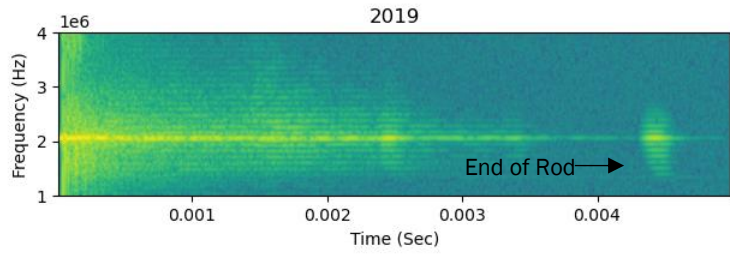
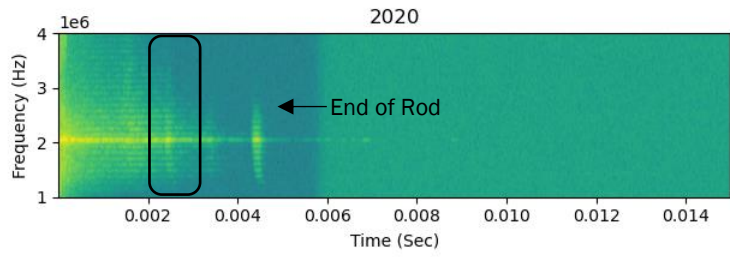
Figure 22. "Possible Defect" rod 2-13.

The amplitude or energy within the anomalous reflectors determines whether or not a tendon is labeled as "Anomaly" or "Possible Defect." The areas enclosed by the black rectangles show the return that ultimately made the decision. Except for rod 7-14, these rods were not labeled as "Possible Defect" in previous years. These three new "Possible Defect" rods show similar signatures as the previous years and should have previously been labeled as such.

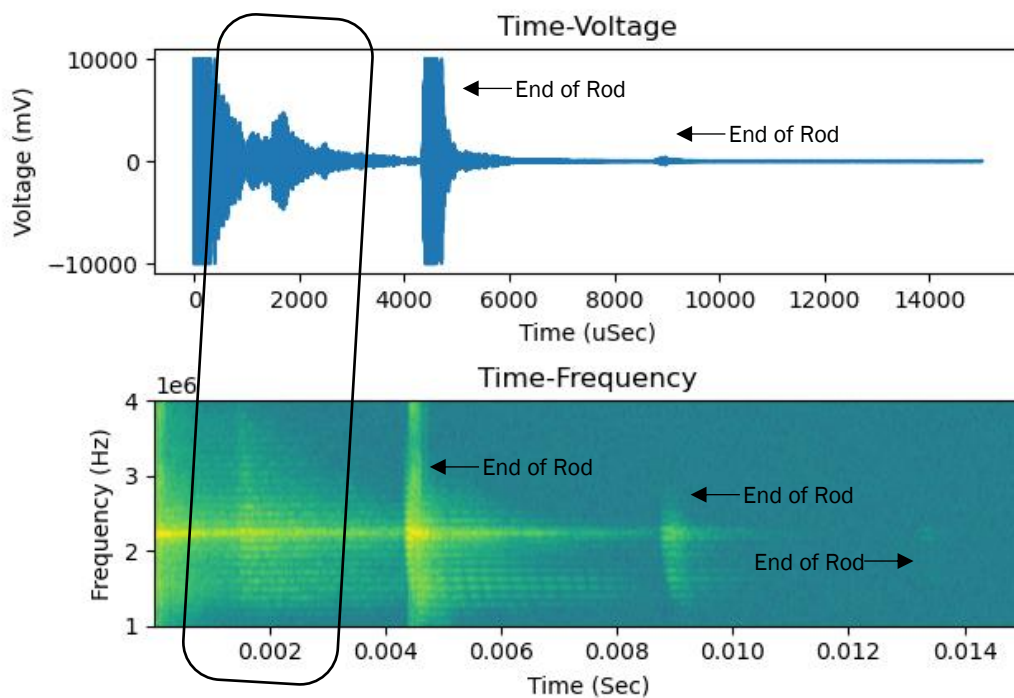
Figure 26. Rod 4-2.

Rods 4-2 and 4-14 continue to show behavior outside what is expected for the Oroville Dam. Not only does the amplitude of the reflections exceed the same positions on the other gates, but the amplitude also exceeds that of most rods at the complex. This larger amplitude response has been confirmed by other contractors on site.

The results of these two rods are shown in Figure 26 and Figure 27. The gain on the transmitting amplifier had to be reduced well beyond what was used on tendons in proximity and in the same position on other piers.

The black rectangle that spans the two plots in each figure shows what looks to be a “Possible Defect.” If a defect is present in a tendon, the expected result in the amplitude of the end of rod reflection is that it is reduced compared to if the tendon was undamaged. In the case of these two tendons, the amplitude of the end of the rod is very large and even exceeds that of many tendons that are more centralized in the bundles. From a blind-testing perspective, these two tendons appear to not have the same progressive bend as the tendons on the other gates in the same location.

At this time, there are no conclusions to draw as to why these two tendons exhibit this behavior. A true defect in the tendon would provide a reflection between the first and second end-of-rod reflection. The time-series and STFT representation of the tendons do not show this. The acoustic behavior in these tendons is similar to the tendons labeled “Anomaly,” though the amplitude of the reflections is greater.

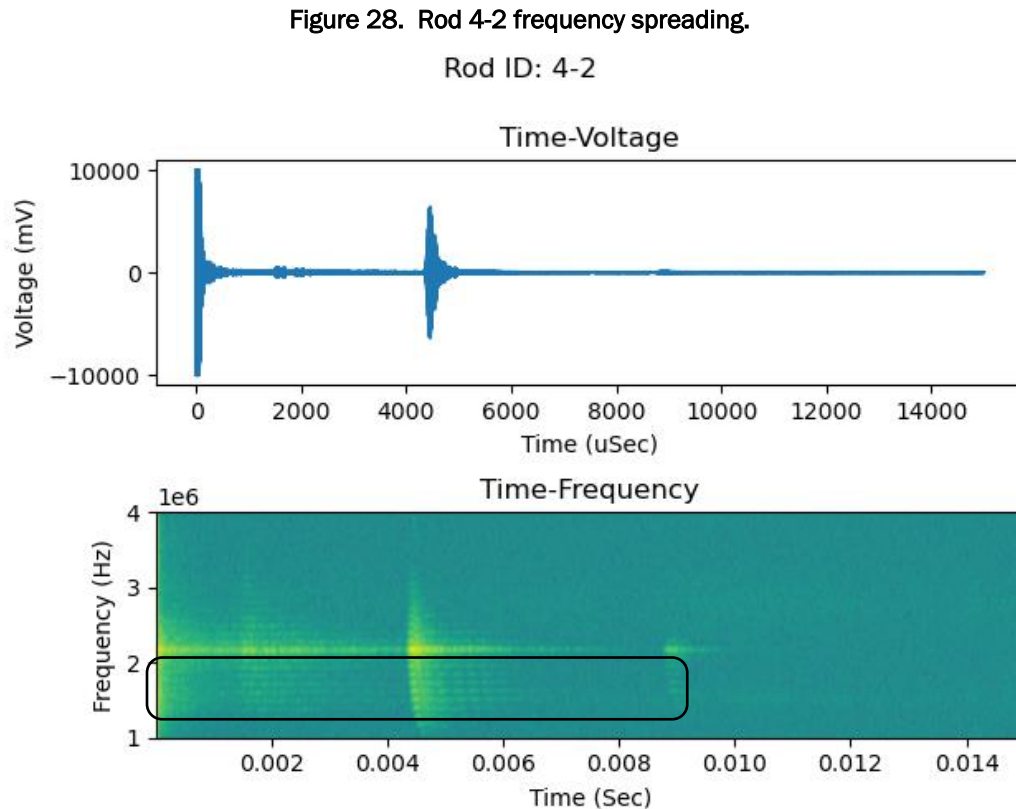
Another observation made on these two rods is how the frequency content on the end-of-rod reflection spreads further in time than other tendons. The area outlined in Figure 28 shows this spreading of frequency when plotted as an STFT.

This figure captures rod 4-2 tested at a different frequency: 2.169 MHz. This capture was chosen because the end-of-rod reflection did not clip the analog to digital converter (ADC).
