Report on Evaluation of Apartment Towers 1–4 and Parking Garages 1–4 at Camp Walker, Daegu, South Korea

April 2022

Final report

Prepared for Far East District, Pacific Ocean Division
U.S. Army Corps of Engineers
573 Bonney Loop, Building 525, Suite A300
Fort Shafter, HI 96858

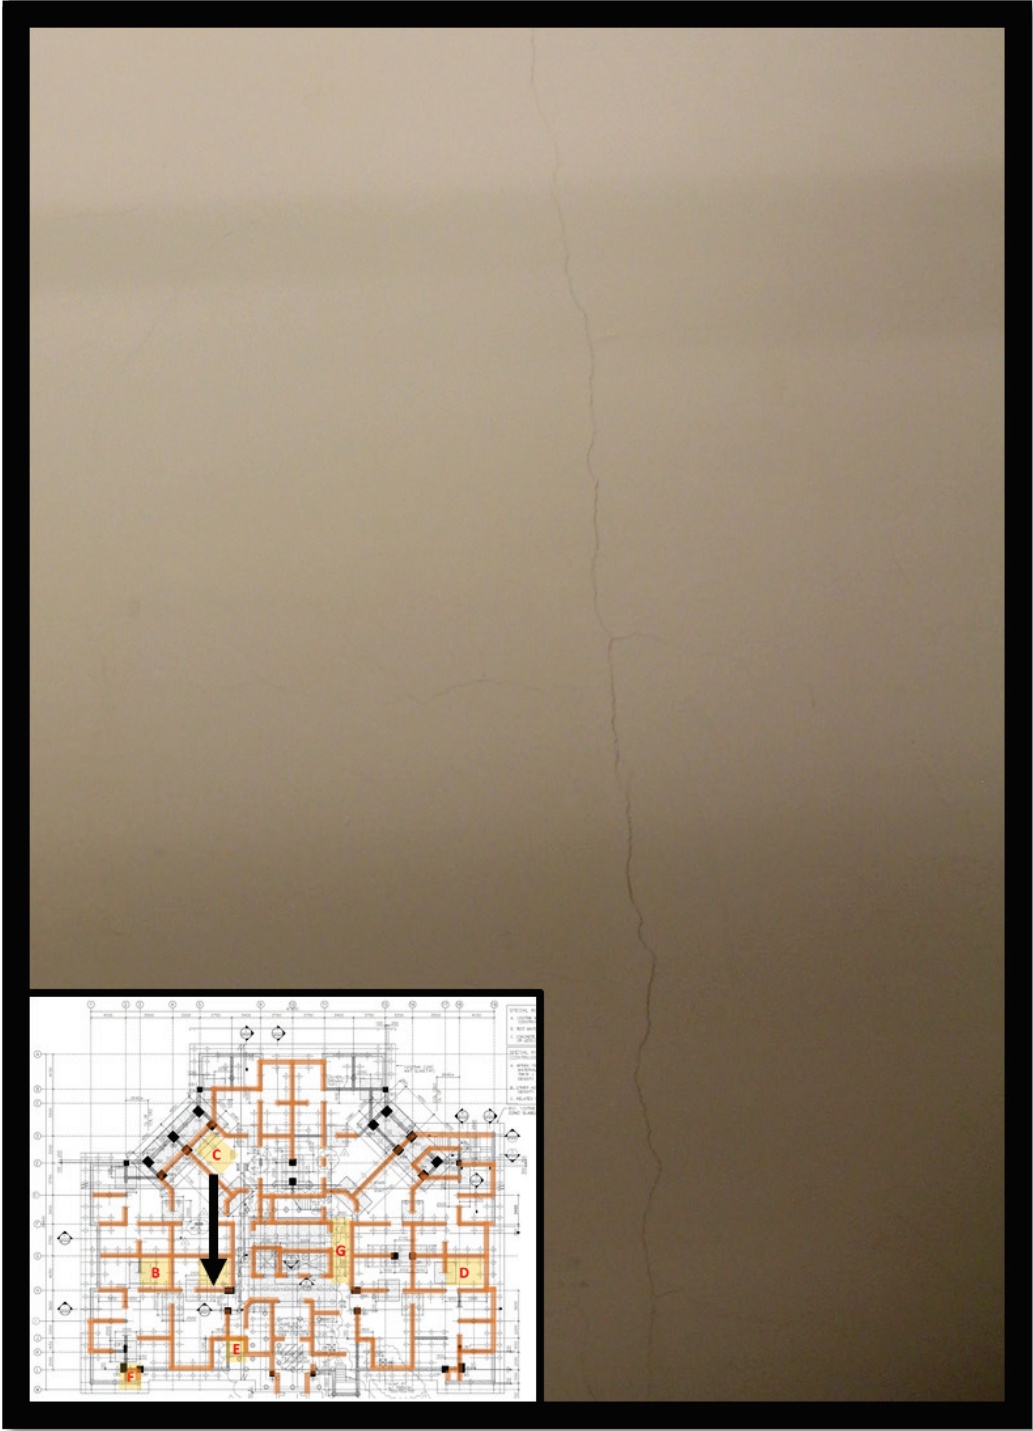
Figure 2. Vertical crack within the Tower 1 basement storage area (Section A of the floorplan insert). The widest area of the observed crack was less than 0.40 mm and did not intersect the floor slab.

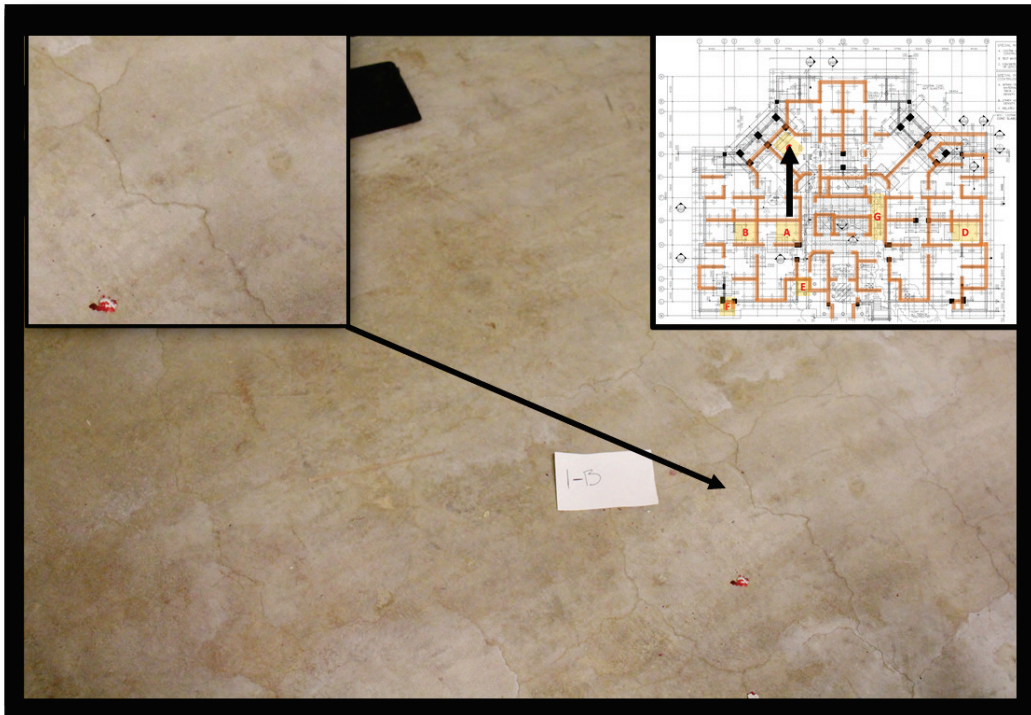
Figure 5. Slab floor cracks within the Tower 1 basement storage area (Section C of the floorplan insert). The widest observed crack width was less than 0.25 mm.

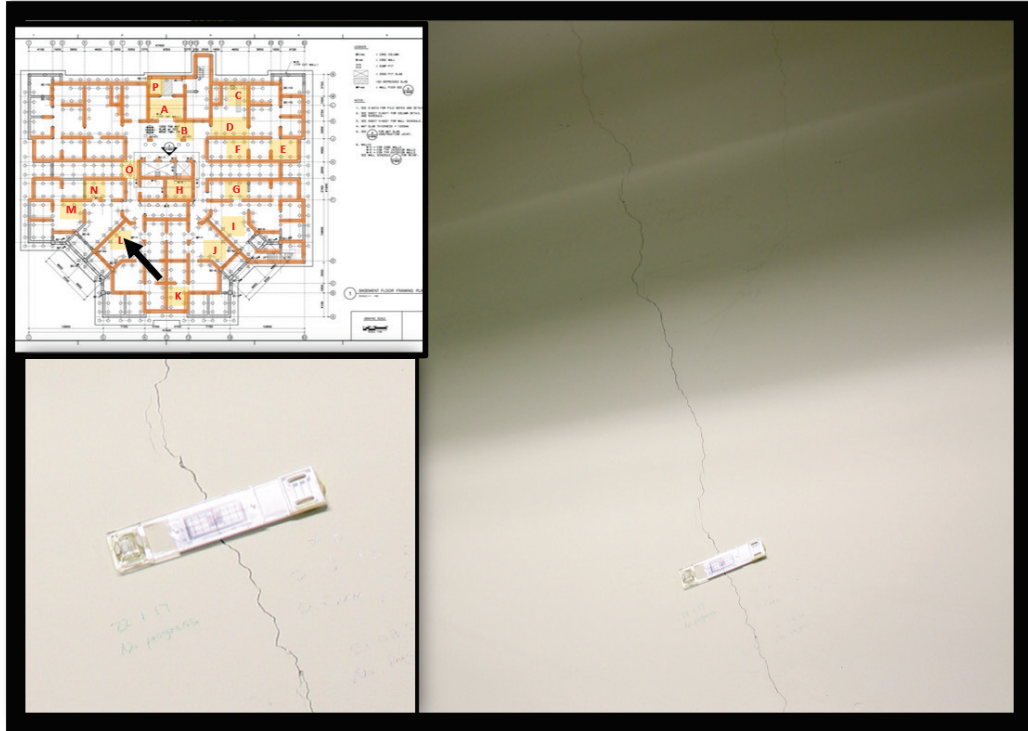
Figure 10. Largest observed diagonal crack within the Tower 2 basement storage area (Section L of the floorplan insert). The widest section of the observed crack was 0.50 mm (crack gauge insert); however, the crack width narrows at the extents and does not intersect with the floor slab.

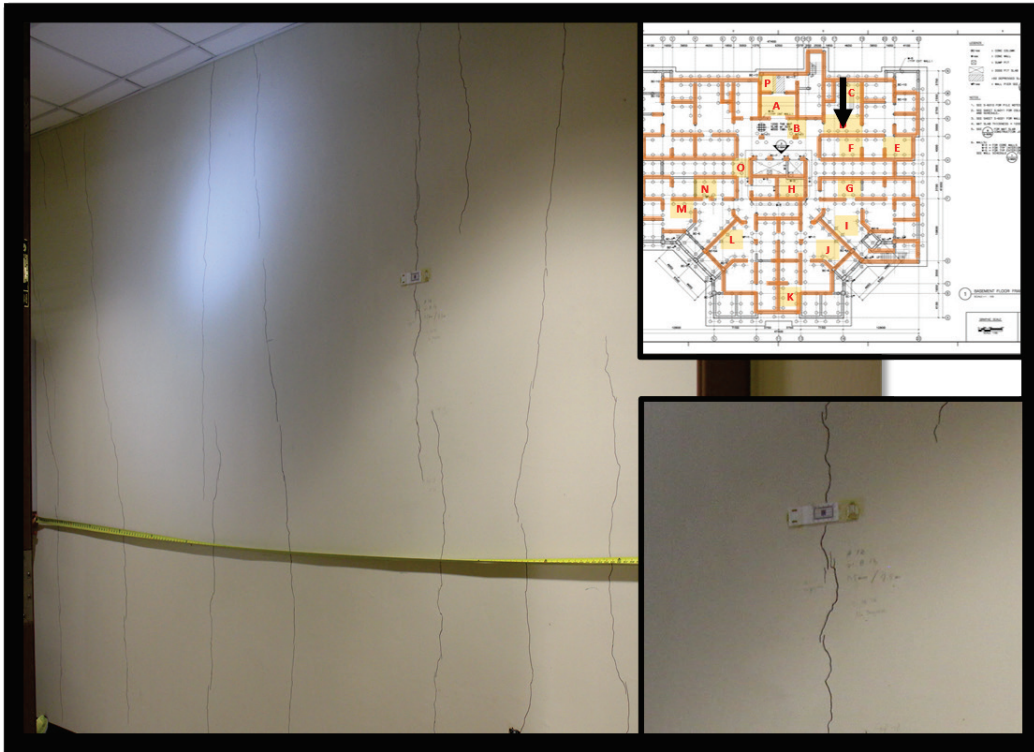
Figure 15. Wall cracks within the Tower 2 basement storage area (Section D of the floorplan insert). The widest observed crack width was less than 0.50 mm (crack gauge insert). The shown cracks were traced with a permanent marker to highlight typical locations, lengths, and spacing and are not representative of crack width.

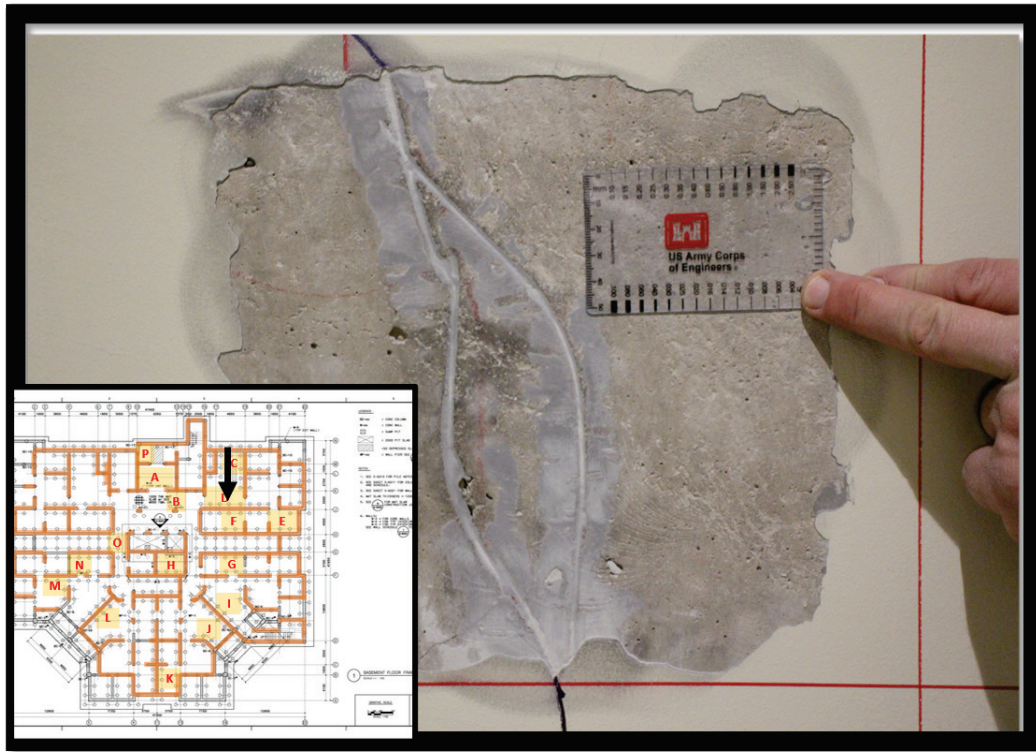
In many areas, it was obvious that cracks had been repaired prior to the structure being turned over to the garrison. Figure 16 shows a typical example of these repairs under the mud and paint. These cracks were first opened and smoothed with a grinder and then infilled with an elastomeric polymer grout. This repair method is common and is useful for preventing water ingress and related durability issues, as well as improving aesthetics.

Figure 16. Typical observed repaired vertical cracking within the Tower 2 basement storage area (Section D of the floorplan insert). The repaired region has been intentionally widened with an angle grinder and filled with a polymer grout.

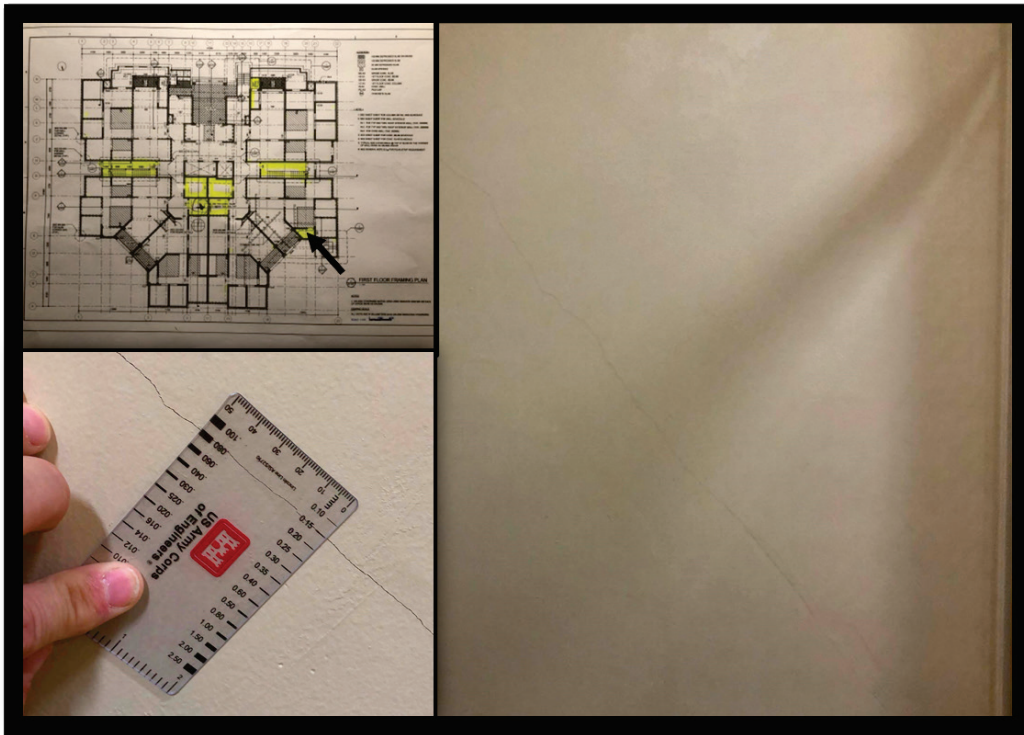
Figure 25. Representative diagonal crack within the nonbasement floors of Tower 3 (Apartment Section of the 1st Floor floorplan insert). The widest section of the crack was 0.15 mm (crack gauge insert).

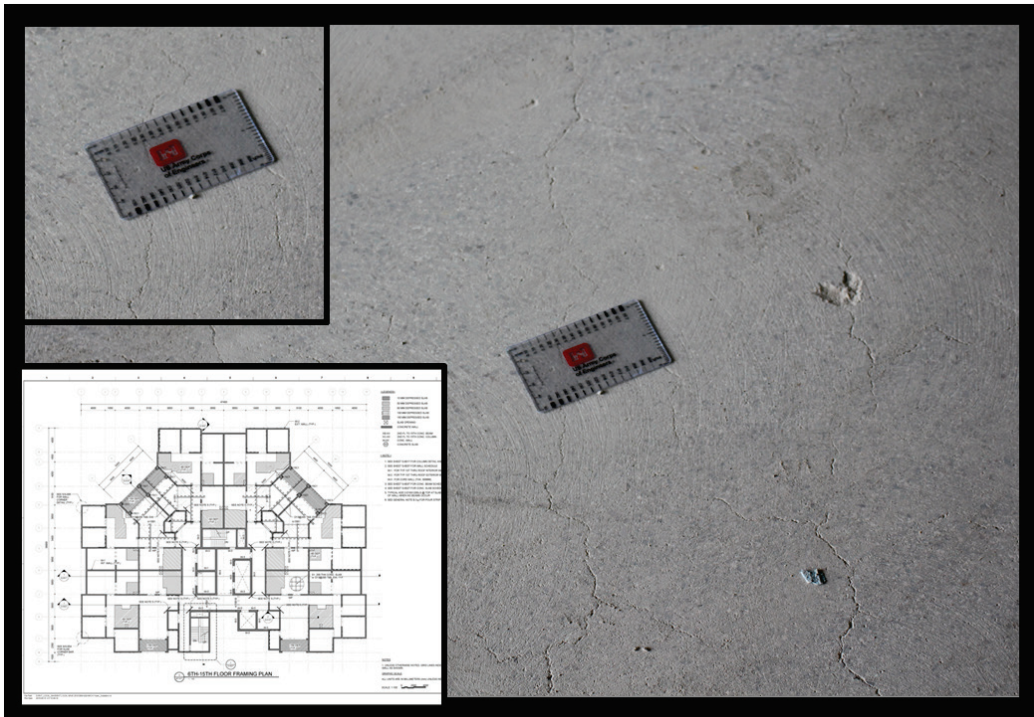
Figure 30. Observed slab cracking in Tower 4 (floorplan insert). The crack widths were less than 0.15 mm (crack gauge insert).

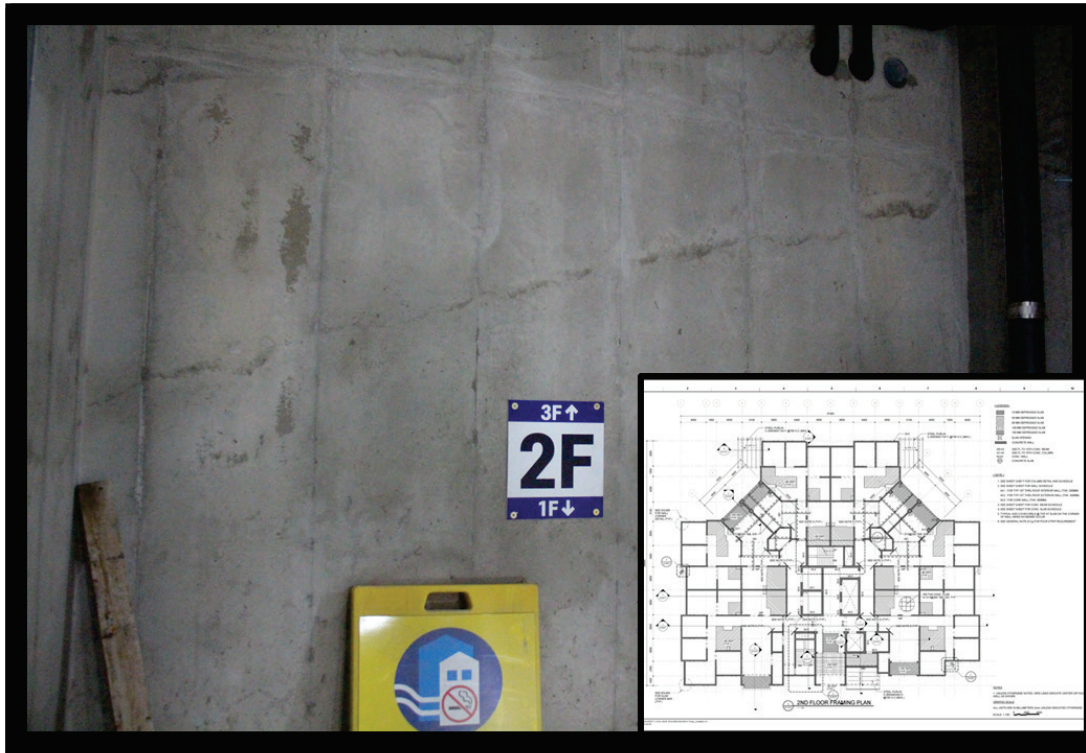
Figure 31. Observed cold joint in Tower 4 stairwell (floorplan insert).

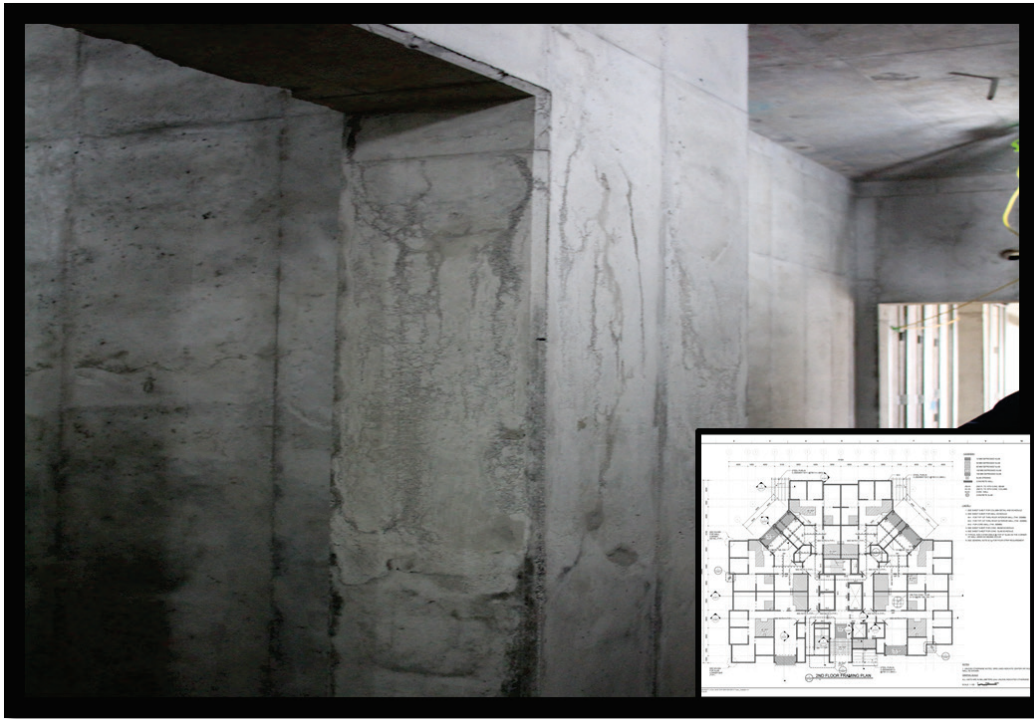
Figure 34. Nonuniformity in Tower 4 concrete wall (floorplan insert).

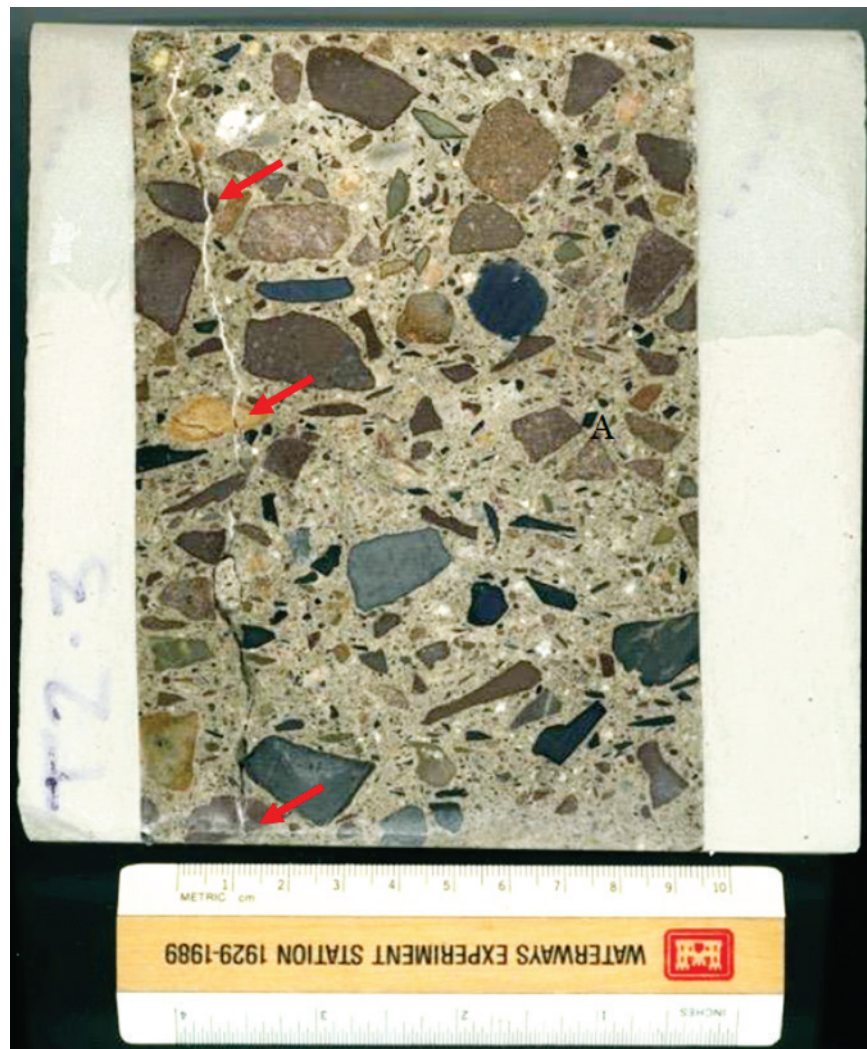
Figure 41. Polished cross section of core T2-3 with locations of cracking through aggregates indicated.

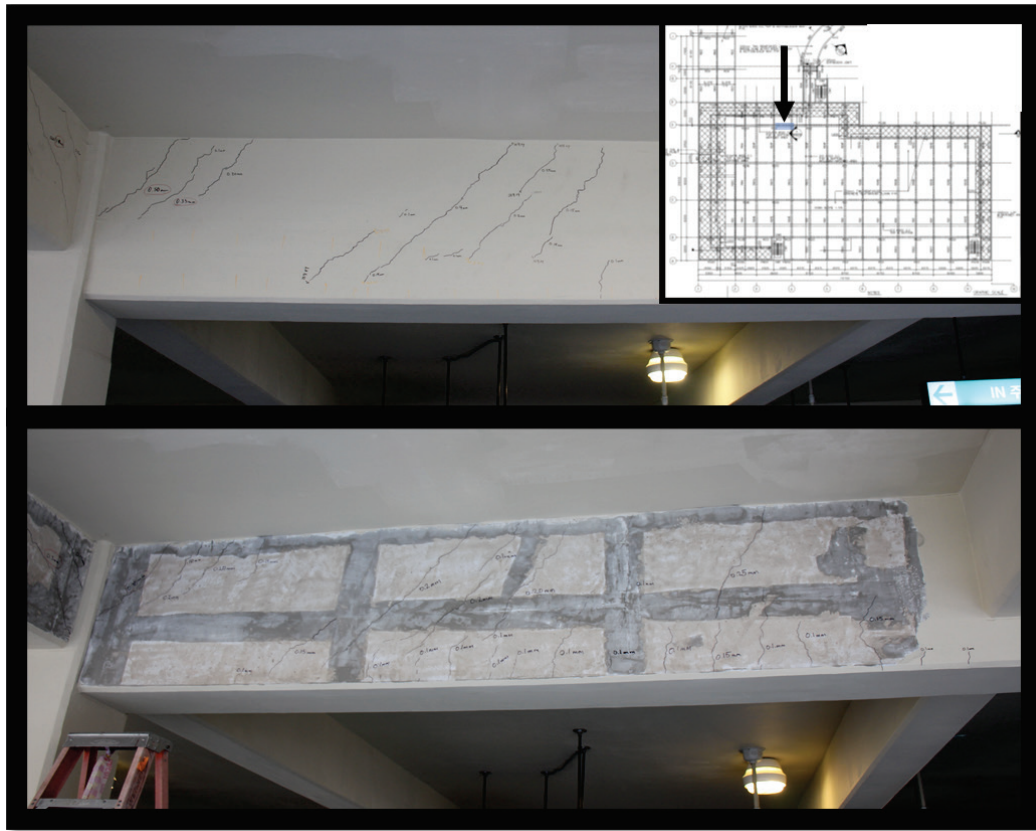
Figure 42. Comparison of crack pattern and width above and below coating in Garage 1. The crack patterns did not change when the surface coating was removed, and the widths were all within 0.05 mm of those measured on top of the coating.

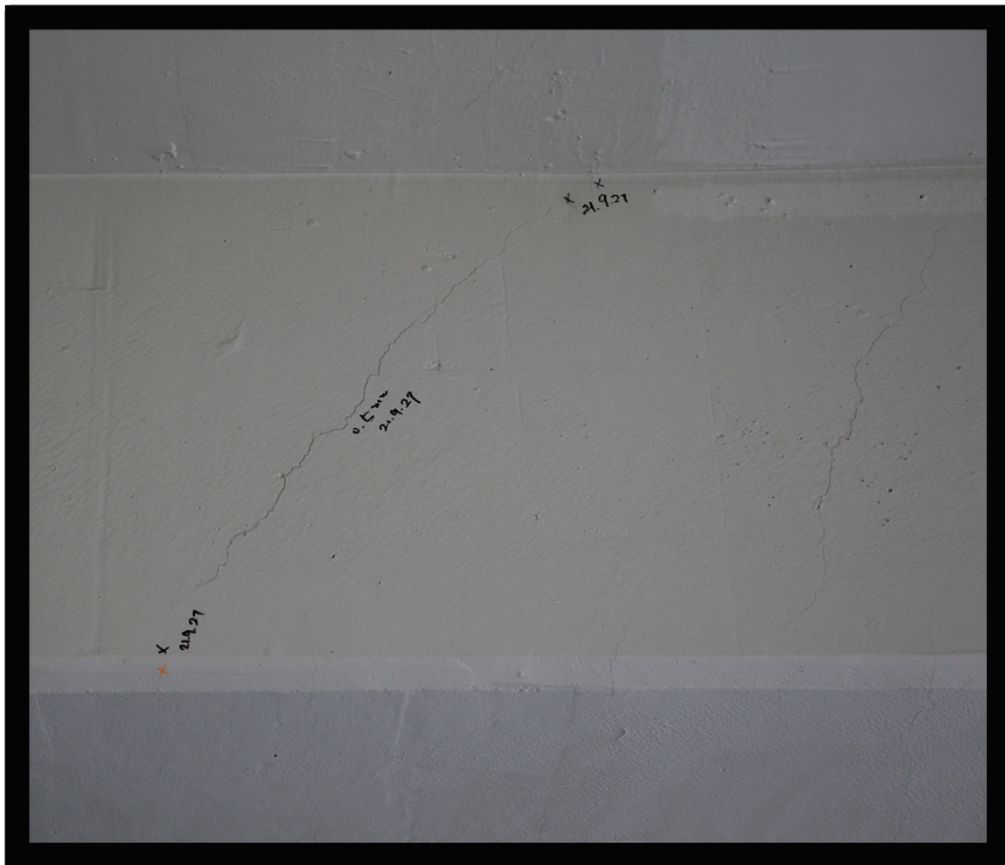
Figure 44. Typical diagonal crack in beam showing decrease in crack width at bottom and top of beam.

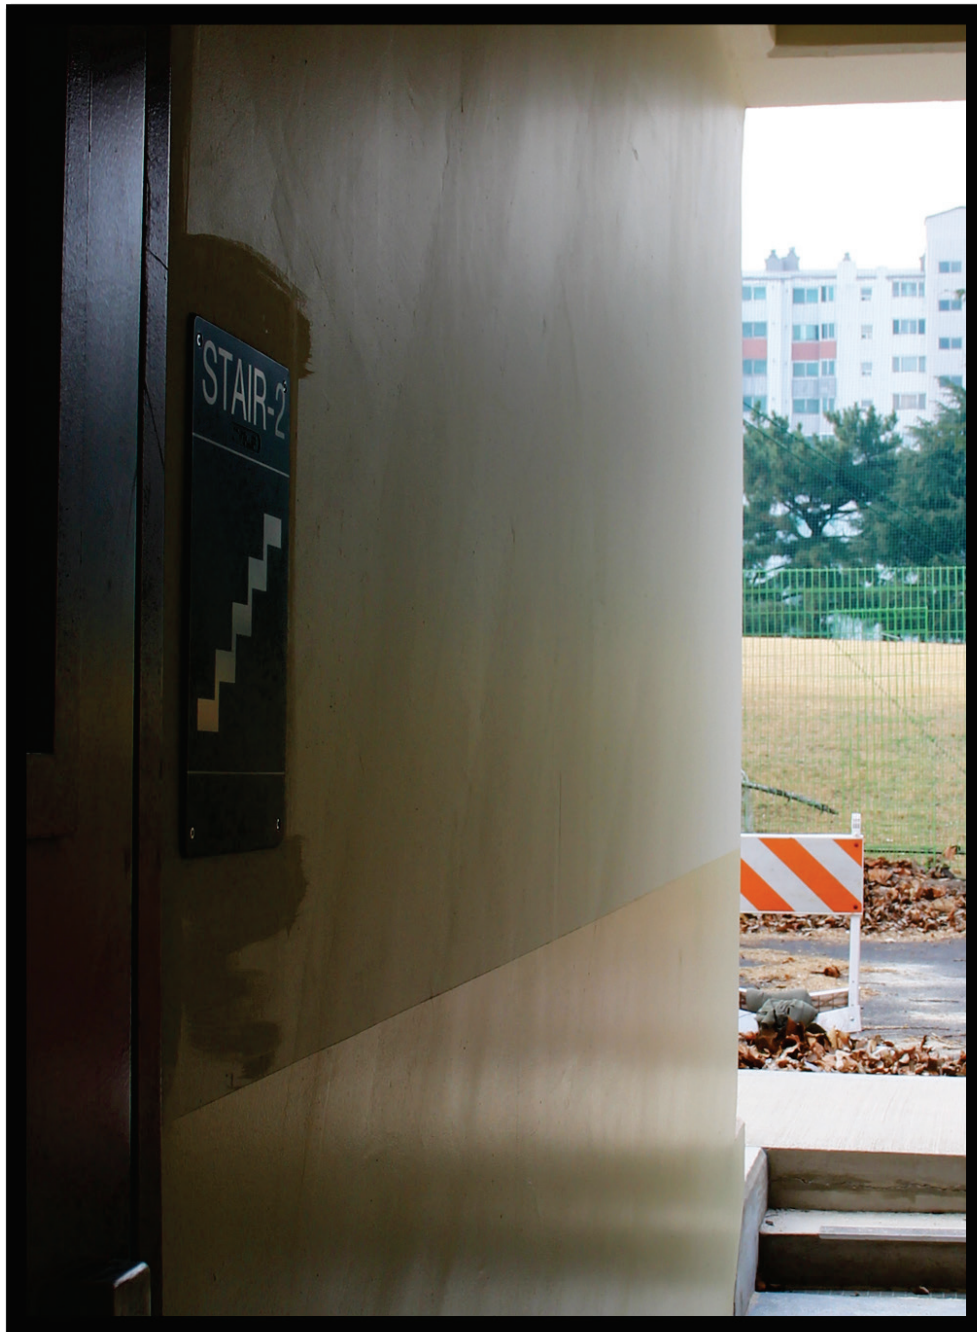
Figure 52. Repaired wall of cracked stairwell in Parking Garage 3.

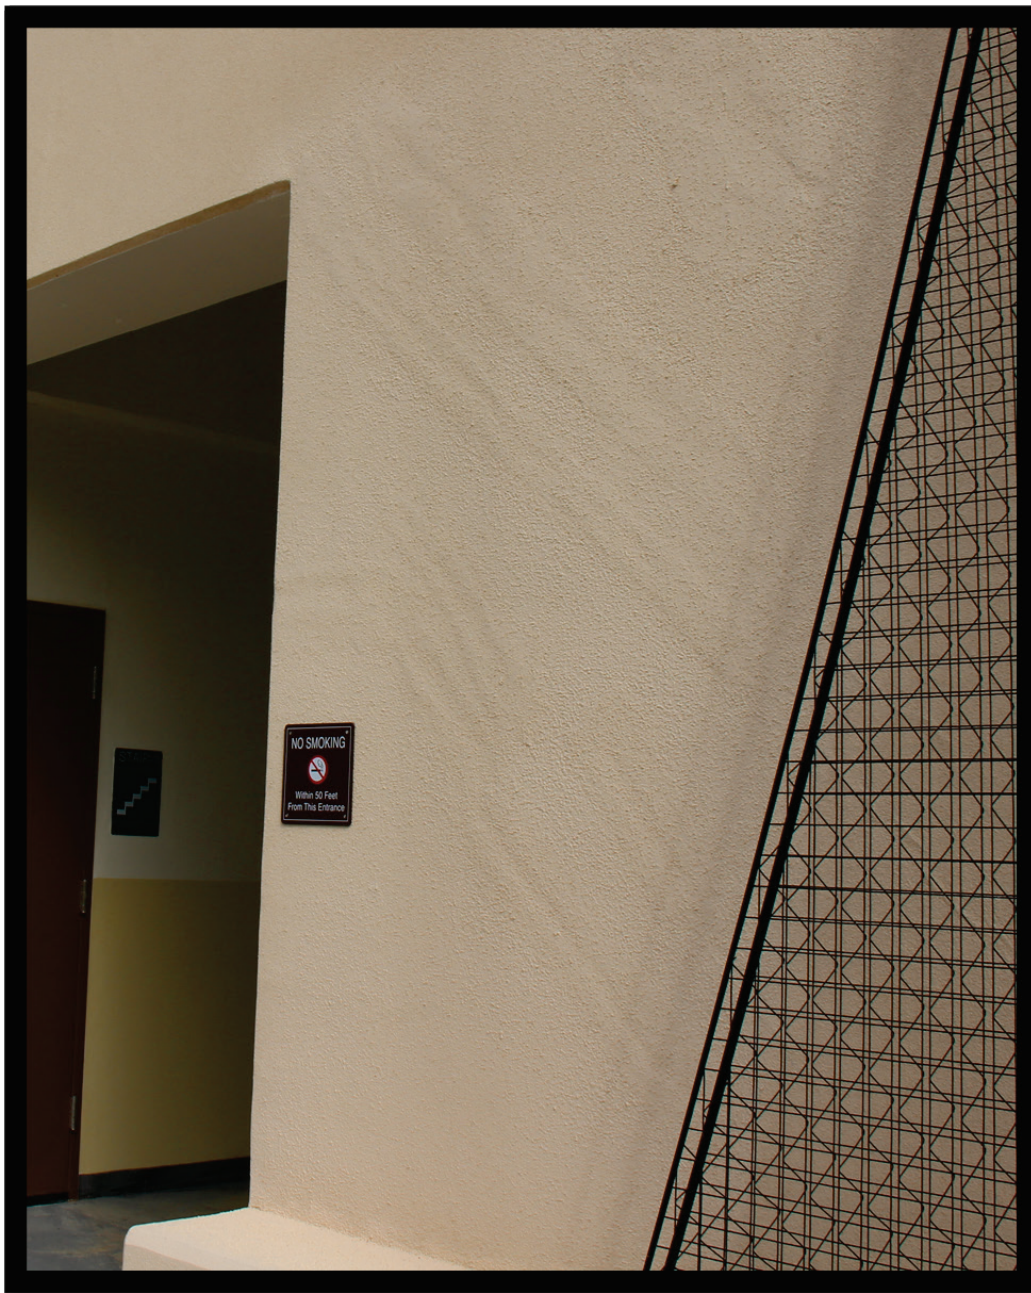
Figure 53. Repaired diagonal concrete cracks visible beneath exterior coating on Parking Garage 3.

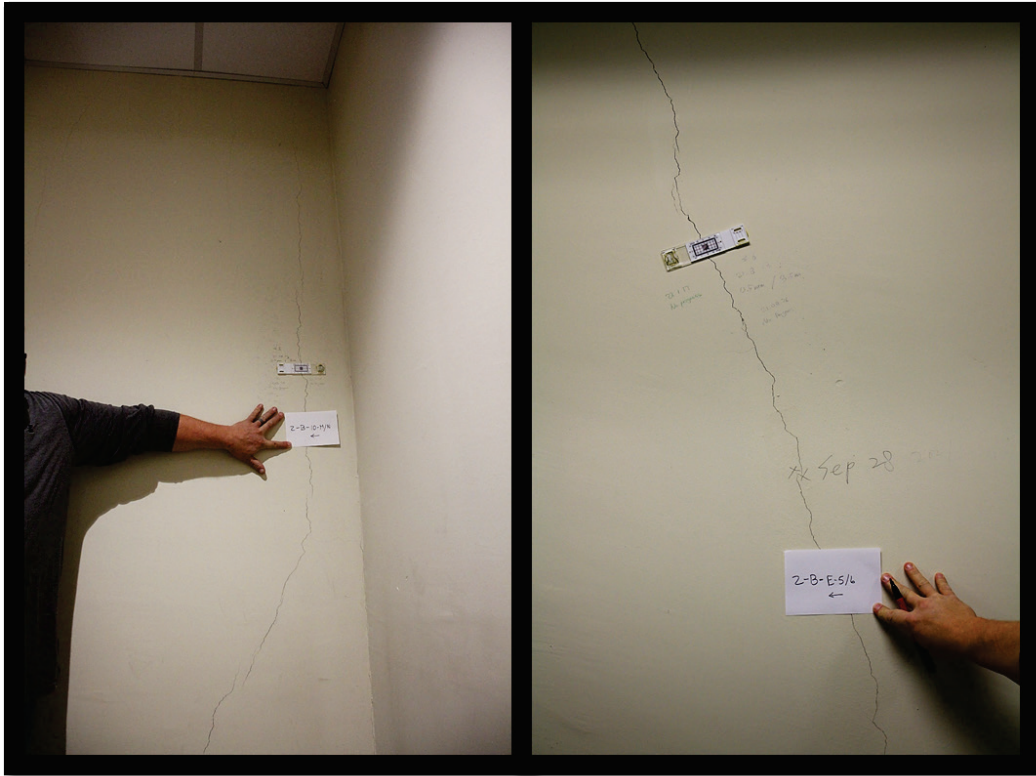
Figure B12. Wall cracks with gauges in Tower 2 basement.

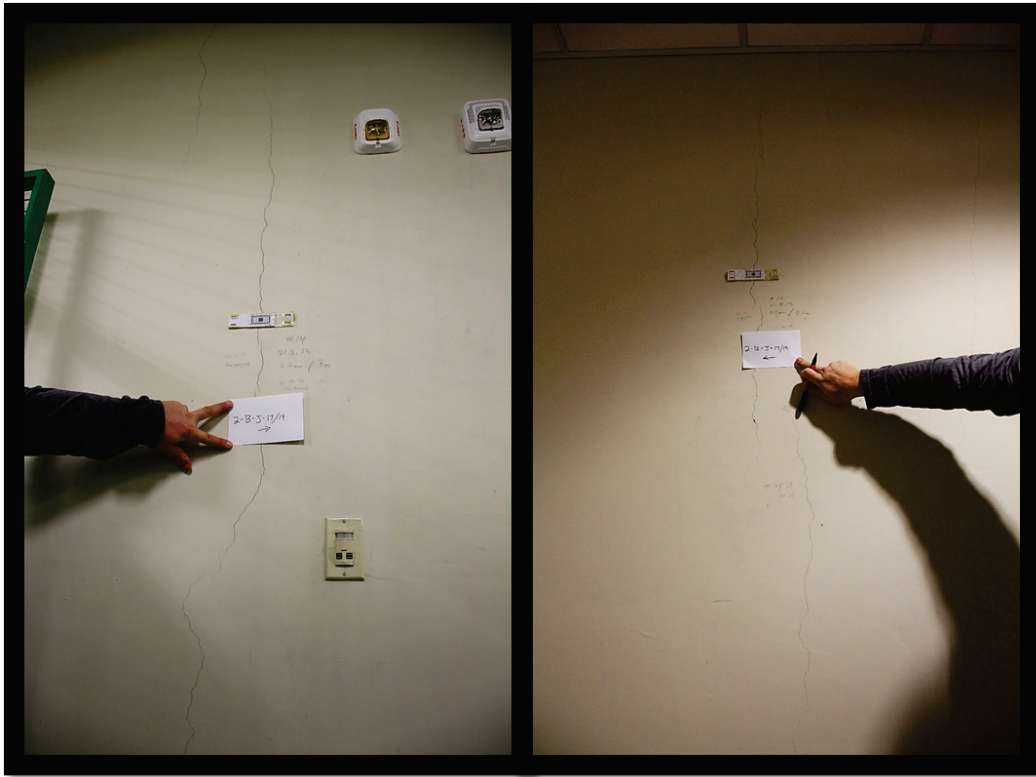
Figure B14. Wall cracks with gauges in Tower 2 basement.

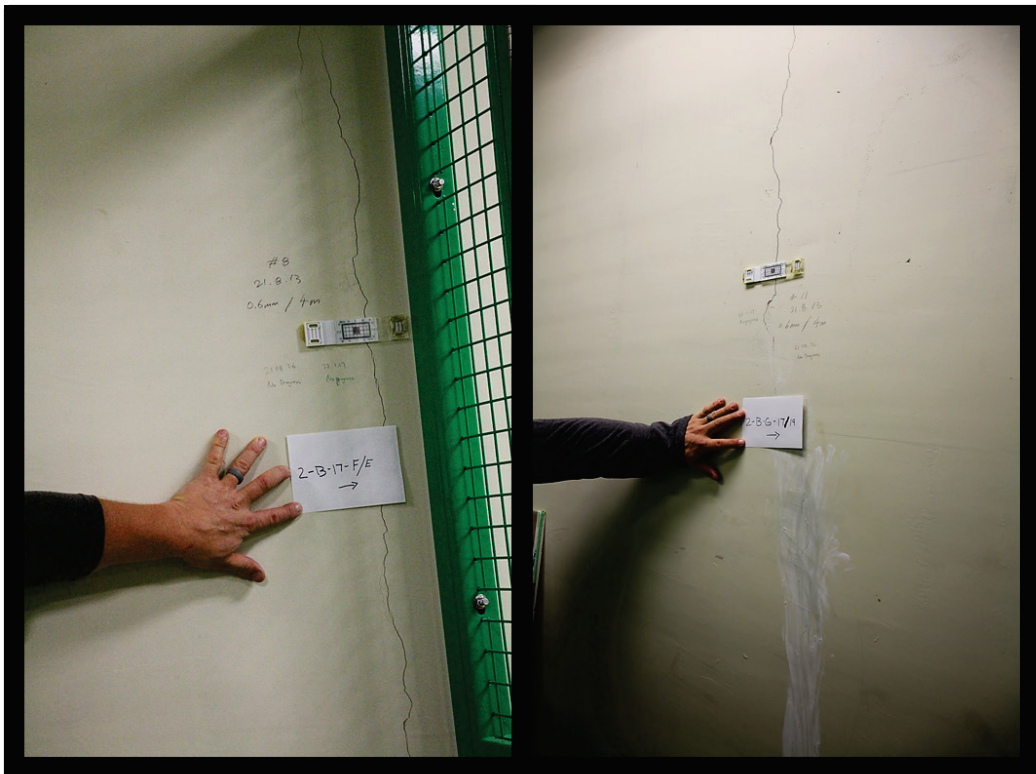
Figure B15. Wall cracks with gauges in Tower 2 basement.

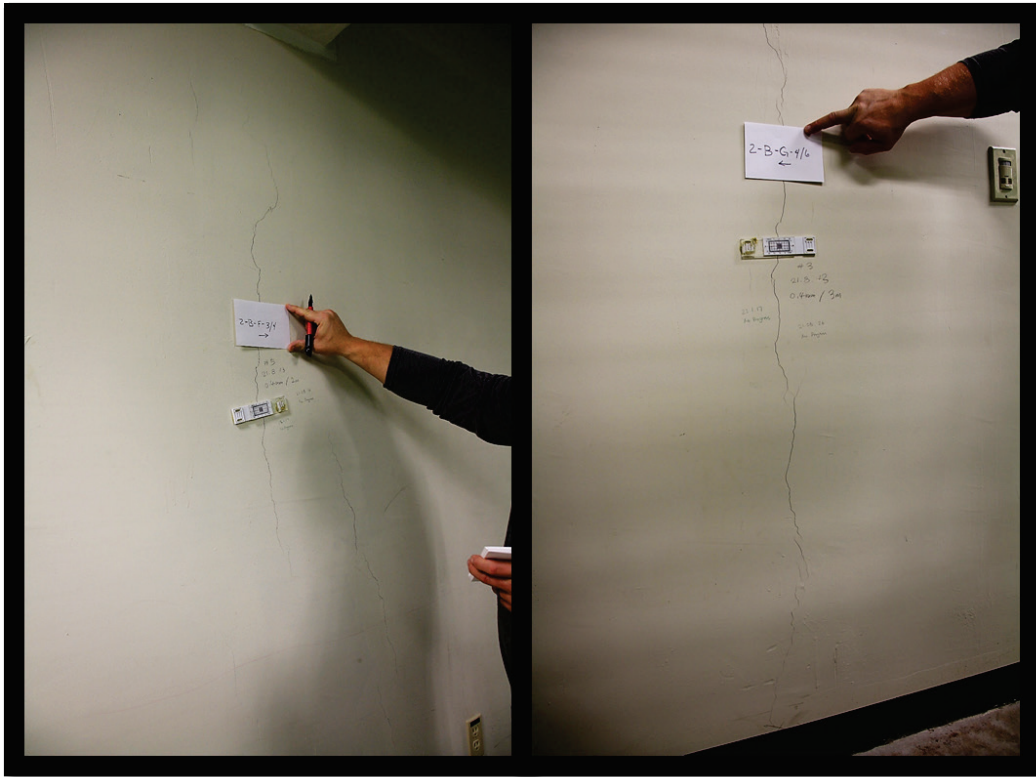
Figure B16. Wall cracks with gauges in Tower 2 basement.

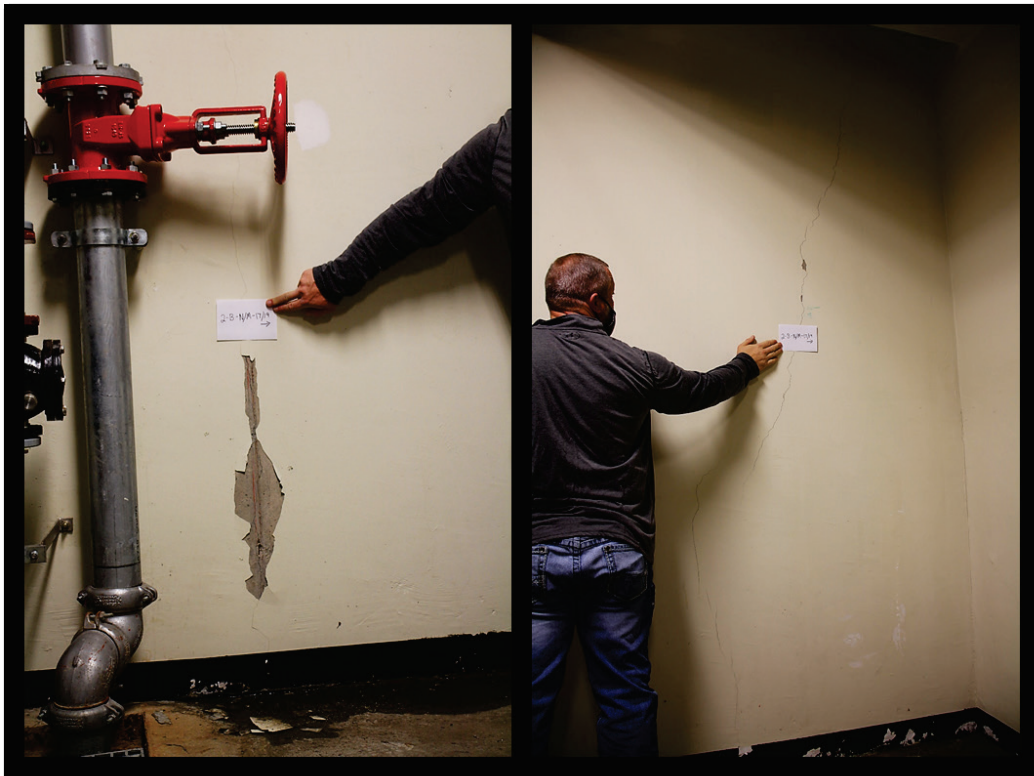
Figure B21. Cracks in basement mechanical room of Tower 2.

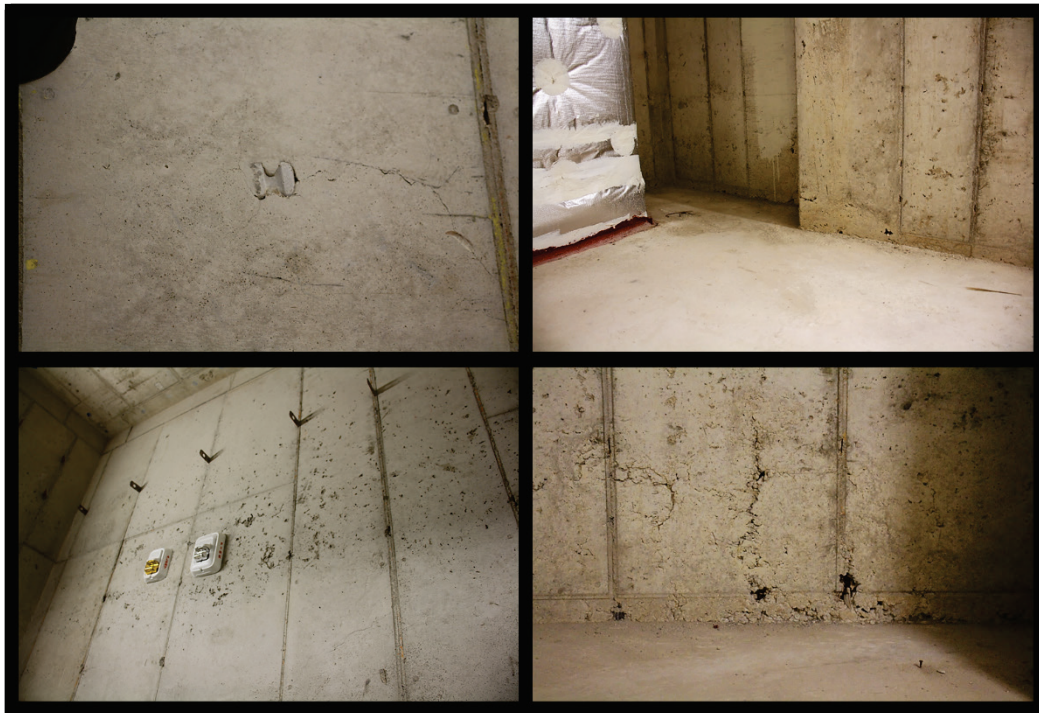
Figure B24. Embedded rebar support (top left) and honeycombing and poor consolidation in shafts behind elevators in Tower 2.

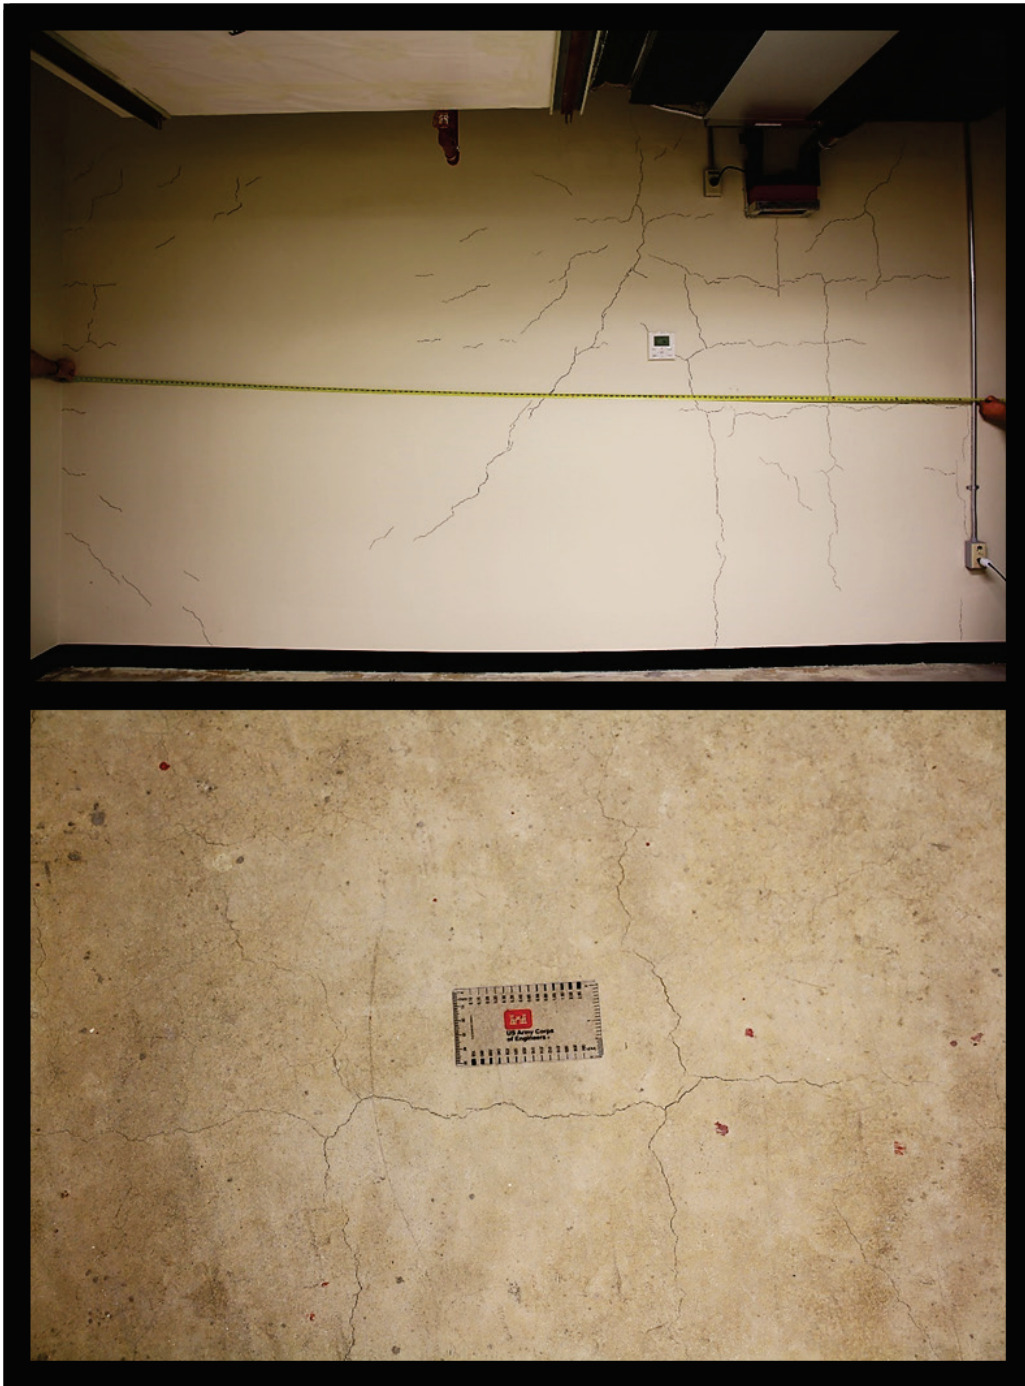
Figure B25. Mapped wall cracks (top) and floor slab shrinkage cracks in elevator mechanical room in Tower 2.

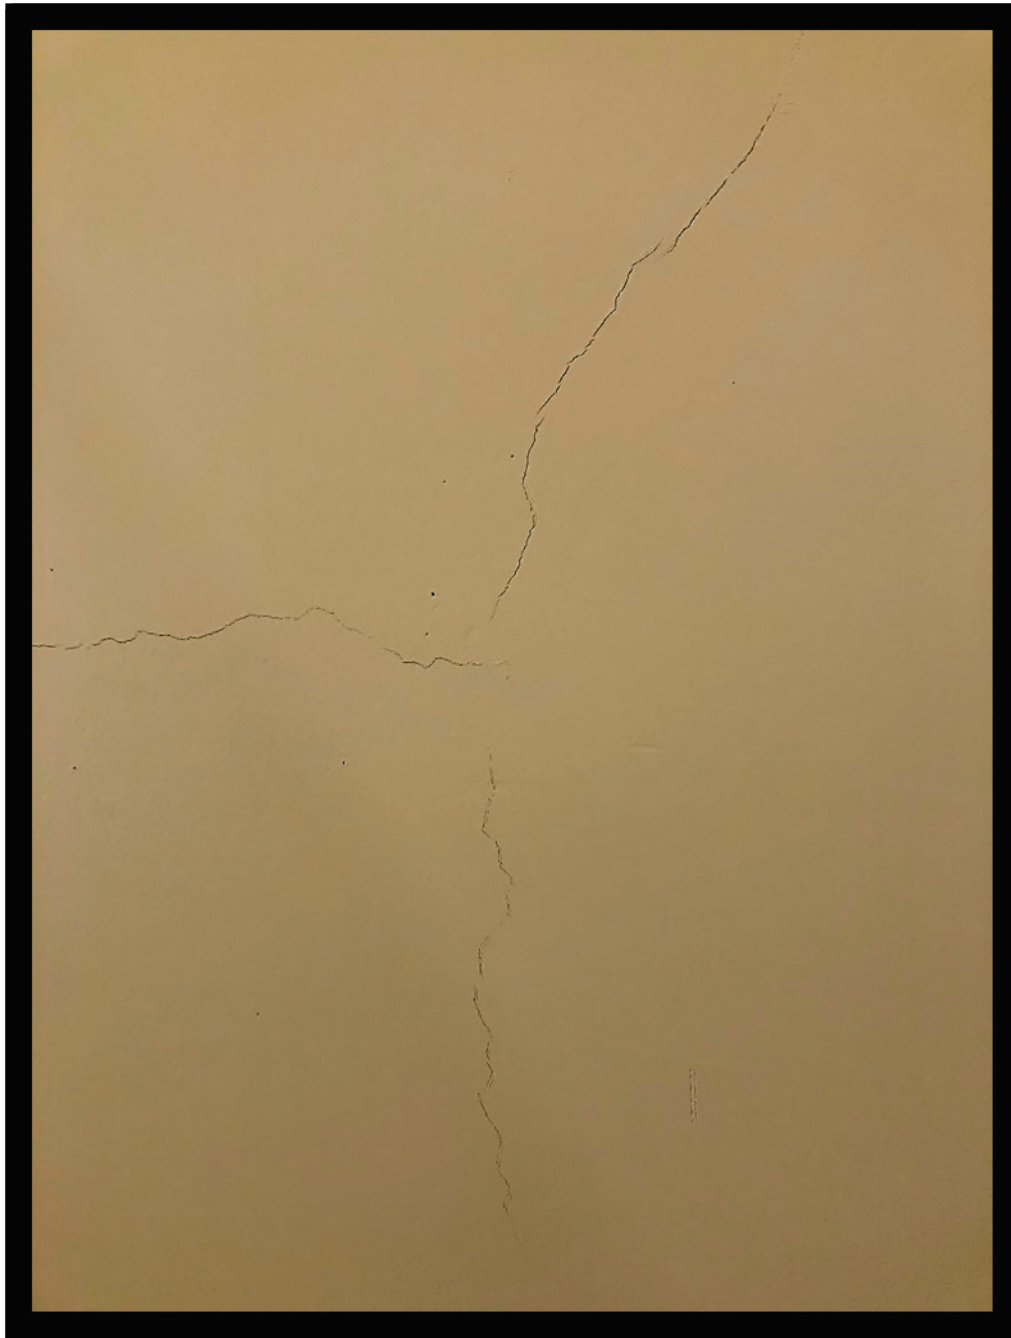
Figure B31. Vertical and horizontal cracks in basement wall of Tower 3.

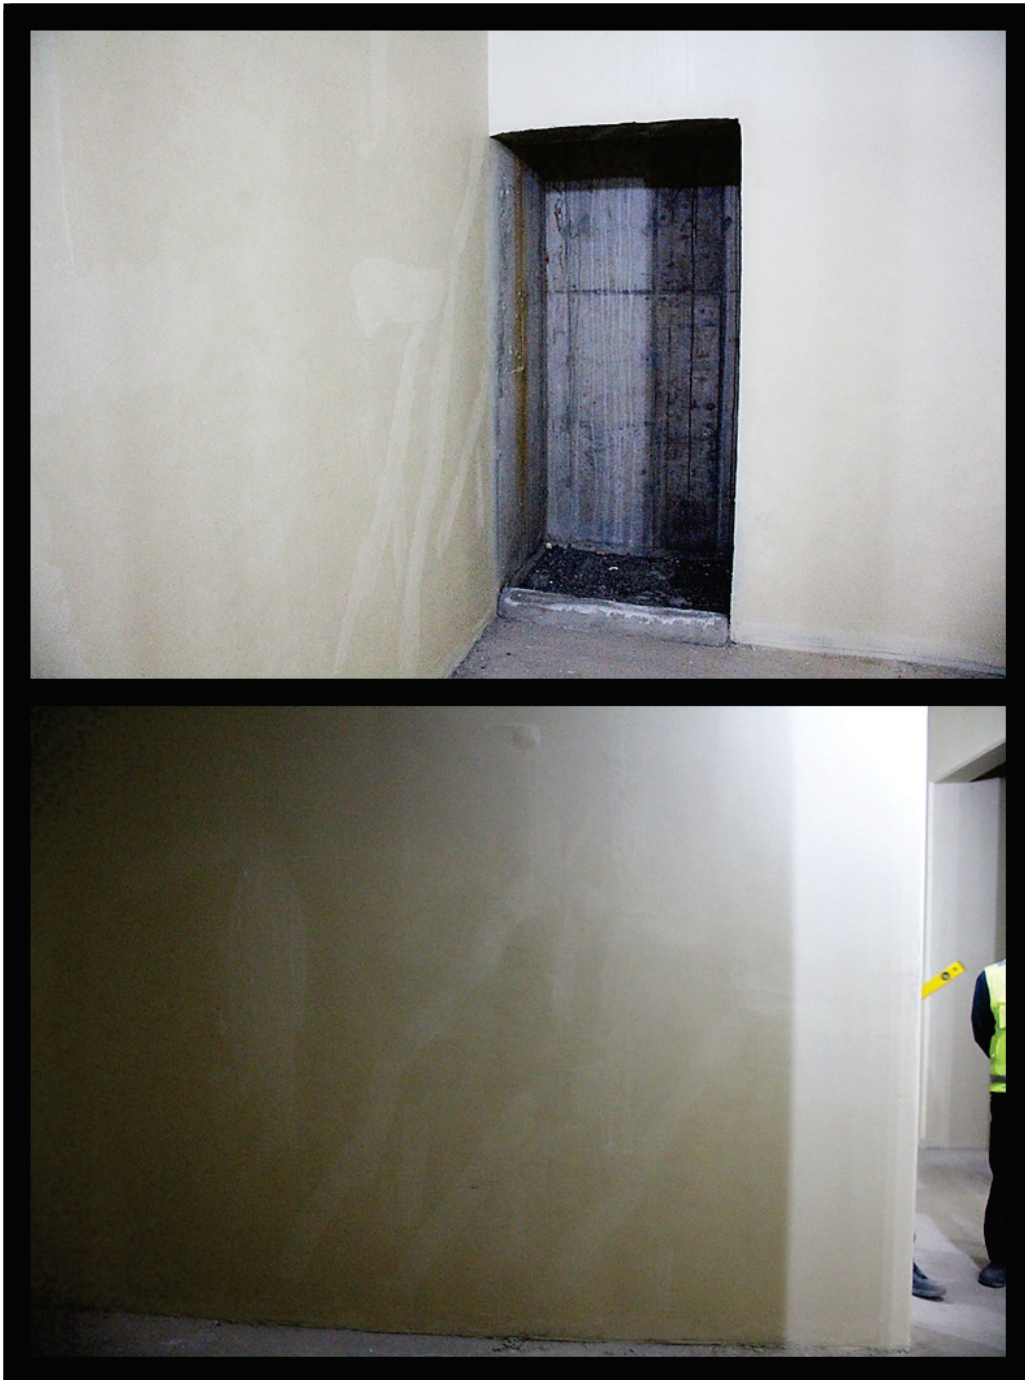
Figure B39. Diagonal cracks in basement walls of Tower 4.
