Report on Evaluation of Apartment Towers 1–4 and Parking Garages 1–4 at Camp Walker, Daegu, South Korea

April 2022

Final report

Prepared for Far East District, Pacific Ocean Division
U.S. Army Corps of Engineers
573 Bonney Loop, Building 525, Suite A300
Fort Shafter, HI 96858

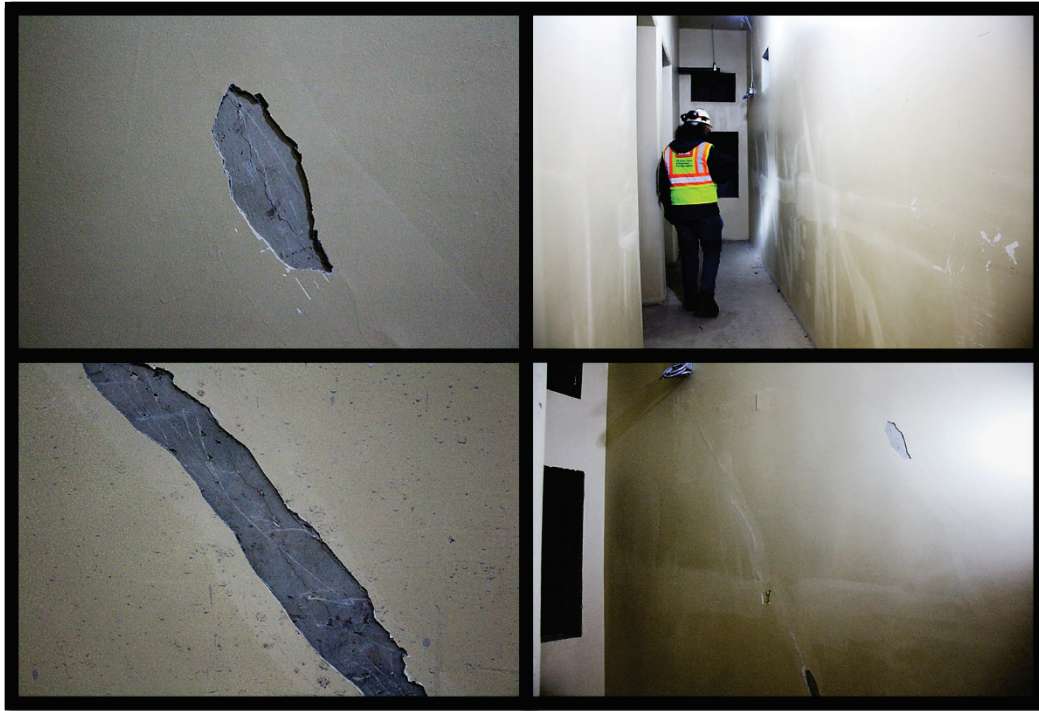
Figure B40. Diagonal cracks in basement walls of Tower 4.

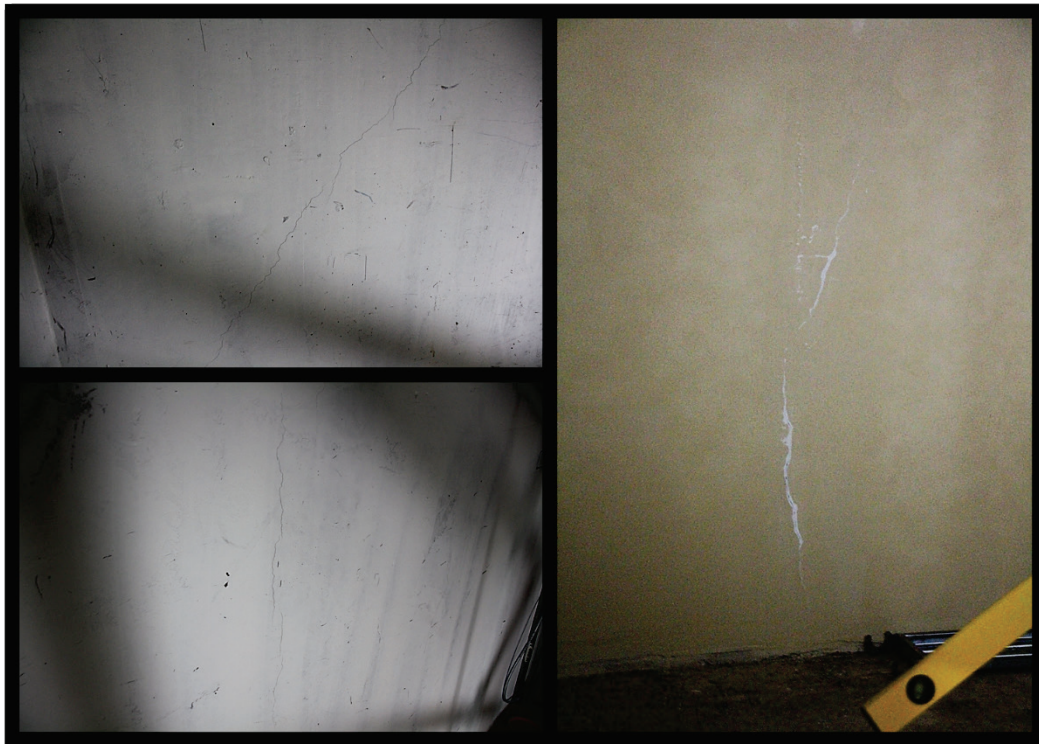
Figure B41. Cracks in walls of Tower 4.

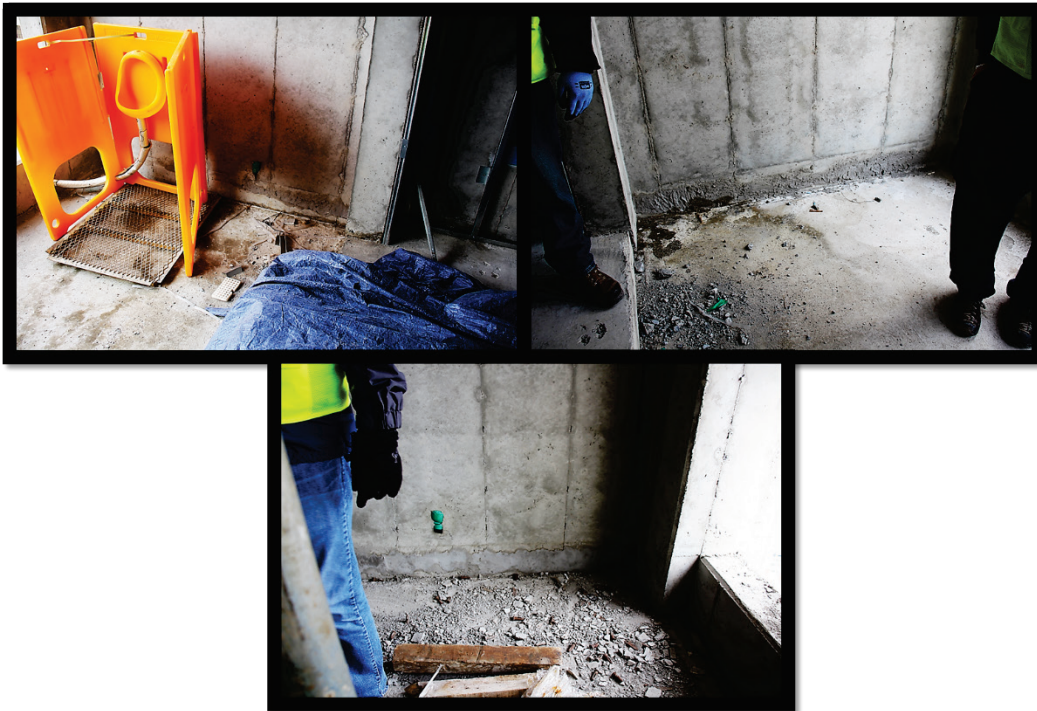
Figure B43. Poor consolidation at balconies of Tower 4.

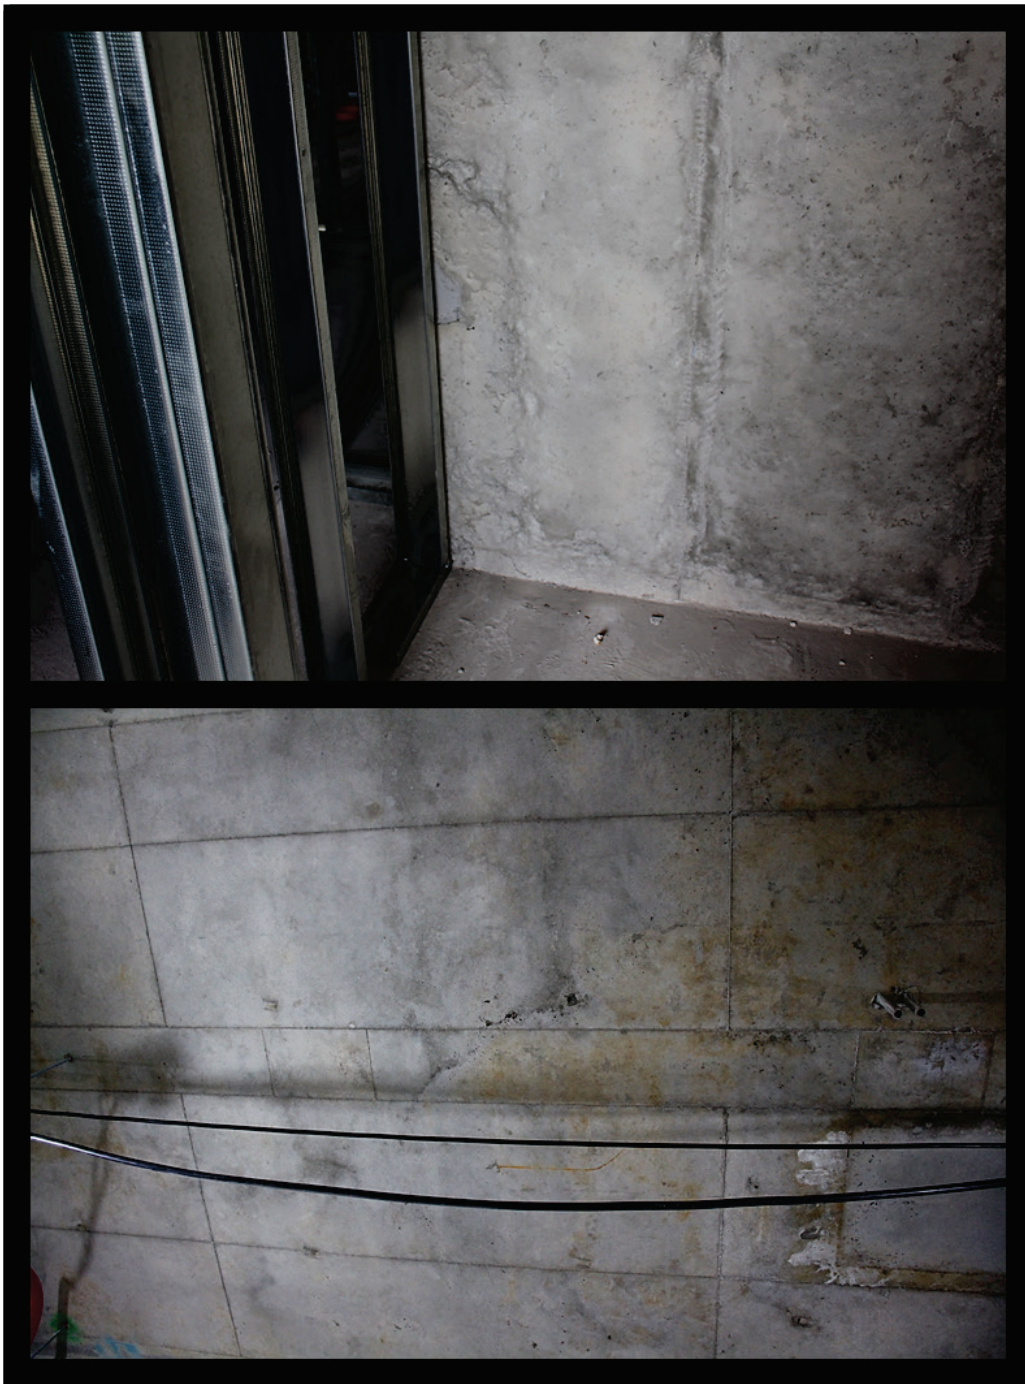
Figure B44. Nonuniformity (top) and staining (bottom) of concrete in Tower 4.

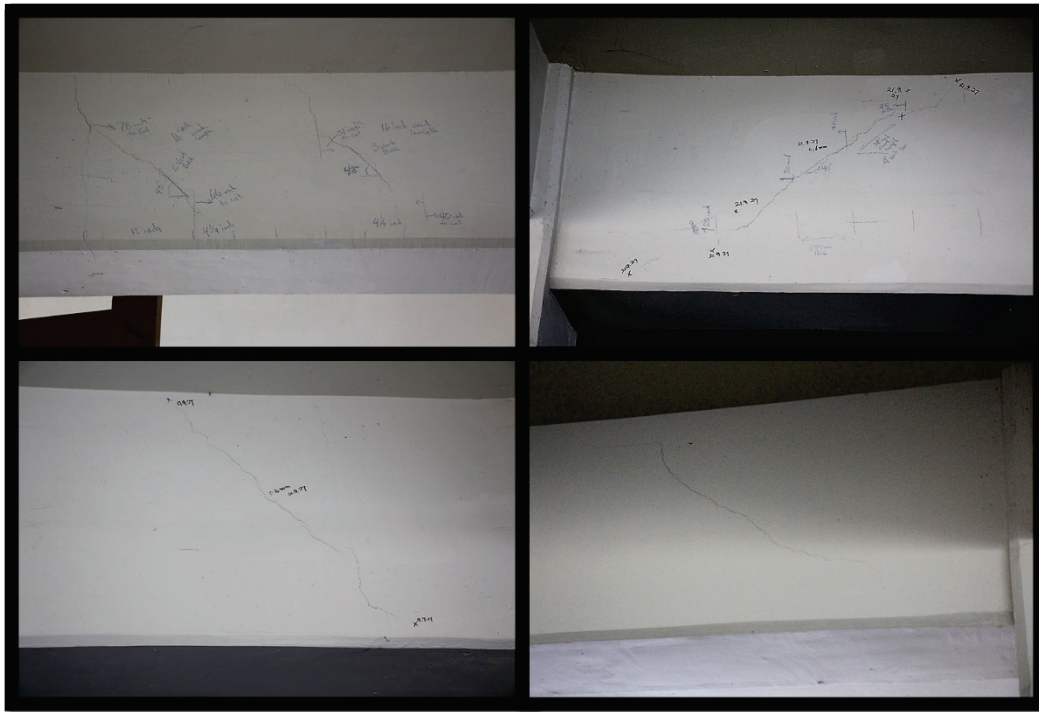
Figure B51. Diagonal cracks in girders and beams in Parking Garage 1.

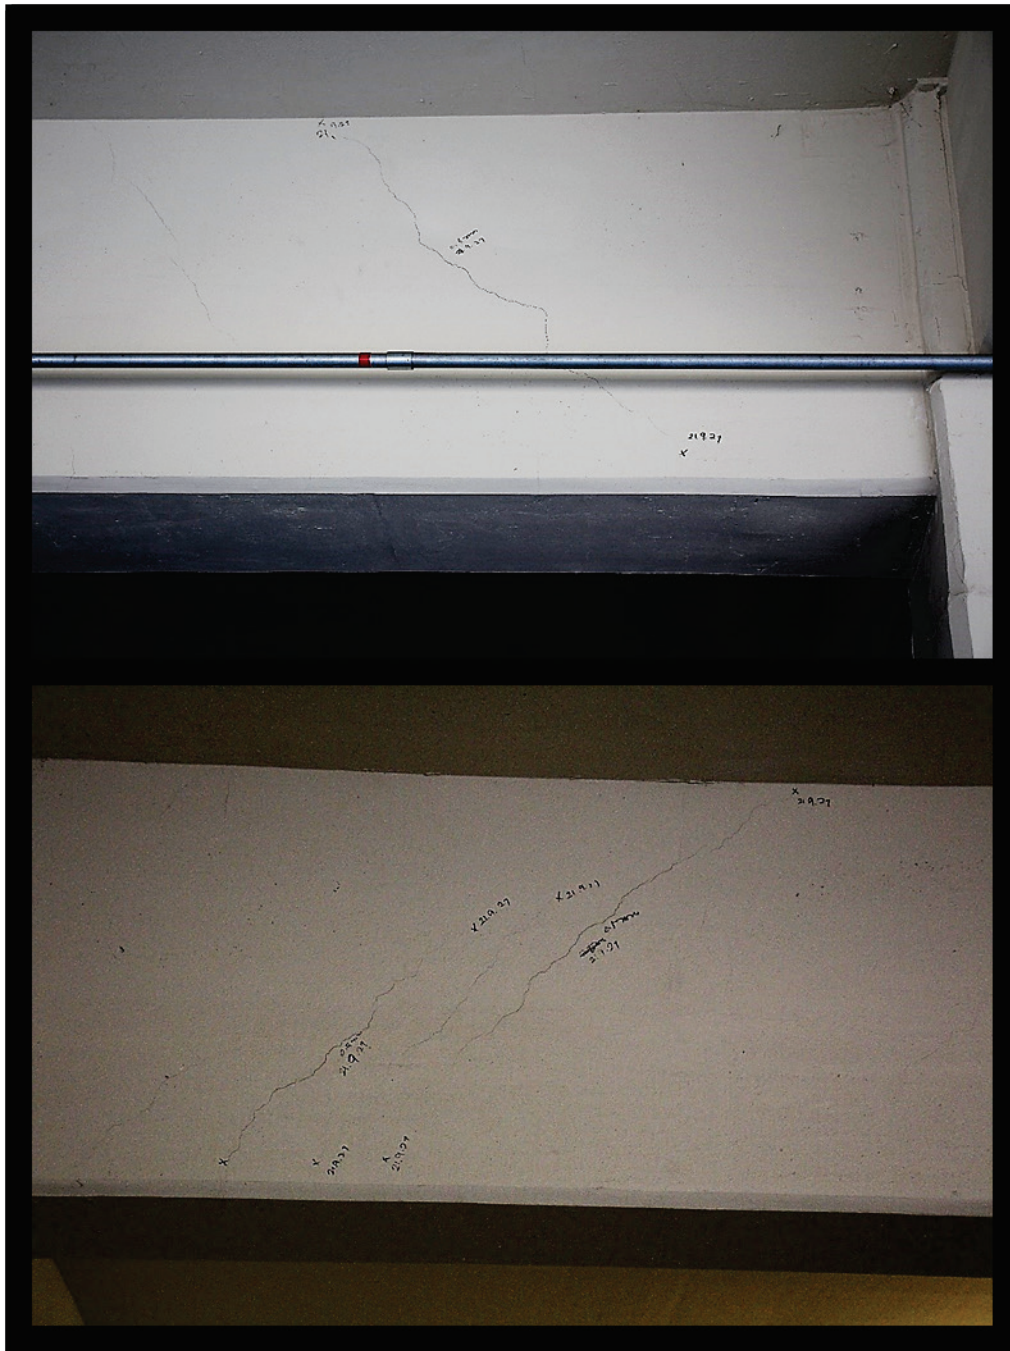
Figure B52. Diagonal cracks in girders in Parking Garage 1.

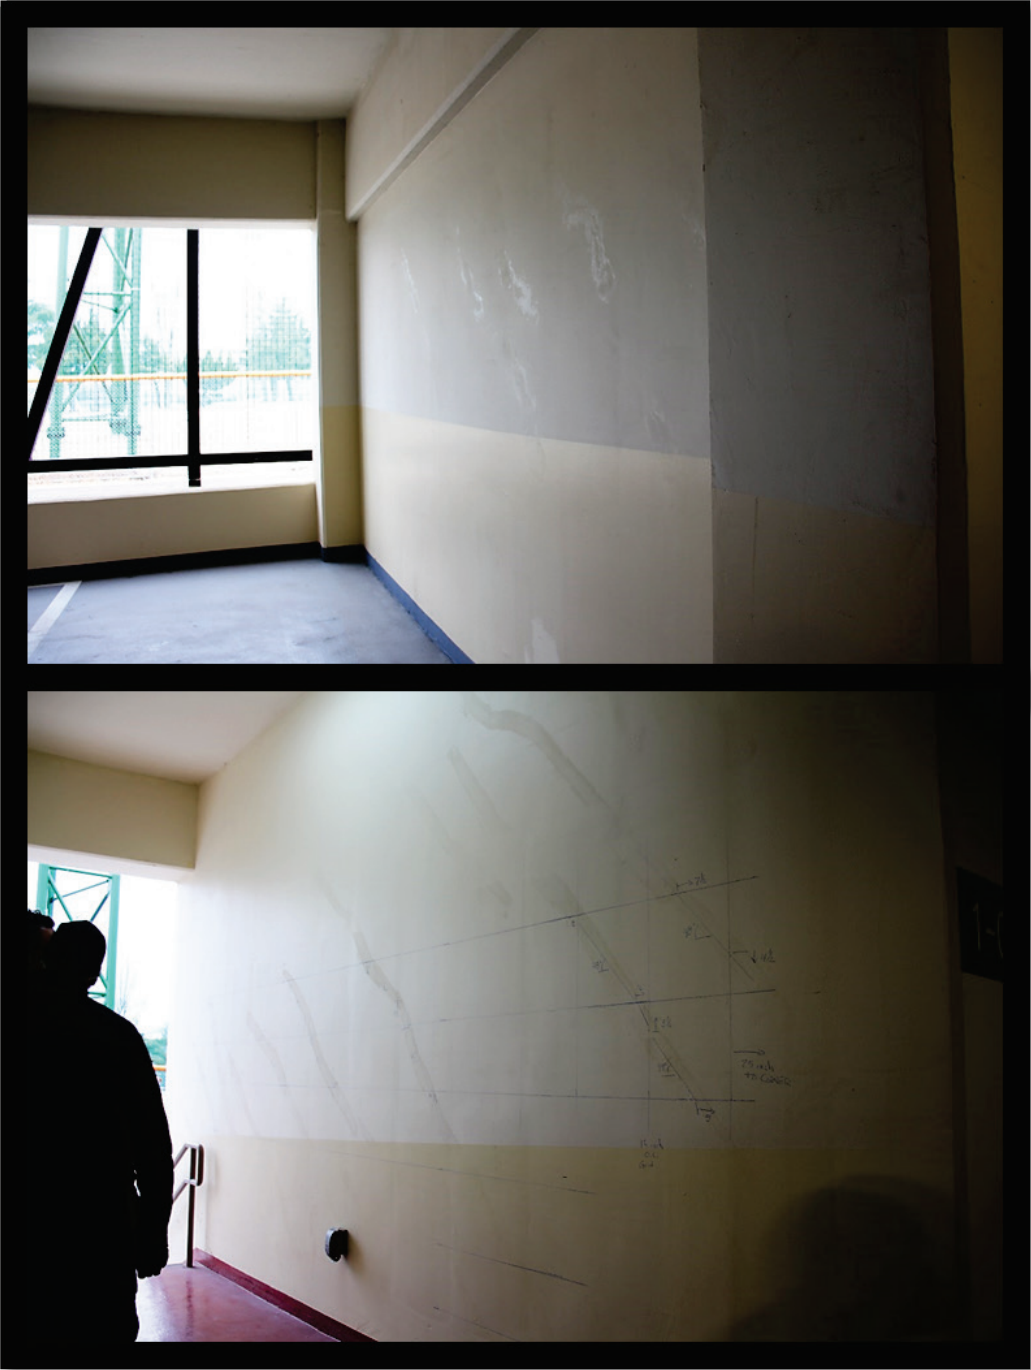
Figure B53. Diagonal cracks in walls in Parking Garage 1.

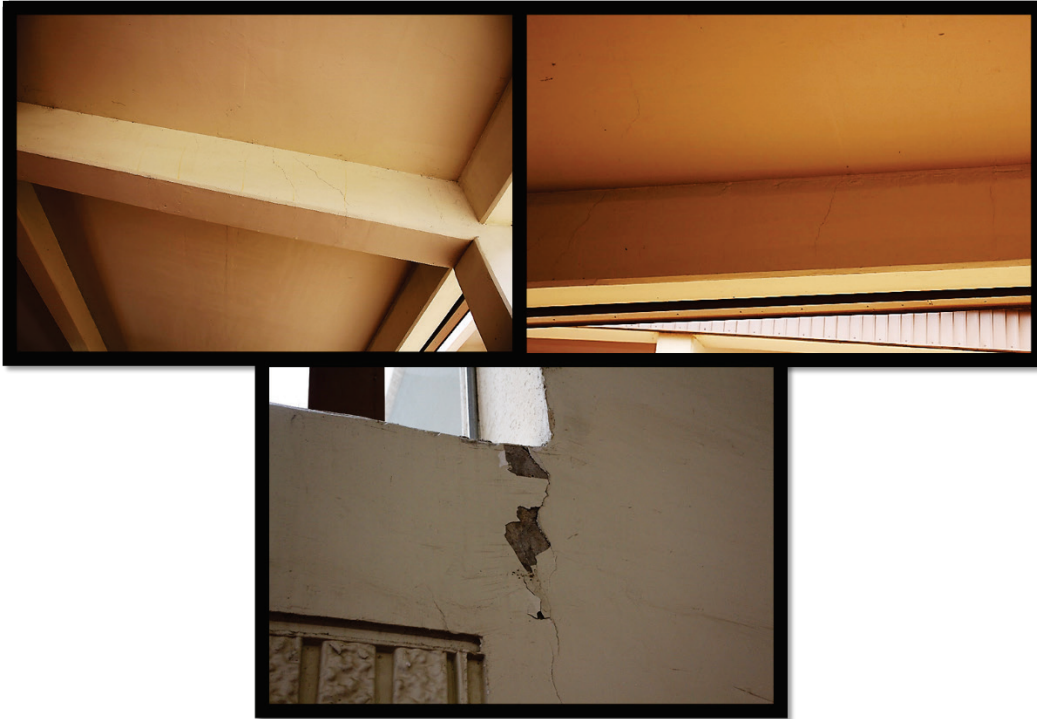
Figure B54. Cracks in ceiling, beams, and wall of entrance to basement of Parking Garage 1.

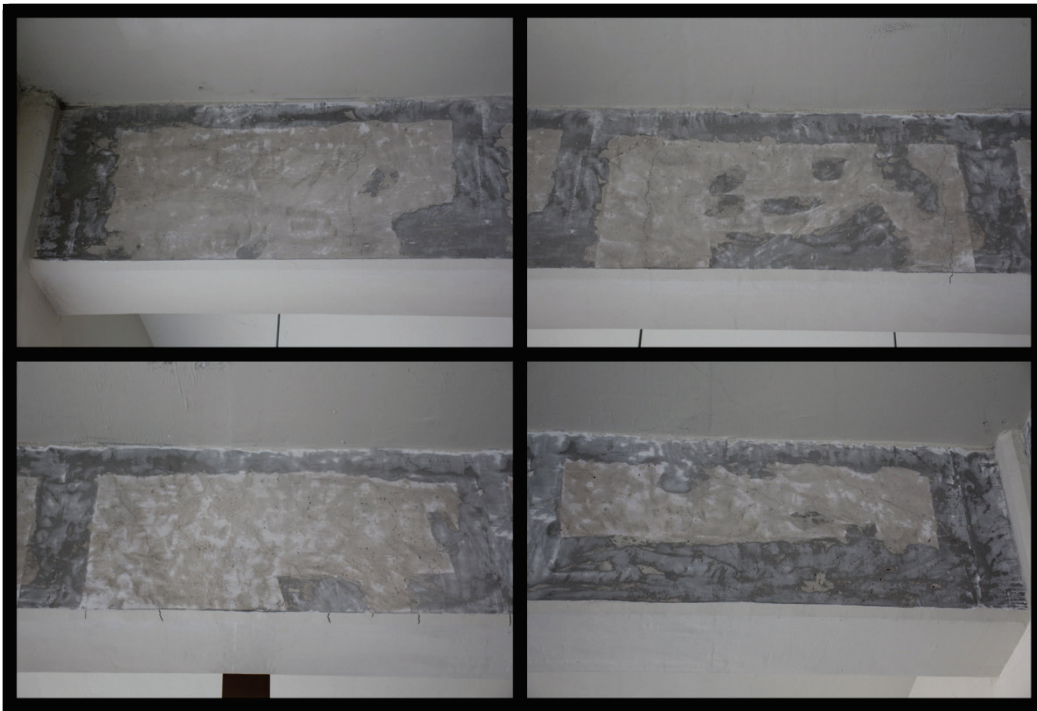
Figure B58. Cracks in bare concrete of beam along column line 4 in Parking Garage 1.

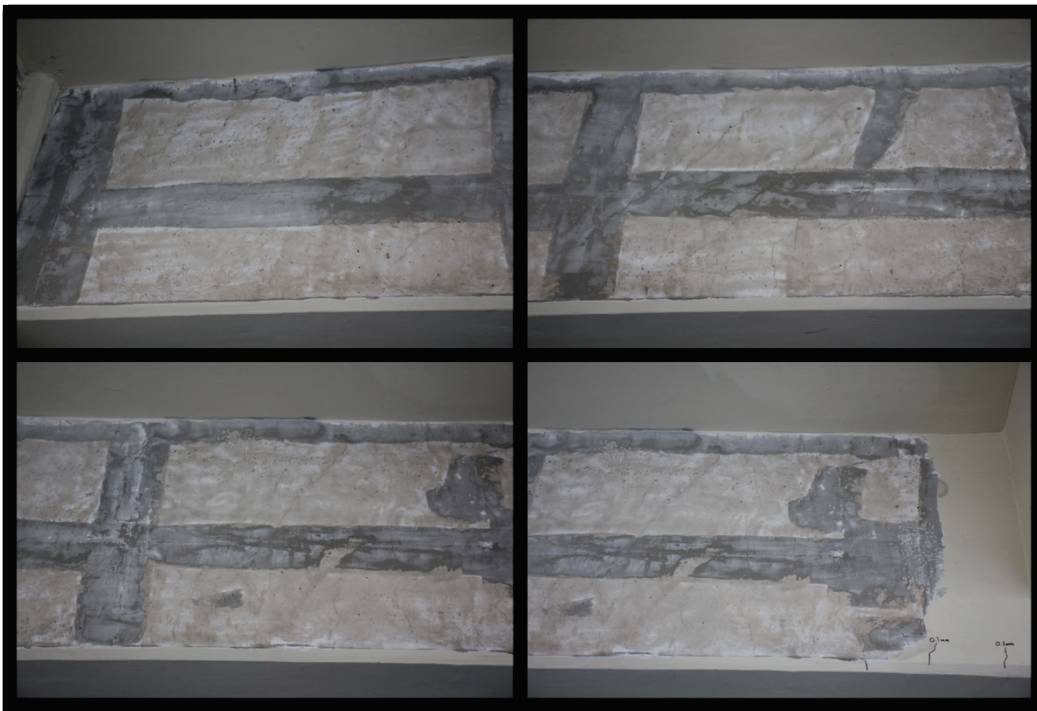
Figure B59. Cracks in bare concrete of girder along column line E in Parking Garage 1.

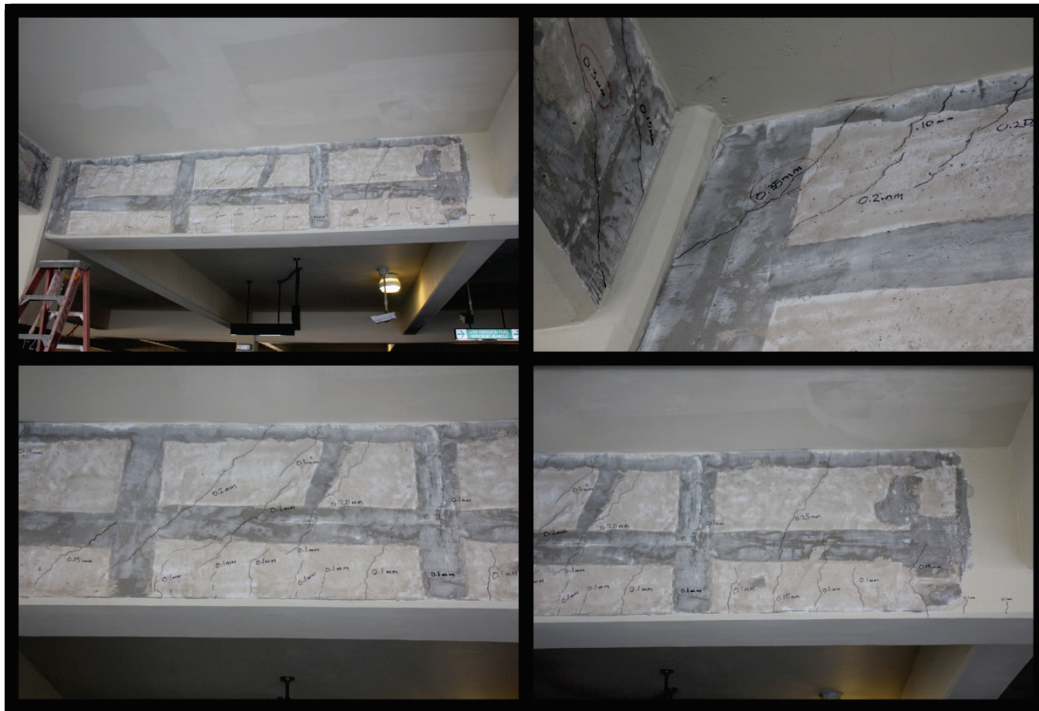
Figure B61. Mapped cracks in bare concrete of girder along column line E in Parking Garage 1.

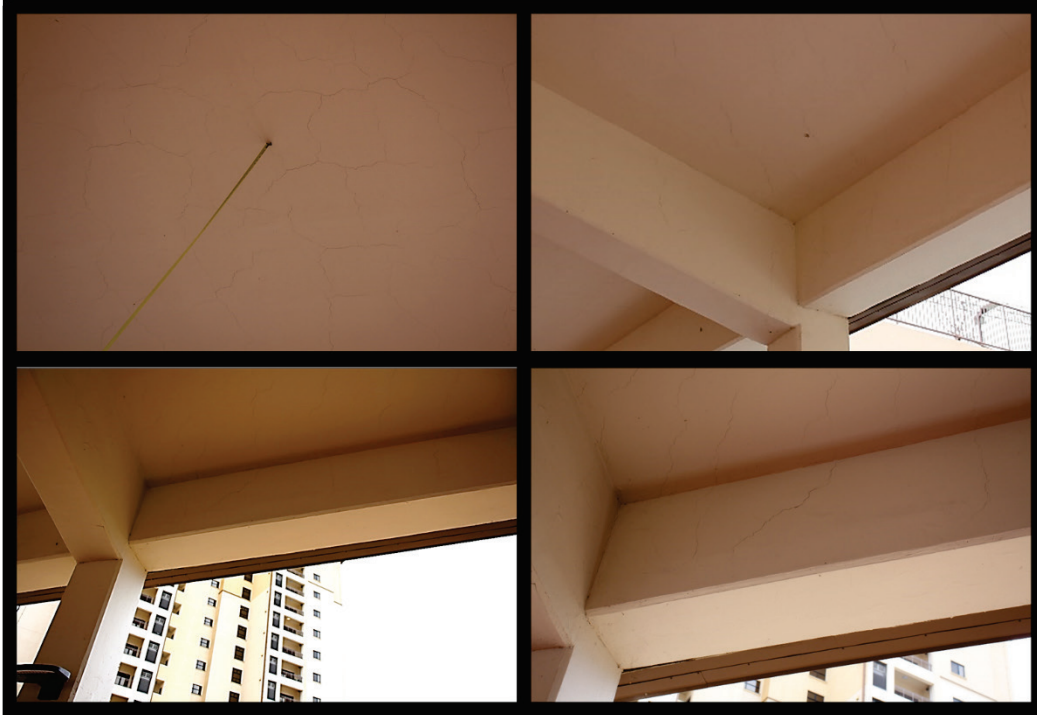
Figure B62. Multidirectional cracks in ceiling and cracks in girder of entryway of Parking Garage 2.

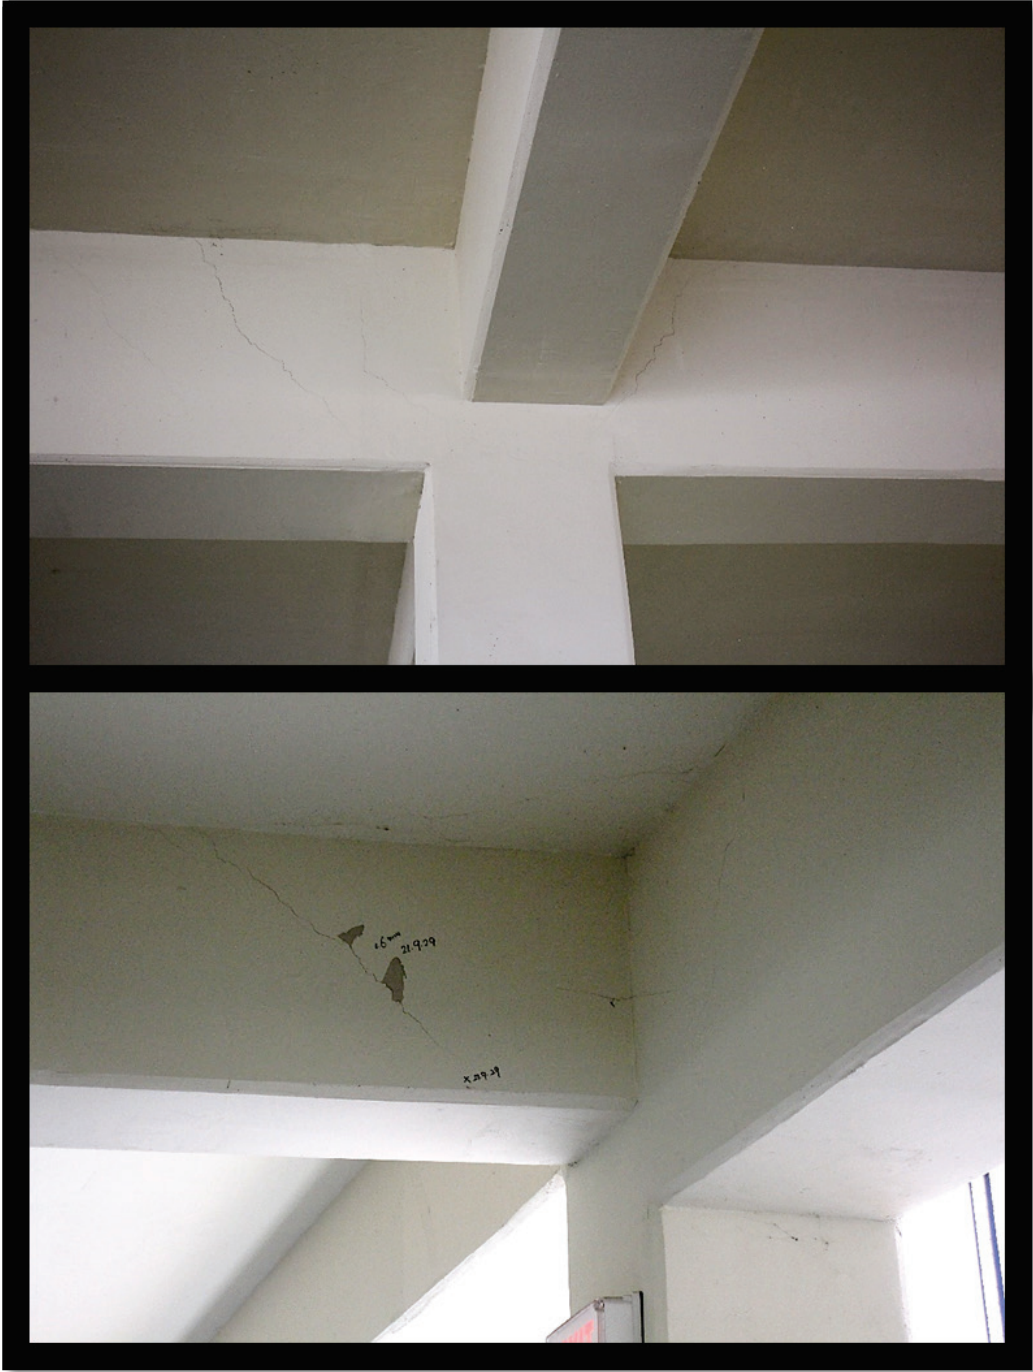
Figure B63. Diagonal cracks in girders and beams in Parking Garage 2.

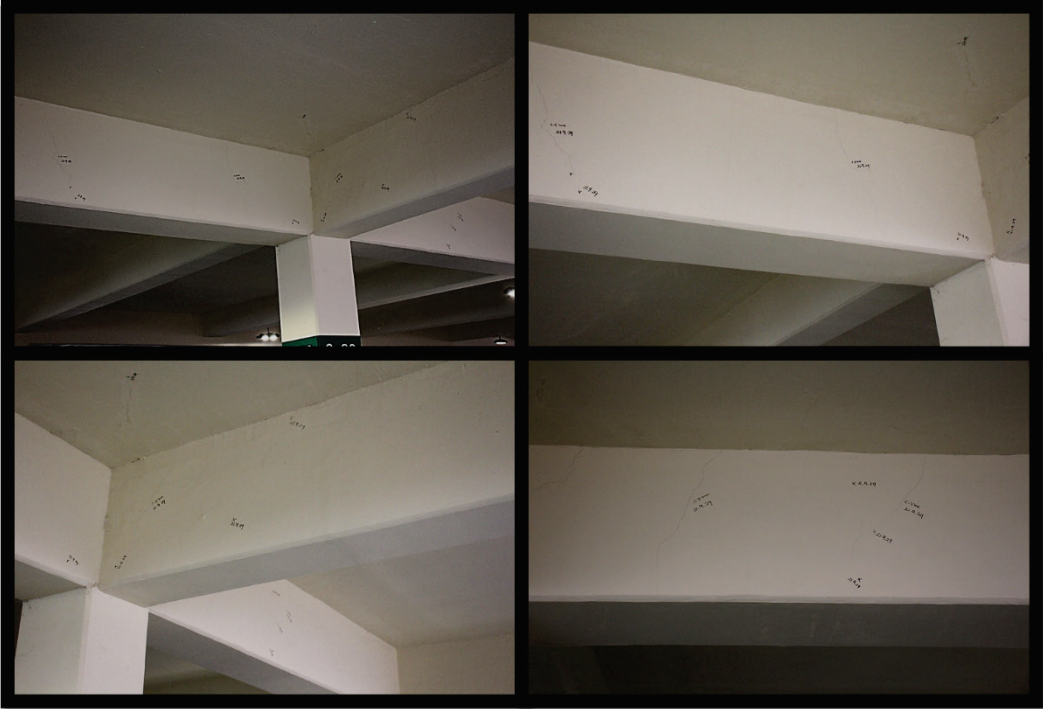
Figure B64. Diagonal cracks in girders and beams in Parking Garage 2.

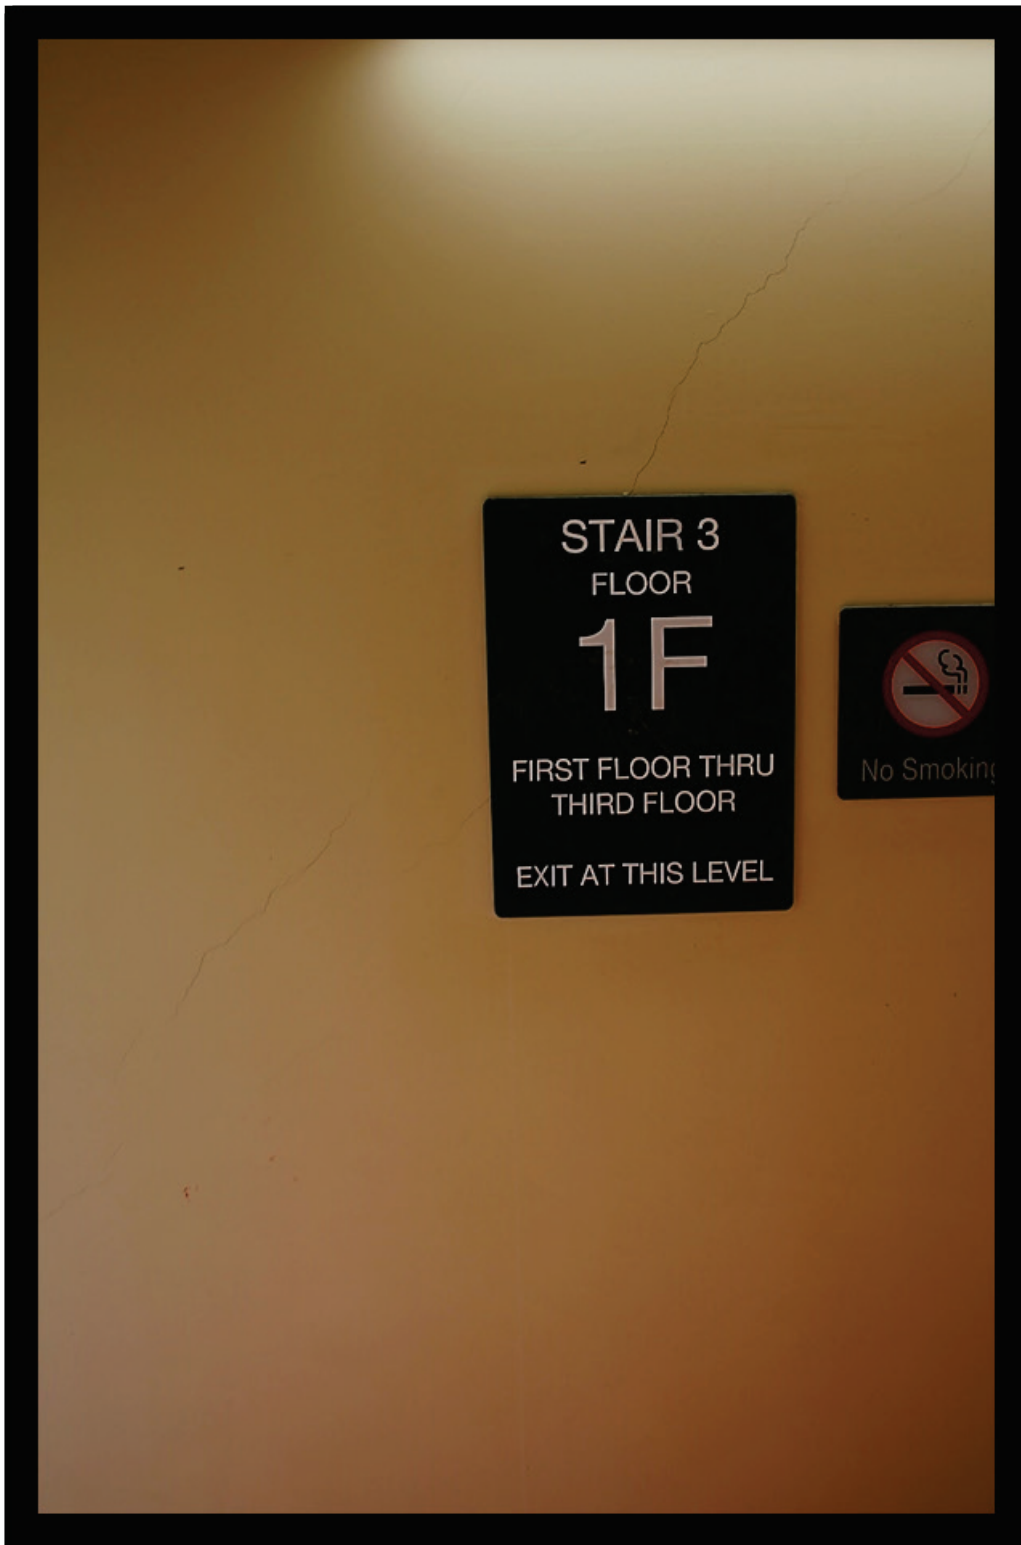
Figure B66. Diagonal crack in wall of stairwell in Parking Garage 3.

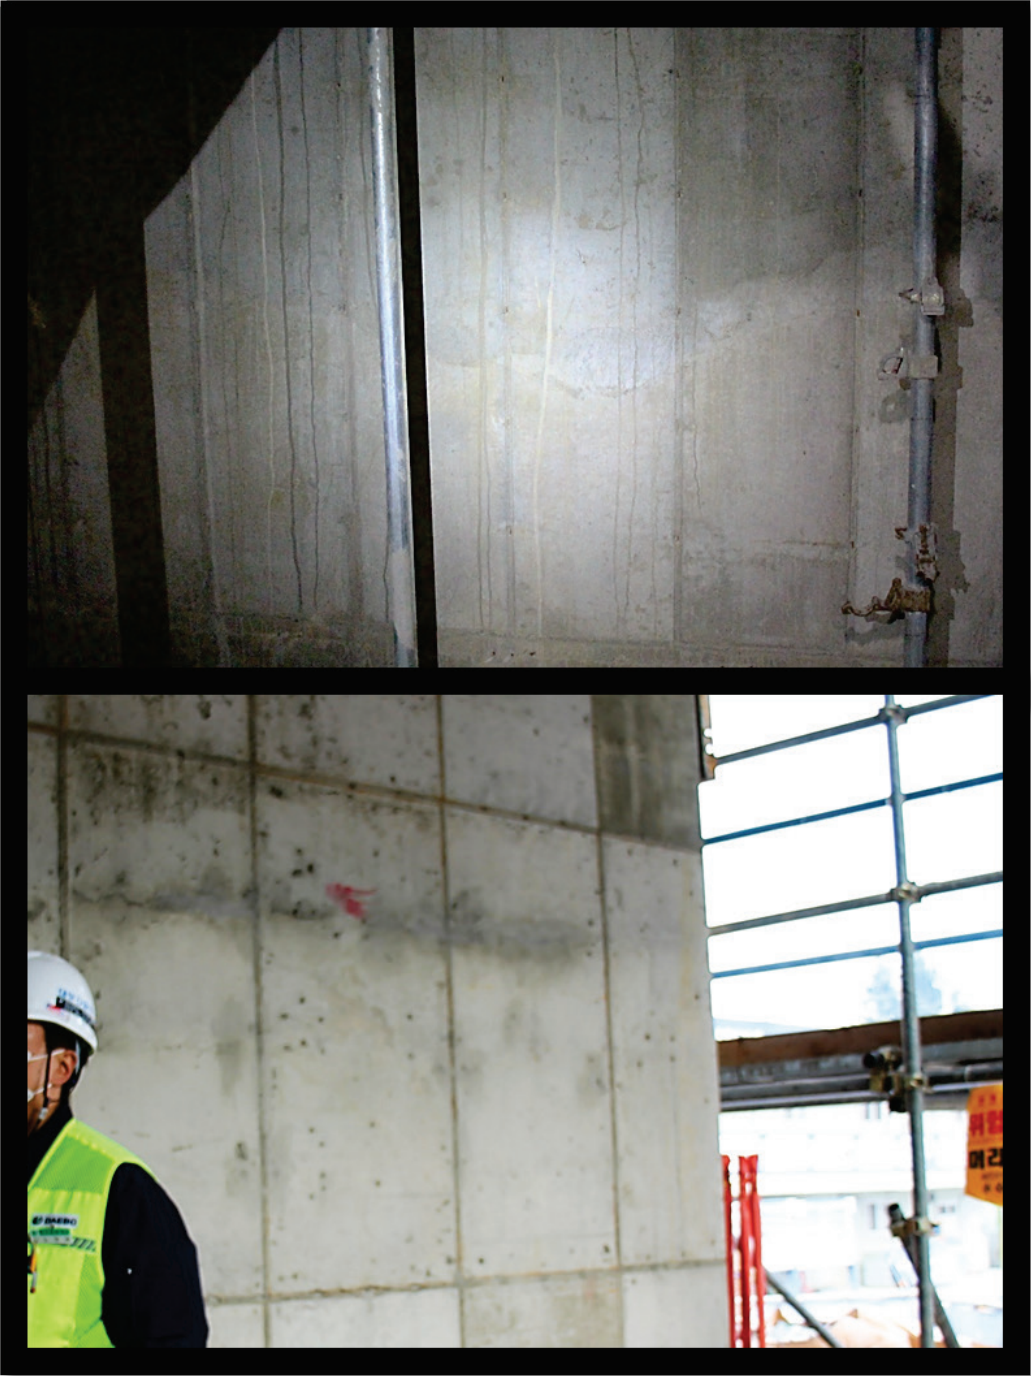
Figure B68. Cold joints in walls in Parking Garage 4.

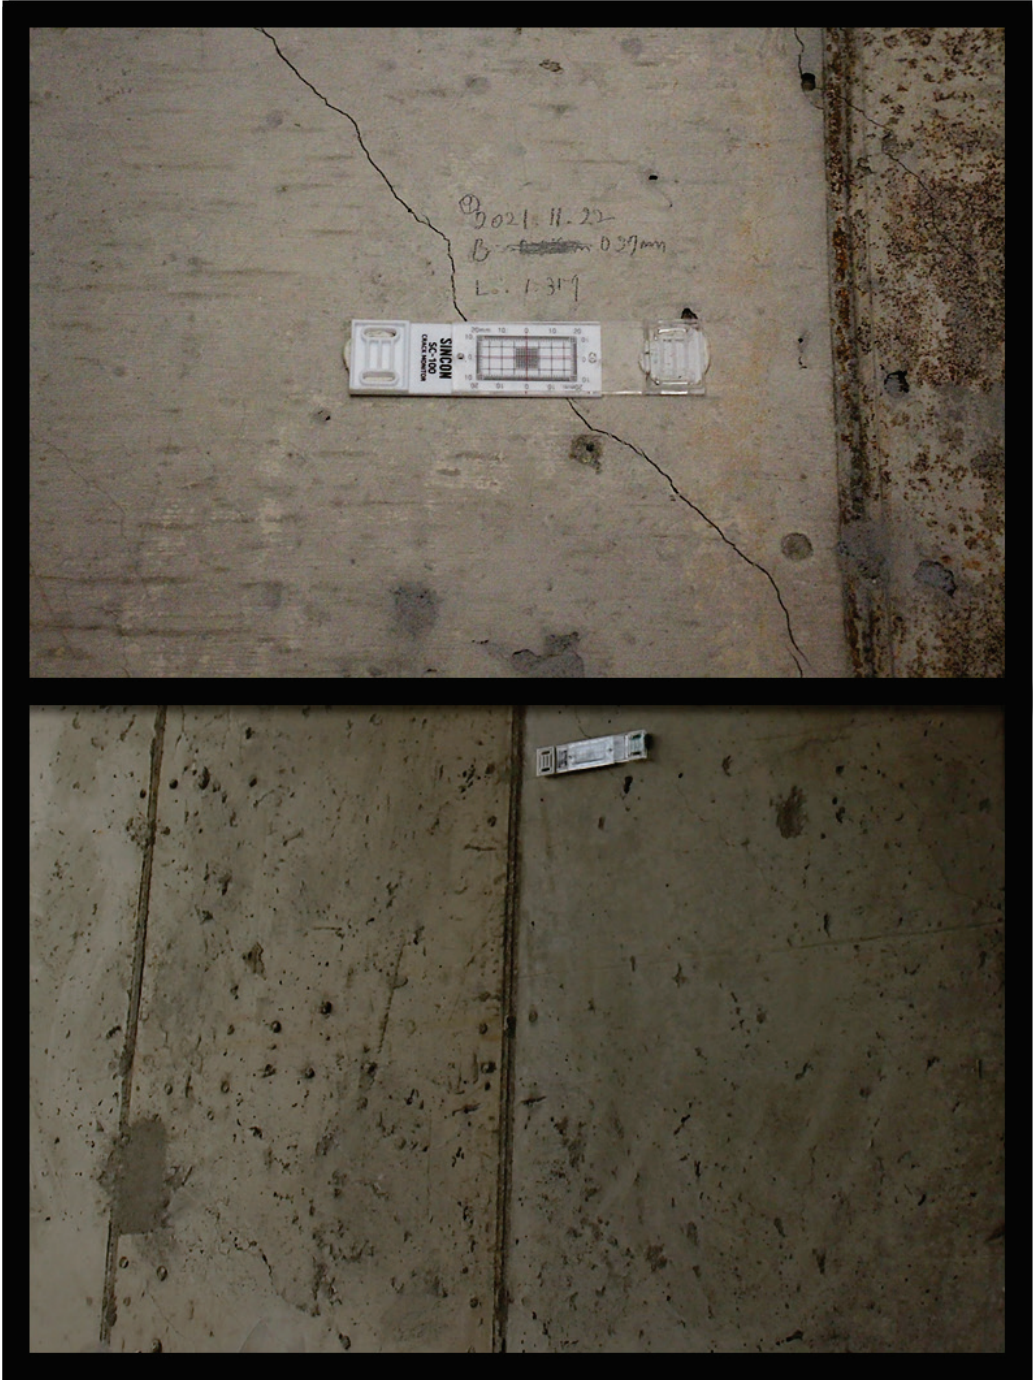
Figure B69. Cracks with gauges and bugholes in walls in Parking Garage 4.

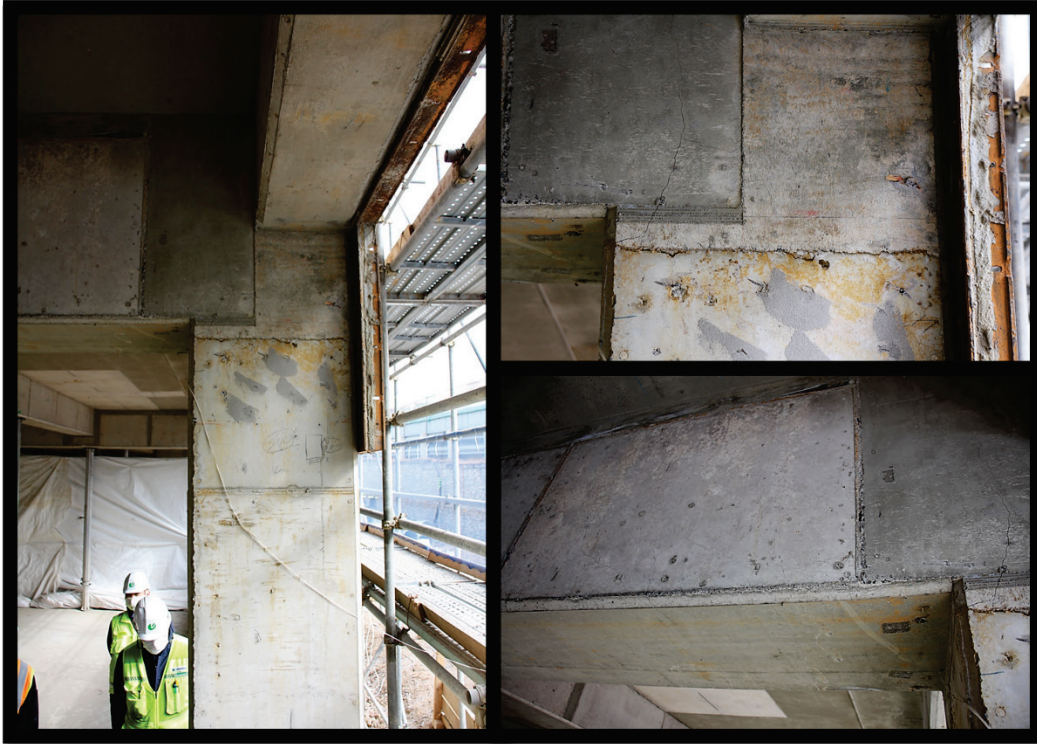
Figure B72. Cracks in exterior column and connected girder in Parking Garage 4.

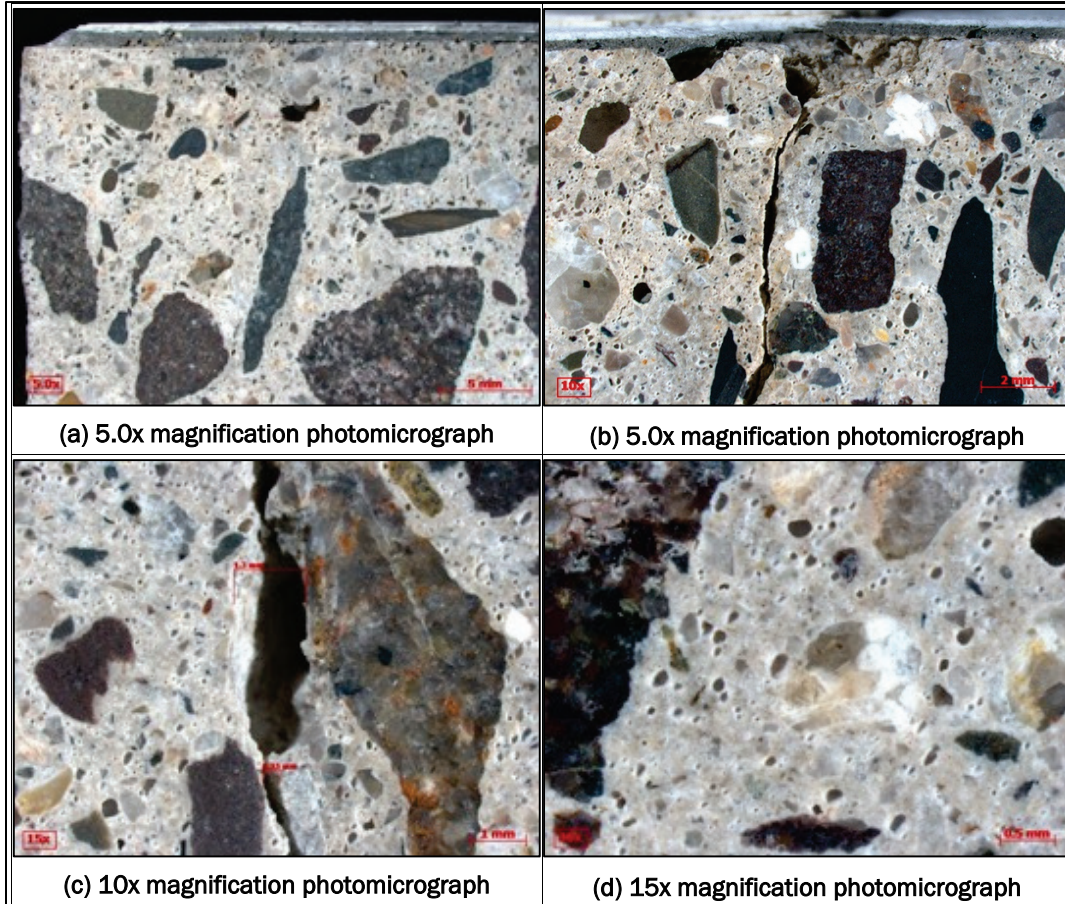
Figure C4. Photomicrographs of T1-S1: (a) 5.0x photomicrograph of paste microstructure; (b) 10x photomicrograph showing crack extending from surface; (c) 15x photomicrograph showing crack along a coarse aggregate with changing width; (d) 30x photomicrograph of air voids within paste.

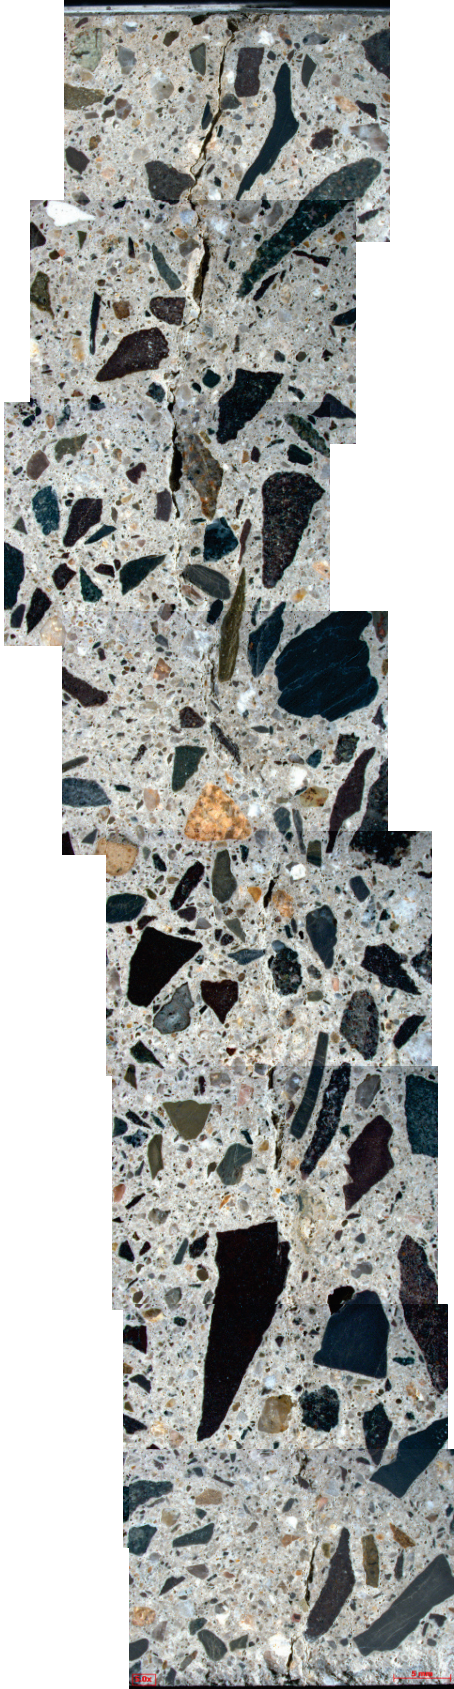
Figure C5. Map of crack observed in T1-1.

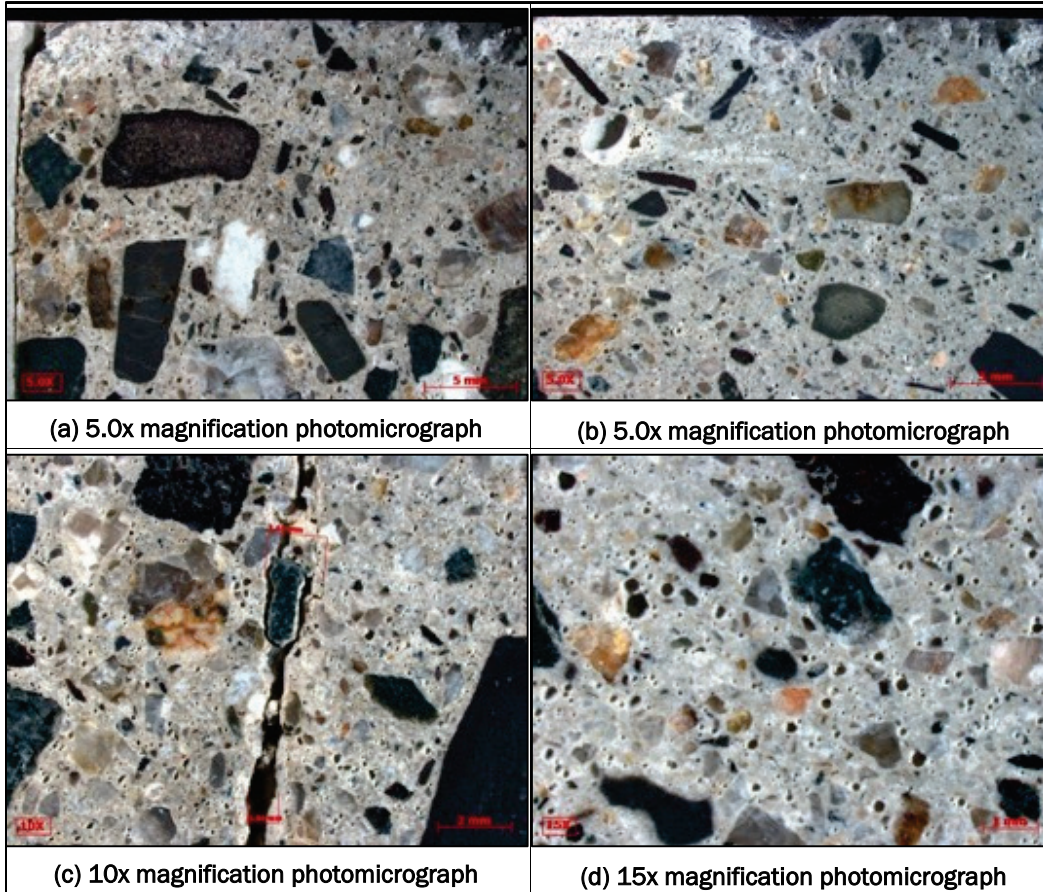
Figure C11. Photomicrographs of T1-S2: (a) 5.0x photomicrograph of paste microstructure; (b) 5.0x photomicrograph of paste microstructure with clusters of voids near an entrapped void; (c) 10x magnification showing vertical cracking with varied width; (d) 15X photomicrograph of air voids.

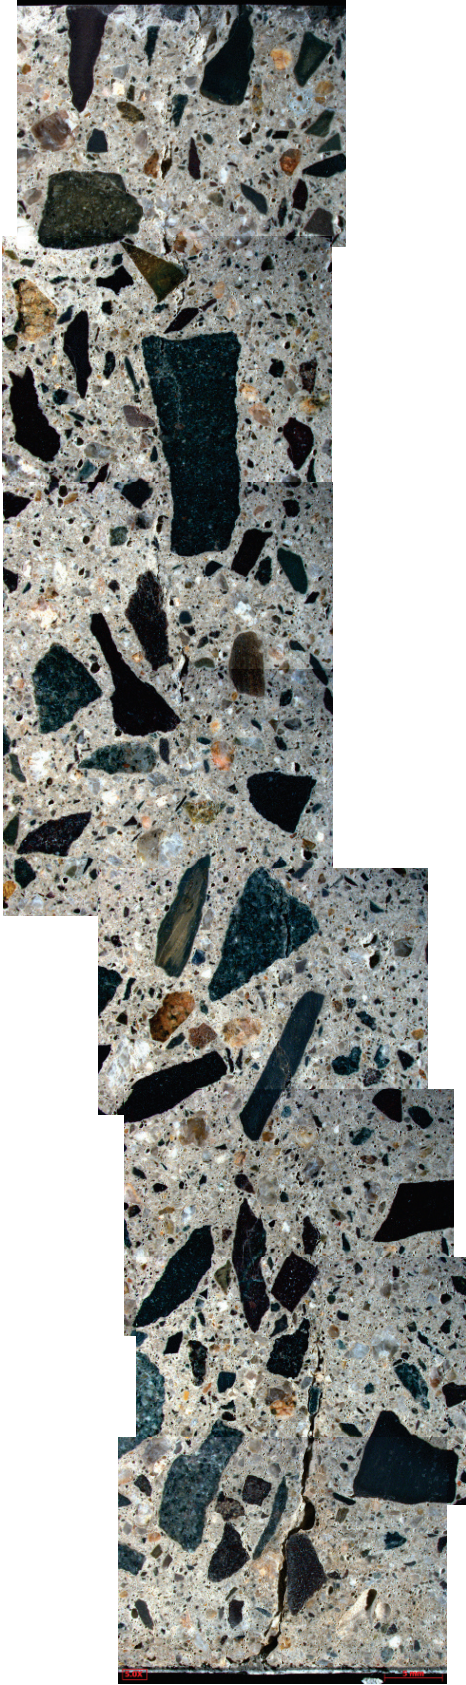
Figure C12. Map of crack observed in core T1-S2.

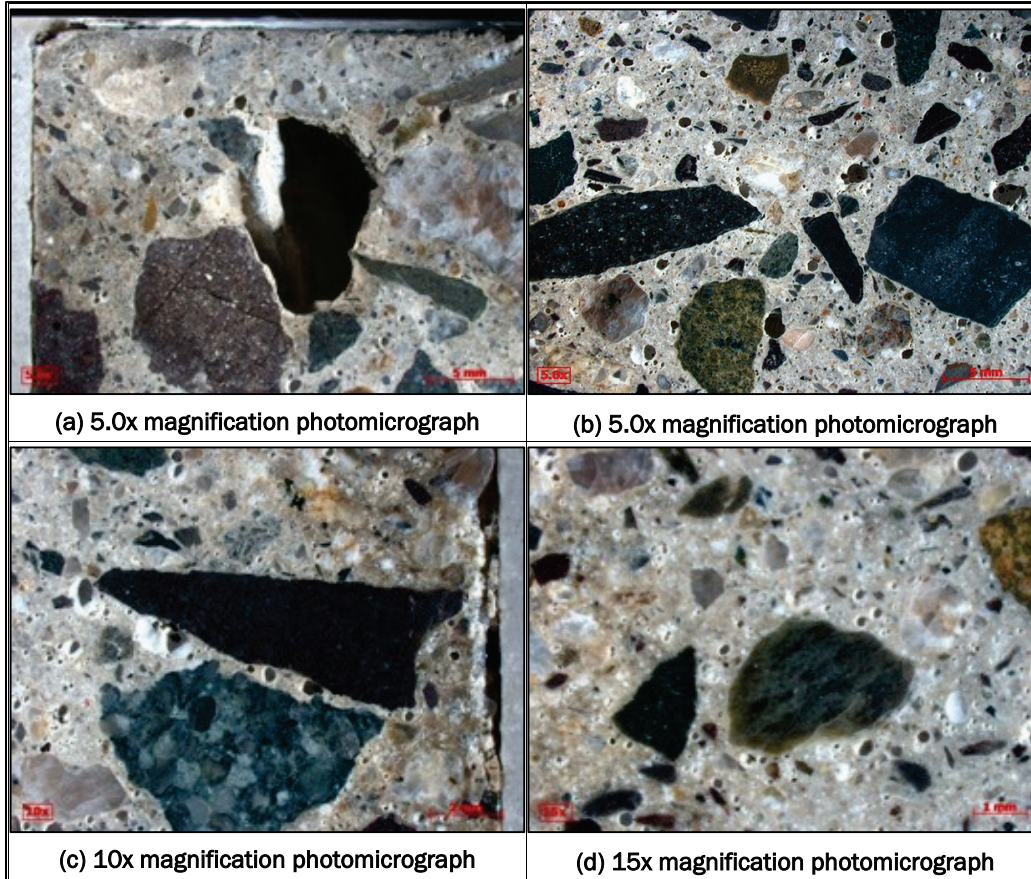
Figure C18. Photomicrographs of 220053-3: (a) 5.0x photomicrograph of paste microstructure showing large entrapped air void; (b) 5.0x photomicrograph showing paste microstructure; (c) 10x photomicrograph clusters of entrapped air along aggregate-paste boundary; (d) 15x photomicrograph of air voids within paste.
