Report on Evaluation of Apartment Towers 1–4 and Parking Garages 1–4 at Camp Walker, Daegu, South Korea

April 2022

Final report

Prepared for Far East District, Pacific Ocean Division
U.S. Army Corps of Engineers
573 Bonney Loop, Building 525, Suite A300
Fort Shafter, HI 96858

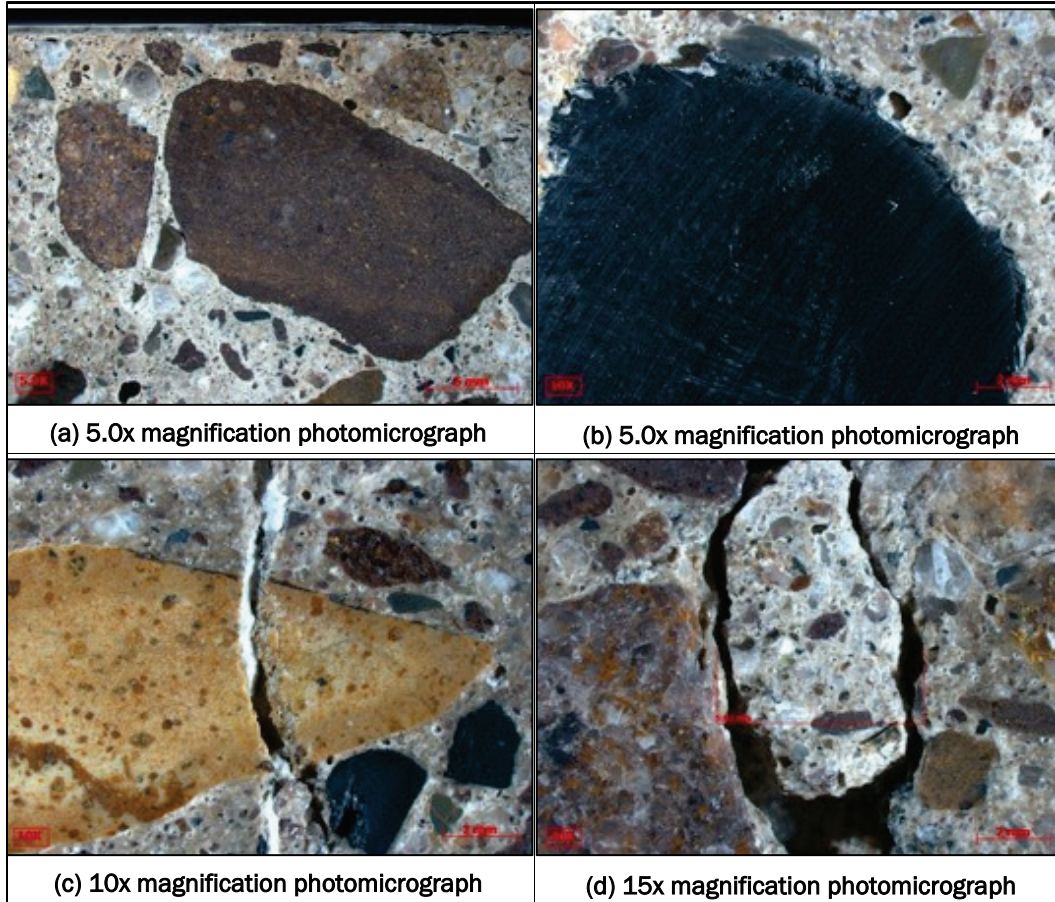
Figure C25. Photomicrographs of T2-3: (a) 5.0x photomicrograph of paste microstructure and surficial paste discoloration; (b) 10x photomicrograph of rebar with voids present at paste boundary; (c) 10x magnification showing vertical crack through a coarse aggregate; (d) 10x photomicrograph vertical crack with varied width.

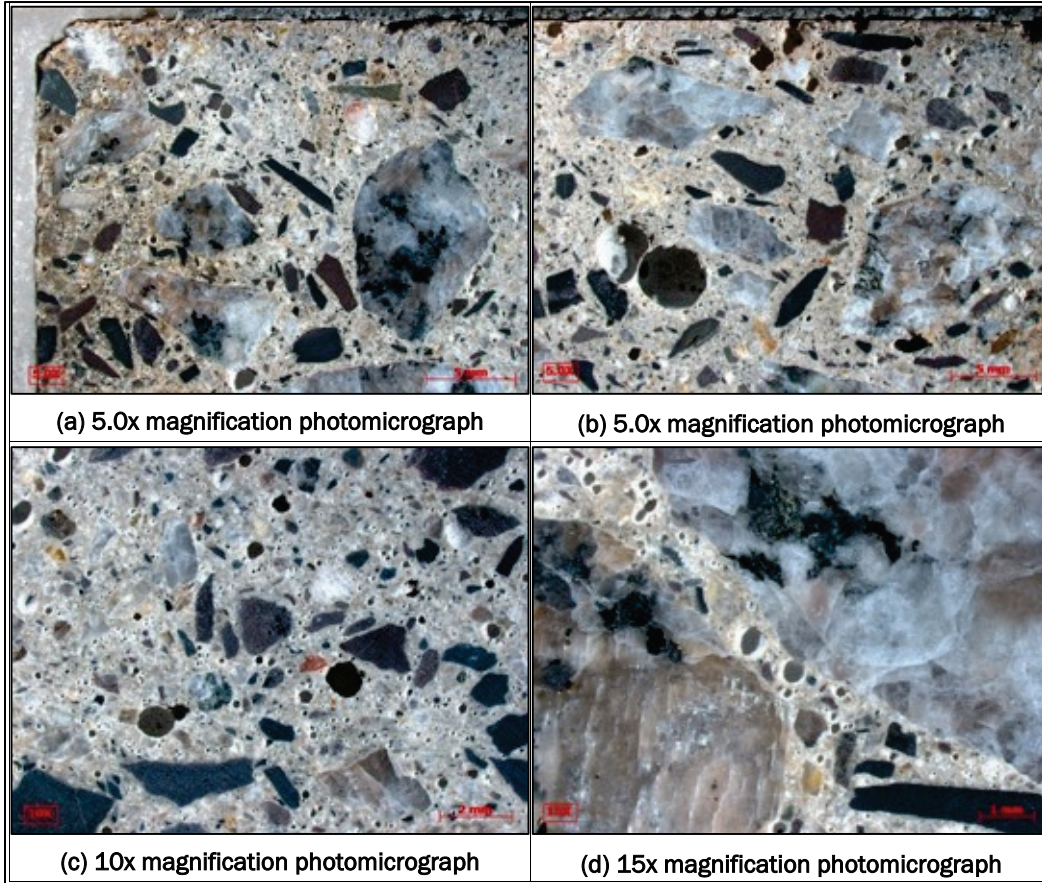
Figure C33. Photomicrographs of T3-3: (a) 5.0x photomicrograph of paste microstructure; (b) 5.0x photomicrograph of large entrapped air voids; (c) 10x magnification showing paste microstructure; (d) 15x photomicrograph showing air voids concentrated along aggregate boundaries.
