FINAL REPORT:

Kauai Source Restart 2021

APL-UW 2021 Kauai Cable Repair Support Trip Report

16 June - 30 June 2021

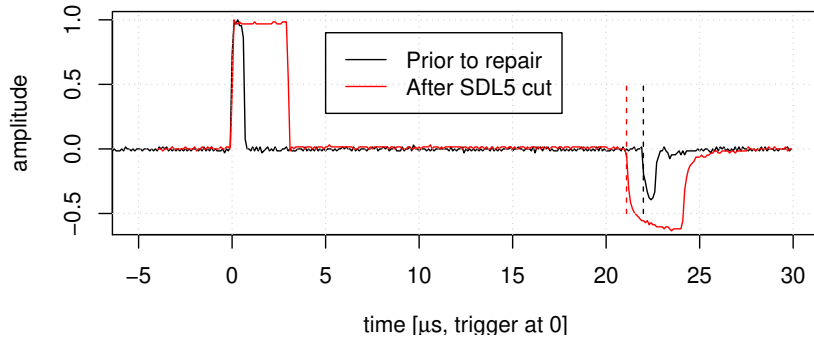
Fig. 7 shows the cable condition before the C/S DECISIVE came on station. The reflection at $21.99 \mu\text{s}$ has been seen before (e.g., in December 2020) and is thought to be at the BSUREB77/SDL3 splice. Fig. 7 also shows the cable condition after the BSUREB77 cable was cut just a few meters shoreward of the buoys. There is a new and distinct short fault at $20.99 \mu\text{s}$. This suggests that the BSUREB77/SDL3 splice was in fact about 100 m further from the buoys (i.e., not at the buoys) and therefore located in the cable loops in the seabed.

Figure 7: Traces before and after BSUREB77 (SDL5) cut. Vertical dashed lines show the change (to earlier time) in the leading edge of the fault. The black curve is the furthest shoreward migration of seawater intrusion from the severed SDL3 cable, and is believed to indicate the location of the BSUREB77/SDL3 splice. The red curve is the reflection from the BSUREB77 (SDL5) cable where it was severed by the ROV hydro-shear. The two measurements had two different pulse widths. There is no perceptible reflection at the cable hut splice (SDL1/BSUREB77, BLDG 539). At this time, there are no discernable faults in what remains of the BSUREB77 shore cable.

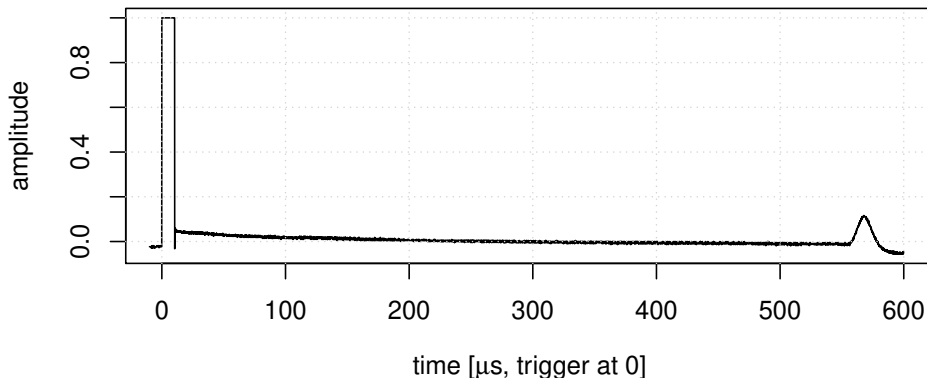
Fig. 8 shows the cable condition after the final splice had been made and lowered into the seawater. The trace is now clear of faults (either open or shorted) and the reflection at $557 \mu\text{s}$ is the HX554.

Figure 8: Final TDR measurement from the Cal Lab.

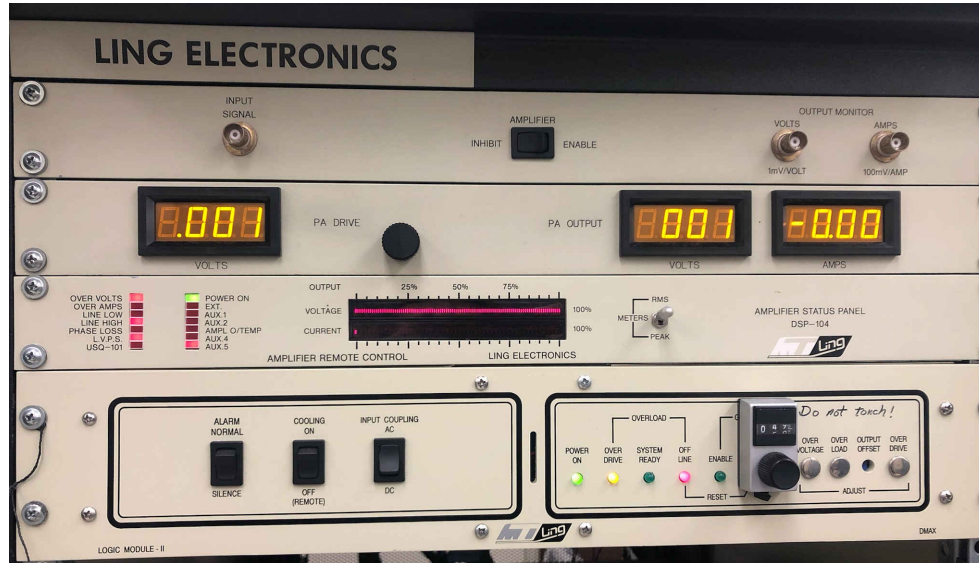
Figure 10: The Ling control panel, after start-up circuitry repair. Fault lights on.

Over 18-30 June the APL-UW shore team diagnosed the faulted shore station Ling amplifier. A damaged “soft-start” circuit was found, and replacement hardware ordered, received and installed. The Ling was successfully powered up, and now presents multiple diagnostic fault indicators. See Fig 10. The Ling remains off-line.

Shoreteam repairs Ling soft-start circuit, brings up amplifier. Various fault LEDs are now active.

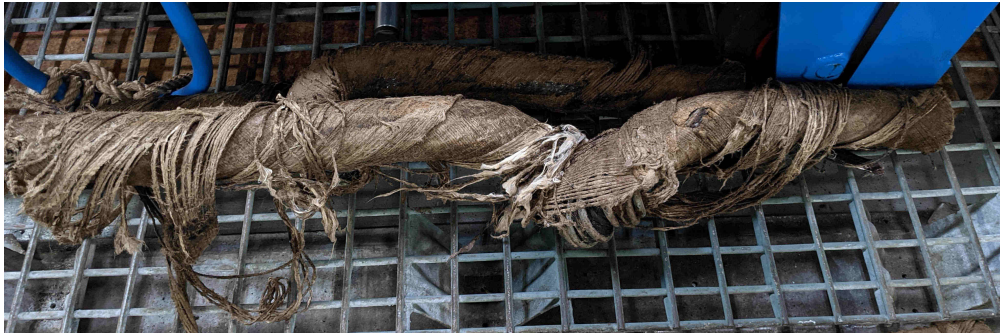
Recovery of the wet stow SDL1 and SDL3 cables north of Kauai. Several hockles develop in the SDL3, and are cut out. See Fig. 12. Two segments of SDL3 are spliced together to form one segment 8.400 km long. See Fig. 13.

Figure 12: One of the hockles in the SDL3 after being pulled tight during recovery.

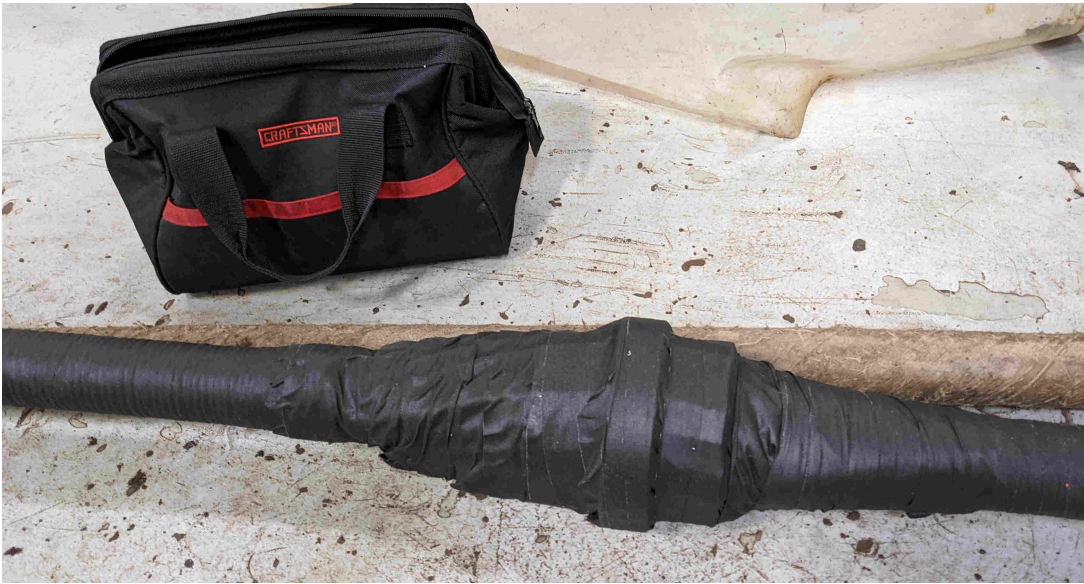
Figure 13: The SDL3 to SDL3 splice (armored to armored), after completion.

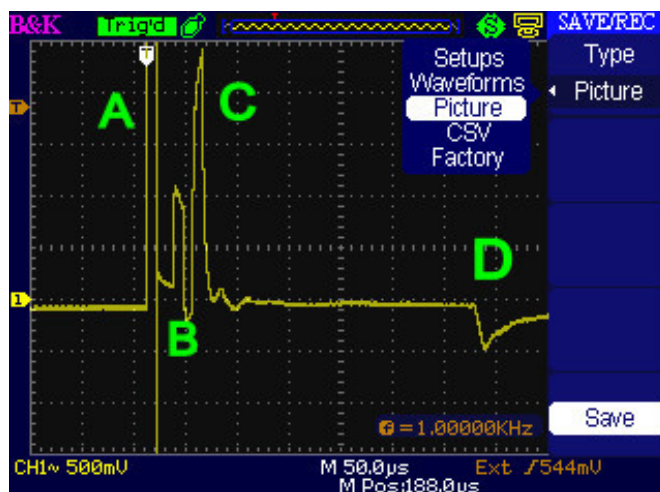
Figure 14: Shoreward TDR from the 2019 cut point. A) Initial outgoing pulse. B) Two closely spaced open conductor returns (not resolved in this image) at about 26.148 and 27.104 μs (respectively, left to right, equivalent to about 2.6 to 2.7 km away). C) Strong open conductor reflection at 45.164 μs (about 4.5 km away). D) The cable short fault, 318.4 μs away (about 31.5 km.) [Measured with Keysight 3321A Function / Arbitrary Waveform Generator and a BK Precision 2530B Digital Storage Oscilloscope.]

Shoreward TDR testing from the 2019 reconnaissance site shows a number of open conductor faults within a few kilometres. See Fig. 14.

The decision is made to splice in a long segment (at least 20 km) of SDL1 from the seaward end of the new SDL3, past the current location of the SDL3/SDL1 splice, past the faults seen in Fig. 14, to the 2019 reconnaissance site, to reach the section of SDL1 known to be good all the rest of the way to the HX554. The SDL1 necessary for this repair had already been recovered 20-23 June and was in the ship's cable tank. This choice would minimize the additional number of splices that would be needed.

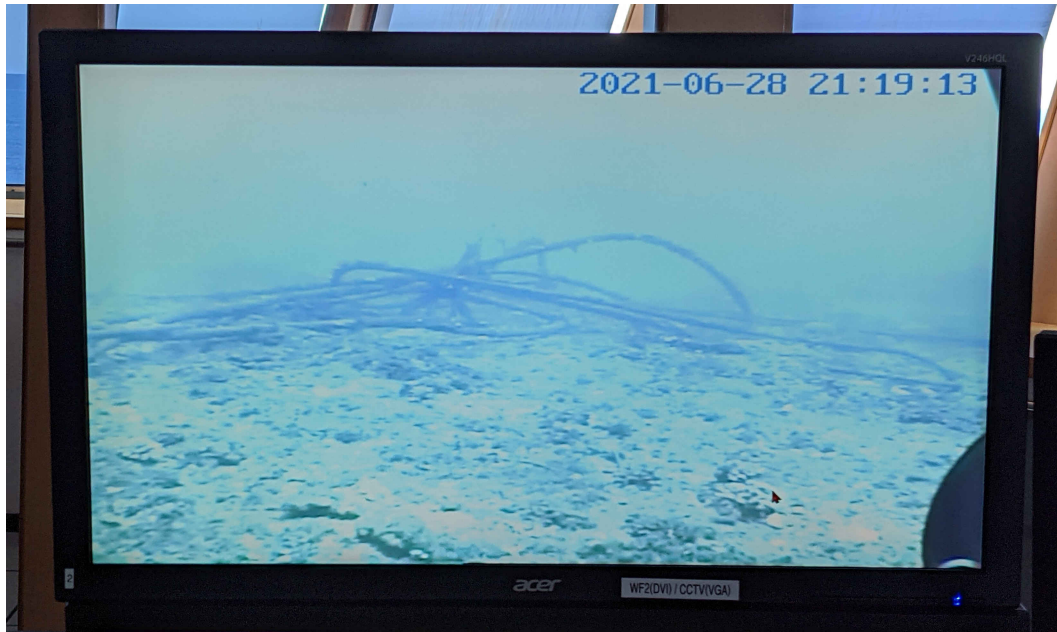
Figure 16: The tangle of cable (mostly SDL3, some SDL5) at the BSUREB77/SDL3 splice, as seen from the ROV. The actual splice is probably in the tangle somewhere.

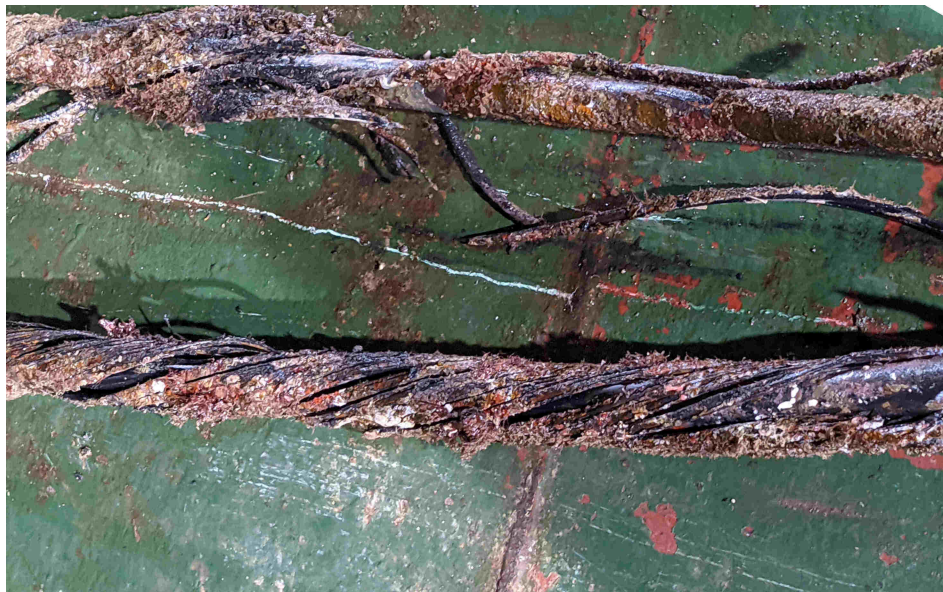
the fault from the seaward side of the tangle. (“RECOVERY1” in Fig. 15.) This turns out to be SDL3 cable; as expected, it was severely abraded in multiple areas. (Fig. 17.) Quite unexpected, a bitter end of the SDL3 is recovered; inspection suggests the cable had been cut. (Fig. 18.)

Figure 17: Abrasion damage in the shoreward end of the SDL3 cable. The armor on the top example is completely gone in the middle.

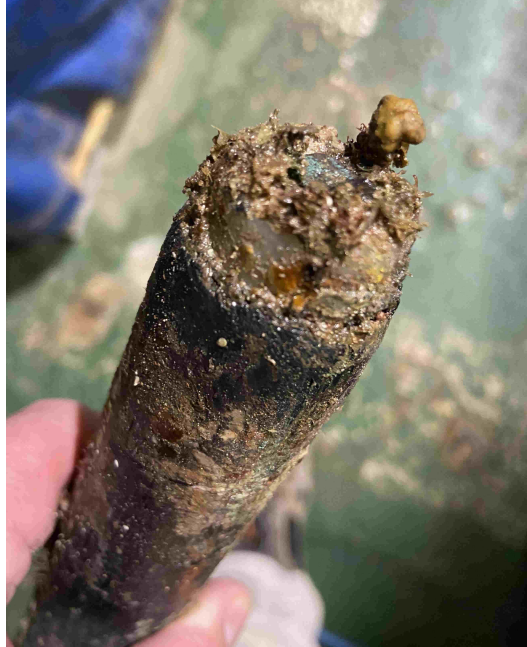
Figure 18: The unexpected end of the SDL3 we recovered.

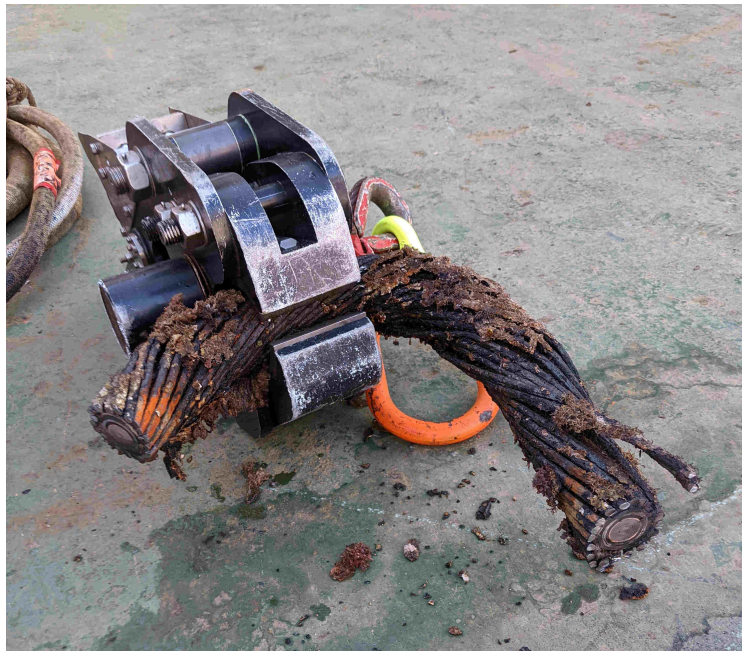
Figure 19: ROV gripper recovered onto the deck, after the BSUREB77 cable has been cut away. The gripper at maximum opening was just barely able to grab the cable (which is SDL5 cable, double armored.)
