Regional Sediment Management (RSM) Program

Two Years of Post-Project Monitoring of a Navigation Solution in a Dynamic Coastal Environment, Smith Island, Maryland

June 2022

Final report

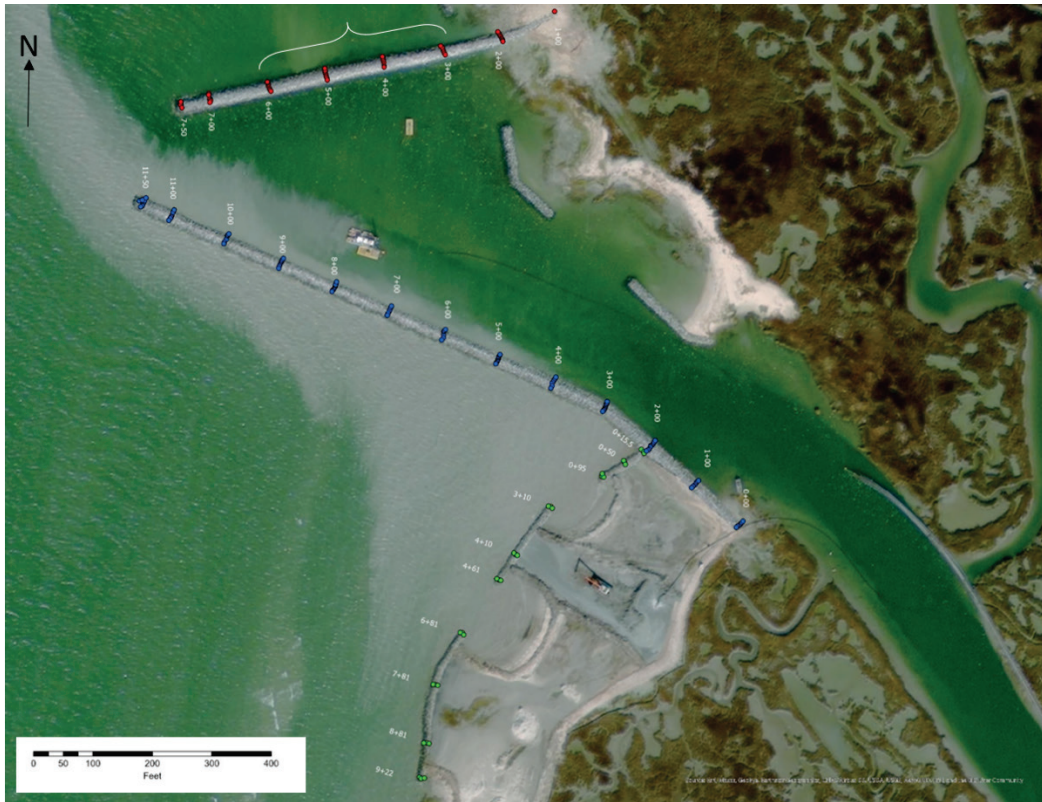
Figure 5. Locations of points and transects surveyed and projected for the structural stability analysis. White bracket at north jetty illustrates area of displacement discussed in Section 3.4.

The team observed that the segment of the jetties that was closer to the landmass was more stable than segments farther into the Bay. Segments farther into the Bay were susceptible to rock displacement (change in position in any direction) and minor settlement. Visually observable displacement had occurred at the north jetty, including rocks that had been displaced such that the originally marked rock was underneath other rocks. Table 2 and Figure 3 show locations on the north jetty have been substantially displaced.

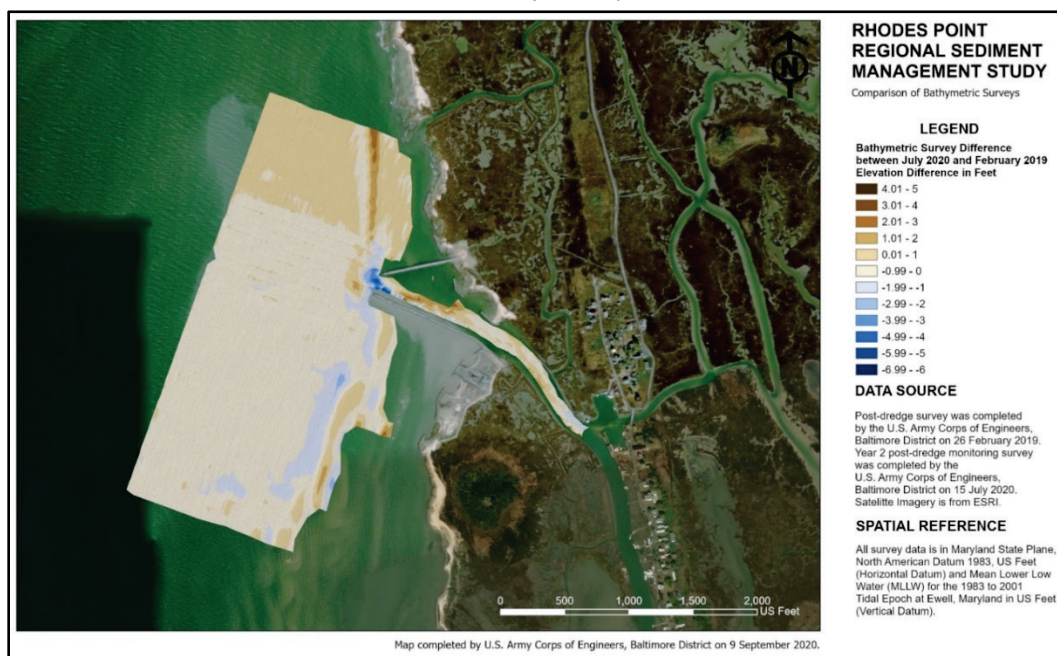
Figures 8 and 9 show comparisons of the channel for the time period from February 2019 to July 2020. Sedimentation (shoaling causing decreased depth) is evident between the two jetties, although some of the channel appears to have increased in depth. Conversely, up to 6 ft of new scour is evident at the very end (west side) of the jetties whereas sedimentation is occurring in the Bay outside of the structures. For the depth categories shown in Figure 8, as a percentage of total channel area, approximately 54% of the channel has accreted (decreased in depth) over the time period

from February 2019 to July 2020 whereas 46% of the channel area has scoured (increased in depth). Most of the increased sedimentation (41% of the channel area) is on the order of 0 ft to 1 ft of depth change (shallowing). An artifact of data collection and/or processing related to the February 2019 survey is evident in Figures 8 and 9, shown by the sharp demarcation between the northern quarter of the Bay in the image and the area south. This is not believed to have a major impact on the analyses described in this report.

Figure 8. Comparison of bathymetric surveys for February 2019 and July 2020 showing elevation difference between surveys (negative denotes increased depth or erosion/scour).

It is expected that the shoaling rates within the channel will slow with time as the local environment comes into dynamic equilibrium with the new jetties and recent dredging. It is recommended that monitoring be conducted periodically (every few years) to determine if longer-term sedimentation and erosion patterns continue to evolve or reach dynamic equilibrium.

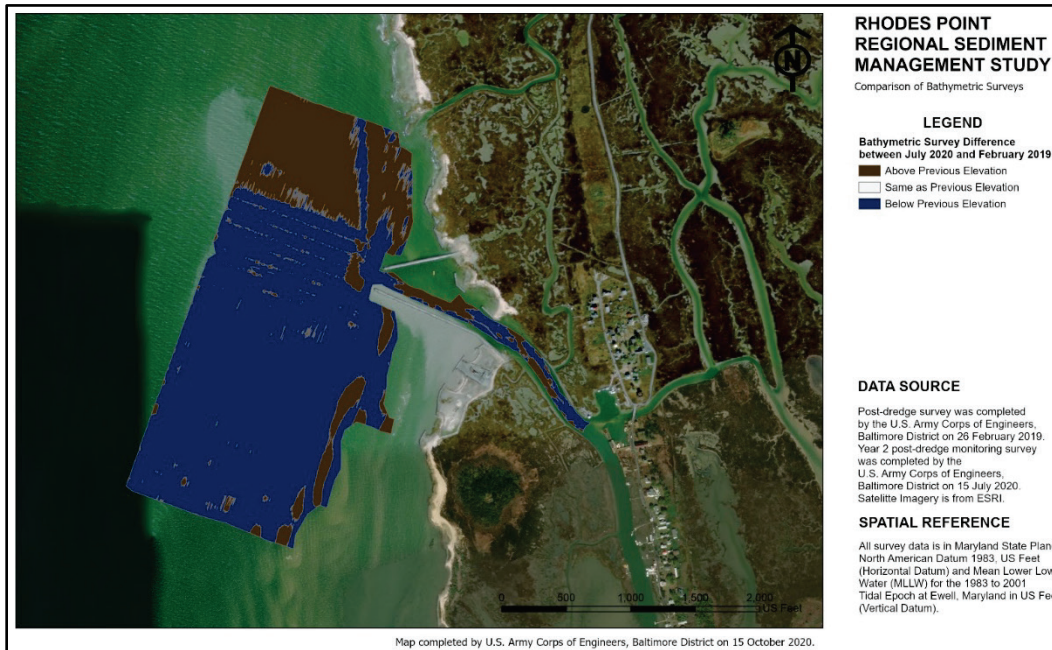
Figure 9. Comparison of bathymetric surveys for February 2019 and July 2020 showing areas above (shallower) and below (deeper) than previously surveyed elevation.

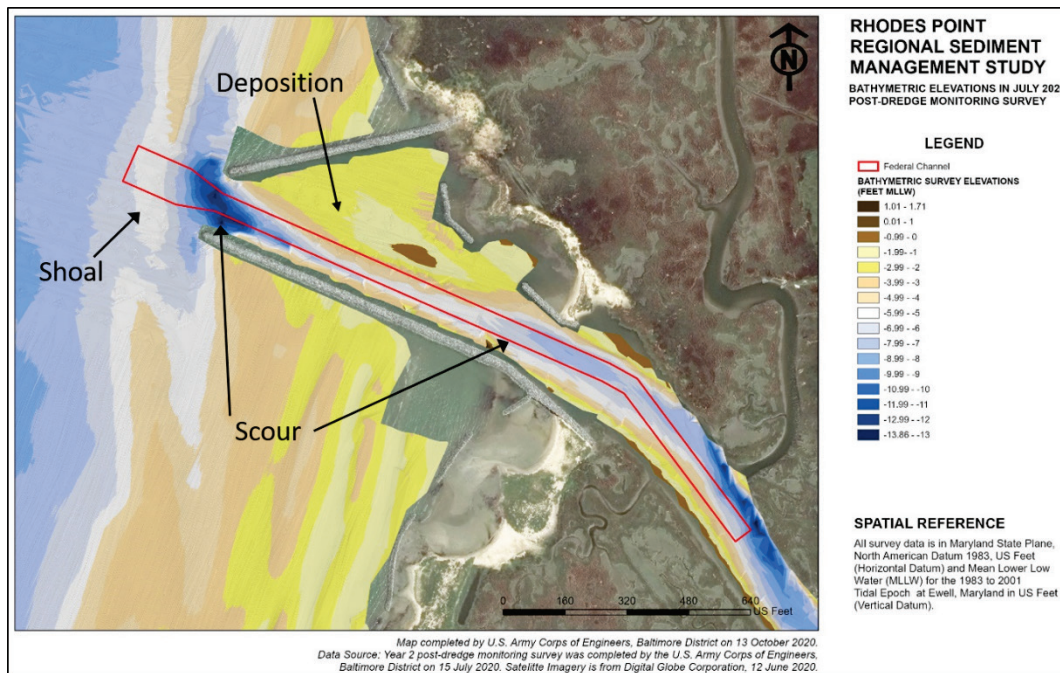
Figure 10. Bathymetric survey from July 2020, with federal channel and areas of deposition and scour described in the text.

Figure 10 shows the most recent survey and the outline of the federal channel. Dredging occurred within the outline of the federal channel in November 2018. Despite the increased volume indicated by the volume calculations and shown by Figure 8, calculations from the bathymetric map from the July 2020 survey show that most (58%) of the channel area is still deeper than the authorized depth of 6 ft. Figures 8 through 10 show the deeper areas to be located at the narrowest points of the channel, including the entrance to the jetties and where the channel is constrained by the easternmost breakwater within the channel. Sedimentation is occurring where there is the greatest distance between the angled jetties, presumably where currents are reduced. It is also evident that although dredged in 2018, the first shoal outside of the channel is reforming, potentially impeding scour and sediment transport outside of the jetties.

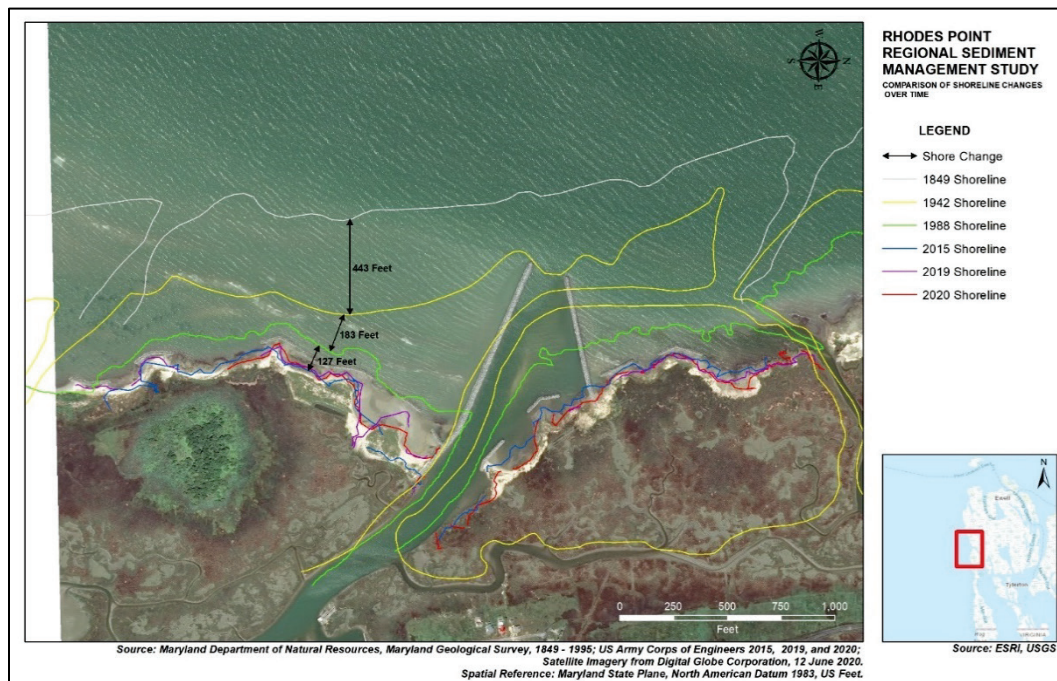
Figure 12 shows the significant shoreline change in the study area from 1849 to the present. Over time, the length of the Sheep Pen Gut channel shortened due to shoreline erosion, and its location shifted to the

southeast. The shoreline has eroded hundreds of feet since 1849, with an estimated erosion rate from this figure of approximately 3.9 to 4.9 ft/yr.

Figure 12. Shoreline changes from 1849 to 2020.

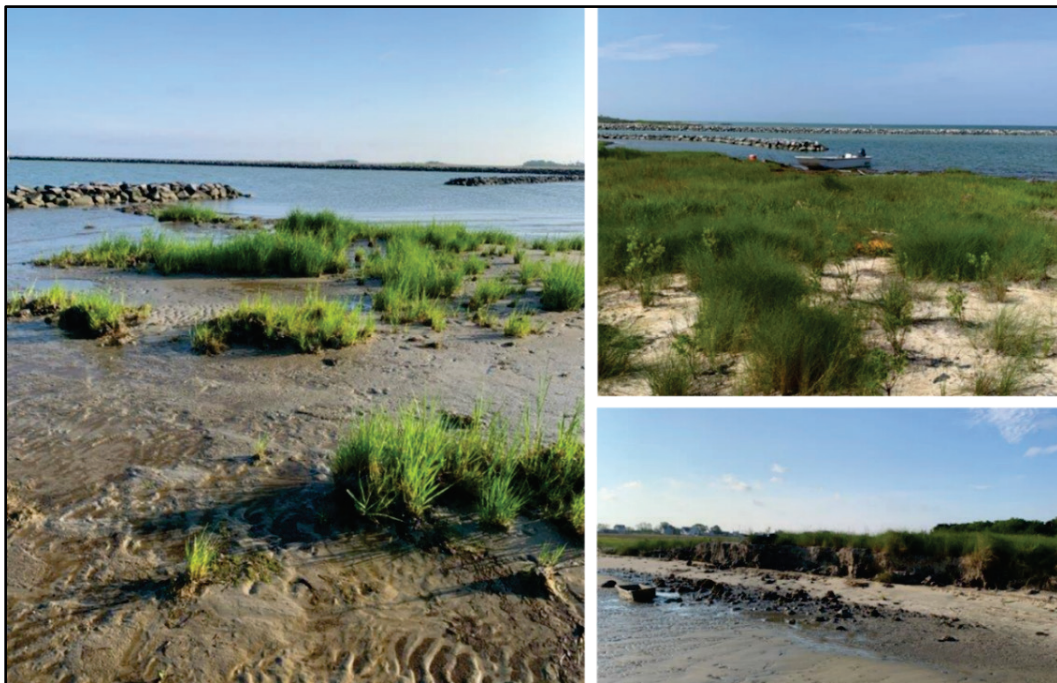
Figure 15. Left: Plantings along the shoreline behind the sill (June 2020). Right, top: Plantings at the north placement site. Right, bottom: Formation of scarp behind gap in segmented sill.

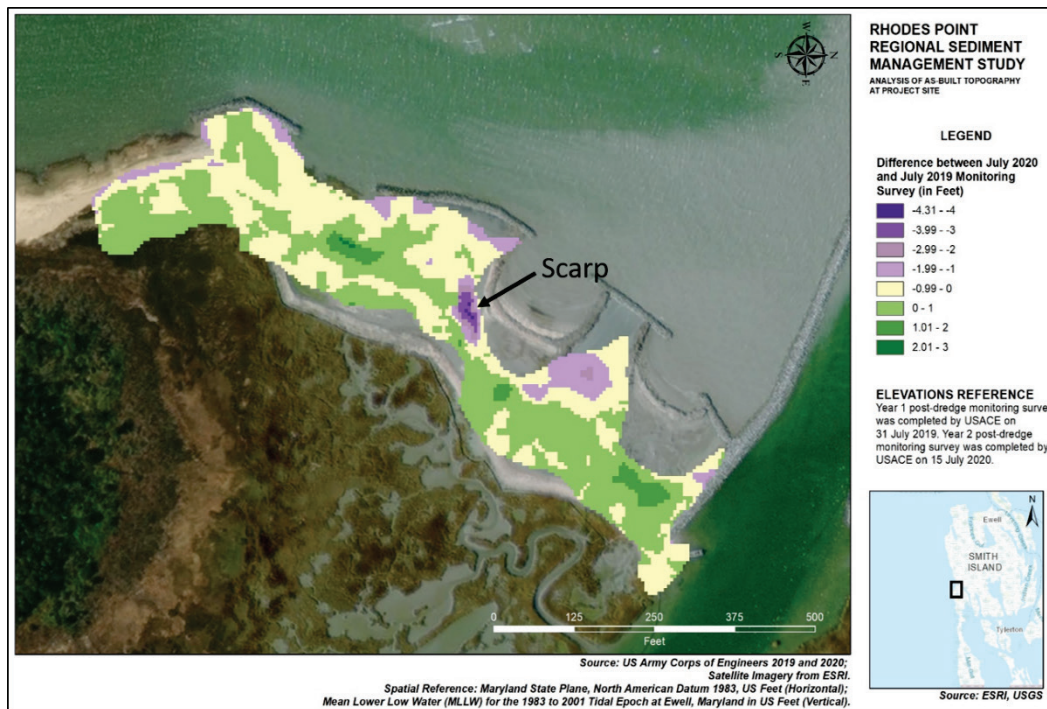
The current site topography is shown in Figure 16 and still largely reflects the as-built elevation ranges for the fill that was placed behind the sill south of the south jetty and on landward side of the north jetty. Post-placement changes in site elevation between July 2019 and July 2020 are shown in Figure 17. The placement area, especially landward, appears to be gaining elevation, mostly in the 0 to 1 ft range, but up to 3 ft in some locations. Overwash deposits were observed during site visits and presumably provided material to increase elevation in lower areas. It is possible that wind action could have acted to deposit sand at higher elevations, analogous to natural sand dunes. However, the gaps in the breakwater continue to allow for erosion of the south placement site through the gaps and behind the breakwaters (Figure 18). The scarped area also continues to erode and is labeled in Figure 18.

Figure 18. Elevation change at south placement site between July 2019 and July 2020 (arrow denotes location of the scarp).

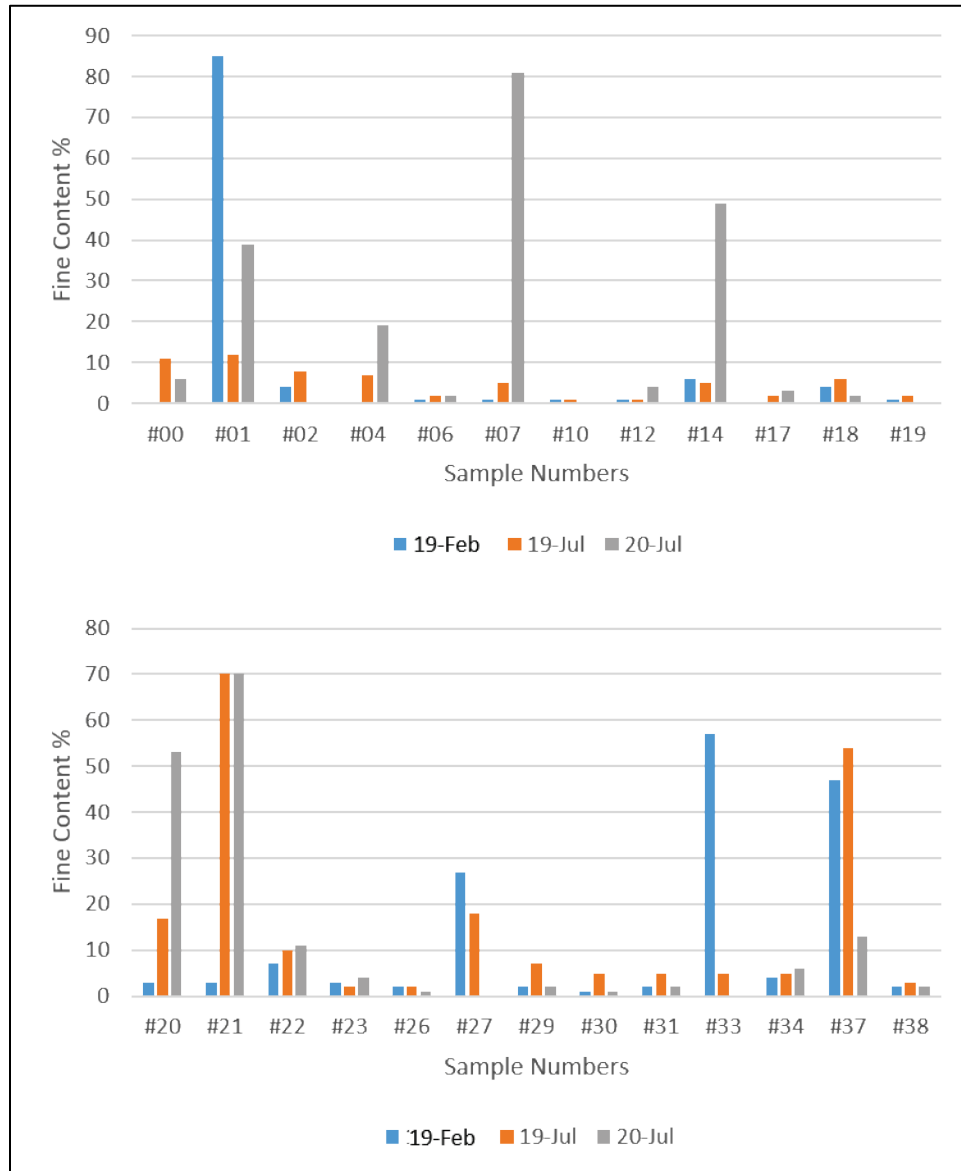
- From February 2019 to July 2020, fine contents remained stable, or where there is a trend have generally increased (Figure 20). Increased deposition of fine material generally represents locations of reduced wave energy.
- For samples x20 (e.g., 120, 220, 320) and x21, shown as Area X (Figure 21) inside the southeast extent of the channel, grain size shifted from silt (grain size less than 0.075 mm) to coarse sand (grain size less than 4.75 mm; 2% fine content) immediately following dredging and has since become siltier (53% and 70% fine content, respectively), possibly representing re-sedimentation within the channel and/or reduced wave energy.

Figure 20. Comparison of grain size (fine content) for samples collected in May 2019, July 2019, July 2020 (Note: where bar cannot be seen, fine content percentage is zero).

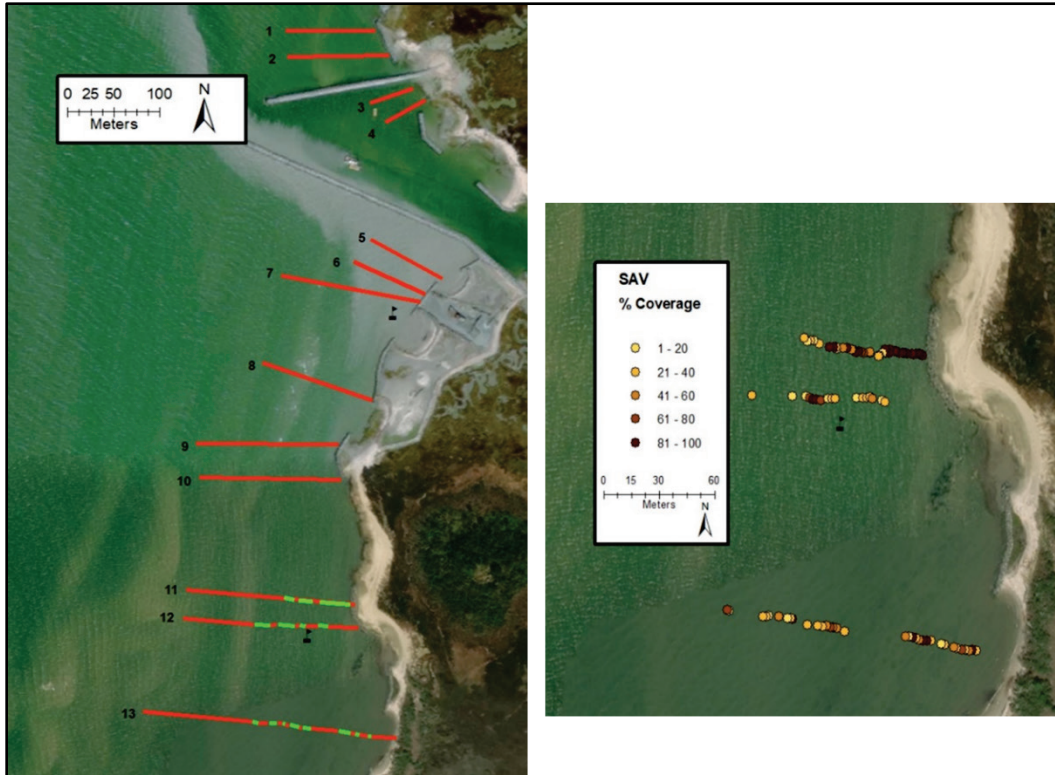
A total of 13 transects (numbered 1–10 in the project footprint; 11–13 in the reference area) was surveyed in June and August 2020. Figure 22 shows SAV monitoring transects and results. No SAV was found in the project area during the June and August 2020 surveys while both *Ruppia maritima* and *Zostera marina* were found during both surveys in the reference area. For comparison with 2020 monitoring data, Figure 23 shows SAV presence as determined by VIMS (VIMS 2020) for 2015 to 2018, prior to project construction. Both SAV species were documented along the southernmost transects within the project area (transect 9 and 10) during the June 2019 survey but were absent in 2020. Because transects 9 and 10 had SAV during the first growing season following the channel realignment, it is assumed there was not physical disturbance along those transects, and current SAV absence is not due to the realignment project. Absence of SAV in transects 9 and 10 may be representative of ongoing local changes in SAV distribution. The VIMS aerial surveys (VIMS 2020) report SAV coverage receding in a southerly

Figure 22. Left: Results from rapid SAV survey in August 2020, with green areas where SAV was found. Right: SAV locations and coverage density measured along the reference transects (11–13) in June 2020 SAV survey. The black flag is the reference water quality sonde location.

positioning of construction equipment and vessels outside SAV habitat to reduce direct physical bottom disturbance could be a means to locally minimize SAV impacts from in-water construction and dredging projects. It is recommended that the site be revisited in several years to determine if SAV beds have regained a foothold in the project vicinity.

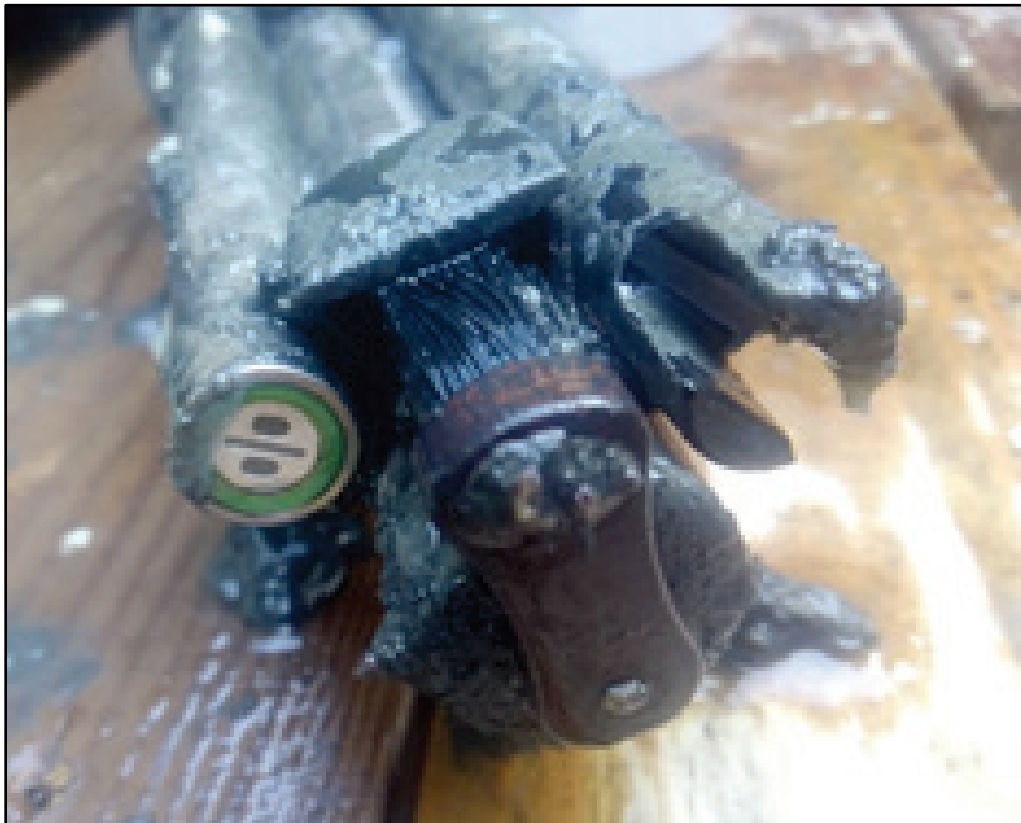
Both water quality sondes remained in place from placement on June 21 and recorded turbidity measurements during the entire deployment. Although biofouling was observed on both water quality sondes, the wiper on the reference sonde appeared to keep the turbidity probe clean (Figure 24). Upon retrieval, the water quality sonde in the project area was primarily buried by sediment. Based on the data downloaded from the sondes, it appears the sonde in the project footprint was buried approximately August 3, corresponding to the presence of Hurricane Isaias (Figure 25). It is assumed that the wiper on the project area water quality sonde kept the turbidity probe clean prior to this burial event. Water quality data in the project area following the burial event are highly questionable, so only data prior to the hurricane (August 3) are discussed.

Figure 24. Biofoul on the reference area water quality sonde; however, the wiper kept the turbidity probe (left) clean during the deployment.

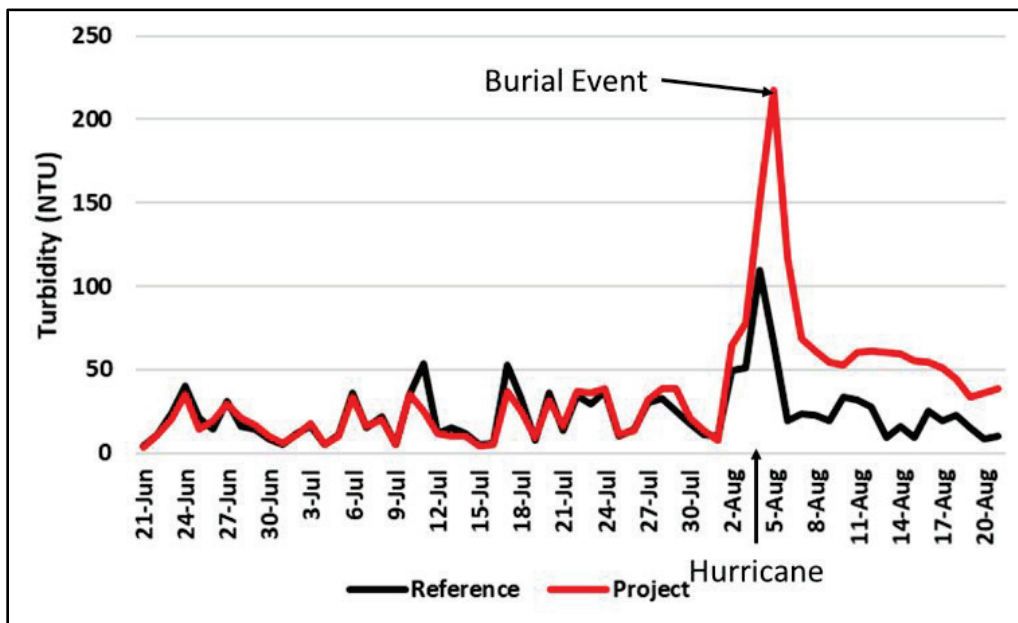
Turbidity values in the reference and project areas were very similar, with mean values of 21 nephelometric turbidity units (NTU) in both sites ($\pm .203$ and $.248$ Standard Deviation, respectively). There was also very little difference in the range of turbidity values observed in the reference site compared to the project area (4-54 NTU, 3-77 NTU, respectively). A two-tail independent t-test assuming unequal variance showed that turbidity within the project area was not significantly different from the reference turbidity values (p-value 0.95). The turbidity values within the project area follow a similar pattern to the reference values with most days being within 5 NTU of each other (Figure 25). During the 42-day sampling period, the reference site had lower values for 21 days, and the project site had lower values the other 21 days. The values during relatively high turbidity events were greater in the reference area compared to the project area (Figure 25).

Figure 25. Plot showing turbidity measured during sonde deployment. The increase and subsequent high turbidity readings recorded by the project area sonde likely correspond to the sonde being buried by sediment. Measurements after August 3, 2020, were not used for data analyses.
