Baseline Data for a Cedar Tree Revetment Monitoring Site near Wichita, Kansas

PURPOSE: This US Army Corps of Engineers (USACE) National Regional Sediment Management technical note (RSM-TN) documents baseline data collected at a cedar tree revetment installation on a small creek near Wichita, KS. These data can be used in subsequent years to add to the understanding of the longevity, effectiveness, and failure modes of cedar tree revetments as bank stabilization.

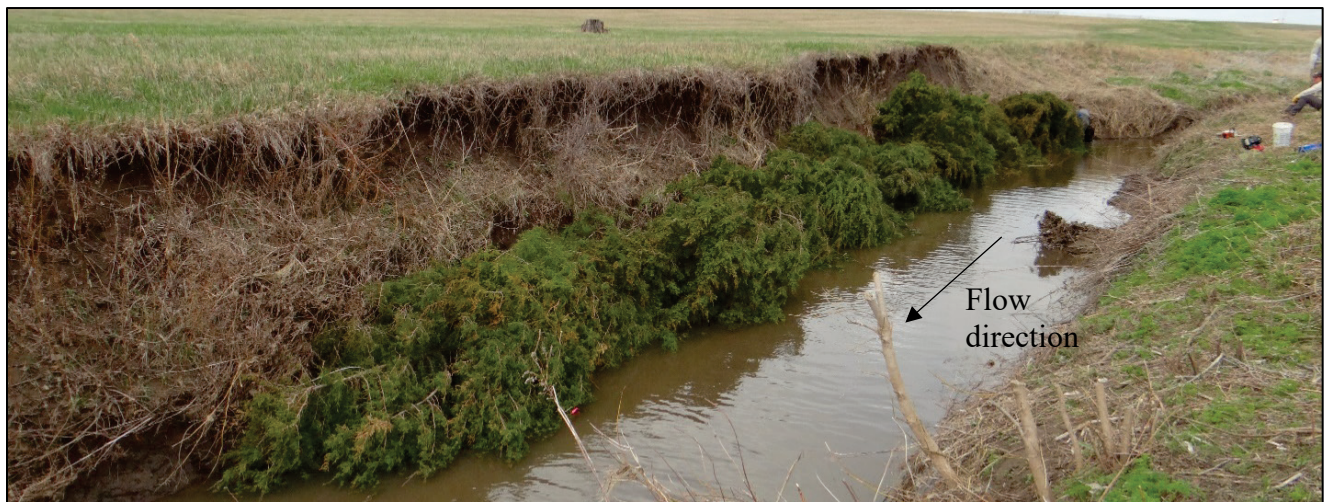
INSTALLATION METHOD: The trees were cut down in nearby fields, trucked to the site, rolled down the bank, and dragged by hand into place. Installation proceeded from downstream to upstream with trees overlapping by one-third to one-half their length. The revetment is 13 trees long, generally 1 tree high (Figure 2). The exception is at Tree #8 (the eighth starting from downstream) where the shape of the tree left some unprotected bank, so a second tree was stacked vertically to fill the gap. In all cases, the full tree was used, meaning branches on both sides were left attached to the trunk.

Figure 2. The completed cedar tree revetment with cedar trees anchored to the toe of the eroding bank.

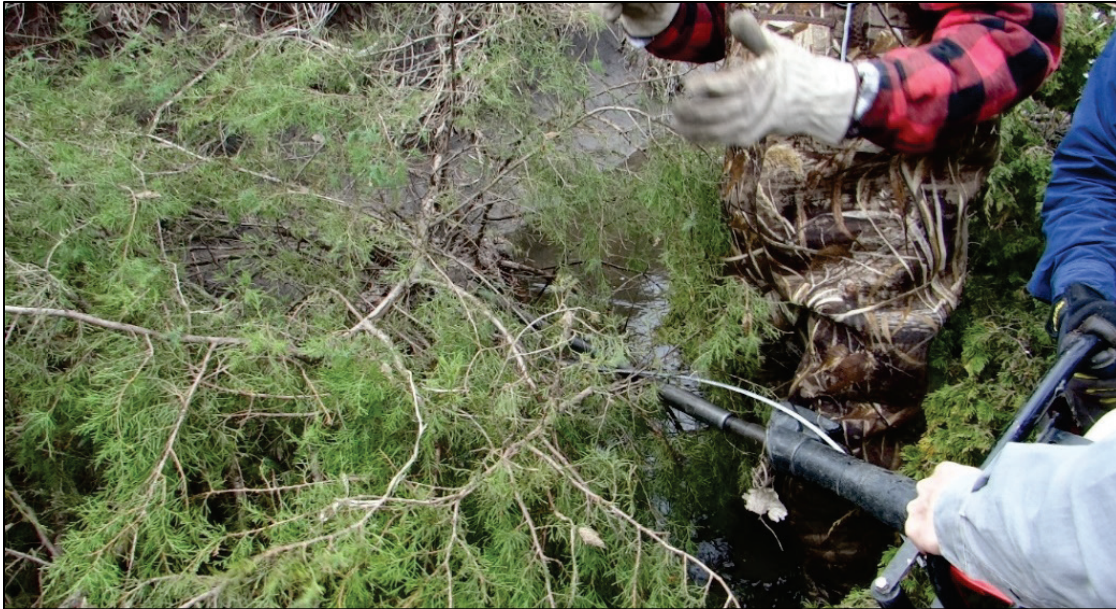
Duckbill 88II-DBD earth anchors were driven using a gas-powered post driver and driving pole (Figure 3) to a depth of approximately 3 ft (0.9 m)*. The quarter-inch (6.35 mm) cables attached to the anchors were manually pulled in an attempt to set the anchors. However, it is unlikely that sufficient force was applied by hand to fully set the anchors. The loose end of the cable was then wrapped around the trunk of the trees and cinched tightly (Figure 4 and Figure 5).

Figure 3. An anchor is driven into the bank to secure one of the cedar trees.

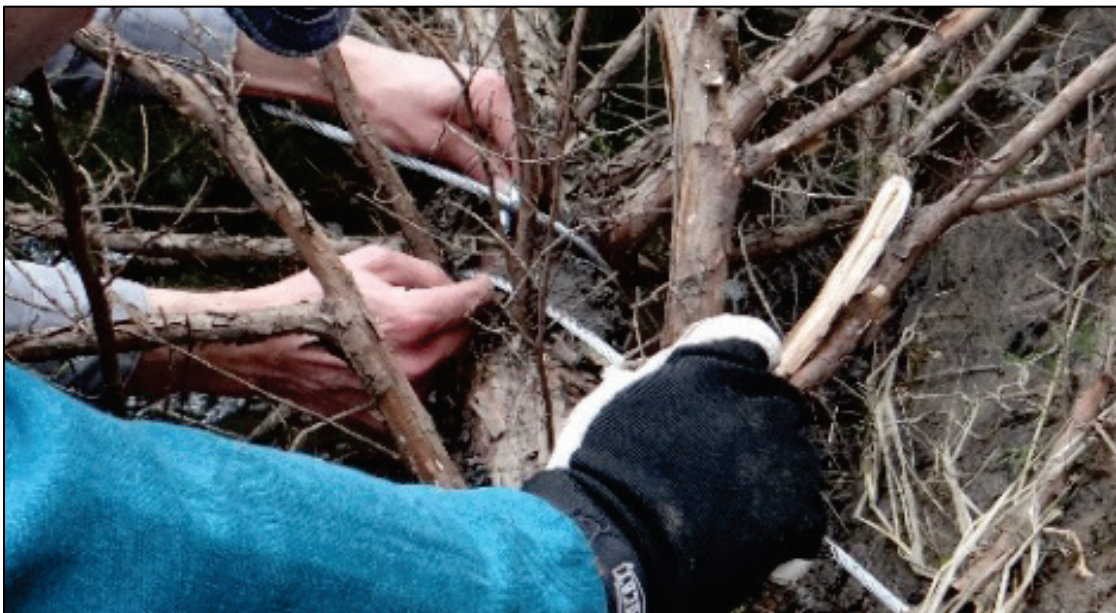
Figure 4. A cable is wrapped around the cedar trunk and secured with a cable clamp.

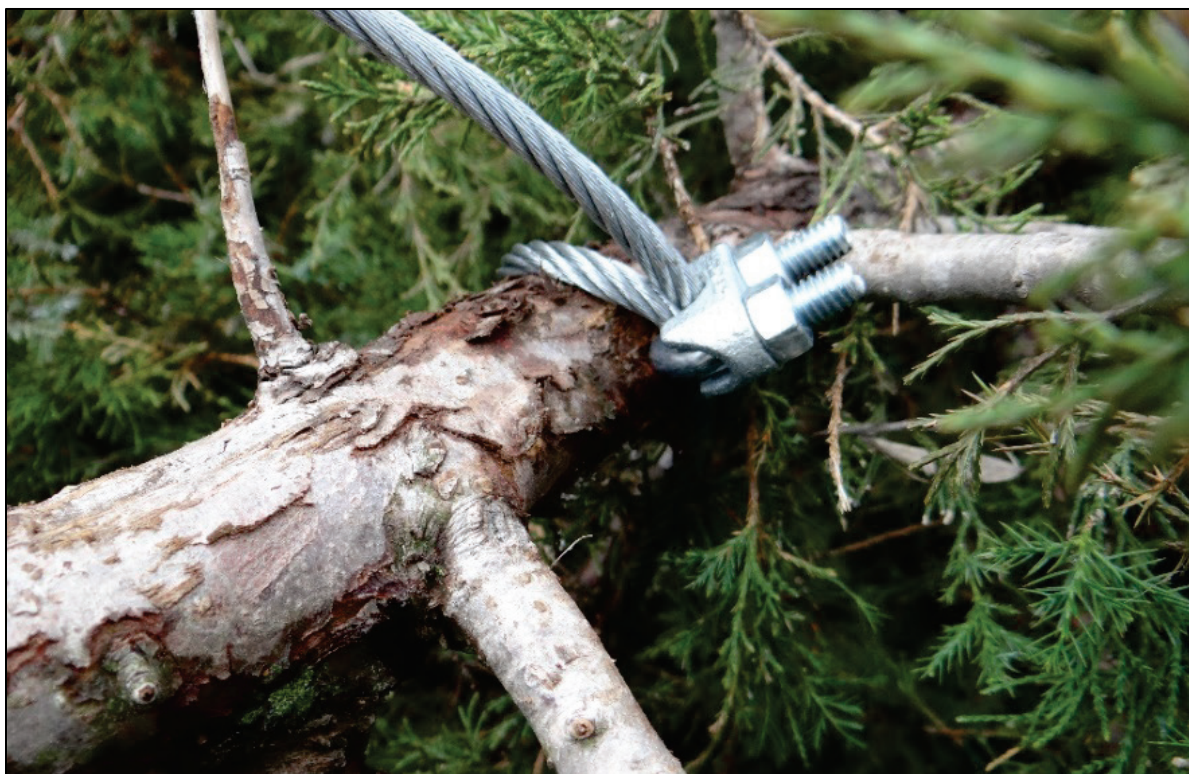
Figure 5. A cable clamp is used to secure the cable on the tapered end of a cedar tree. The coordinates for these connections are labeled “anchor points” in Table 1.

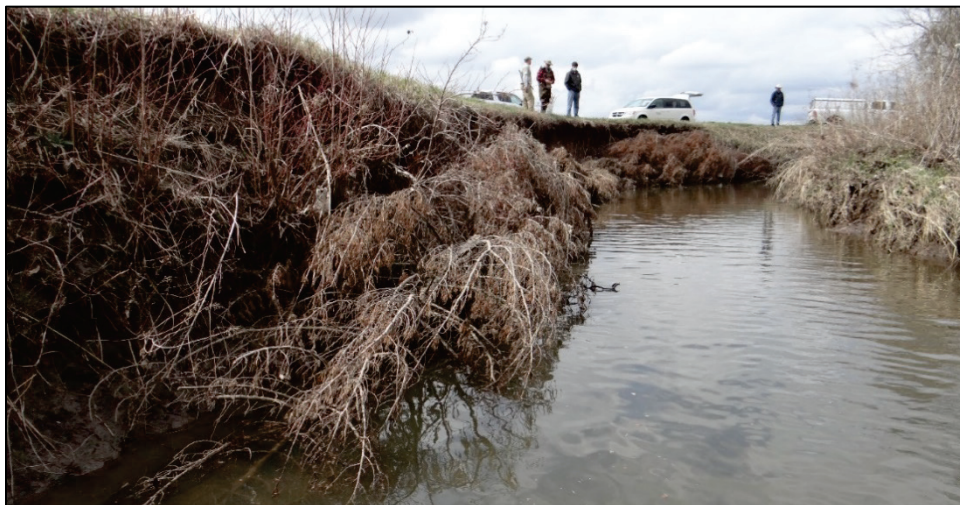
Another revetment had been installed on the same creek in June 2020. At this site, only two anchors were installed per tree, as opposed to the March 2021 revetment that used three anchors per tree. Water flow in the 9 months since installation had stripped the fine branches of the trees at this site, causing the area of the older trees (i.e., the area perpendicular to flow) to be considerably smaller than for the newly installed trees. This reduces the drag imparted on the water by the trees and thus reduces the effectiveness of the revetment. Perhaps more important, as the branches on the bank-side of the trees deteriorate, the trunks will no longer be snug to the bank toe. This could allow flanking of the structure as well as displacement of the cedar trees during high flow, both of which the authors have observed at other, older sites. Four cross sections were collected throughout this revetted bank, as shown in the upper right corner of Figure 6. These cross sections were named using letters A, B, C, D, with A being the most upstream. Table 2 presents the data. Figure 7 shows the revetment.

Figure 7. The upstream cedar tree revetment, installed June 2020. Photo was taken approximately 9 months post installation. Some deterioration of the trees is evident with many of the fine branches and needles missing.
