NRL Report No. B-2077

Report of Test

Switch, Rotary, Type J

Burkaw Electric Company
104 East 29th Street
New York, New York

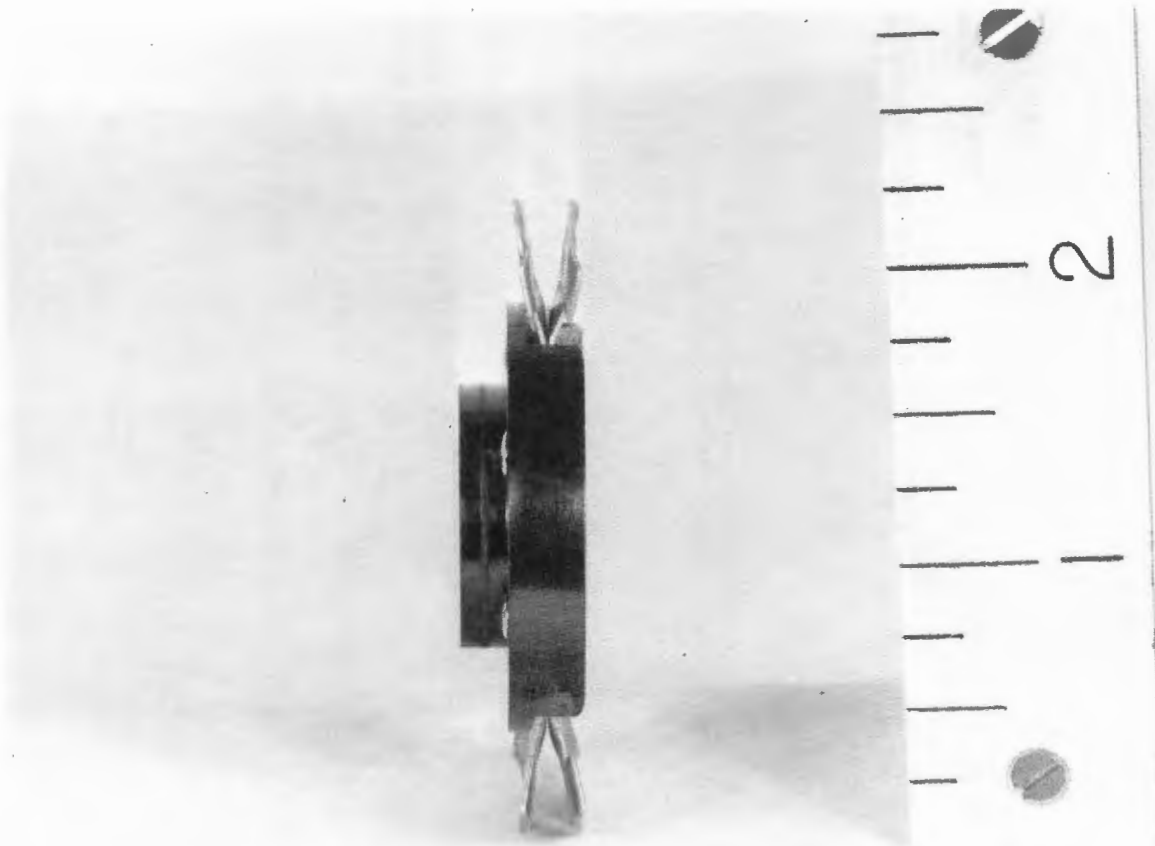
(a) The failure of the switch initially to make positive circuit between some of the terminals and later to comply with the endurance requirements is attributed to dimensional faults of both stationary contacts, pc. 12, and blades, pc. 9. The blades tips are separated by a wedge-shaped gap, wider at the outer ends (instead of being substantially parallel) and the fixed contacts are approximately 0.010 thicker than shown on drawing, reference (b), with the result that a doubtful line to surface rather than surface to surface contact is obtained. Plates 4 and 5 show these contacts.

(a) That the subject switch be NOT APPROVED due to the deficiencies noted under "Conclusions".

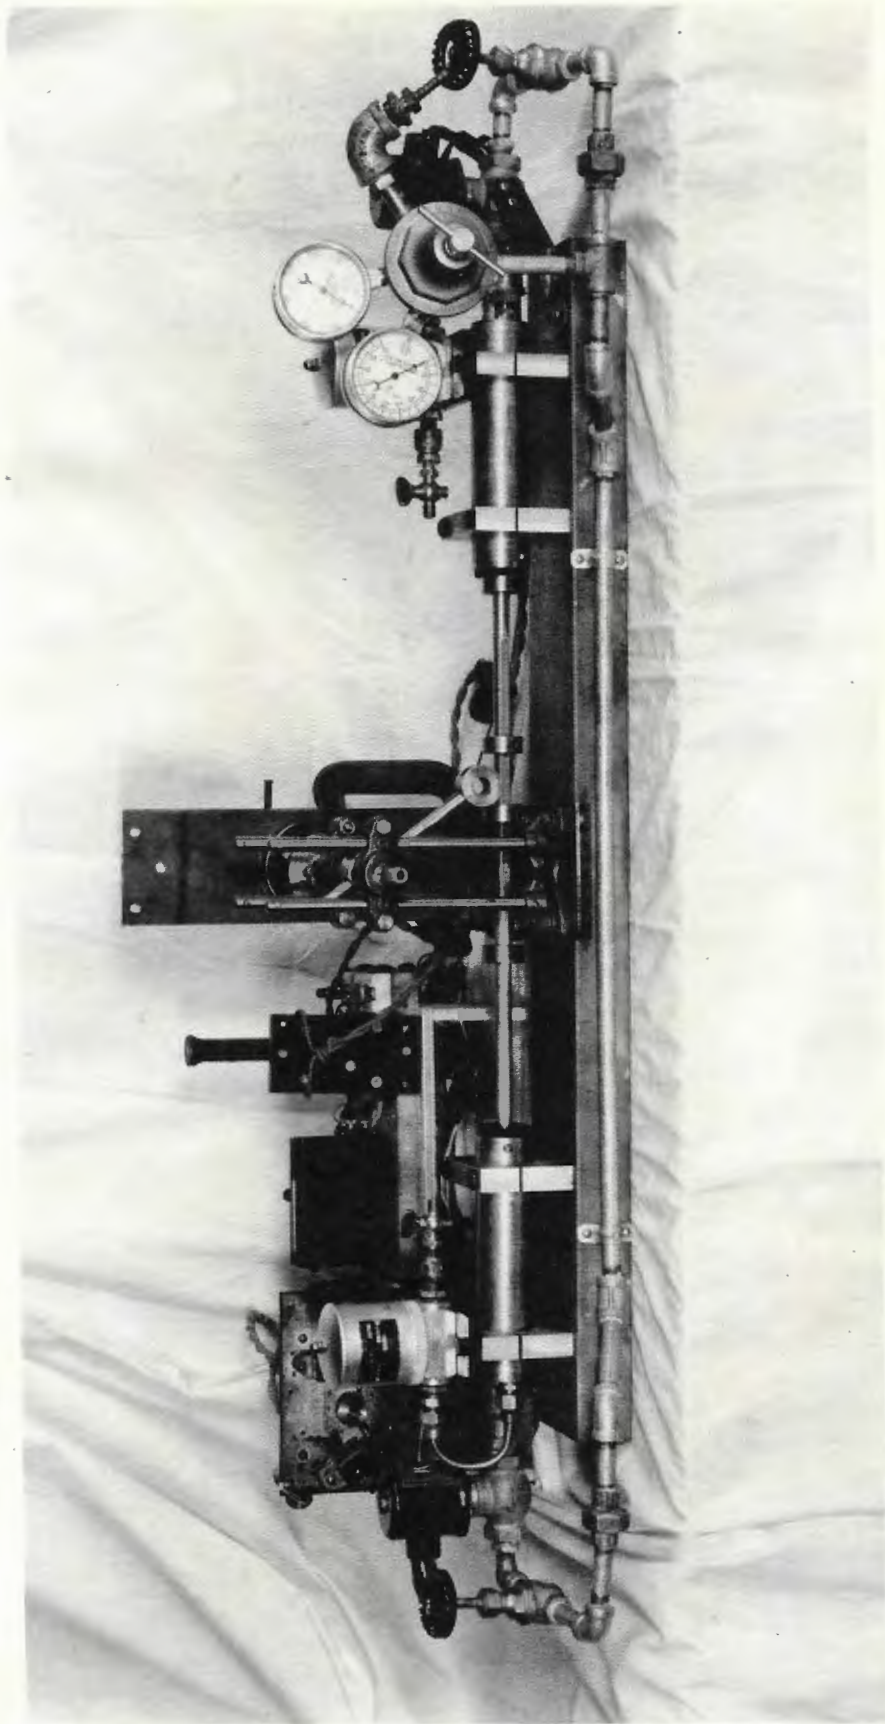
PLATE 6

10. The switch was operated by a compressed air mechanism at the rate of 10 operations per minute when carrying a load of 10 amperes, 125 volts, 60 cycles, 0.5 power factor. The transfer (45° rotation of the switch handle) was accomplished in approximately 0.4 second. The driving mechanism is shown by Plate 6. The millivolt drop across the contacts was measured before the test by a Ballentine Laboratories, Inc., Model 300 electronic voltmeter.
