Radon Leakage from Navy
Radium Capsules

NRL Report No. M-2036

RADON LEAKAGE FROM NAVY
RADIUM CAPSULES

NAVAL RESEARCH LABORATORY
ANACOSTIA STATION
WASHINGTON, D. C.

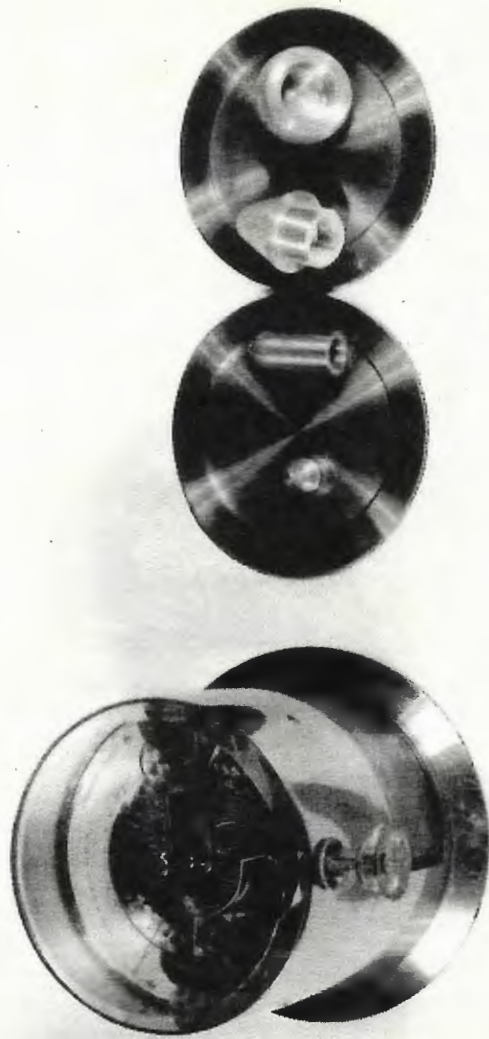
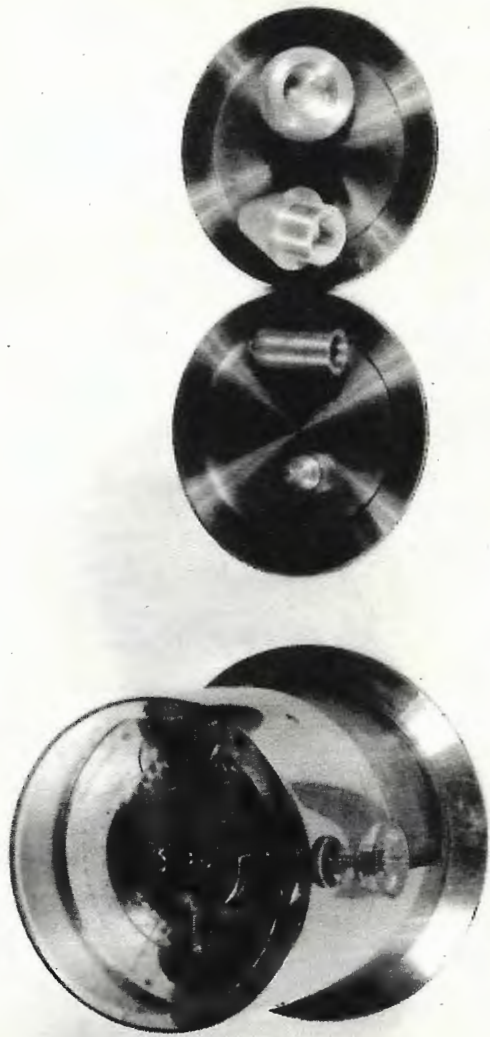
PLATE

6. Plate 1 shows a photograph taken of a section through a silver alloy capsule and also of a complete capsule. The construction is such that the wall thickness of the capsule is substantially uniform but it must be noted by the evident tarnishing at the joints as seen in the external view that a condition of inhomogeneity exists at these points which may be conducive to promoting cracking and leakage through these joints.

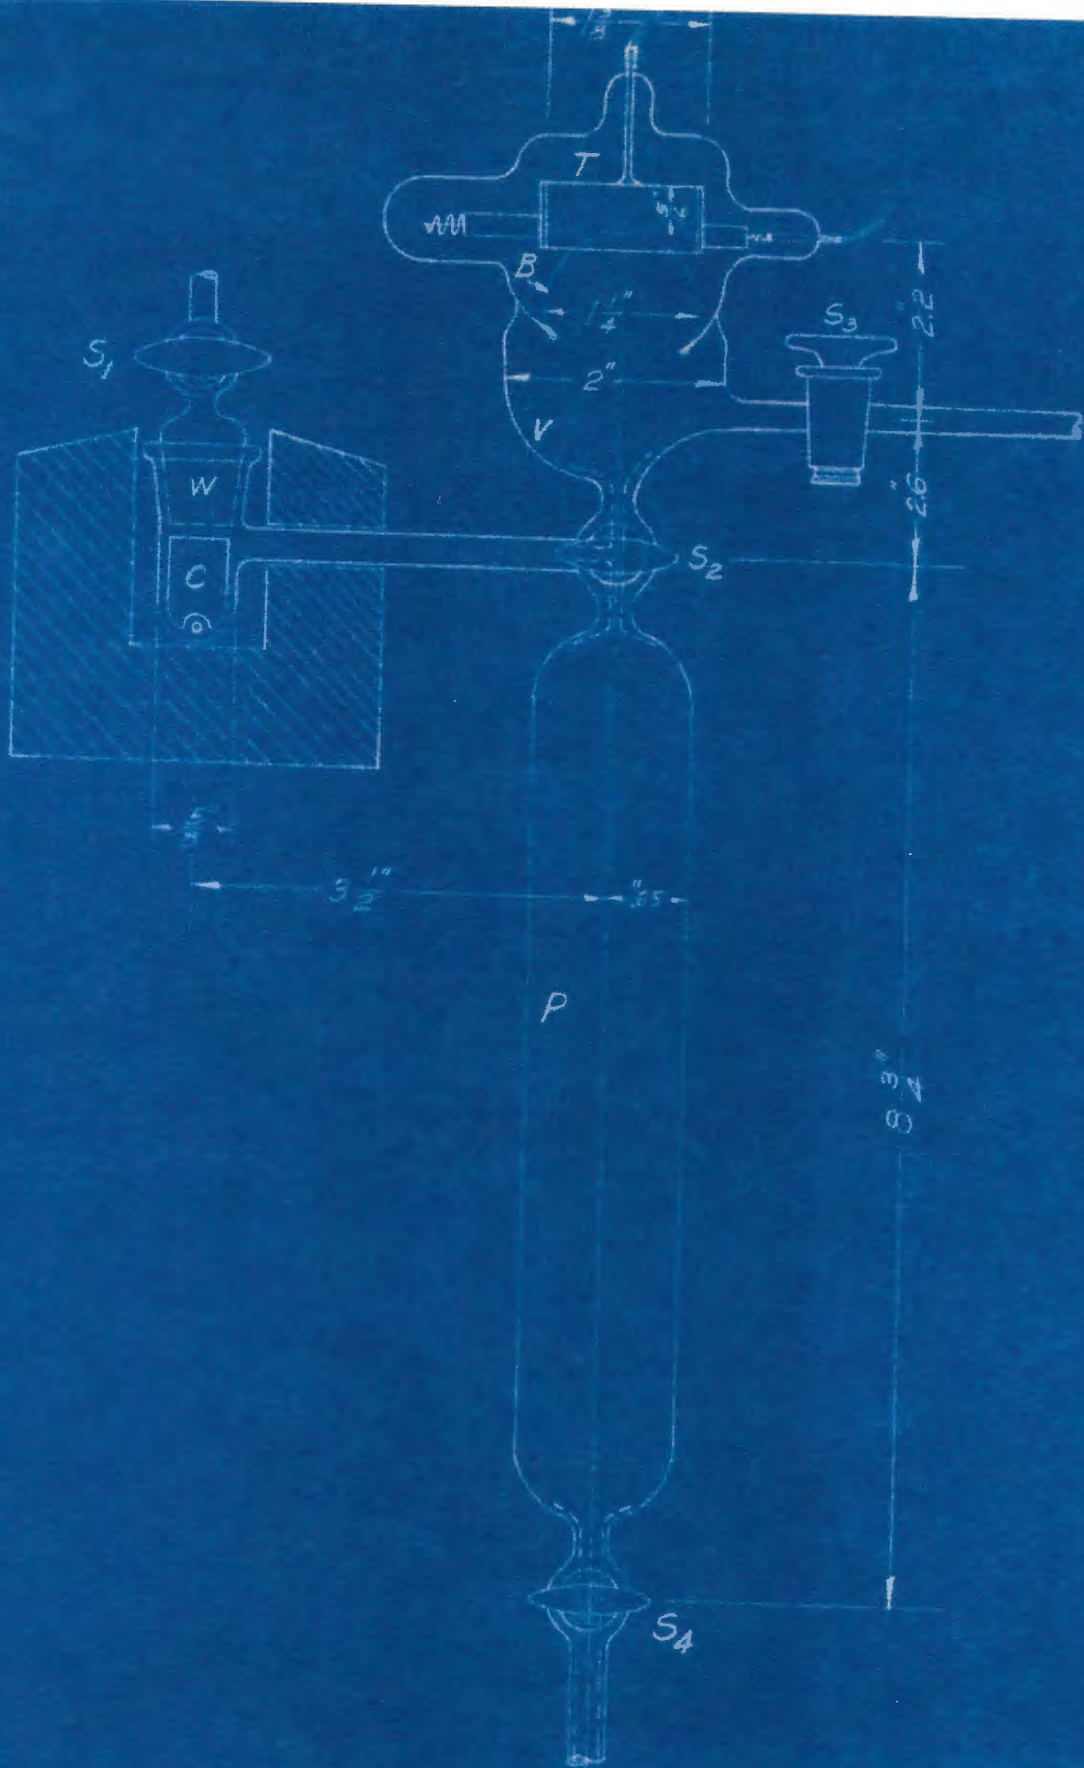
PLATE 3

13. The counter-apparatus is shown in Plate 3. In this drawing is seen the receptical W with stopcock arrangements for holding a steel radium cartridge C, the Geiger-counter tube T connected at the top to both the cartridge well W and a pump cylinder P by means of the central stopcock S₂. In use the radium cartridge is placed in the well C and the cone stopper with stopcock S is put in place. The central cylinder P is filled with mercury from a leveling flask connected to the lower end with rubber connecting hose. After filling, the central stopcock S₂ is turned so that the mercury column is connected directly to the cartridge well W and also so that the counter chamber is not. The mercury level is then lowered leaving the cartridge well under vacuum to aid the escape of radon from the cartridge. After being under vacuum a desired test time the cartridge well is flushed by repeatedly letting in air through the stopcock S₁ on the well until a sufficient volume of gas exists in the gas cylinder P to fill the gas specimen chamber V of the Geiger counter. The central stopcock S₂ is then turned to connect the gas cylinder P to the chamber V on the Geiger-counter and the stopcock S₃ on this chamber is operated to allow passage of air. The mercury level is raised to force the gas into the counter chamber, the air in the chamber and excess being passed off through the counter chamber's stopcock S₃ through a connecting tubing to a gas reservoir designed to hold several volumes of the pump chamber. With this reservoir it is possible to remove the radon bearing air from the apparatus by repeated flushings and finally, by disconnecting the reservoir, to remove it to some place where the gas in the reservoir may be safely released and the reservoir emptied out.

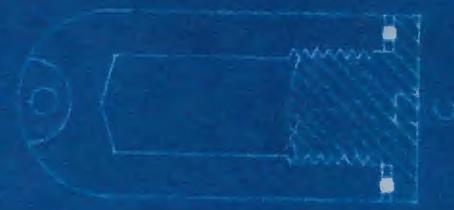
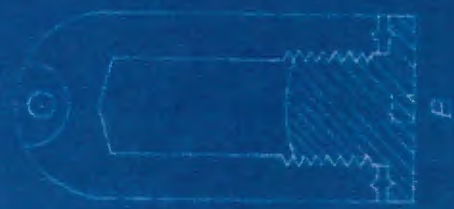
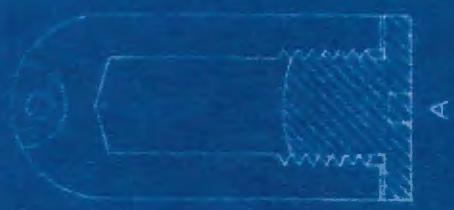
METHODS OF GASKETING USED IN TEST CARTRIDGES

20. The results of the above and further tests are summarized in Table II in which it may be noted that a variety of gaskets were tried using copper and lead as gasket materials. Even though due allowance for sensitivity due to drift in the Geiger counter meter circuit be made it may be noted that definite leakage was observed with various types of mechanical seals. These seals made with copper and lead gaskets are possibly fairly tight and reduce leakage to a small amount but it may be noted that these may become loose or may not be properly made. In test No. 13 a seal was tried in which a wire solder gasket was trapped in a lodged recess machined on the inside of the cartridge body. This seal seemed tight in first test and was thought to be the best tried but further tests showed that this also gave slight indication of leakage. Finally sealing the cartridge by means of tin solder was considered. A preliminary test on the efficiency of a solder joint on the material of the cartridge body was made by making a soldering test on a small Hypernik alloy specimen for simulating the lower end of the radium cartridge. This was tinned with zinc chloride flux and soldered with a special lead tin alloy solder. Plate 7 shows the cross-section of this alloy specimen and also a photo-micrograph of a section of the solder joint which is definitely not perfect throughout its length and indicates that care must be taken in making such joints.

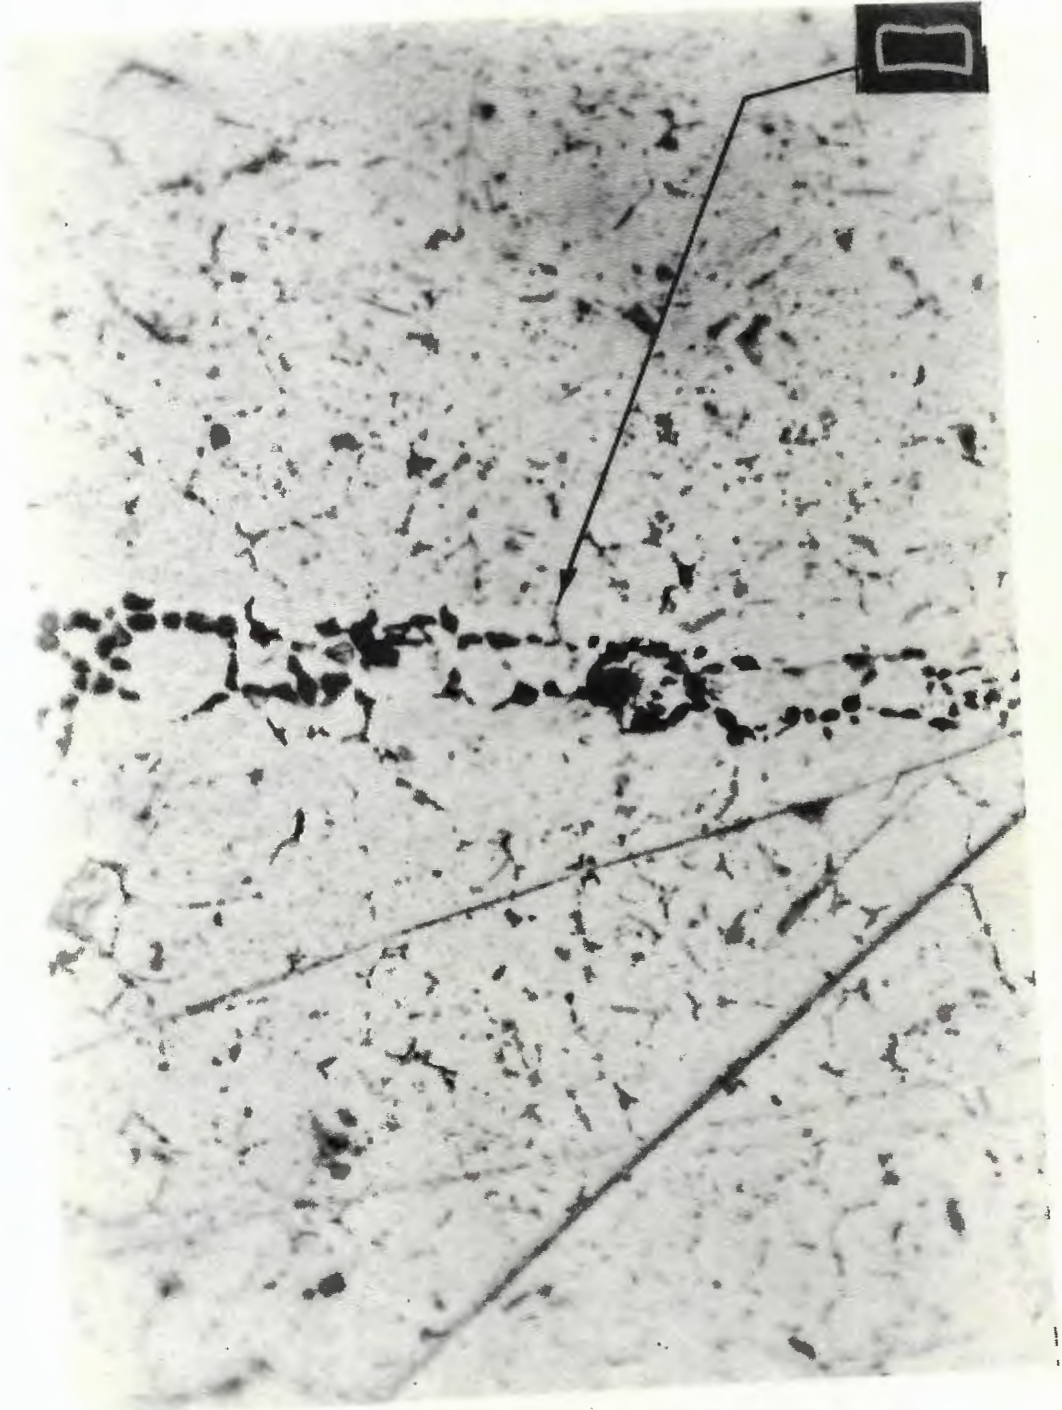
PLATE 8

25. Plate 8 shows a cross-section in the vicinity of the mentioned above and a photo-micrograph of the section in the vicinity of the corner where the side and bottom of the capsule are joined. In this may be seen a line of dark inclusions tracing the course of the silver solder joint. The grains outlined by a network of darker constituents are the primary silver-rich solid solution crystals of the alloy while the dark constituent is either a Cu - Ag eutectic mixture or the beta copper-rich solid solution of Ag in Cu. It is evident that precipitation has occurred within the grains of silver alloy which is to be expected from its composition. Whether or not the dark constituents in the junction is the eutectic or some other materials cannot be said from the photo-micrograph alone. The high solid solubility of Zn in silver makes it unlikely that this is a zinc compound such as the beta-phase of the silver zinc system. Presence of silver or copper oxide inclusions are more likely. In any case this string of inclusions along the junction affords a zone of weakness for propagation of intercrystalline corrosion and cracking along the junction. The presence of Zn in solid solution will change the galvanic potential of the solder alloy to promote such corrosion.

29. The analysis and photo micrograph made on the silver alloy capsules have shown that there is a definite tendency for corrosive action to take place in the joints of the silver capsule and that the silver solder used in making these seals contains a conceivable amount of zinc. Aside from the possibility of cracking in the solder joint after the capsules have been made there is the possibility that much of the leakage is due to an imperfect bonding in the joints leading to opening of the joints after the capsule has been in service for some time.

31. It is recommended that future radium sources purchased for use in Navy gamma radiography be enclosed in silver alloy containers having a minimum wall thickness of one millimeter and made as nearly free of joints as possible by spinning the cartridge from a single piece of material. If improvement along this line does not result attention should be turned to the use of steel cartridges in which the radium salt is sealed by welding.
