FR 2105

2. The object of this test was to determine the shatter prevention qualities of the modified Shatterbond coating, when applied to 50 and 100 watt rough service lamps. Additional information was obtained relative to the value of the coating on flat instrument dial window glass to prevent its shattering under high intensity shocks.

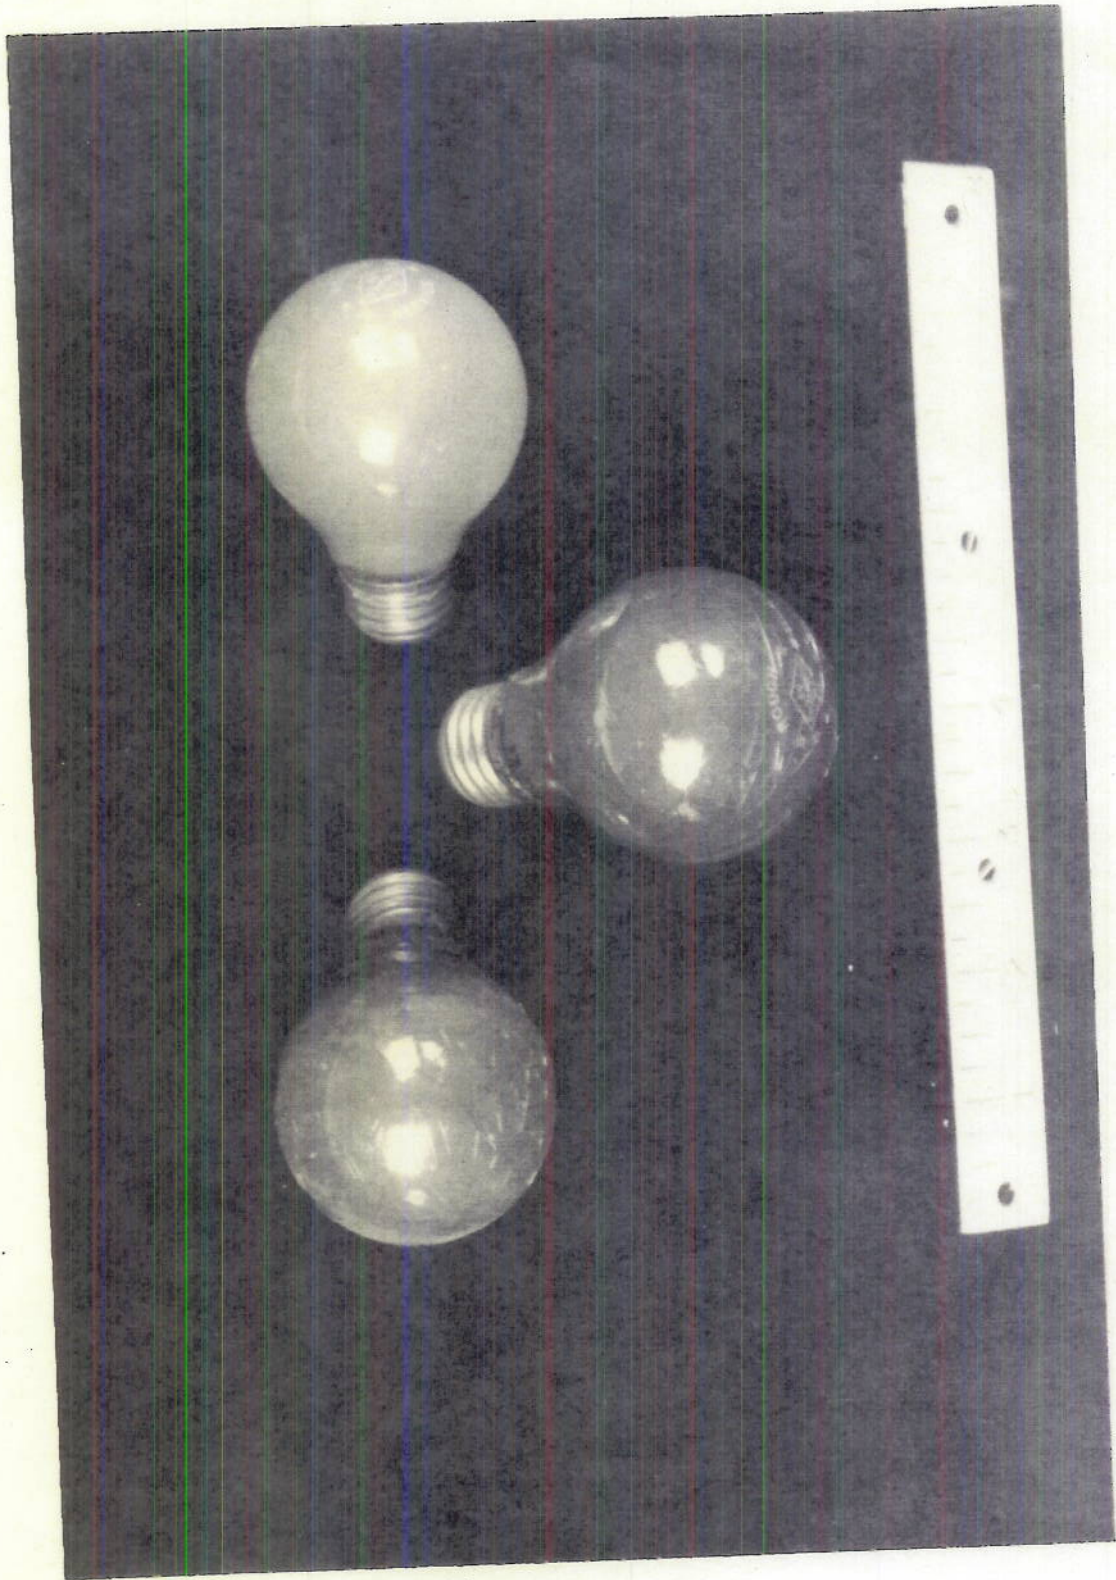
PLATE I

17. The coatings on the fifty watt rough service lamps did not deteriorate as much as the coatings on the 100 watt lamps, but these coatings also became very brittle and discolored to a dark brown. However, the coating did not melt or form ridges as in the case of the 100 watt lamps. These lamps can be seen in plate (1).

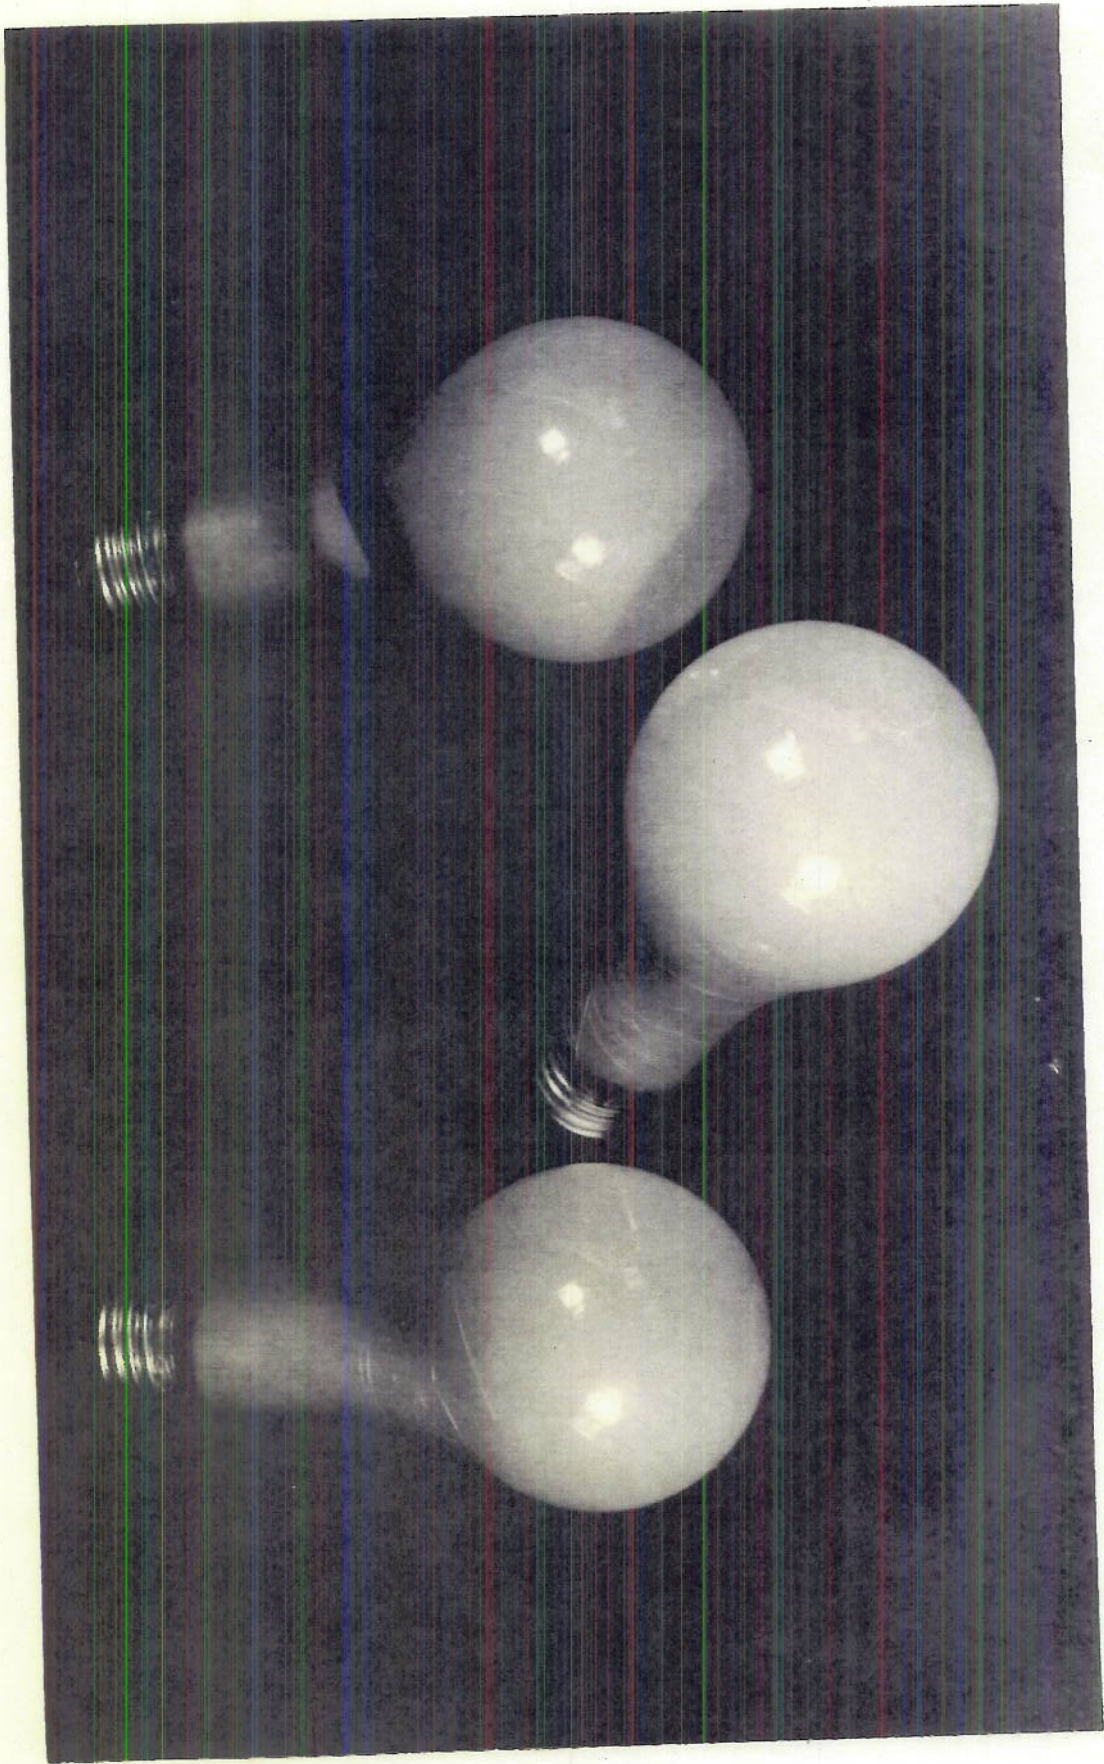
PLATE 2

16. After the lamps that had been coated with the Shatterbond had been burnt for as little as 20 minutes, the coatings became brittle and on cooling cracked. After longer burning periods, the coatings discolored to a dark brown and at places melted on the glass and formed thick brown ridges. The position of the lamp while burning affected the location of the areas where the coatings melted but not appreciably the extent to which they melted. Some of these lamps can be seen in plates (2) and (4).
