of Park 4 Mod. 1 Serial 235 Radar Equipment

on the USS MURPHY, DD603

NRL Report No. R-2294  
Prob. O-39R-C

Report on  
Installation and Operation  
of Mark 4 Mod. 1 Serial 285 Radar Equipment  
on the USS MURPHY, DD603

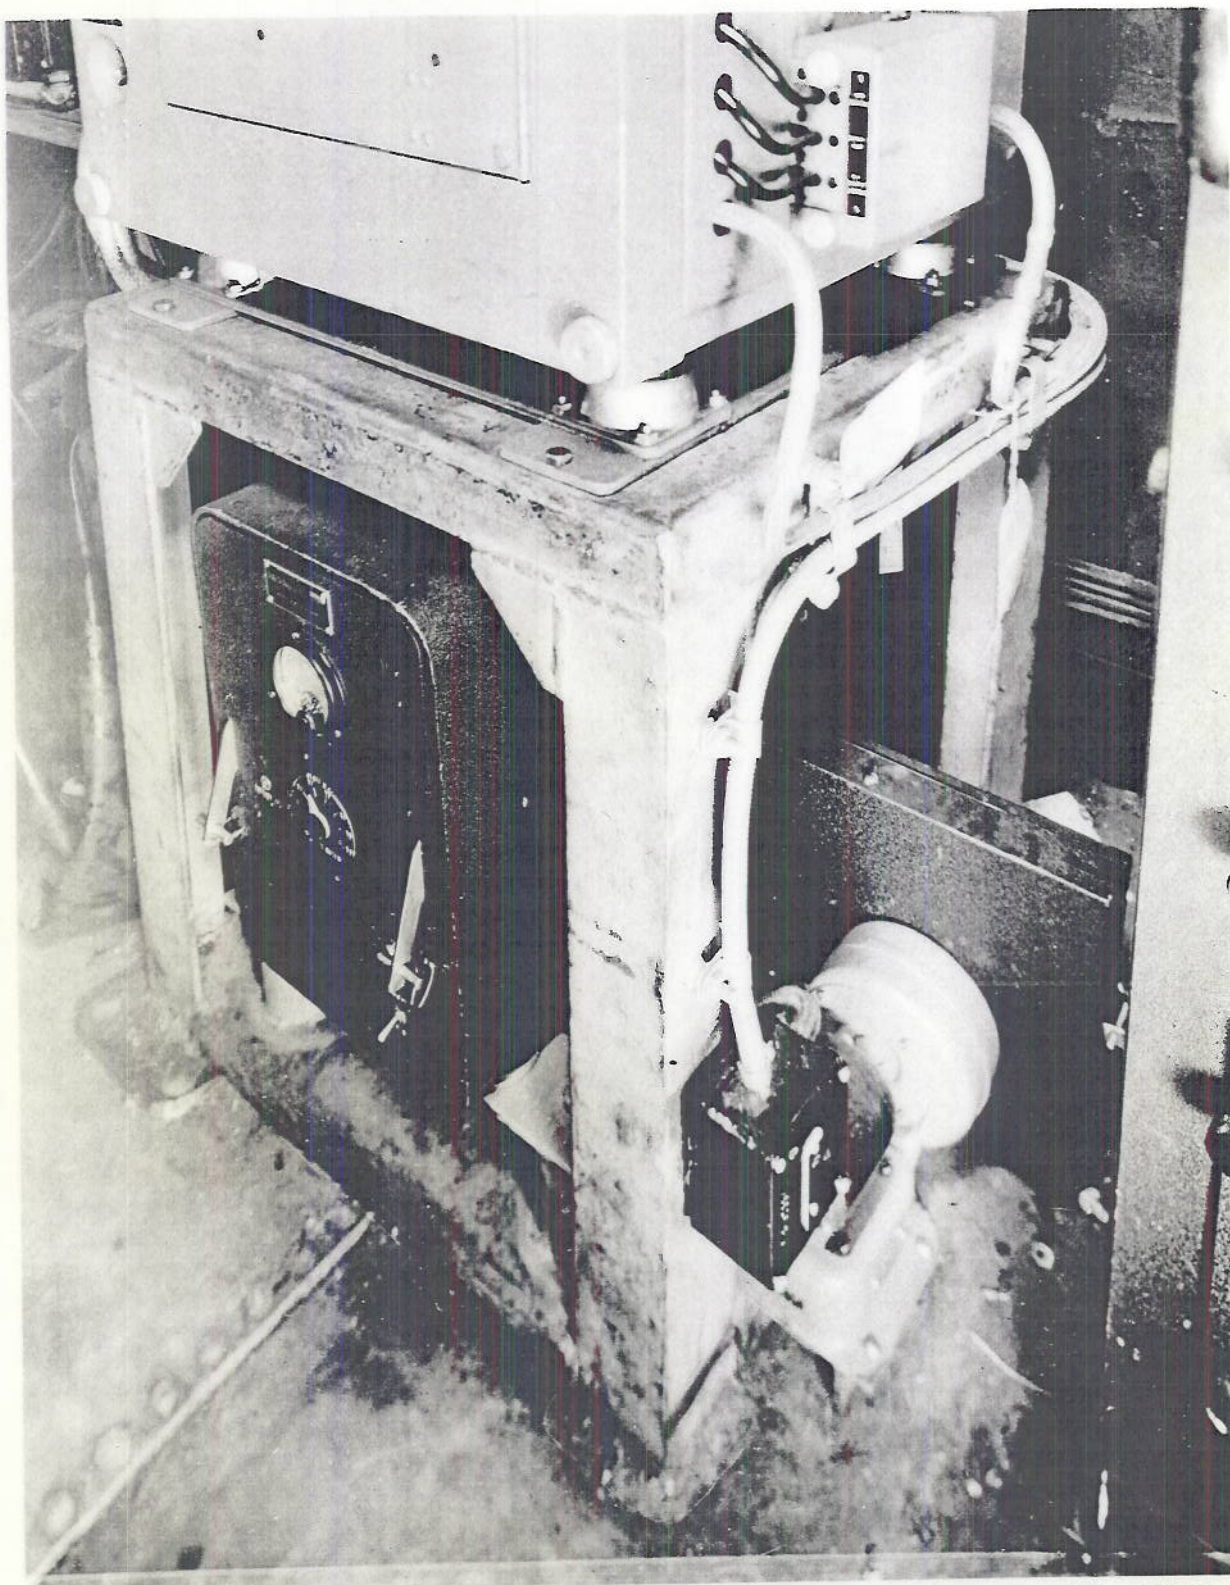
DIATE 2

4.2. Regulated Rectifier. The Regulated Rectifier and its associated blower was installed to the left of the Main Frame, and directly under the Model BM Radio Equipment. The blower motor and air filter assembly is solidly secured to the deck. It was necessary to modify the two supporting plates for the regulated Rectifier shock mounts to provide the necessary clearance for the added air filter chamber. The shock mounting characteristics were unaffected by this change. Plate 12 is a drawing of the modified supporting plate, and Plate 3 is a photograph of the unit installed.

F644C5765 NAVY YARD, NEW YORK  
U.S.S. DD 603, MK 4 RADAR INSTALLATION.  
REGULATED RECTIFIER AND BLOWER MOTOR.

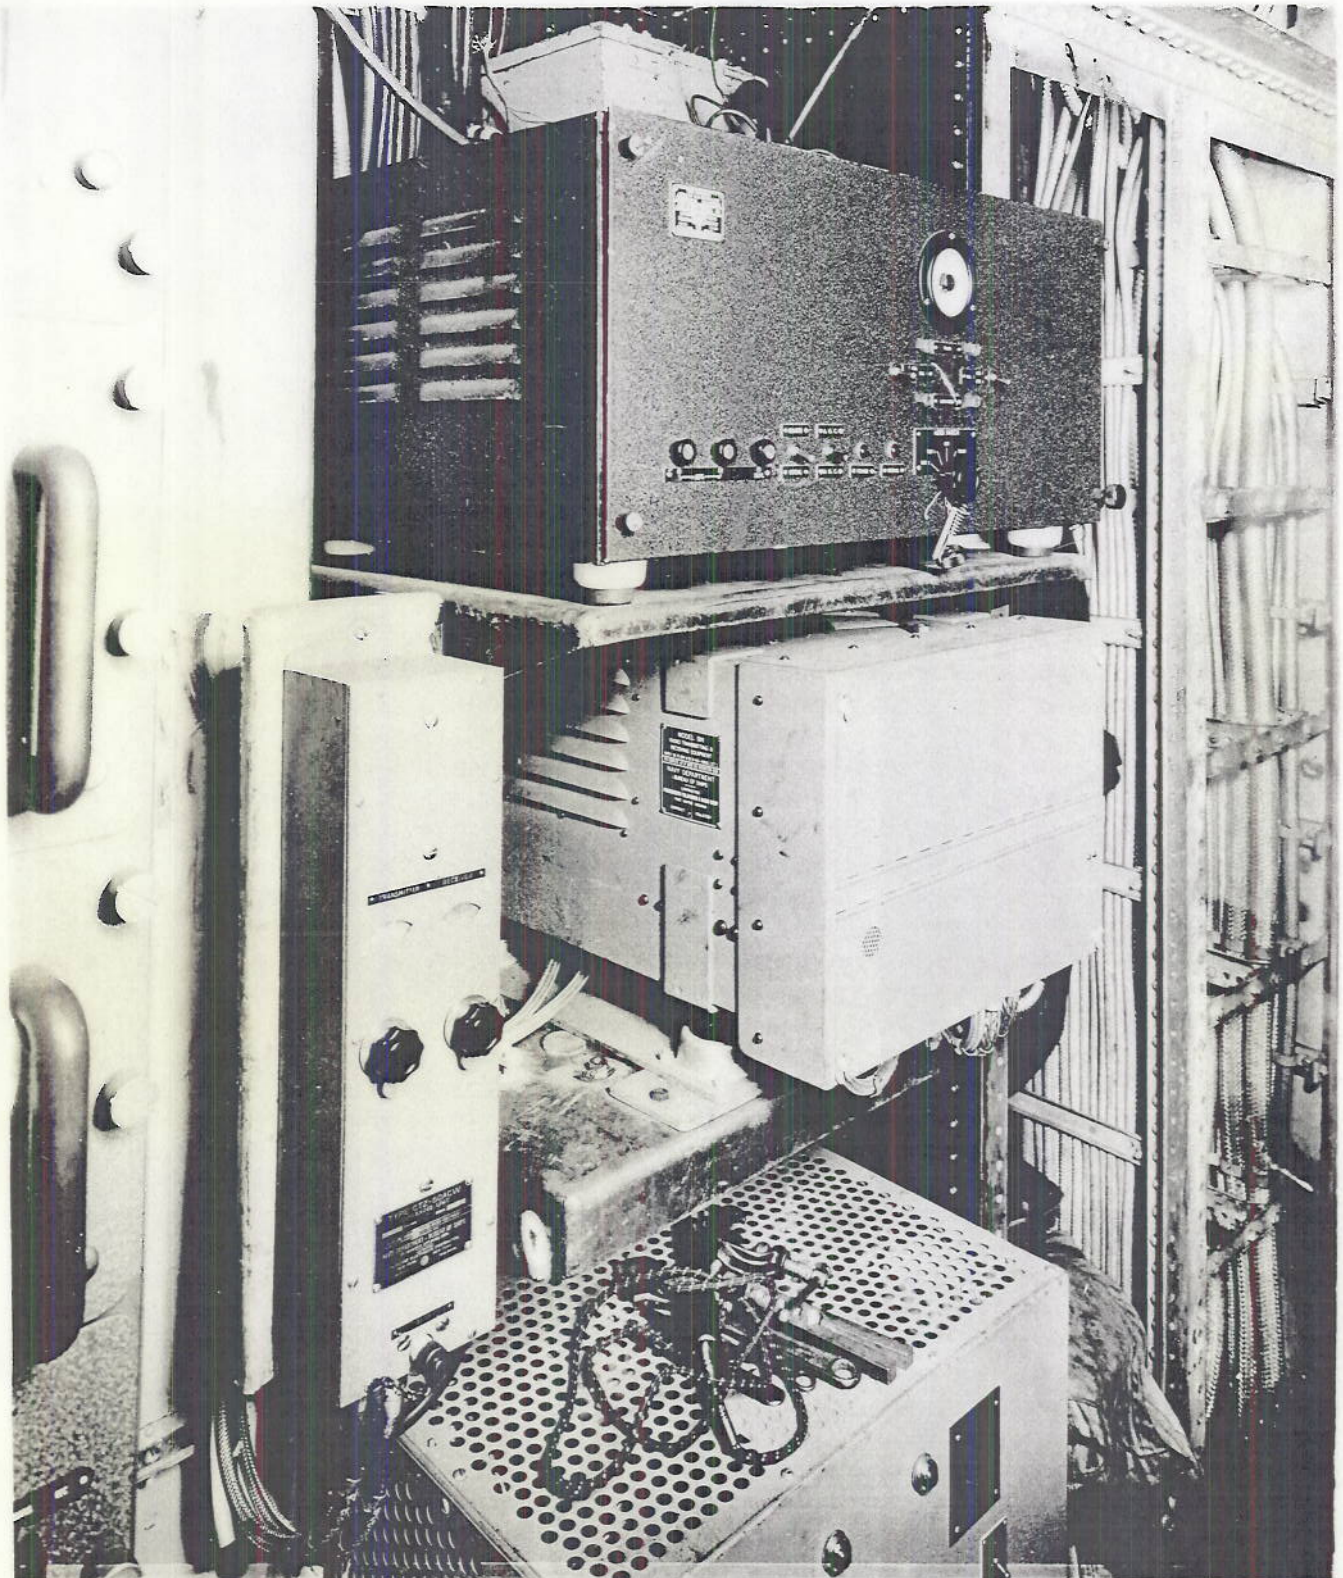
PLATE 4

clearance was provided around the unit. The pins securing the heads to the knurled thumb screw for the front panel were too small and sheared off. They were replaced with larger pins. Plate 4 is a photograph of the installation. The unit may also be seen in Plate 2.

F644C5764 NAVY YARD, NEW YORK  
U.S.S. DD 603, MK 4 RADAR INSTALLATION.  
AUTOMATIC GAIN CONTROL UNIT.
