2021 Guided Wave Inspection of California Department of Water Resources Tainter Gate Post-Tensioned Trunnion Anchor Rods

Oroville Dam

December 2022

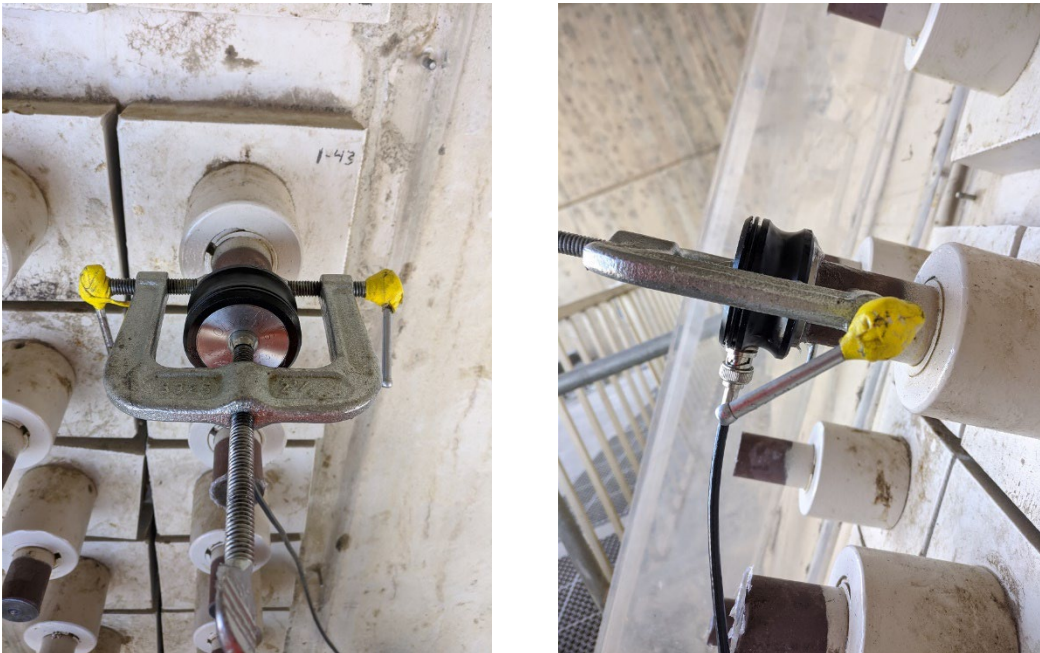
Figure 3. Transducer attached to tendon end.

The conditions of the tendon ends remain unchanged from the previous year (Figure 3). Through sufficient greasing, use of cover boxes, and overhead coverage, it is not expected that the tendon ends will change from year to year. All tendon ends have previously been ground flat and polished.

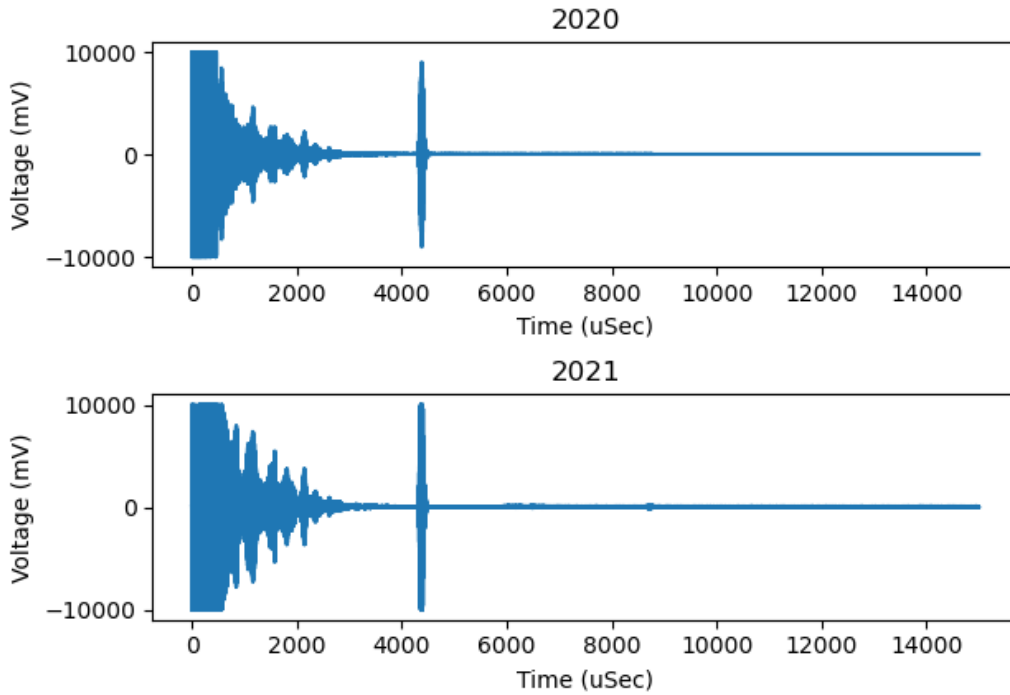
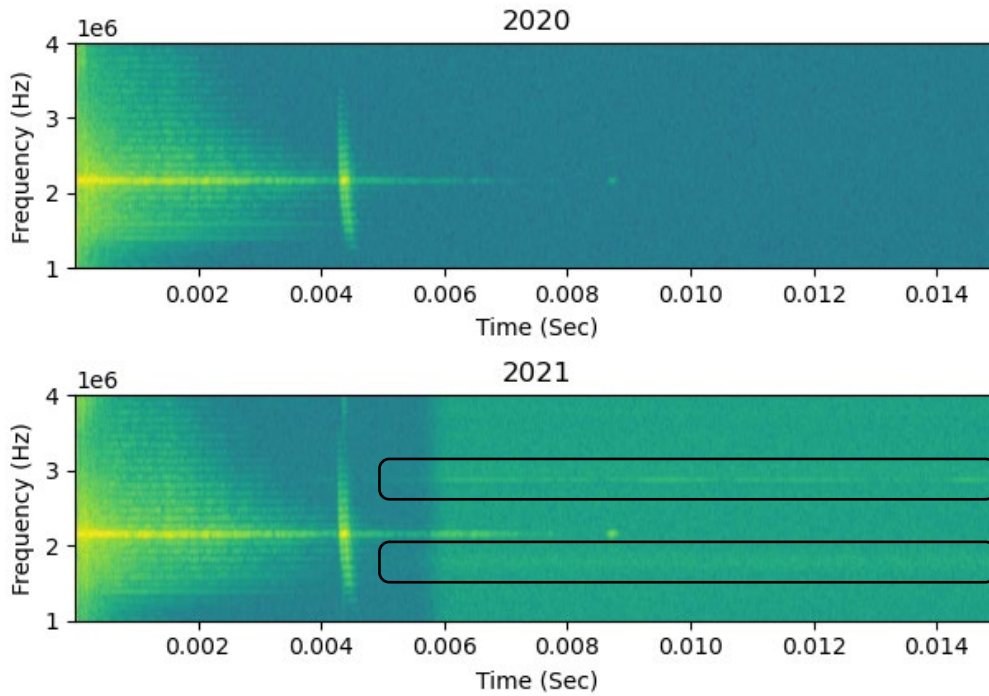
Figure 12. Example of a Variance from Previous Year result.

The main indication of rods in this category is the presence of what appears to be electrical noise coupled to the response. This effect is not seen in the time-series data but is pronounced in the time-frequency data. An example of this is shown in Figure 12. All results marked Variance from Previous Year contained similar noise.

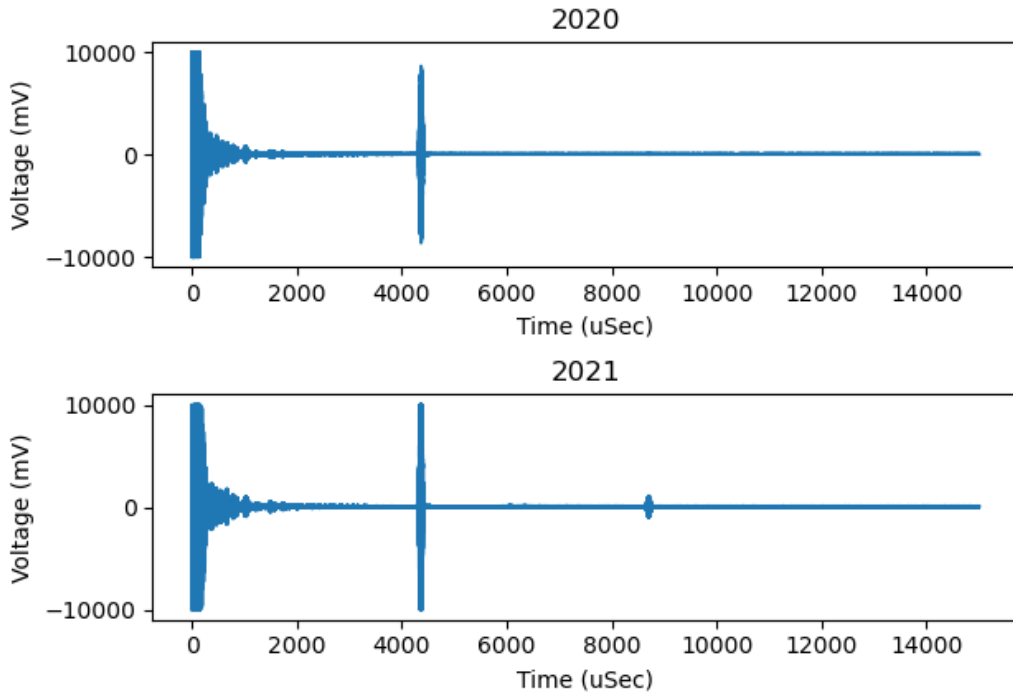
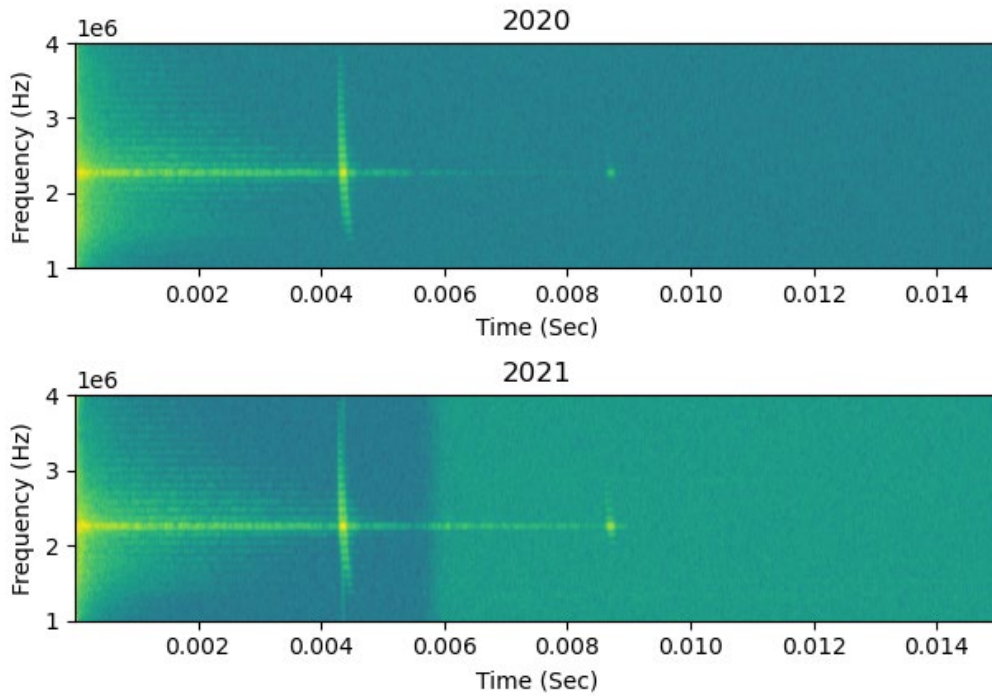
Figure 13. Example of a No Issue result.

The results labeled as No Issue mainly consist of anchors that are more centralized within the bundles. In making decisions on what category an anchor falls in, the area between the start of the test and the first rebound is primarily investigated. Any reflectors present in the tendon will appear in this area. Reflectors close to the testing end can be lost in the noise of the return signal due to the amount of energy required to propagate the full distance. Figure 13 shows an example of a No Issue result and illustrates the region of interest in the black rectangular area.

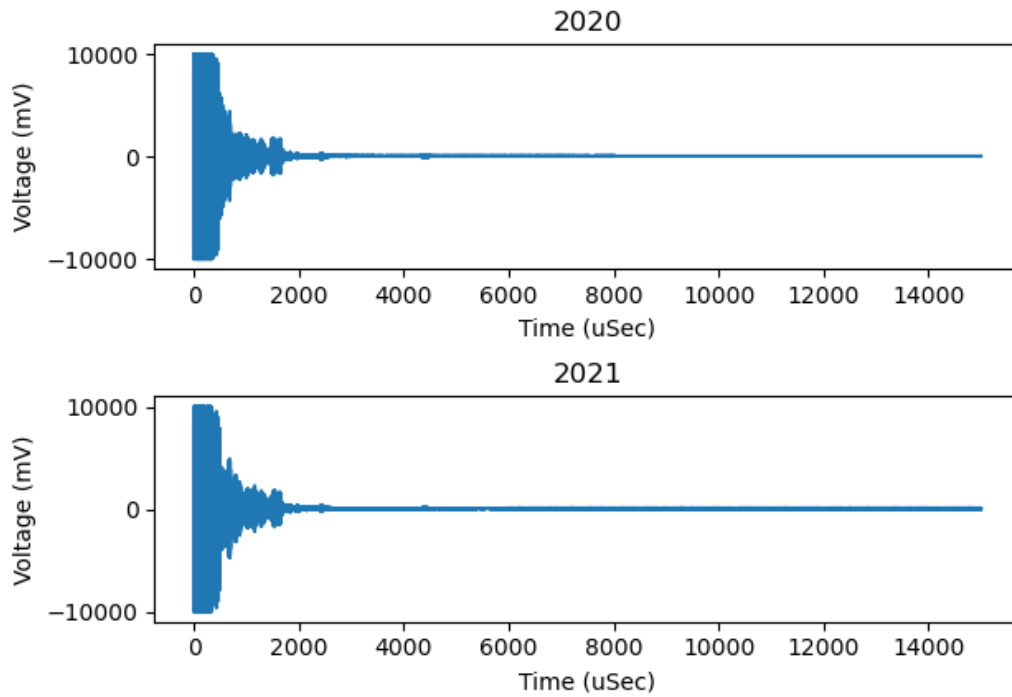
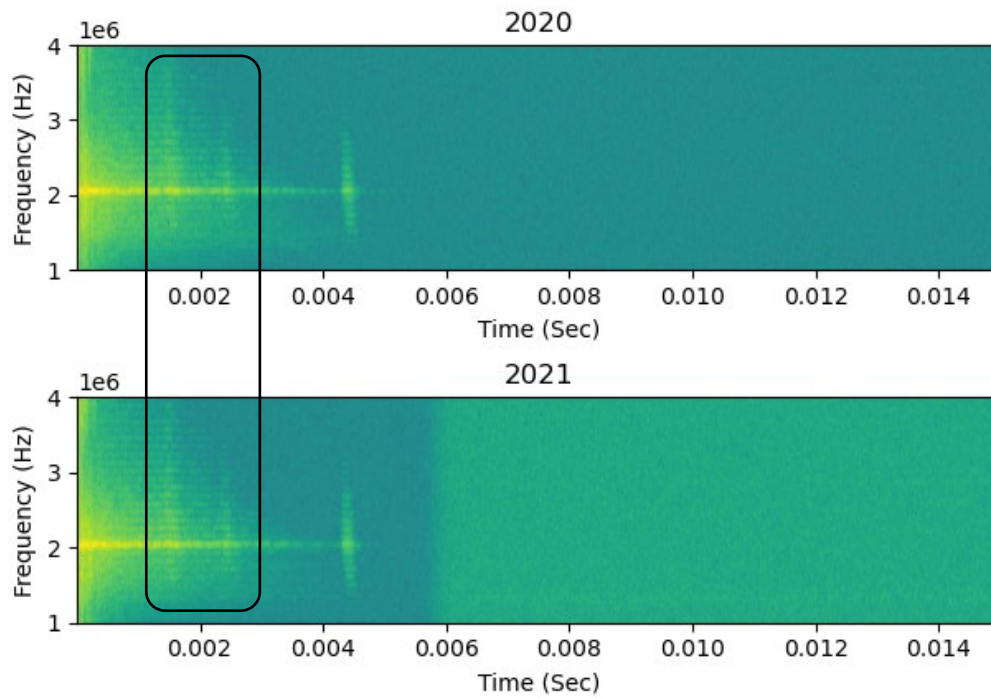
Figure 14. Example of an Anomaly result.

Across the eight piers at the Oroville Complex, it has been shown over the previous two testing years that the upper and lower rods within the bundles contain reflectors in the vast majority of the collection. While not thought to be defects, something related to the rod bending in the design specifications causes both these reflectors to appear and greatly attenuate the return signal related to the end of the rod. Figure 14 shows an example of an Anomaly result and illustrates what gave it this label.

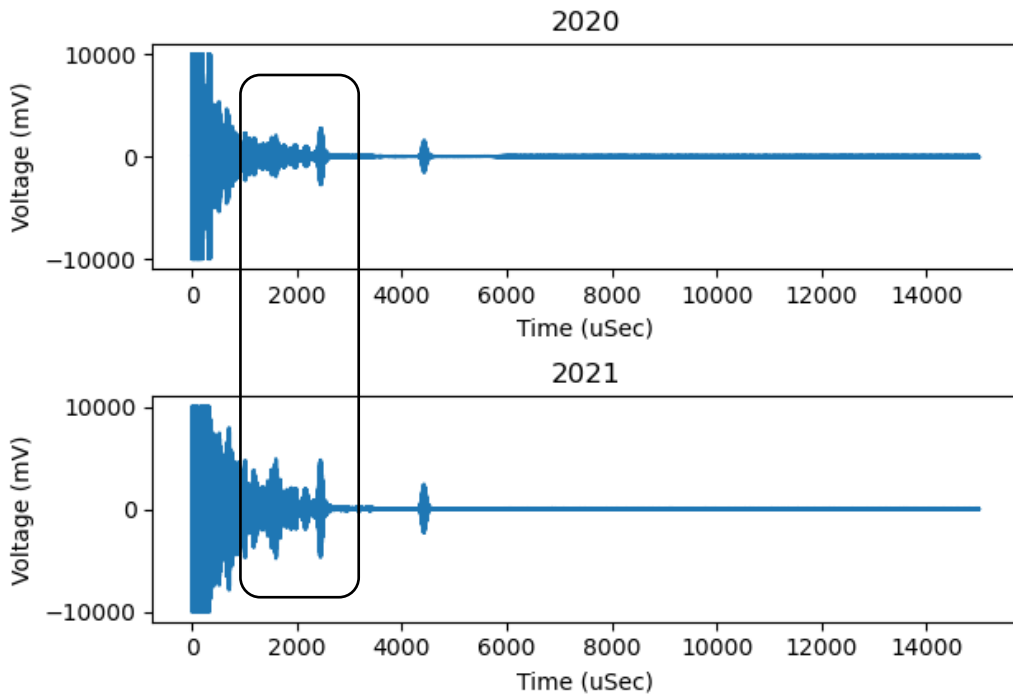
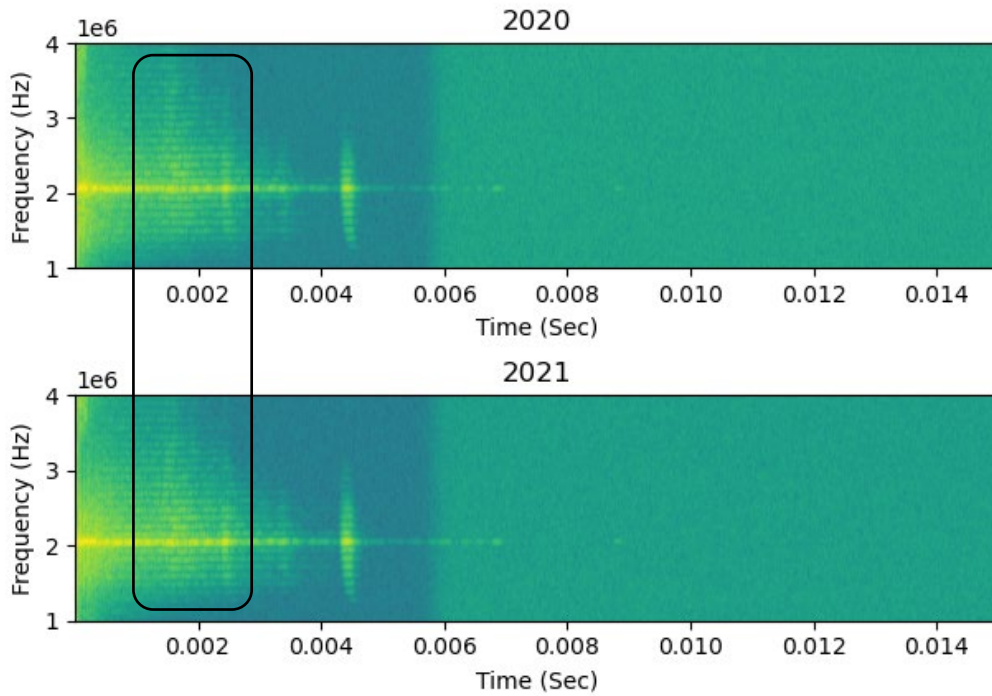
Figure 15. Possible Defect rod 2-13.

As the signature of the reflections on each rod has not changed since the 2020 inspection, the rods that were previously labeled as Possible Defect remain labeled as Possible Defect. Each instance of this labeling is shown in Figure 15 through Figure 18.

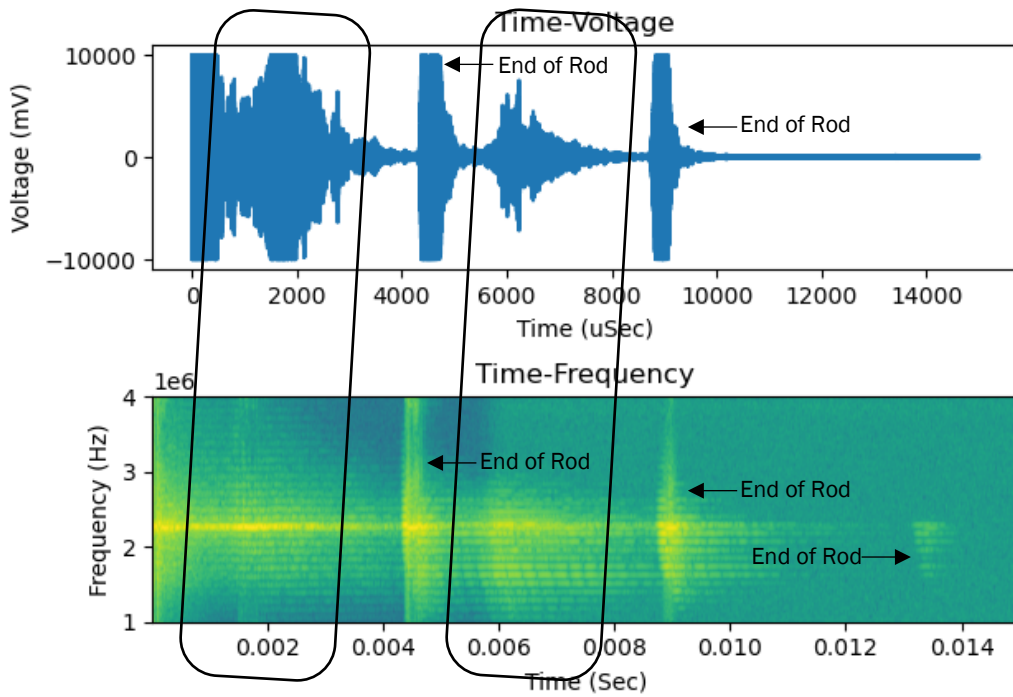
Figure 19. Rod 4-2.

Rods 4-2 and 4-14 continue to show behavior outside what is expected for the Oroville Dam. Not only does the amplitude of the reflections exceed the same positions on the other gates, but the amplitude also exceeds that of most rods at the complex. This larger amplitude response has been confirmed by other contractors on site.

The results of these two rods are shown in Figure 19 and Figure 20. The gain on the transmitting amplifier had to be reduced well beyond what was used on tendons in proximity and in the same position on other piers.

The black rectangle that spans the two plots in each figure shows what looks to be a Possible Defect. If a defect is present in a tendon, the expected result in the amplitude of the end of rod reflection is that it is reduced compared to if the tendon was undamaged. In the case of these two tendons, the amplitude of the end of the rod is very large and even exceeds that of many tendons that are more centralized in the bundles. From a blind-testing perspective, these two tendons appear to not have the same progressive bend as the tendons on the other gates in the same location.

At this time, there are no conclusions to draw as to why these two tendons exhibit this behavior. A true defect in the tendon would provide a reflection between the first and second end-of-rod reflection. The time-series and STFT representation of the tendons do not show this. The acoustic behavior in these tendons is similar to the tendons labeled Anomaly, though the amplitude of the reflections is greater.

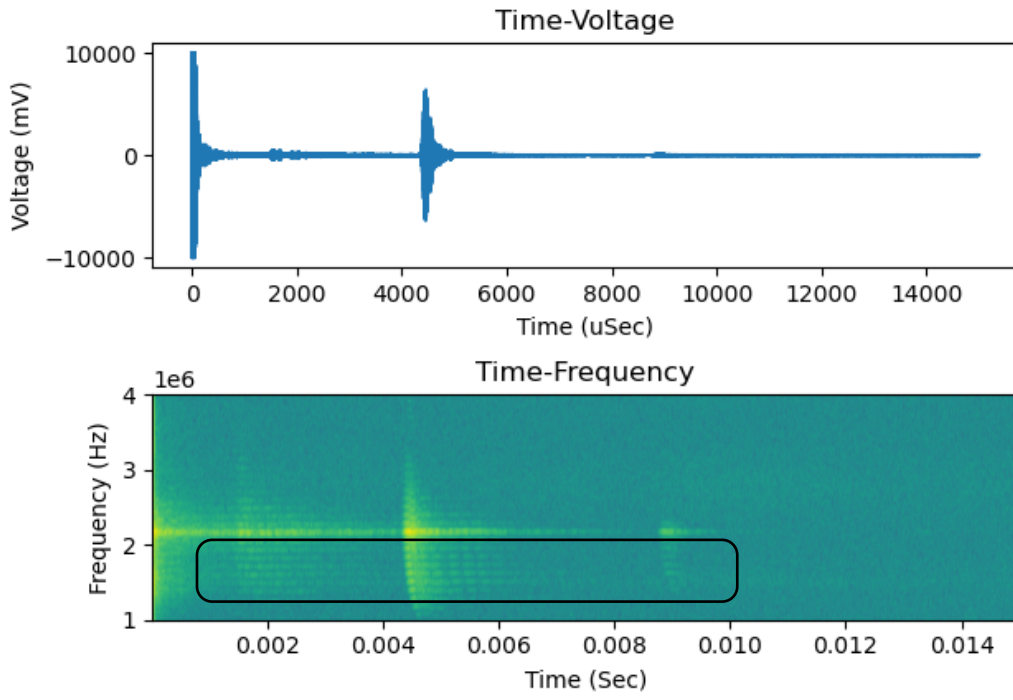
Figure 21. Rod 4-2 frequency spreading.

Another observation made on these two rods is how the frequency content on the end-of-rod reflection spreads further in time than other tendons. The area outlined in Figure 21 shows this spreading of frequency when plotted as an STFT. This figure captures rod 4-2 tested at a different frequency: 2.169 MHz. This capture was chosen because the end-of-rod reflection did not clip the analog-to-digital converter (ADC).

Unexpected information like this helps to identify tendons that were either installed differently, have a defect, or some other unknown.
