NAVAL RESEARCH LABORATORY
Washington, D.C.

28 November 1945

REDUCTION OF INSTRUMENTAL ERROR IN
MODEL DAB DIRECTION FINDING EQUIPMENT

- Report R-2672 -

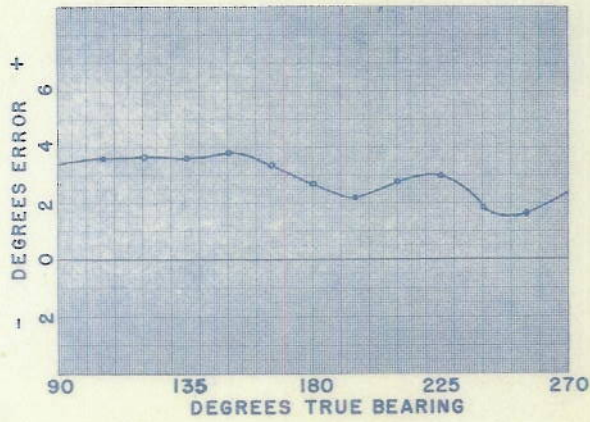
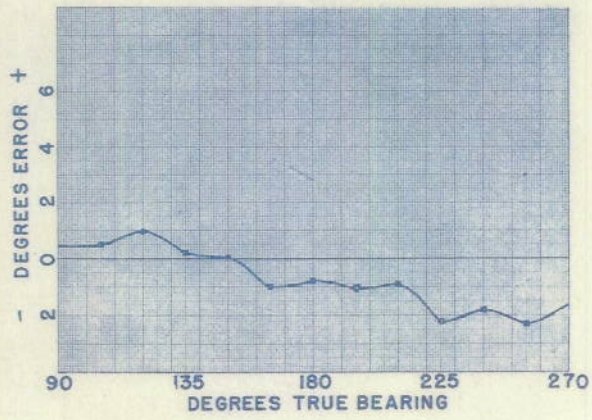
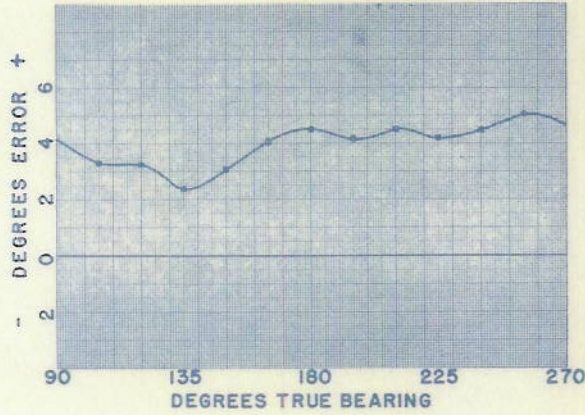
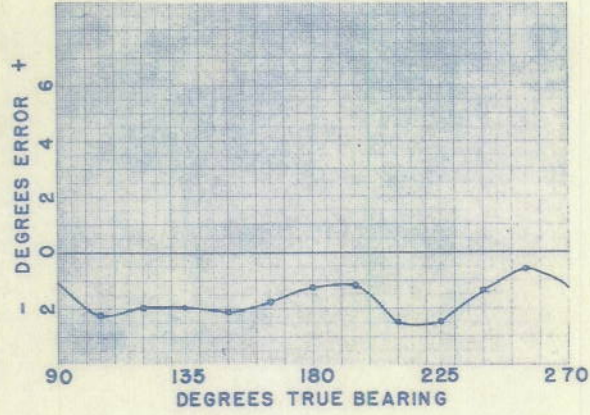
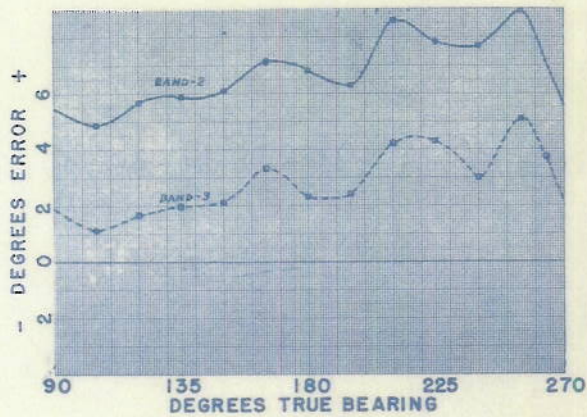
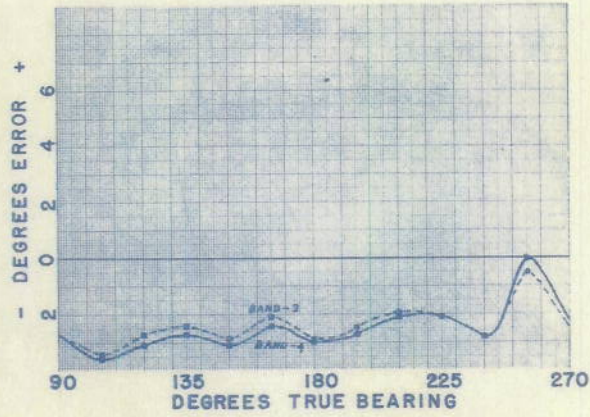
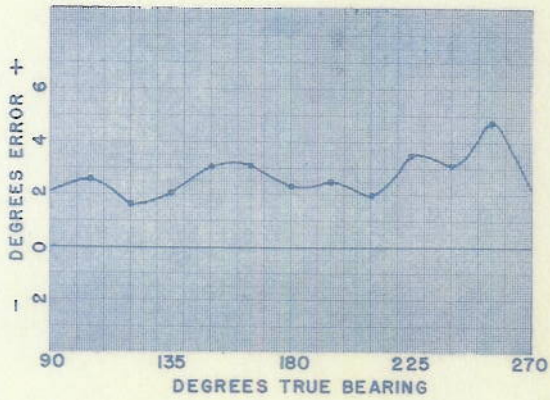
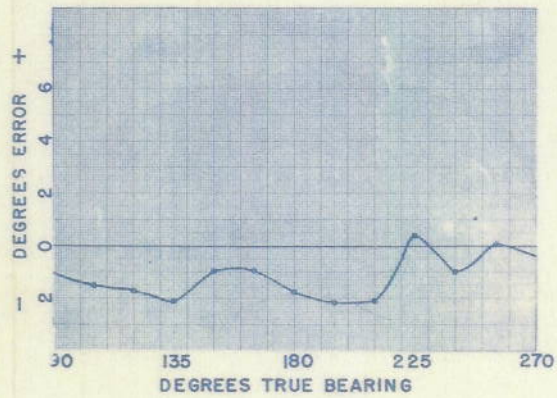
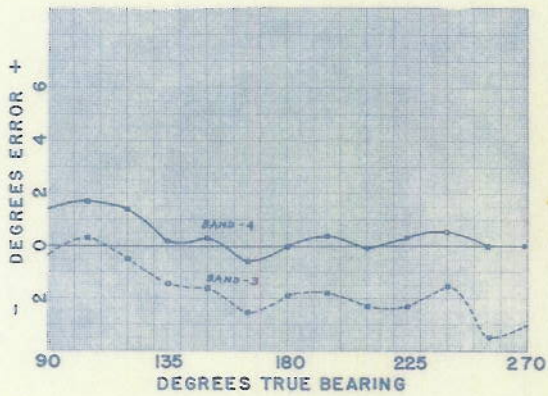
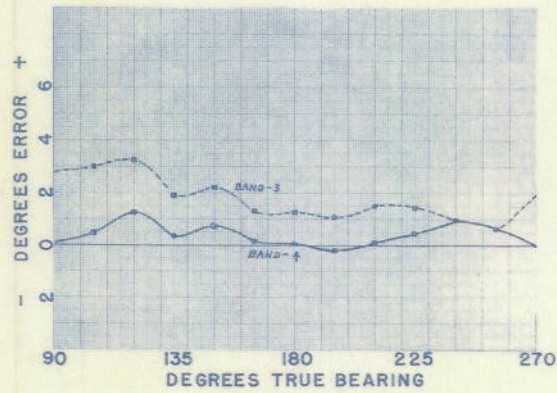
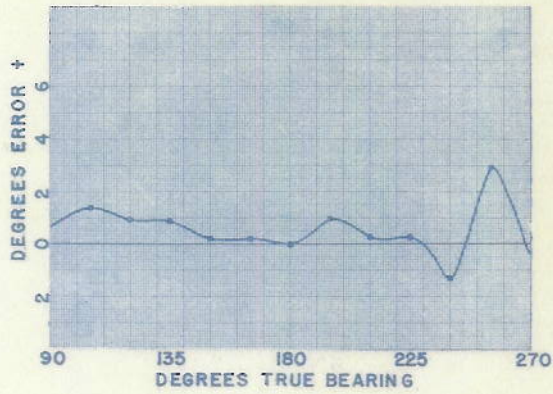
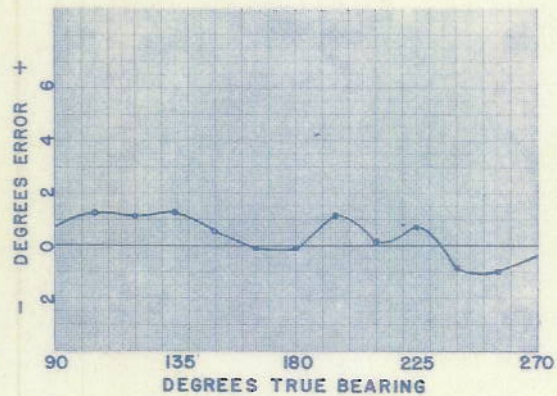
PLATE 2 DECLASSIFIED

5. The second investigation conducted at the Coast Guard Training Station, Brigantine, consisted mainly of a pilot installation of the Naval Research Laboratory prototype of the recommended modification. Plates 1 and 2 show the calibration taken before modification was attempted. This indicates a bearing difference of 4 degrees between Bands 2 and 3, as well as differences of 0.25 degrees between Bands 1 and 2 and 2.1 degrees between Bands 3 and 4. Following modification, the calibration also shown in Plates 1 and 2 was taken. This indicates the order of improvements to be expected and shows a reduction of difference in bearing between Bands 2 and 3. The existing difference between bands was now less than 1.5 degrees average in all cases. The difference between Bands 2 and 3 was 0.22 degrees and the difference between Bands 1 and 2 and between 3 and 4 were 0.15 degrees and 1.5 degrees respectively. The error shown in Plates 1 and 2 with respect to true bearing is the error determined by use of a local target transmitter at a distance of approximately 100 yards from the DAB equipment. These values, therefore, may be influenced to some extent by local site conditions, but should, in any case, give a reasonably accurate means of comparison between the unmodified and modified conditions.

6. According to the station personnel, the bearings obtained on distant stations prior to modification, had a tendency toward excessive swing which made accurate results difficult to obtain. After the modification was completed a test was made to determine the operational characteristics of the equipment on sky wave signals. Table 1 summarizes the data which indicate that the between-band difference is reasonably small with signals of random polarization and no adverse effect is noticeable. Station personnel also indicated that some improvement in the bearing swing was made, but this cannot be verified by any of the experiments performed. Analysis of the bearings on distant stations show that the sky wave bearings are accurate within the limits set down in Table 1 and vary from the true mainly on the weak and obscure signals.

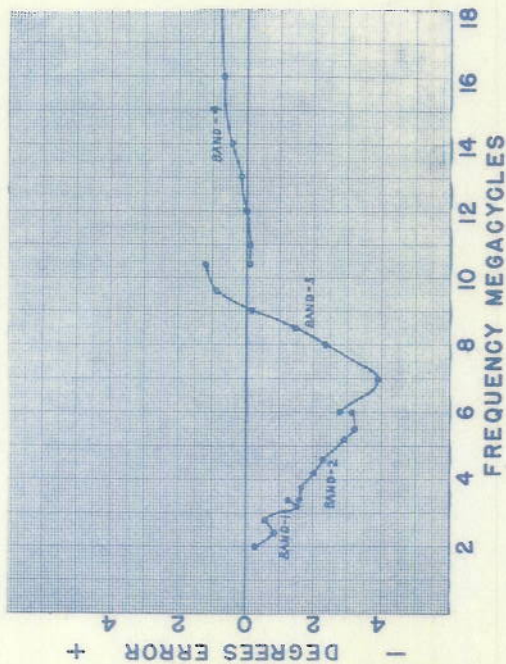
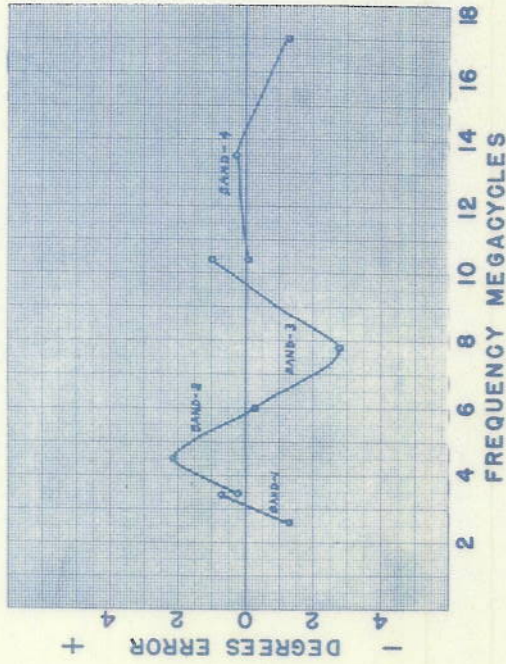
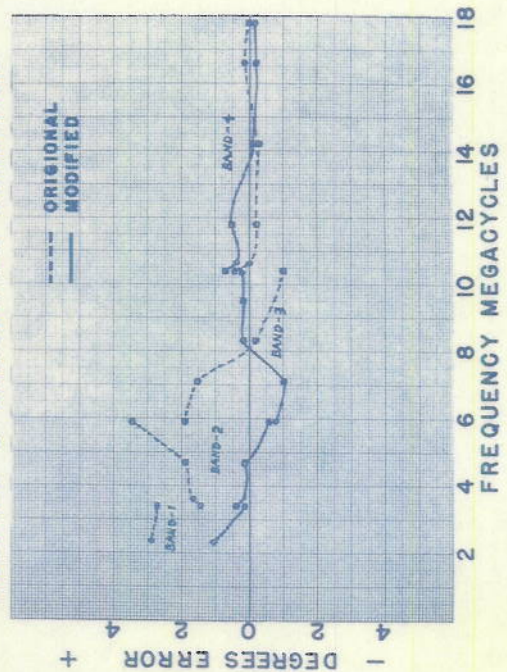
FREQUENCY CHARACTERISTICS
OF
MODEL DAB EQUIPMENTS

10. Correction, by use of the field and rewiring, as specified in this report is not absolutely complete. Examination of the "frequency characteristic" curves in Plate 7 will show that a difference between Bands 3 and 4 is still present after the modification is made. It will also be apparent that there is a bearing

error which varies with frequency and appears in about the same way on all of the Model DAB equipments tested. This error cannot be completely attributed to the site. An investigation of this error indicates that the cause is associated with an unbalanced condition of the loop, caused or accentuated by the characteristic of the lower loop tuner units; in particular, the characteristics of the loop coupling transformer. This error is less than two degrees between bands and average 1.6 degrees over the several experiments conducted. Due to the complexity of the cause of this error, and due to its relatively small value, a complete investigation and solution was not attempted under this problem. A brief discussion of the error, however, will be found in Paragraph 11 below.

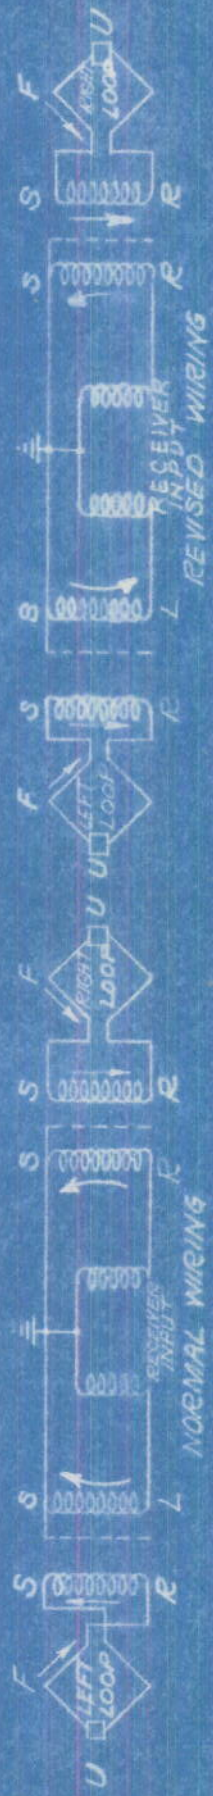
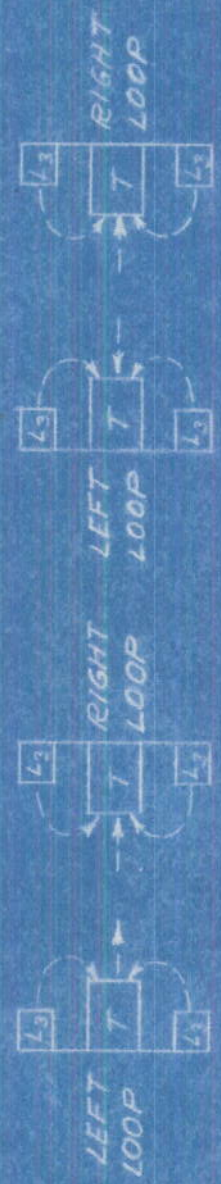
CURRENT FLOW IN LOOP COUPLING CIRCUITS

11. Plate 9 shows the construction of the loop coupling transformer as detailed by the manufacturer in Reference 6. The wiring of these transformers is not alike in all respects, as is most easily shown by the drawings in Plate 8. This drawing indicates two cases in which the connections to the primary of the loop coupling transformer are reversed. In Figure (a) of Plate 8, the transformers are connected normally. In this condition, the bearing difference between Bands 3 and 4 is 1.8 degrees; and the flux linkage between the coupling transformer and the Band 3 inductances is as shown in (c) of Plate 8. In this case, it may be considered that the flux linkage amounts to a change in the coupling, which may explain part of the existing error. In the second case, the connections to the primary of the coupling transformer on the left loop were reversed, resulting in the circuit of (b) and (d), Plate 8. In this case, the difference in bearing between Bands 3 and 4 was reduced to 0.4 degrees. This may be explained by the same consideration as above due to the increased symmetry and more symmetrical coupling. Data showing the effect at the overlap frequencies of reversing the connections to the coupling transformer primary are given in Table 3. This reversal of the primary leads of one coupling transformer is not a complete solution, but indicates the direction in which a complete solution must proceed. In the case of one primary reversed, it will be noticed that the current flow in the secondary circuits of the two transformers aid rather than buck each other. This leads to a thumping sound in the audio output of the receiver due to the periodic shorting out of the receiver inputs in commutation. A complete solution of this problem would probably necessitate the replacement of the unbalanced receiver inputs with a more nearly balanced system. This, however, would be a sizeable problem in itself. The amount of this error varies with equipment and in some cases, such as at the Bureau of Standards Station, Sterling, Va., Plate 7, is so small after the prescribed modification has been made, that further correction is unnecessary.

- ∇ Connections to the loop coupling transformer normal, with the corrective modification of the loop made, and bearings taken on a fixed local target transmitter.
- * Connections to the primary of the left loop coupling transformer reversed, and with all other conditions as described above for the normal circuit condition. This condition corresponds to that shown in Figures (b) and (d) of Plate 8.
