# Underwater Carbon Fiber–Reinforced Polymer (CFRP)–Retrofitted Steel Hydraulic Structures (SHS) Fatigue Cracks

*by Guillermo A. Riveros and Hussam Mahmoud*

**PURPOSE:** Recent advances in the use of fiber-reinforced polymers (FRP) to retrofit steel structures subjected to fatigue cracks have shown to be a viable solution for increasing fatigue life in steel hydraulic structures (SHS). Although several studies have been conducted to evaluate the use of FRP for retrofitting metal alloys and the promising potential of such has been well-demonstrated, the application has never been implemented in underwater steel structures. This Coastal and Hydraulics Engineering Technical Note presents the implementation of FRP patches to repair fatigue cracks at Old Hickory Lock and Dam miter gate.

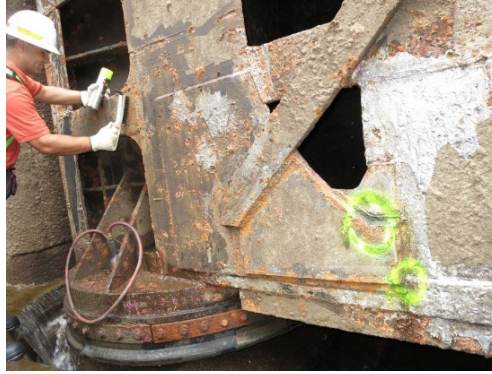
Figure 3. Poor welding quality at diagonal gusset plate (river side).

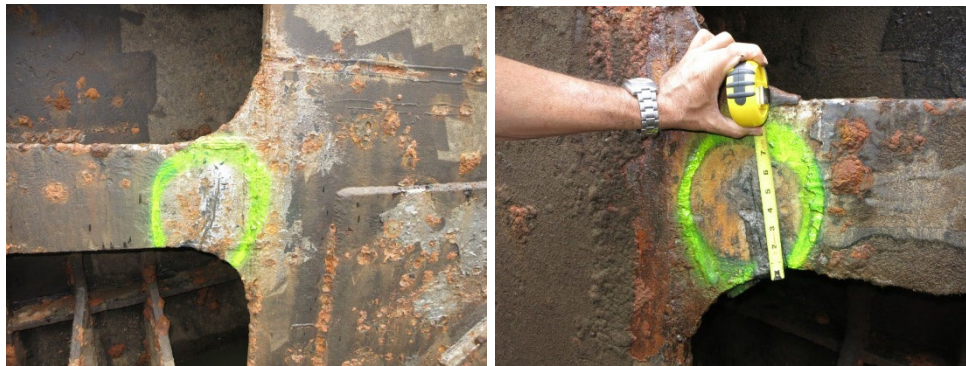
Figure 4. Crack at end diaphragm downstream flange with tapered end section flange and at end diaphragm downstream flange with girder flange.

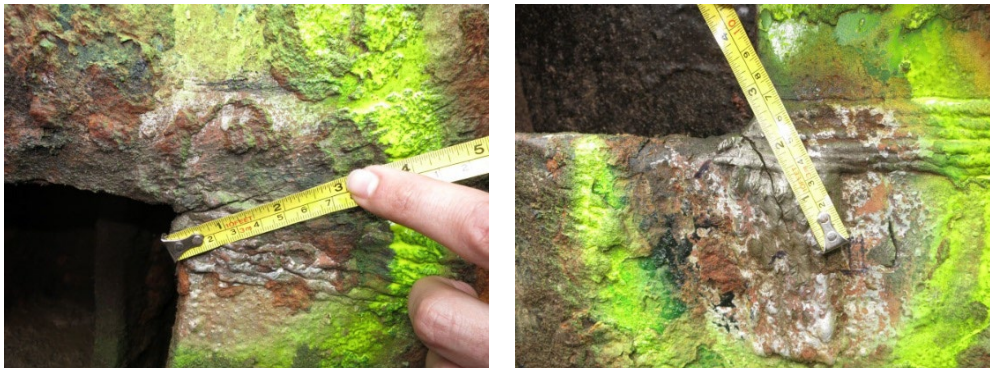
Figure 5. Cracks at intersection of intermediate diaphragm and girder flanges.

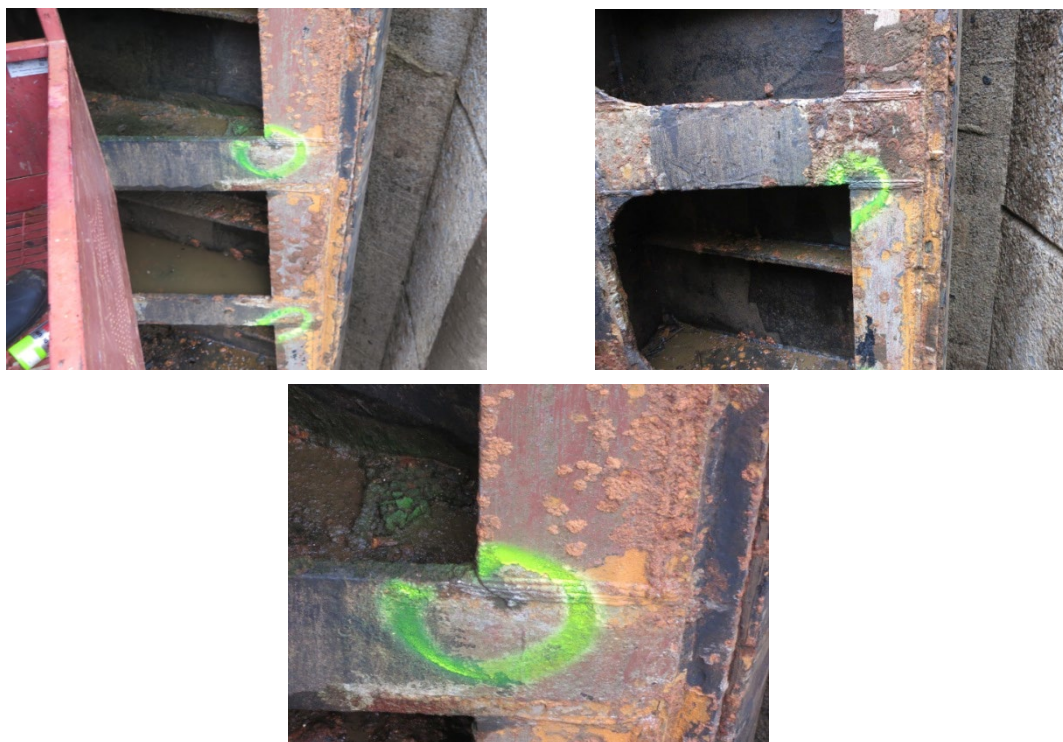
**Miter Gate Inspection:** An inspection of the land and river side leafs was conducted with the purpose to find all fatigue cracks on the gates and areas with severe corrosion. Corrosion was not an issue in this gate, but several areas with fatigue cracks were found, and poor welding was also observed and documented. Figure 3 shows a poor welding connecting the diagonal gusset plate with the girder downstream flange. The two green circles show rough weld profile. The big circle shows weld undercut, while the small circle is pointing to intersecting welds. Figure 4 shows cracks that developed at the intersection between the end diaphragm downstream flange with the tapered end section flange and the end diaphragm downstream flange with girder flange. Cracks at the intersection of intermediate diaphragm and girder flanges are shown in Figure 5. Figure 5 also shows a rough weld profile and weld undercut. Finally, cracks at the downstream tapered end section flange and end plate flange and rough weld profiles are shown in Figure 6.

Figure 6. Cracks at downstream tapered end section flange and end plate flange.

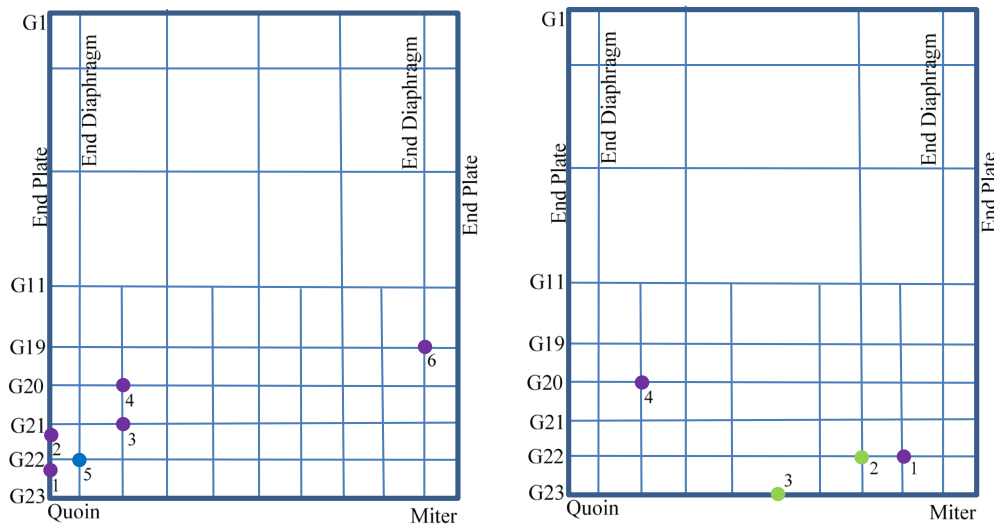
Figure 13. Land (left) and river (right) side leafs showing CFRP applications. Purple: Cracks with CFRP repairs, Blue: Cracks welded and repaired with CFRP. Green: No cracks, poor welds strengthened with CFRP.

**Old Hickory Application:** CFRP patches were applied on five locations on the Old Hickory gate: on cracks, on top of weld repairs of cracks, and on locations with no crack but with a potential to crack due to poor welding. Locations are shown in Figure 13 for the land side (left) and river side (right) leafs.

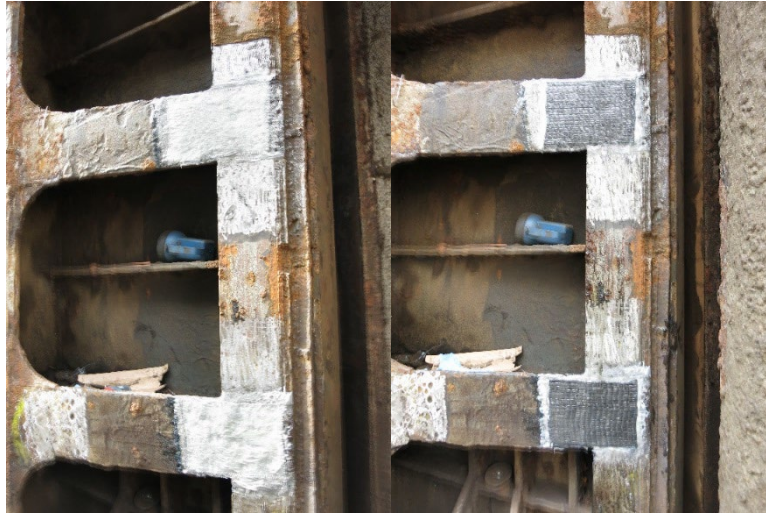
Figure 14. Repairs at locations 1 and 2. At left, glass fiber. At right, carbon fiber.

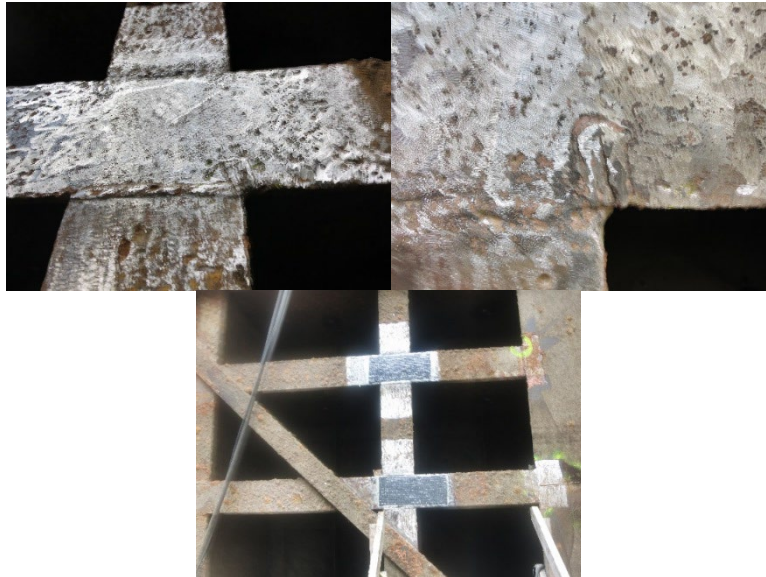
Figure 15. Crack pattern and CFRP repairs at locations 3 and 4.

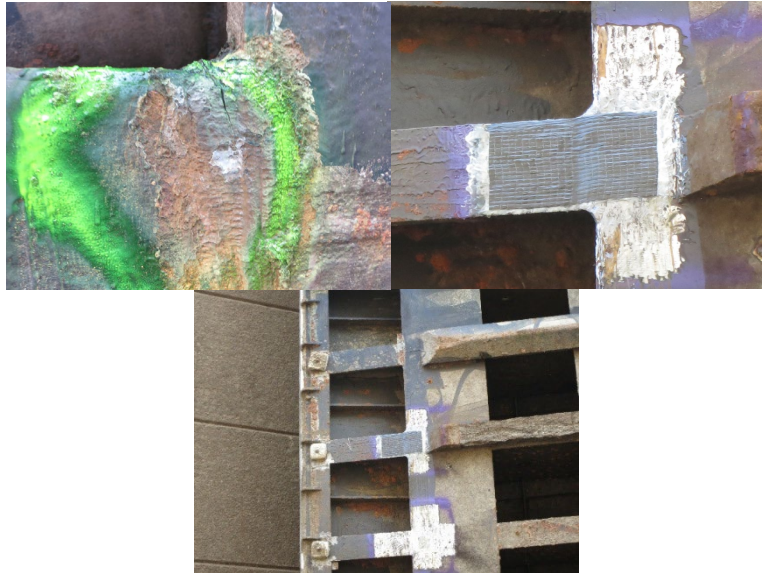
Figure 16. Welded crack repaired with CFRP at location 5.

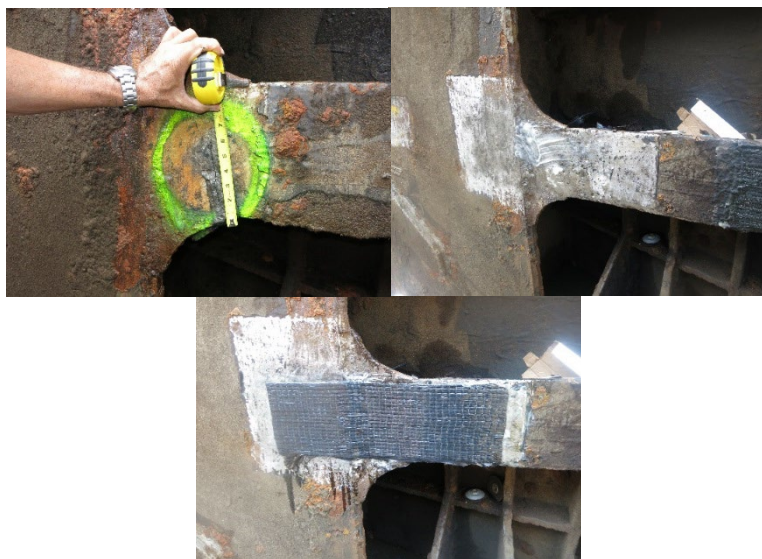
Figure 17. Crack repaired with CFRP at location 6.

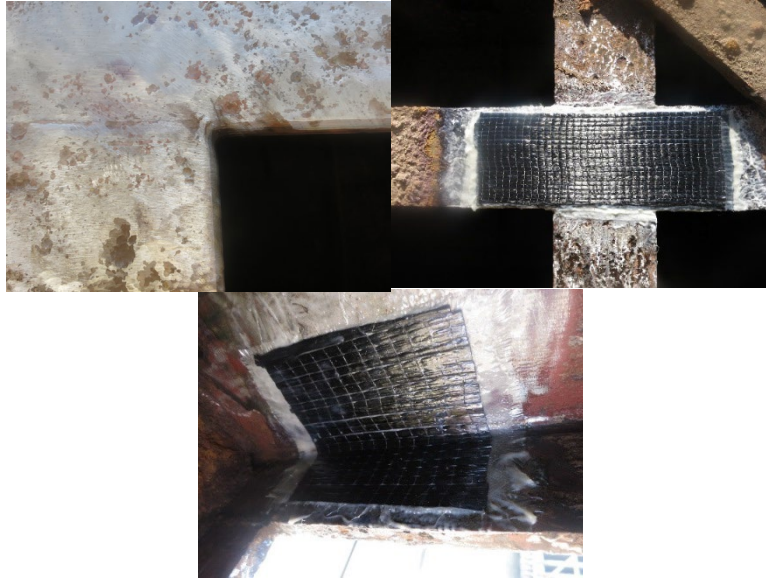
Figure 18. River-side crack repaired with CFRP, location 1.

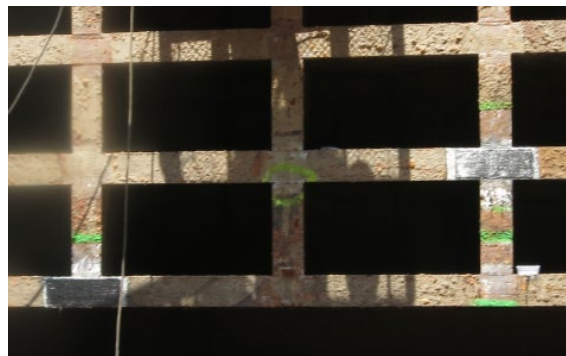
Figure 19. River side showing CFRP repairs when no cracks are present, locations 2 and 3.

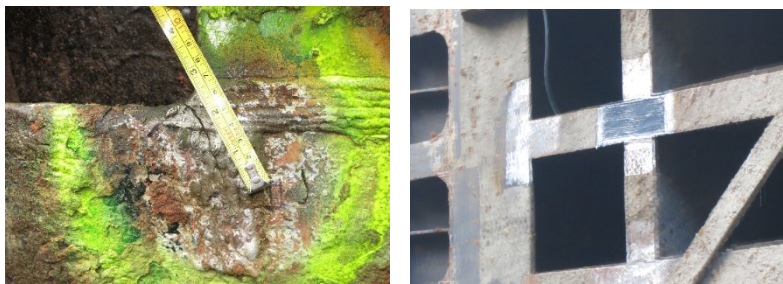
Figure 20. River-side crack repaired with CFRP.
