ERDC/GSL SR-23-2

Old River Control Complex (ORCC) Low Sill: A Literature Synthesis

March 2023

Final report

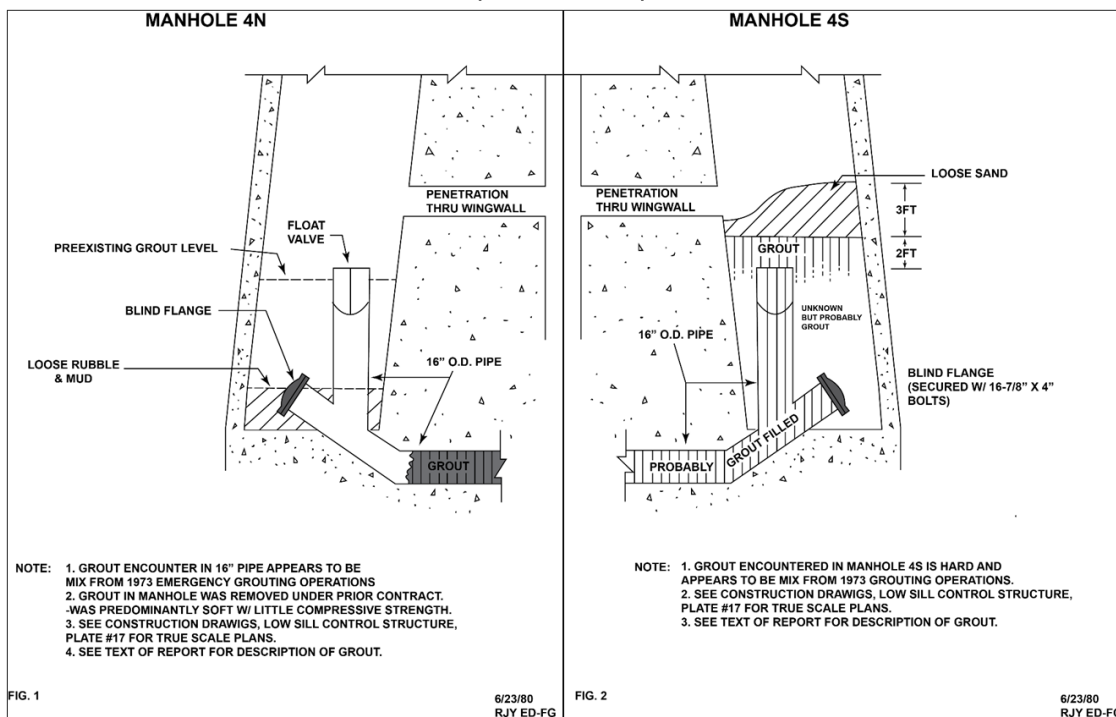
Problems with grout blocking more of the drainage structures continued with ongoing remediation efforts. USACE (1980) notes problems with manholes 4N and 4S related to being plugged with grout. Drawings of the conditions in the manholes were included in the report to illustrate the problem and are shown in Figure 12.

Figure 12. Illustration of grout blocking manhole 4N (left) and 4S (right) (USACE 1980).

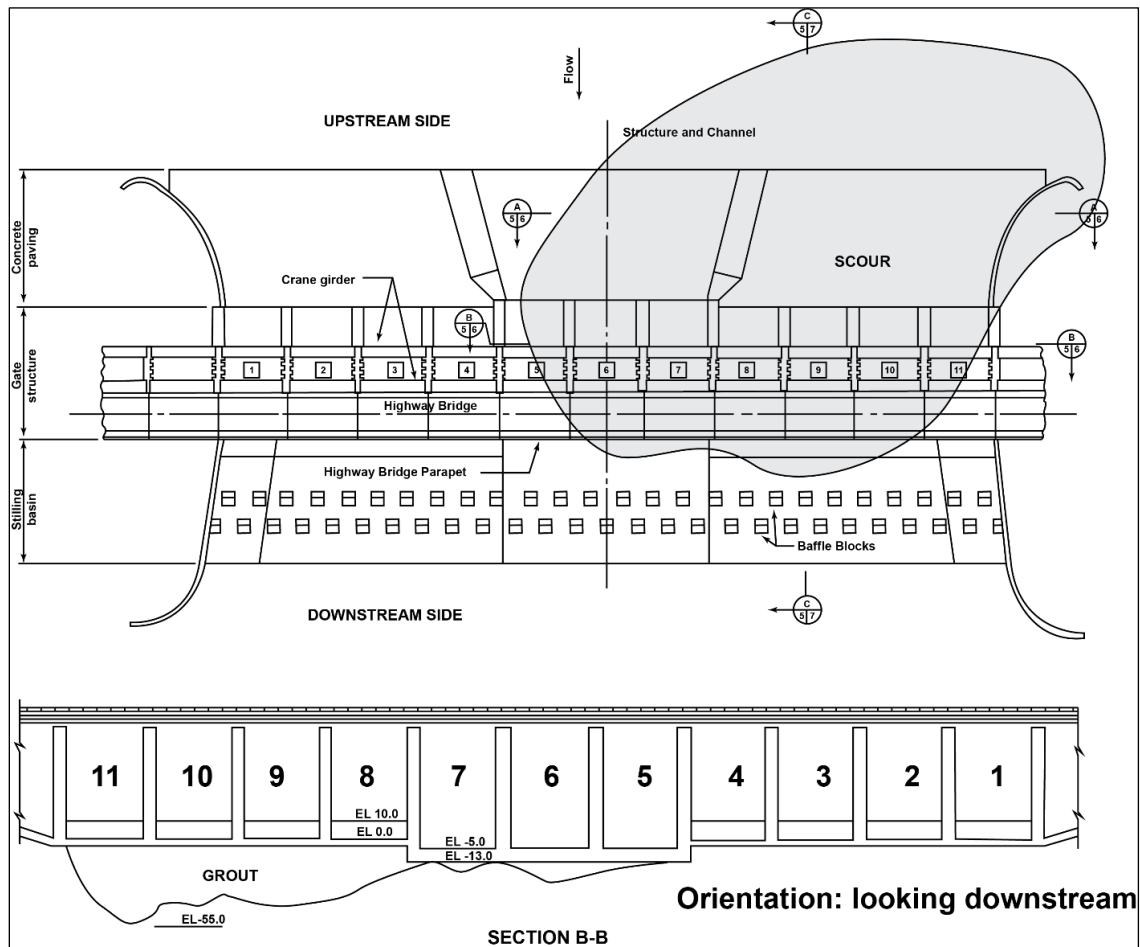
Date	Event	Remarks
12 Apr 1973	Monolith A of left approach wing wall parted caused by scour	Rock dike construction initiated in the vicinity of threatened wing wall
14 Apr 1973	Monolith A slowly sinks and disappears; monolith B and C sank later in the evening followed by monoliths D and E. Headwater elevation 59.7 ft and tailwater elevation 54.9 ft were recorded during this time.	Upon notification of the wing wall failure, the Overbank structure was opened to relieve pressure on Low Sill. Following wing wall failure, the rock dike construction was redirected to provide a rock dike to replace the collapsed wing wall; this effort was completed 7 May 1973.
5 May 1973	A preliminary survey of the scour hole was conducted using the Low Sill gantry crane; strong currents prevented use of a boat. The results of the survey indicated that the scour hole in the inflow channel was 55 ft deep and ranged from 200 ft upstream of the base slab and extended from gate bay 5 to 11; the hole was approximately 320 ft wide; plan view of the scour is shown in Figures 5 and 14.	—

Figure 14. Plan view showing extents of 1973 upstream scour (USACE 1975).

Repair efforts began by placing riprap in the scour hole in the forebay area with the additional construction of a rock dike where the wing wall had previously been located (Figure 14). Drilling efforts began to investigate the extent of the scour hole beneath the main structure and the stilling basin. A total of 48 borings were completed, and grout mixes were developed to fill in the void spaces. Grouting repairs were conducted using several mixtures of a low-cement-content and low-bond-strength grout, which would have minimum bonding to the sheet piling (Wilson 1978; Ainsworth 1979; Wilson and McDonald 1981).

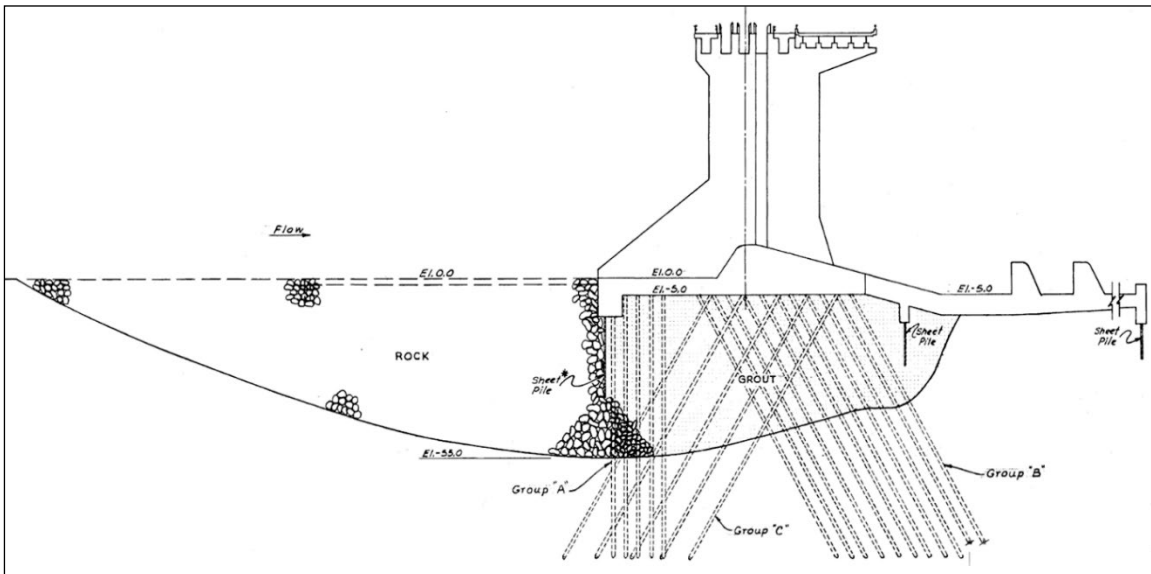
Figure 15 shows section C from Figure 14, which shows the results of the remediation through gate bay 9 following the 1973 flood event. The status of the structure reported in DM-12 (USACE 1975) was that the drainage blanket beneath the bays was either destroyed by the scour process or filled with grout. Only one drainage collector on the stilling basin was functioning properly, and the relief wells were destroyed. Alignment and settlement following grouting operations showed initial elastic movement, but these dissipated, and the structure showed no permanent movement. Four remote telemetry piezometers were installed in line 73 ft downstream of the weir centerline during remediation. Differential heads across the structure were limited to 13 ft.

Figure 15. Cross section showing foundation remediation (reference 14 section C) following the 1973 flood event (USACE 1975).

Approximately 30,000 cubic yards of grout were needed to fill the voids (Wilson 1981). Ainsworth (1979) gives a detailed description of the use of instrumentation to monitor the flow, height, and any contaminants in the grout during the repair operations. Check borings were made following the placement of grout and indicated that most of the voids were filled (Wilson and McDonald 1981). Grout also was used in 1971 to repair stilling basin erosion between the end sill wall and downstream row of baffles. A later inspection in 1978 revealed that additional steel plates had been ripped away and that minor erosion had again occurred. Fiber-reinforced concrete was injected below the anchored steel plates for reinforcement (Wilson and McDonald 1981). In 1980, fiber-reinforced grout was used again to repair spalled and eroded concrete on the surface of the stilling basin slab (Wilson and McDonald 1981).
