TESTS FOR INFORMATION ON
SHAFT REVOLUTION INDICATORS,
MAGNETO-VOLTMETER TYPE,
WESTINGHOUSE ELECTRIC CO. - MFR.

- Report B-2903 -

October 31, 1946

NRL Problem IC-1109

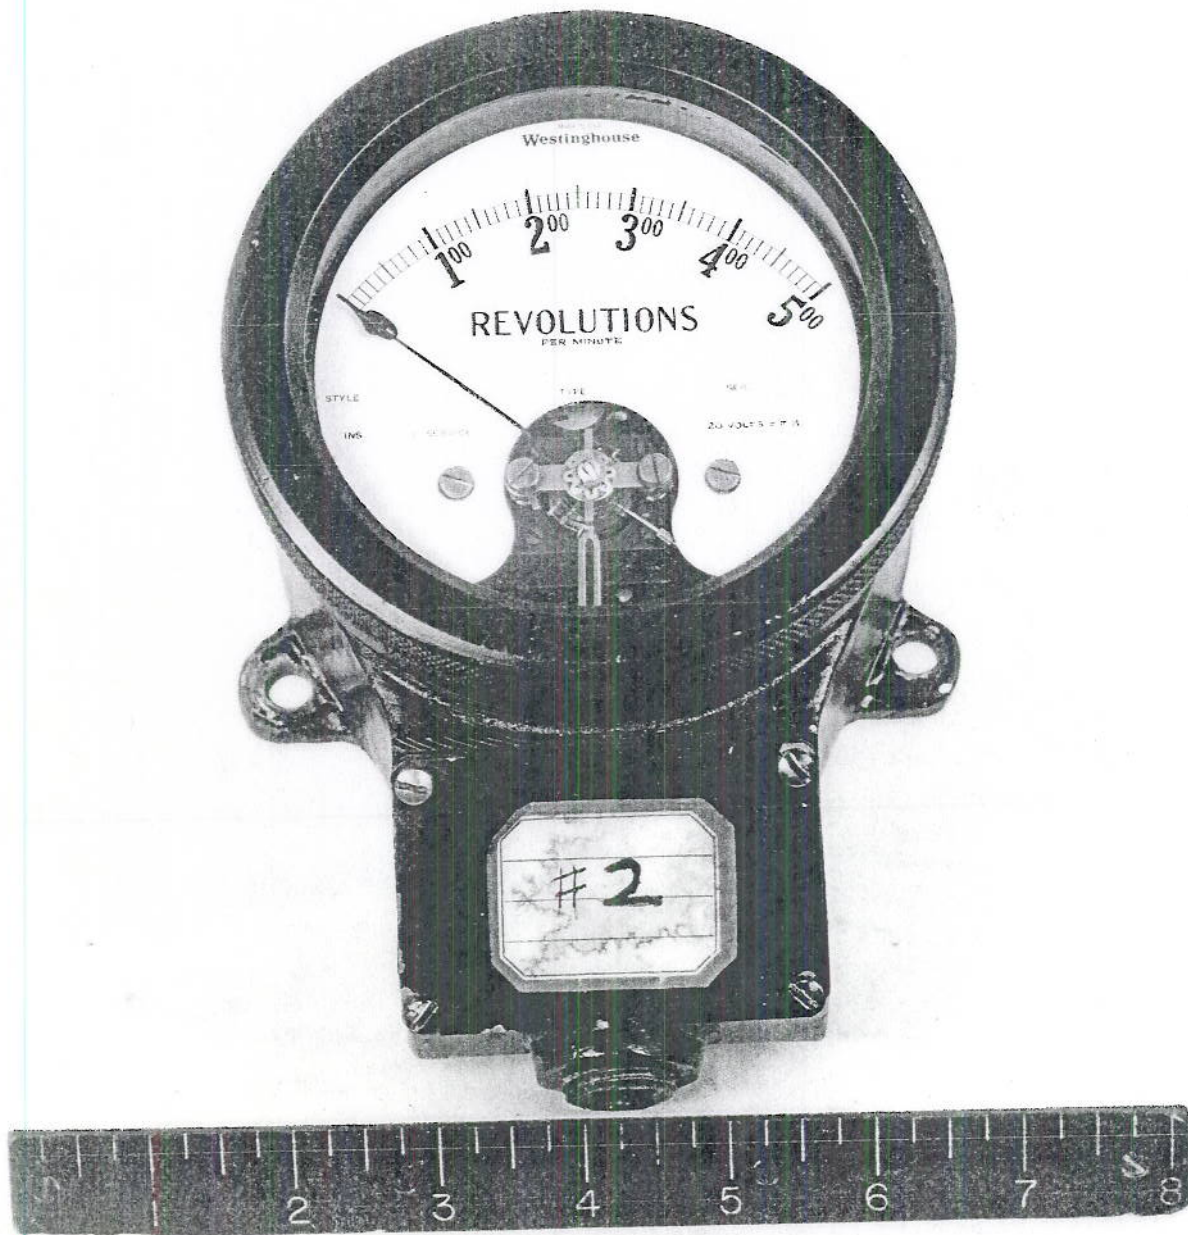
INDICATION NO. 2

18. Shortly after the vibration test began, the meter elements of indicator No. 2 became loose in the case. Investigation showed that the screws in the lead inserts securing the meter element phenolic mounting base to the metal mounting plate had become loose and entirely worked out. These were replaced and tightened. The zero position of the pointer was accidentally shifted during this process and was reset.

28. The data of indicated errors, table in paragraph 16, taken during the tests for effects of inclination show that the movable element of indicator No. 2 did not maintain its deflection when inclined from the vertical. The maximum discrepancy was of the order of 5% when inclined forward from the normal position. No attempt was made to determine the cause except to note that the movable element including the pointer was in no way directly obstructed. It is probable that the movable element including the pointer was not in proper balance or alignment.

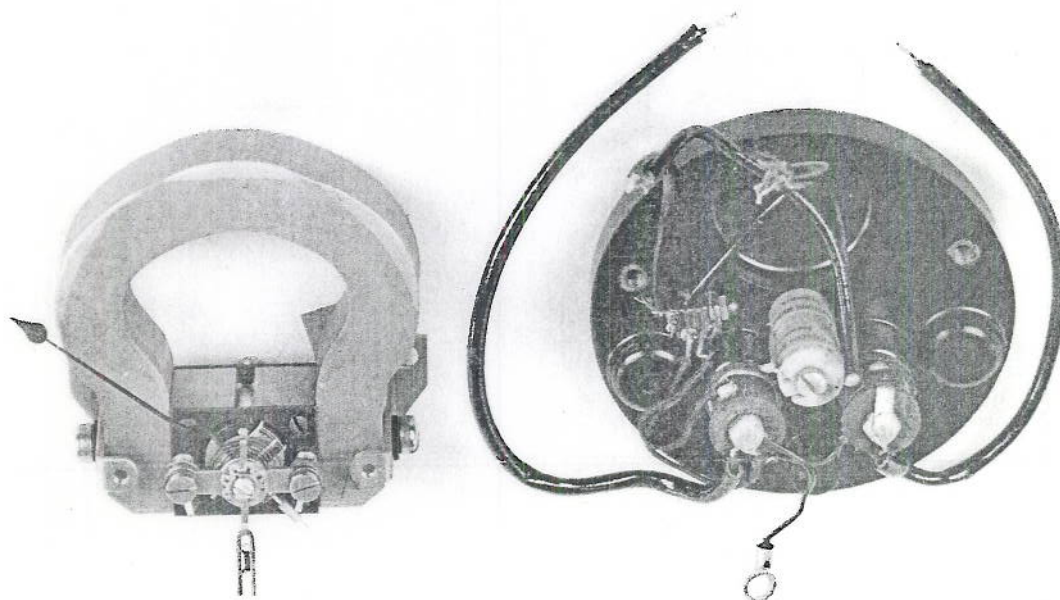
METER COMPONENTS OF INDICATOR NO. 1

13. A partial material inspection was made. The equipment was submitted to the specified dielectric test before and after the insulation test. At this point the generator was disassembled to determine if provisions were made to prevent entry of water. Due to the observed lack of shaft seals, the watertight test was omitted, however, both indicators were subjected to the specified splash-proof test and examined afterwards for leakage. Indicator No. 1 was then completely disassembled, reassembled, and rechecked for accuracy. There was some discrepancy in the indications noted before and after disassembly of the generator and indicator No. 1 so the magnetic shunt of the generator was adjusted to produce the previous generator voltage-output/speed values and the indications were found to be similar to those previously recorded, except in the case of the indicator No. 1. The rectifier unit of the latter was injured in disassembly.

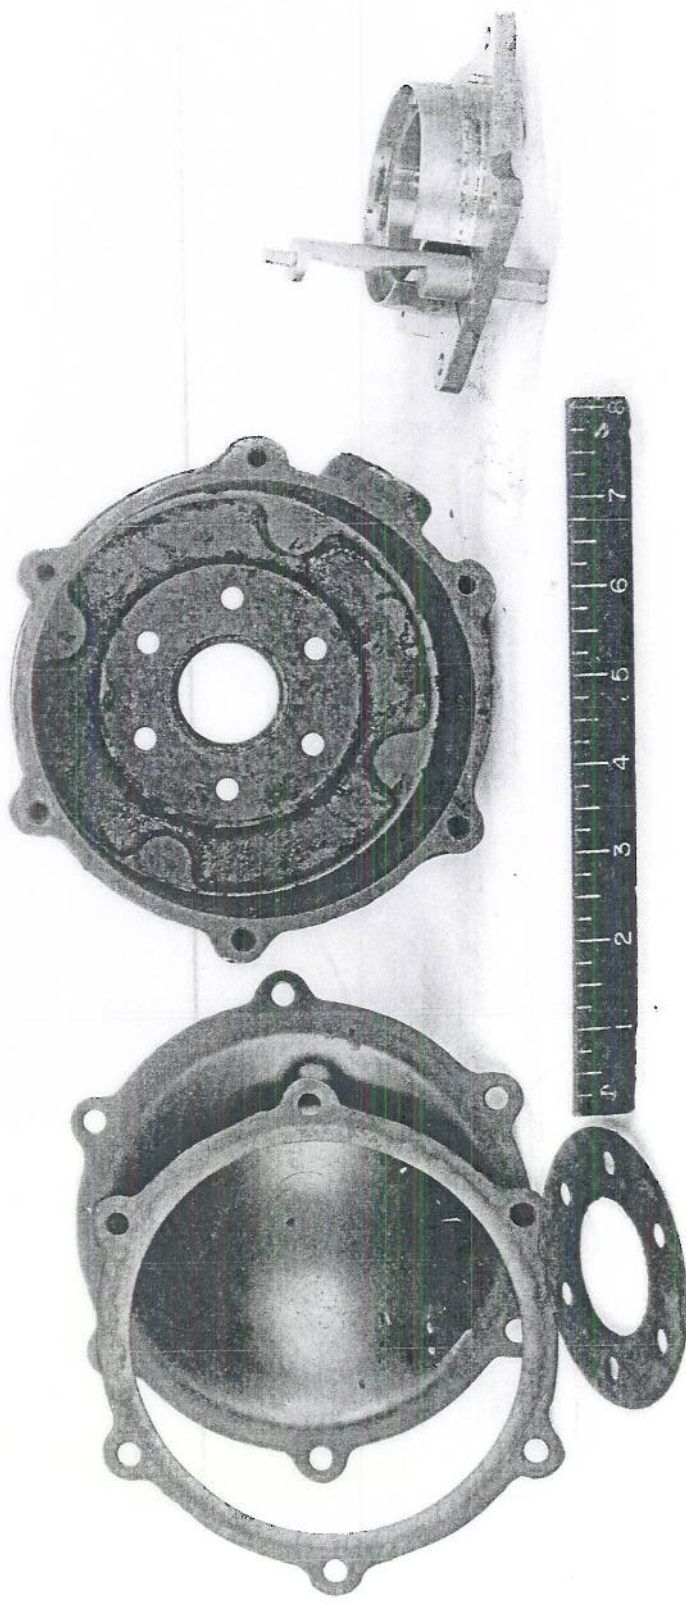
GENERATOR HOUSING AND MAGNETIC SHUNT

19. The electrical circuits of the indicators and the generator complied with the dielectric and insulation test requirements. During the splashproof test about 1 cc of water leaked into the housing and about the same amount into the terminal block chamber. The stiff paper gasket under the cover plate of the terminal block chamber was soaked around the edges. Water was found in the space between the phenolic ring and the windowed screw cover. Examination suggested the leak to have occurred between the flange of the screw cover and the glass window and since the black sealing compound was wetted, between the glass window and the phenolic ring.

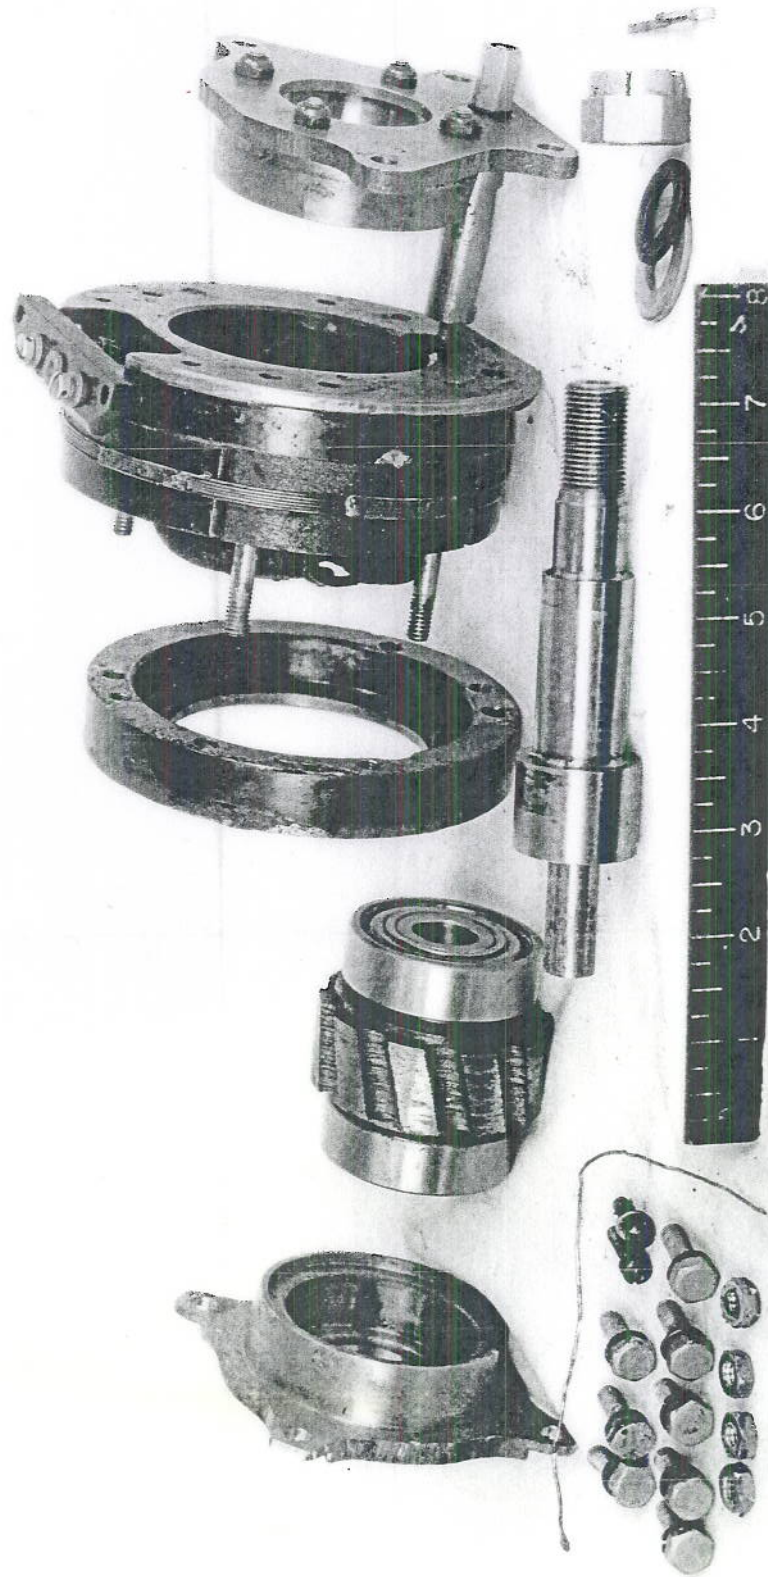
GENERATOR - DISASSEMBLED

16. At the 0°F. ambient temperature some trouble was encountered with the generator when low temperatures caused the shaft to stick. This was remedied by oiling and greasing the shaft and bearings and by running the generator continuously for several hours before continuing the test.
