NAVAL RESEARCH LABORATORY
WASHINGTON, D.C.

27 August 1946

Vibration, Shock and Salt Spray Tests of
5, 10 and 25 Watt Diehl and 5 Watt Blake
Low Inertia A-C Servo Motor

- Report R-2950 -

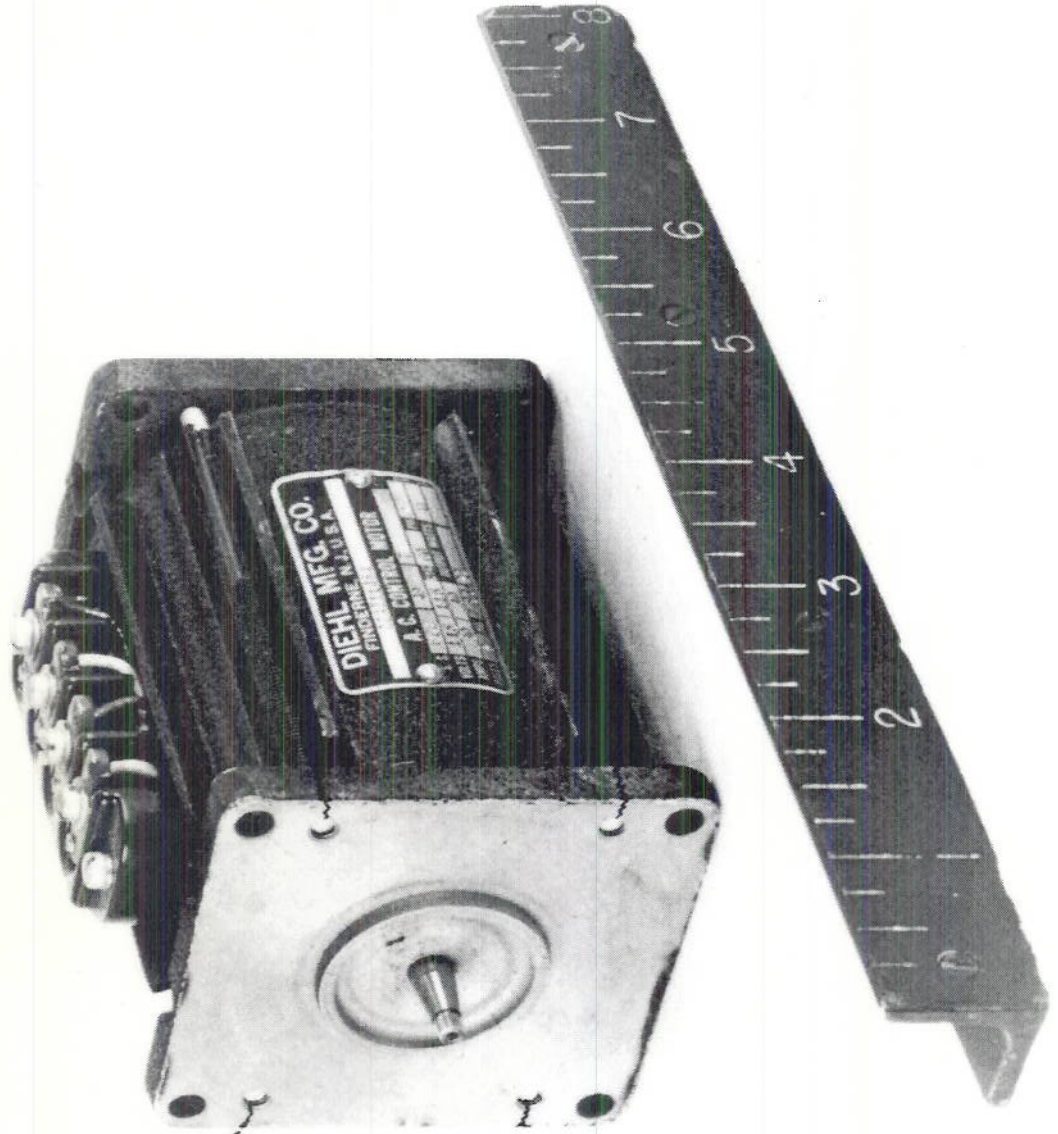
10 WATT DIEHL MOTOR

13. The type of failure occurring in the 10 watt Diehl Motor shows the advantage of a through hole (as used in the Blake Motor) as compared to a tapped hole (used in the Diehl Motor). The base of the 10 watt Diehl motor shows progressive fracture from these tapped holes to the outside of the motor (see Plate (2)). The heavier base of the 25 watt Diehl Motor saved it from the failure noted in the 10 watt motor. The Blake Motor showed no evidence of shock failure and needed no adjustment during the tests.

15. The 10 watt Diehl Motor is considered unsatisfactory for shock, but is considered satisfactory for vibration and salt spray requirements.

FAILURE

17. The 10 watt Diehl Motor should be equipped with the heavy endbells similar to those on the 25 watt motor, and all the Diehl Motors should employ an assembly technique eliminating tapped holes in the mounting flanges.

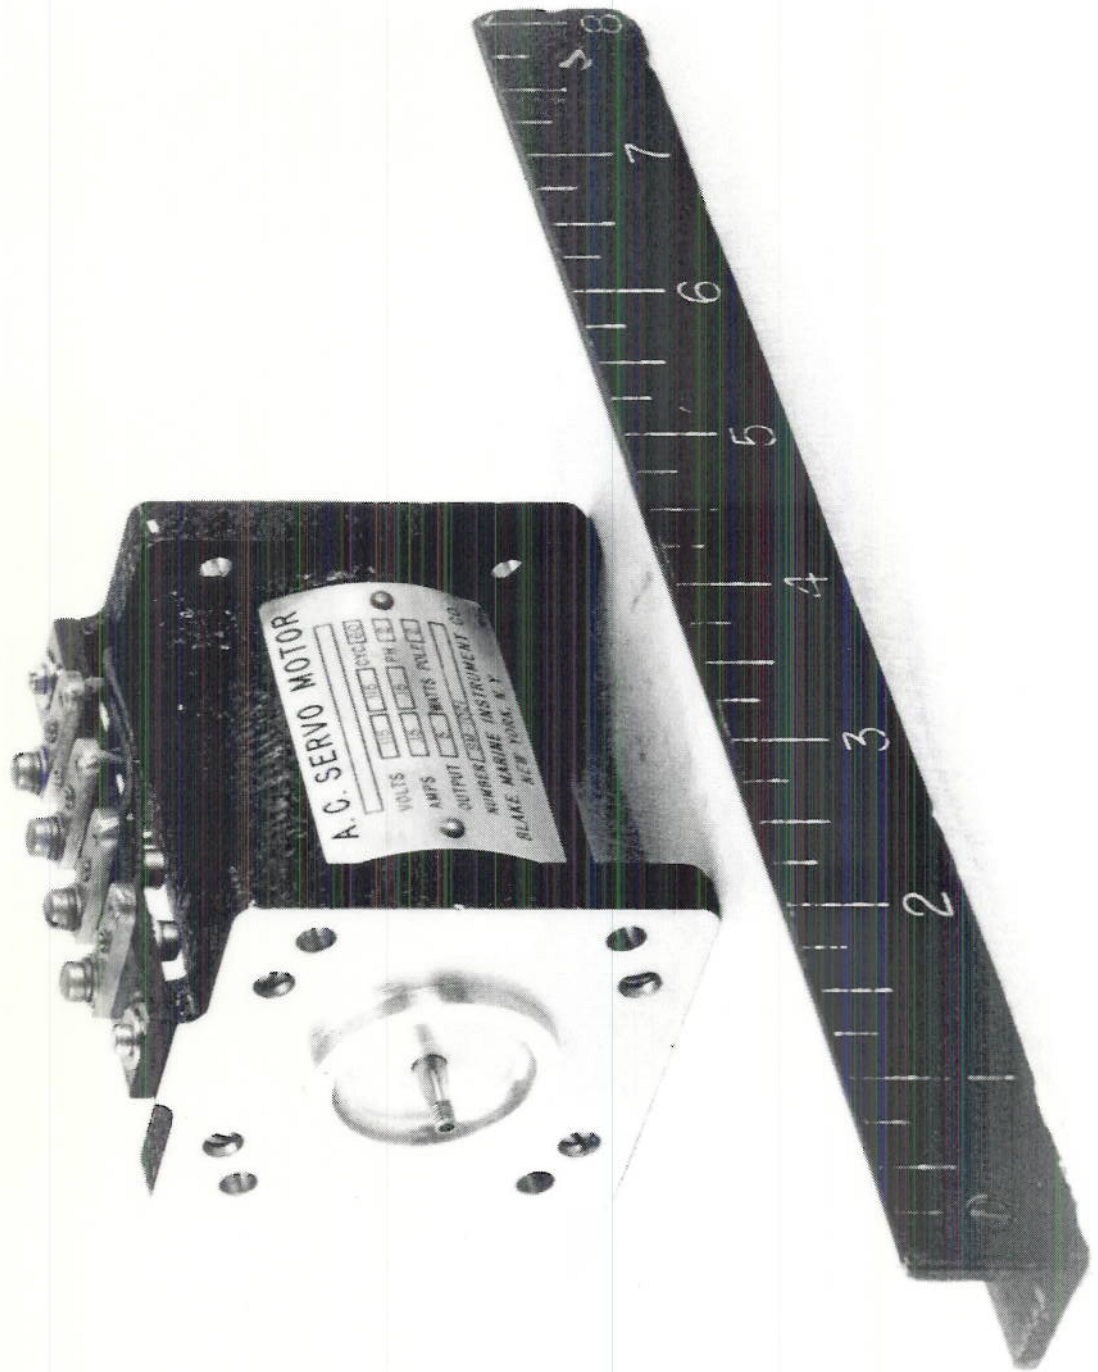
5 WATT BLAKE MOTOR

9. The 5 watt Blake Motor endbells (machine surfaces), terminals and name plates were corroded.

14. The 5 watt Blake Motor performed satisfactorily through the vibration and shock tests, however, if the noise can be considered as objectionable it would be deemed unsatisfactory. This motor failed to pass the salt spray test.

18. Some anodizing process should be used on the machine surfaces of the Blake Motor endbells to prevent corrosion. Noncorroding terminals and shafts should be used through all the motors. Some measure should be taken to prevent the corrosion that occurred on practically all of the components on the 25 watt Diehl Motor's blower unit.

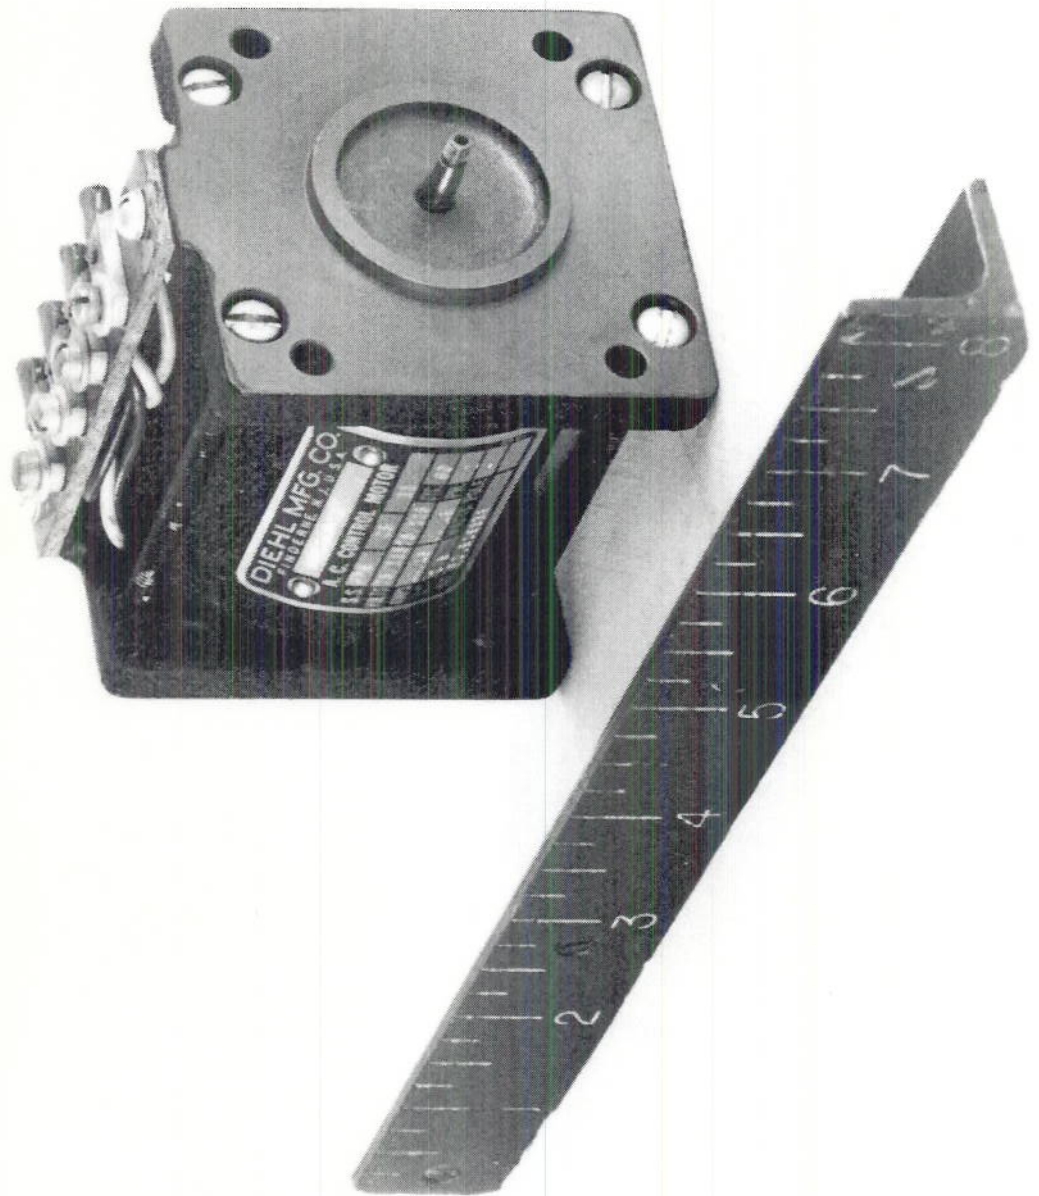
5 WATT DIEHL MOTOR

10. The terminals and shaft were corroded on the 5 watt Diehl motor.
