SPECIAL REPORT FCDD-AMR-23-01

# COMPOSITE REPAIR ENGINEERING CASE STUDIES FOR U.S. ARMY AEROSTRUCTURES

August 2023

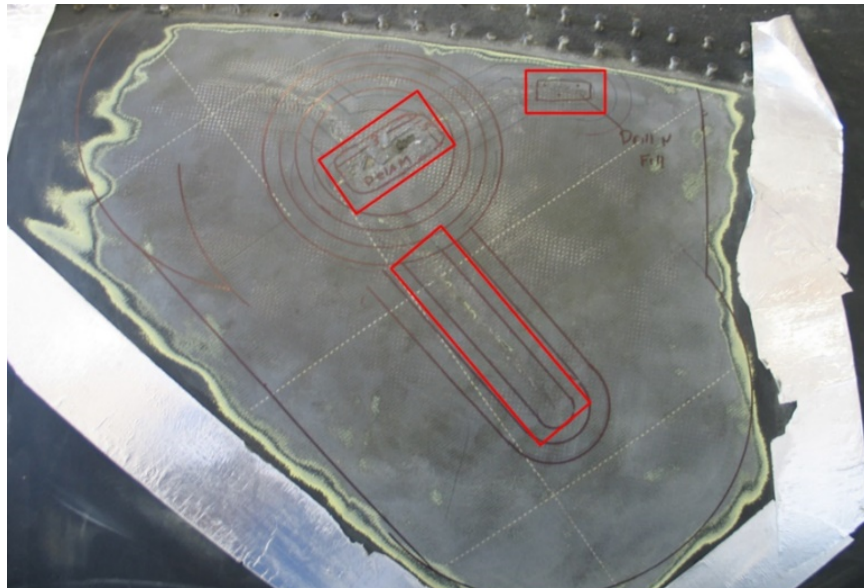
Figure 7. H-47, Right Hand Upper Crown Skin Damage.

The U.S. Army deploys aircraft into hostile locations throughout the world from both an environmental and combat related perspective. These locations subject U.S. Army aircraft to harsh conditions in which aircraft and components deteriorate and are damaged at an accelerated rate. Figure 5 shows the magnitude of typical debonding between aramid laminates and honeycomb on a H-60 transmission access bay door; this debonding is a result of the normal operating conditions. Figure 6 shows sudden impact damage to an H-64 Apache EFAB close-out panel and sub-structure, exposing the carbon fiber/epoxy fibers. Figure 7 shows significant debonding damage to a H-47 Chinook upper crown skin, exposing the carbon fiber/epoxy internal structure.

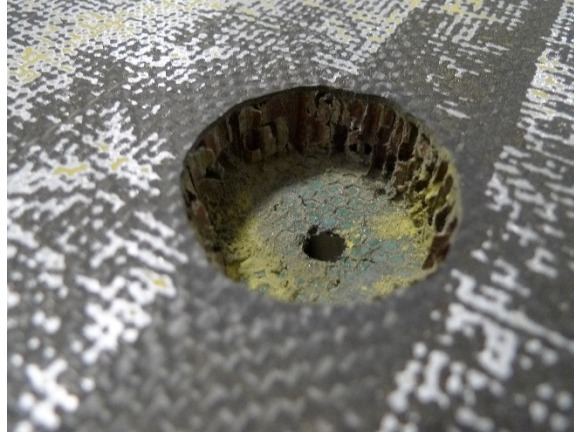
Figure 12. Damage Simulation.

To initiate the process, the subject crown skin was removed from an aircraft and used as a repair specimen. A one-inch circle of simulated damage was imposed onto the inner surface of the panel as shown in Figure 12. The damage included full laminate thru thickness and honeycomb core damage, requiring the complete removal of material to the opposite laminate face.

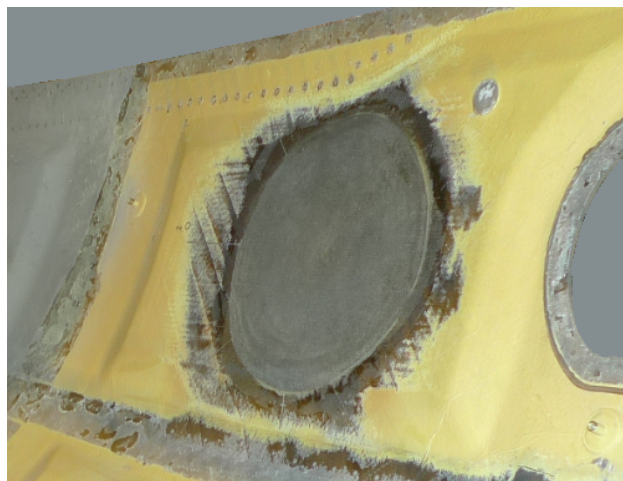
Figure 16. Final Repair.

The repair provided in this case study has not been included into the Chinook DMWR or any other U.S. Army technical data as of this writing. This is due to the need for testing (static and fatigue) of the laminate and bonded joint structure, further verification of the repair process, and damage tolerance development of the base structure. However, it served as an opportunity for further analysis from a statics perspective; based on publicly available material allowables. This

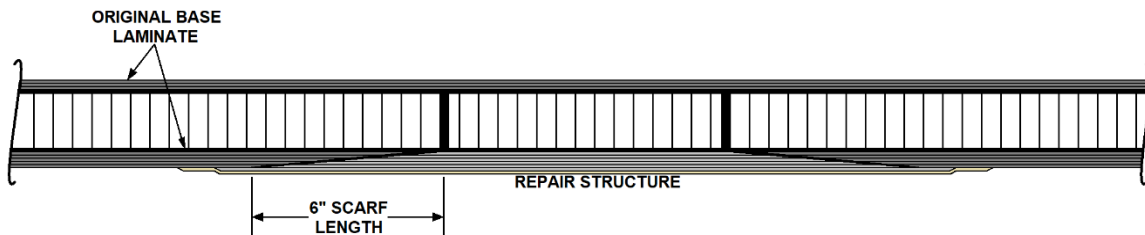
Figure 18. Scarf Repair Configuration.

While the repair performed on the subject Chinook crown skin employed a scarf type configuration as shown in Figure 18, this analysis will also consider a typical external bonded scab patch as shown in Figure 19 for comparison. Although the image is representative and not to scale, an additional carbon repair ply and external fiberglass ply were included in this repair and case study. This scarf repair uses a filler ply (included in analysis), and a 1/2-inch overlay per ply for a total scarf length of 6 inches per side. Alternatively, Figure 19 demonstrates the typical one-sided bonded scab patch repair. This configuration is assumed to include the same ply stacking and orientation sequence as the scarf repair but practically truncates the edges of the plies and uses a one inch overlay beyond edge of damage. In both repair cases, the opposite face of the skin panel is considered undamaged, there are no out-of-plane loading effects, and the repair laminate has been stabilized as is it bonded to the core and filler material.
