NRL REPORT F-3417

FULL SCALE SHOCK TESTS - USS NIAGARA APA87

PART 2 - FAILURES IN ELECTRONIC EQUIPMENT

February 15, 1949

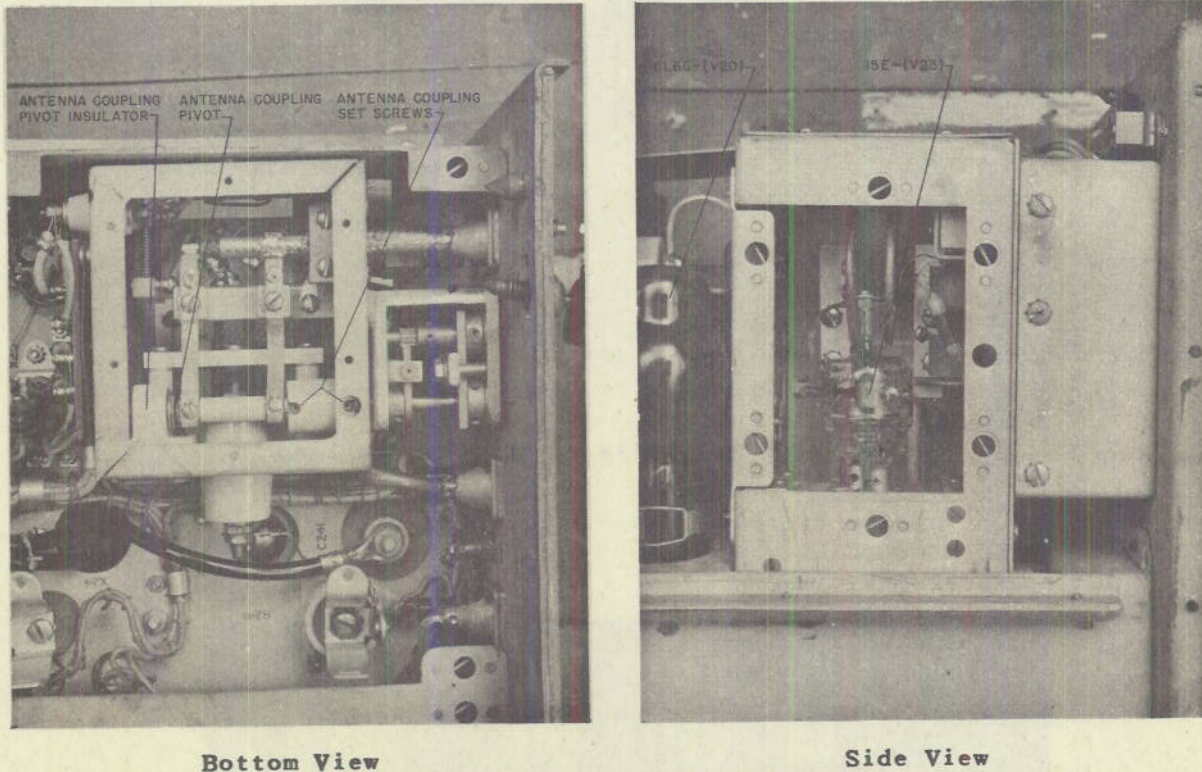
Figure 3- BN Oscillator Assembly Showing Components which Failed

The component that sustained the most failures in the Model BN equipment during the underwater explosion program was the 15E (V23) vacuum tube. This tube is used as the pulsed oscillator in the transmitter portion of the Model BN equipment and is mounted in the oscillator assembly by means of its filament leads which come directly through the glass envelope of the tube. Most of the envelope breakage of this tube occurred where the glass envelope was sealed to the filament leads. Other failures of this vacuum tube were open filament, no emission, and loss of vacuum.

Many failures of the variable-antenna coupling loop located in the transmitter-oscillator assembly were encountered. The loop became dislodged from its pivot and shorted out the oscillator high-voltage plate supply. (See Figure 3.) The force holding the coupling loop in place at its pivot was applied by a coiled spring imbedded in a small ceramic insulator which is fastened to one side of the oscillator assembly case. Figure 4 shows the details of the antenna coupling-loop assembly.

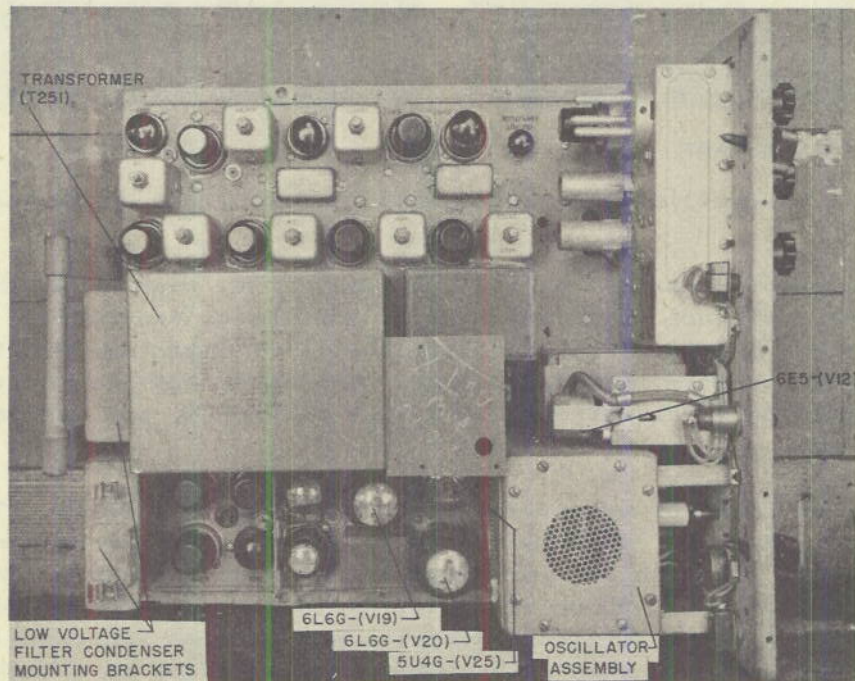
Figure 5 - Top View of BN Equipment Showing Components which Failed

The filament structure of the type 3B24 (V24) high-vacuum high-voltage rectifier tube could not withstand many of the shocks encountered during the program. This was indicated by the large number of disintegrated filaments found in this tube after many explosions. The other failures of this tube type were found to be loss of emission, loss of vacuum, and envelope breakage (Figure 5).

Envelope breakage of the type 5U4G(V25) and 6L6G (V20) vacuum tubes was due primarily to the close proximity of these tubes to the side of the oscillator assembly, so that during shock these tubes would col-

lide with the assembly causing fracture of the glass envelopes.

5. The failure to provide adequate clearance around the type 6L6G and 5U4G vacuum tubes accounted for a great many failures. It cannot be stressed too strongly that adequate clearance of a minimum of 1/2 inch around each vacuum tube is absolutely essential. No amount of ruggedization of the internal structure of a tube will be of any benefit if the envelopes are broken from impact with adjacent objects.

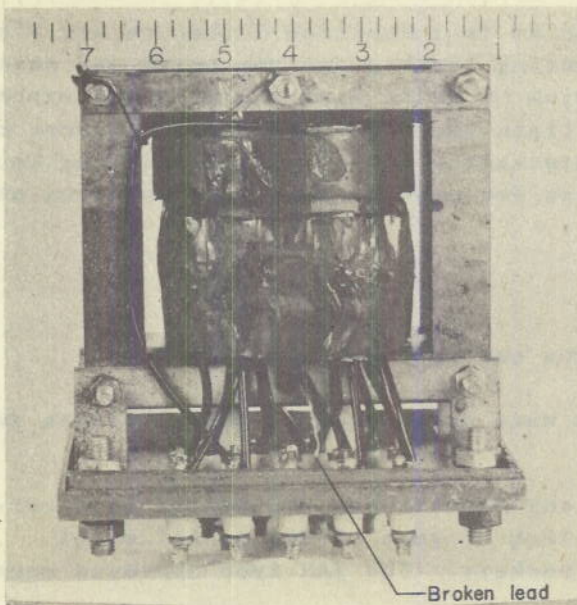
Figure 6- Power Transformer with Case Removed

A total of 11 power transformers failed during the tests. These transformers (T251 - Navy No. 301201) failed principally from breakage of the transformer leads from the core windings to the case feed-thru insulators. The windings and the laminated core of this transformer are secured to the bottom mounting plate of the oil-filled protecting case by two right-angle brackets (Figure 6). These brackets and the transformer assembly act as a cantilever beam supported by one side of the transformer housing. There was approximately 1/4 inch clearance between the unsupported end of the transformer and the housing, so that during a severe shock, that end of the transformer was

able to vibrate with 1/2 inch excursion. This vibration back and forth probably fatigued the lead wires causing the apparent transformer failures. The probability of failure was increased by the fact that the leads between the windings and the terminal board were multistrand copper wires, tinned a considerable portion of their lengths. This greatly stiffened those sections and increased the chances of fatigue where the lead was soldered to the feed-thru insulator.

7. The support of the power transformer in its oil tight case was mechanically poor. An additional support at the opposite end of the case would have eliminated the excessive motion and reduced transformer failures.

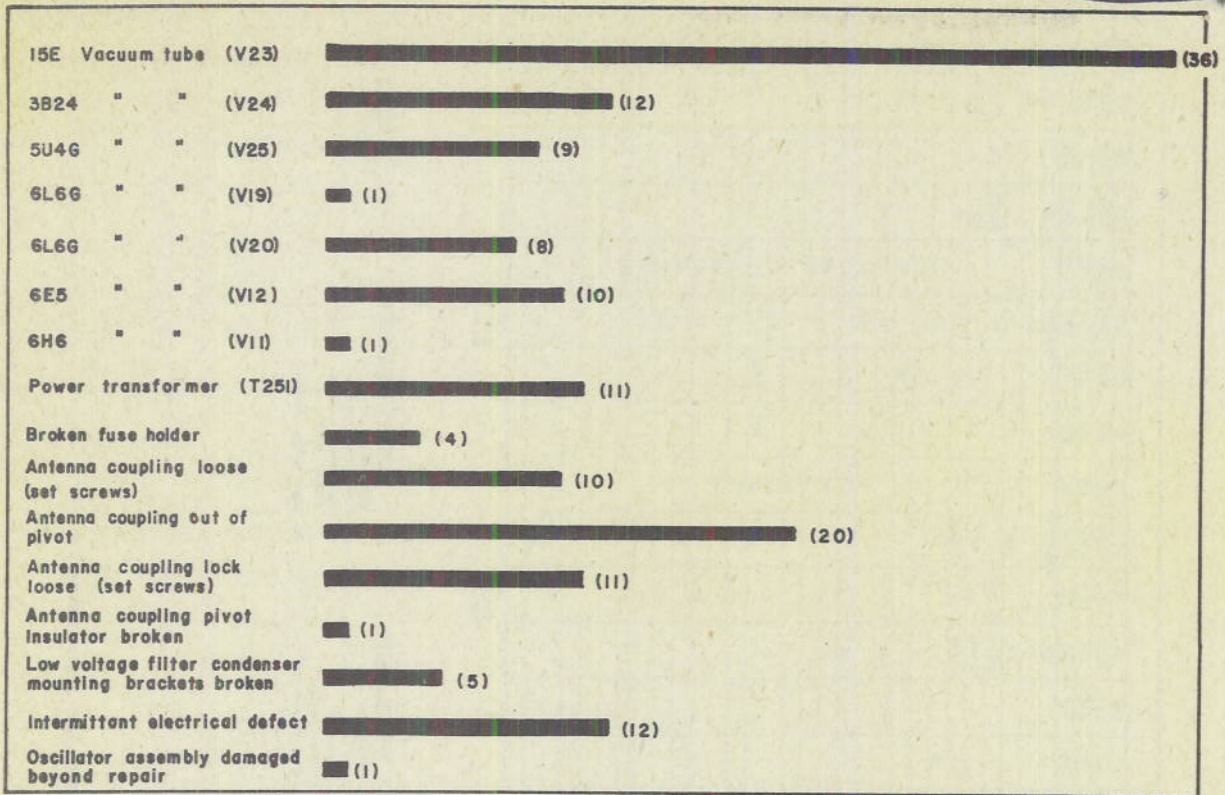
Figure 8- Comparison of Failures in BN Equipments

The chart of equipment failures, Figure 7, lists an intermittent electrical defect. An equipment failure was listed in this class if the equipment failed to operate properly when first energized after a shot. The equipment would ordinarily be withdrawn from the housing for a detailed inspection, whereupon the equipment would function normally. If no visible defects were observed, and no further intermittent operation was observed after a few minutes of operation, the equipment would again be secured in its housing. It was later discovered that many of these intermittent electrical failures were probably due to loose or intermittent contacts of transformer leads inside the transformer cases. Small motions produced when the units were withdrawn would restore contact and the equipment would operate normally. Figure 8 presents graphically the total number of failures of each type.
